# COLLIERS WOOD

# TECHNICAL INFORMATION

194-196 HIGH STREET, COLLIERS WOOD, SW19 2BN

# TFL\_PSF\_9131 SITE INVESTIGATIONS: SMALL SITES INITIATIVE SITE OPPOSITE COLLIERS WOOD STATION, MERTON, SW19 2BN

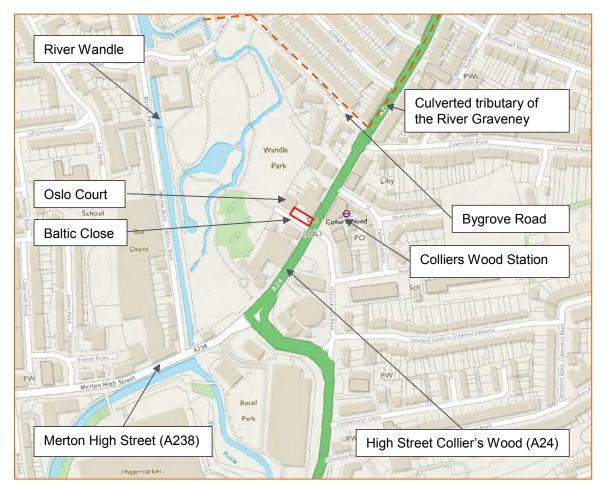
Figure 1: Site Location. Site Boundary Outlined in Red.
Contains Ordnance Survey data © Crown copyright and database right 2016. All rights reserved.

The Site is located at the end of a terrace plot and consists of vacant, paved land, currently used as a car park. The Site is located within a generally suburban setting and is surrounded by residential, commercial and public buildings as well as some green open spaces. The Site is bounded by High Street Collier's Wood (A24) to the east, Baltic Close to the south, Oslo Court (apartment block) to the west and residential properties to the north, as shown in Figure 1.

A side channel of the River Wandle splits off the right bank of the watercourse and flows through Wandle Park approximately 100m to the west of the Site. The side channel connects to a small pond, and then re-joins the main channel (see Figure 1).

The River Graveney, an EA designated Main River, flows westwards approximately 500m north of the Site and confluences with the River Wandle approximately 900m northwest of the Site. The River Graveney is a heavily modified watercourse and a culverted tributary of the river flows southwards along High Street Collier's Wood and then turns westwards along Bygrove Road towards the River Wandle. At its closest, this culverted watercourse is located less than 100m north of the Site (see Figure 1).

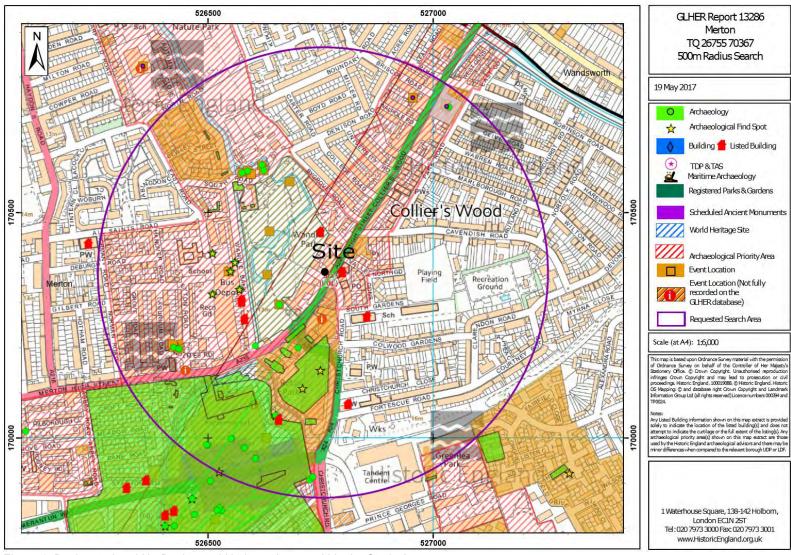
Figure 1: Designated and Un-Designated Heritage Assets within the Study Area

Numbers in brackets in the text are unique identifiers assigned to heritage assets for the purposes of this report. A list of all heritage assets including archaeological events can be found on Tables 1 and 2. All heritage assets and APAs are shown on Figure 1.

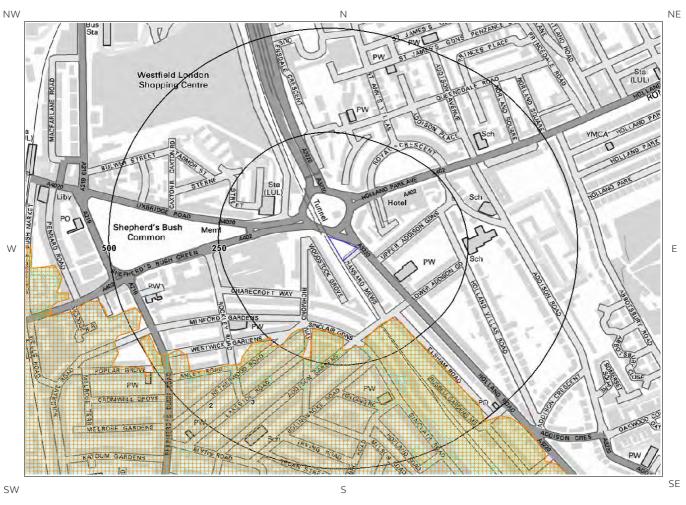
# 7a. Environment Agency/Natural Resources Wales Flood Map for Planning (from rivers and the sea)

The EA *Flood Map for Planning* identifies the Site as within Flood Zone 2. Following the NPPF guidance, the Site would be suitable for all development types, but triggering the requirement for application of the Exception Test for '*Highly Vulnerable*' developments (which includes emergency services stations and command centres; basement dwellings; caravans, mobile homes and park homes intended for permanent use; and installations requiring hazardous substance consent). Use for '*More Vulnerable*' development, including residential land use, is appropriate in this Flood Zone in accordance with the NPPF, subject to satisfaction of the Sequential Test, which steers new development to Flood Zone 1. A Flood Risk Assessment (FRA) would need to be prepared in support of a planning application for any development on the Site.

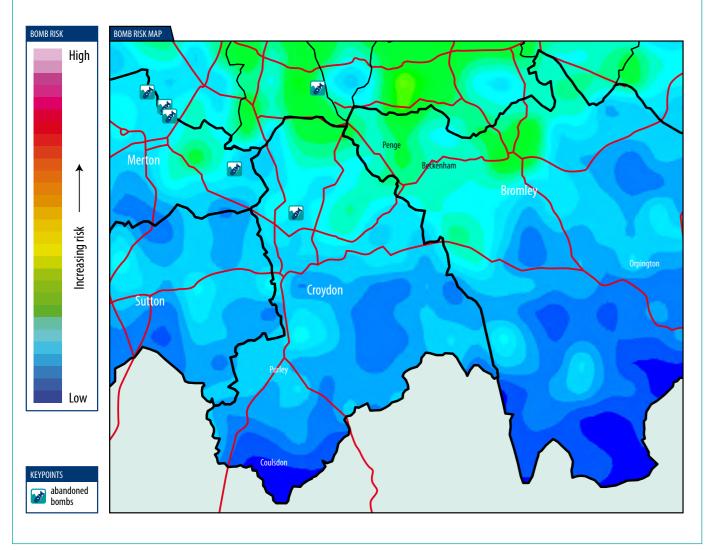
#### Risk mitigation map

This map is based on Zetica's bomb risk map and can be used as a guide to the relative risk of intrusive activities such as piling, drilling or deep bulk excavation, and the likelihood that some form of risk mitigation may be recommended. However, this map is a guide only and, in practice, a detailed desk study may conclude that extensive risk mitigation is not required even in a high risk area.

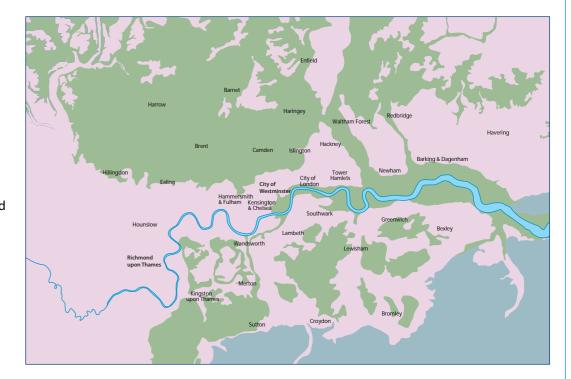
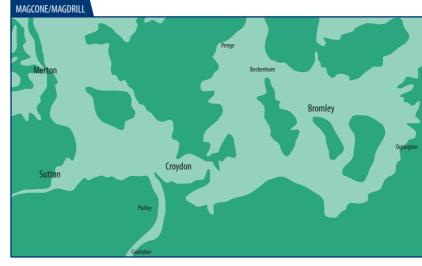
#### MagCone/MagDrill map

For the London area, the geology is extremely complex with a complicated succession that includes several units that are unsuitable for MagCone techniques. To give a first order approximation as to which technique might be appropriate for a site, a simplified map has been produced. This map has been compiled from the BGS Solid and Drift map sheets 256, 257, 270 and 271. The complex geology has been reduced to three areas coloured grey, green and pink. Areas that involve units that are probably only suitable for MagDrill, which include gravels, are shown in

pink. Areas that involve units probably suitable for MagCone, such as London Clay or alluvium, are coloured green. Where chalk crops out at surface or there is negligible soil cover over chalk,

it is shown in grey.

This map is for indicative purposes only and specific site geology needs to be taken in to account, especially close to the boundaries shown on the map.

This map compilation provides a guide to appropriate intrusive UXB detection methods.

The unexploded bomb (UXB) risk for intrusive site works, such as drilling or piling that usually extend to depths greater than can be mapped from surface, can be effectively managed by clearing borehole or pile locations using MagCone or MagDrill techniques.

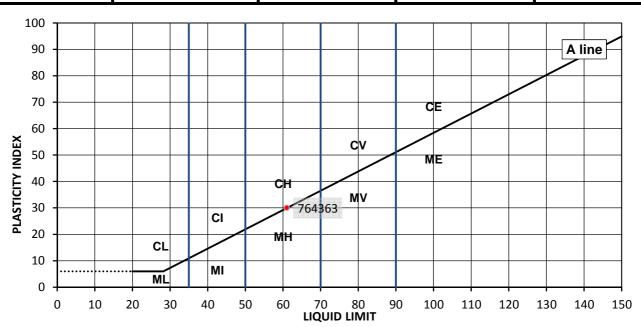
Depth Base [m]: 2

As Received	Liquid Limit	Plastic Limit	Plasticity Index	% Passing 425µm
<b>Moisture Content [%]</b>	[%]	[%]	[%]	BS Test Sieve
48	61	31	30	99

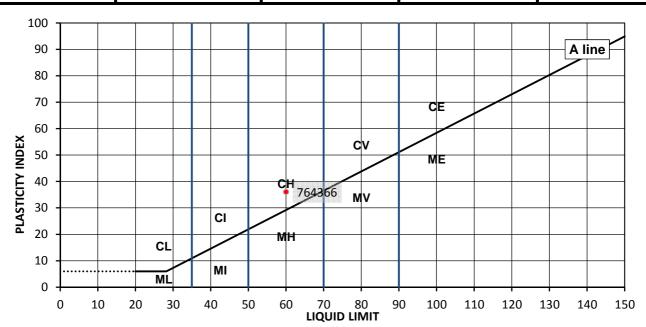
Depth Top [m]: 4.8 Depth Base [m]: 5

As Received	Liquid Limit	Plastic Limit	Plasticity Index	% Passing 425µm
<b>Moisture Content [%]</b>	[%]	[%]	[%]	BS Test Sieve
26	60	24	36	82

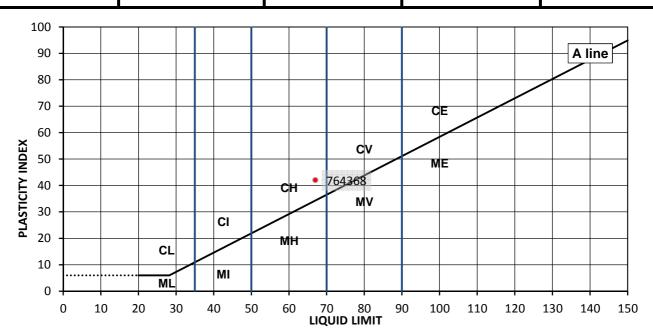
Location: WS102 Depth Top [m]: 4.8 Sample Preparation: Depth Base [m]: 5

As Received Liquid Limit Plastic Limit Plasticity Index % Passing 425µm Moisture Content [%] [%] [%] [%] BS Test Sieve
