CHRISTCHURCH ROAD

TECHNICAL INFORMATION

LAND AT CHRISTCHURCH ROAD, BRIXTON HILL, SW2 4AP

**Geotechnical and Geo-Environmental Desk Study and
Preliminary Investigation**

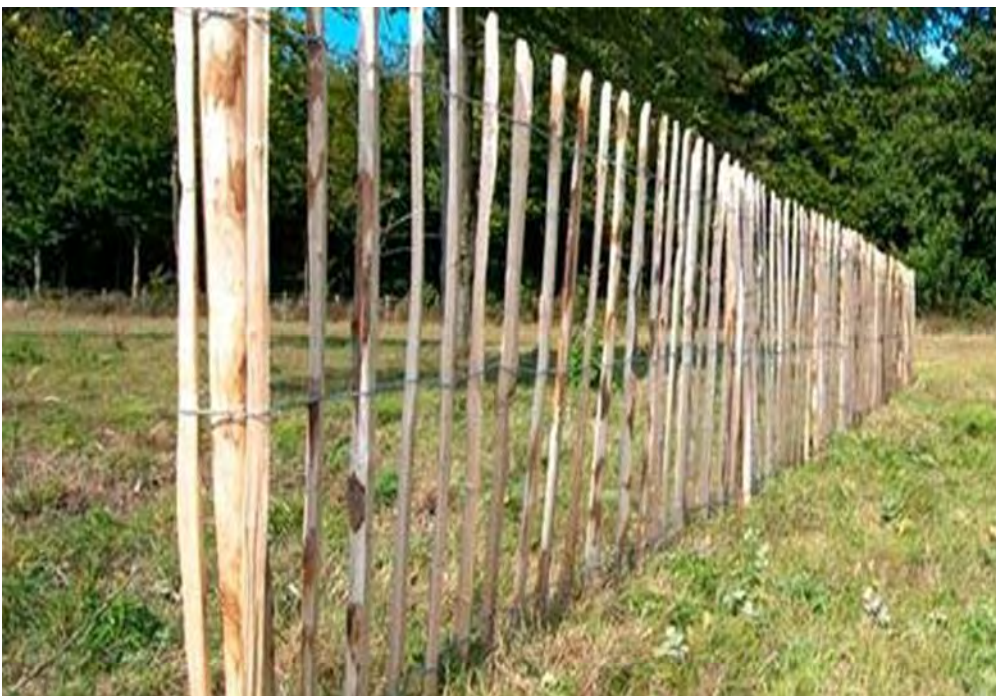
Figure C1 Tree Protection fencing example for low use areas

The system illustrated in Figure C1 is adequate to define areas of protected vegetation and exclude traffic, and comprises Cleft Chestnut Pale Fence in accordance with *BS 1722 Part 4: Specification for cleft chestnut pale fences (British Standards Institution, 1991)* supported by 150mm wooden stakes. Assembled with galvanized 14-gauge (2 mm) wire, four strands per row, peeled and pointed one end. Approximate spacing of pales 75 mm.

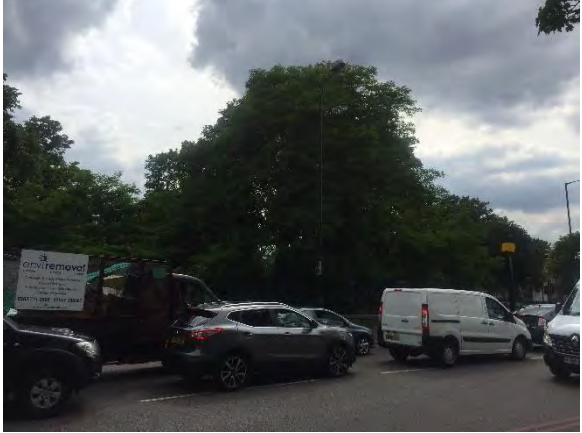
Tree No.	Description	Photograph
T8 London plane	T8 London plane (<i>Platanus x hispanica</i>) is protected by a TPO No. 160 1980. The tree is easily visible from the surrounding public highway

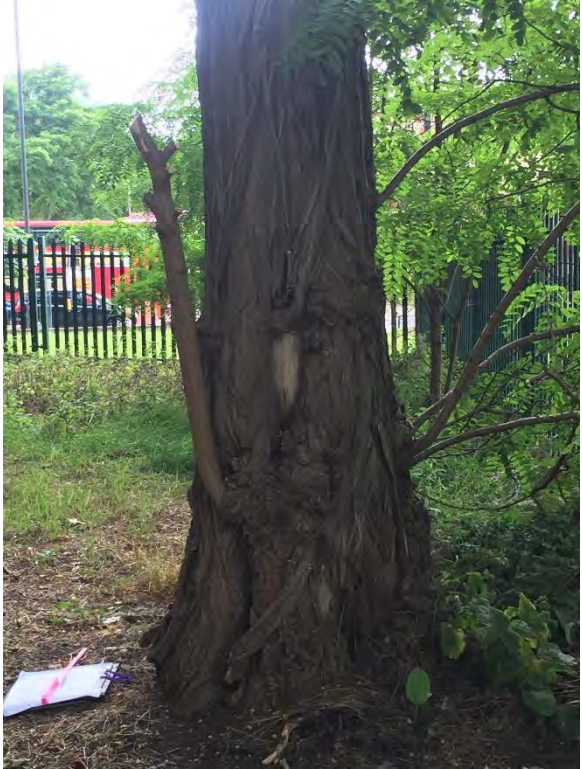
T15 false acacia	Poor structural condition of the Category U tree

Two on-Site false acacias (*Robinia pseudoacacia*) (protected by TPO no.160) have been categorised as Category U trees given their dangerous structural form and they are located within failure distance of the public highway. One of these is protected by a TPO and a five days notice of an imminently hazardous and or dangerous tree has to be submitted to the LPA before any tree works take place.

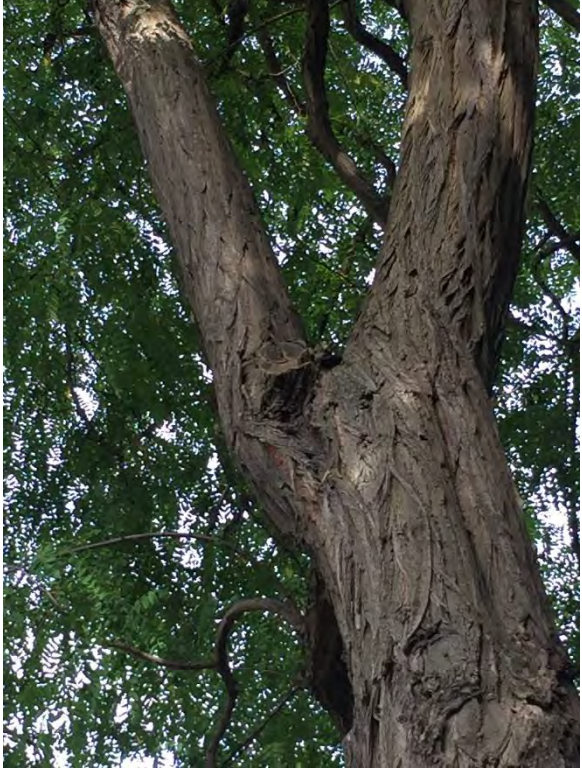
Tree No.	Description	Photograph
T15 false acacia	Western upper stem the right-hand side apical attachment is suboptimal and increase the risk of failure of this part of the tree

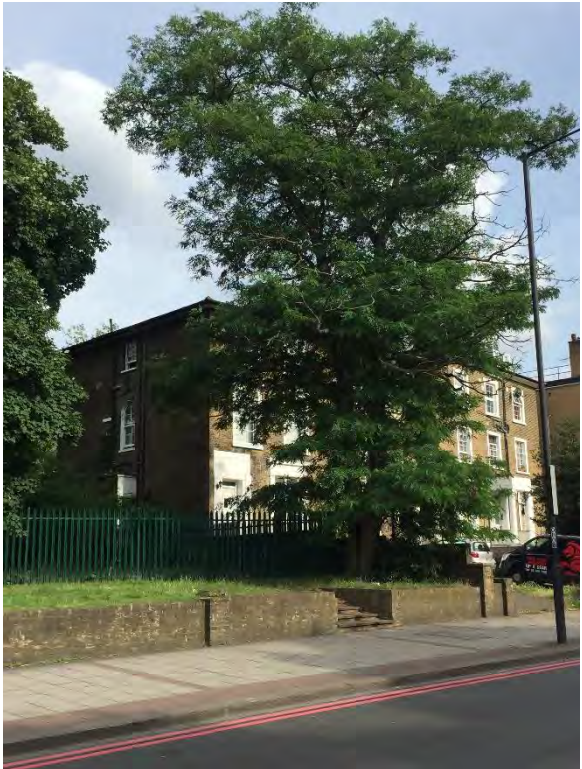
T14 false acacia	North and western side of tree dead wood on western canopy over the roadway Category U tree

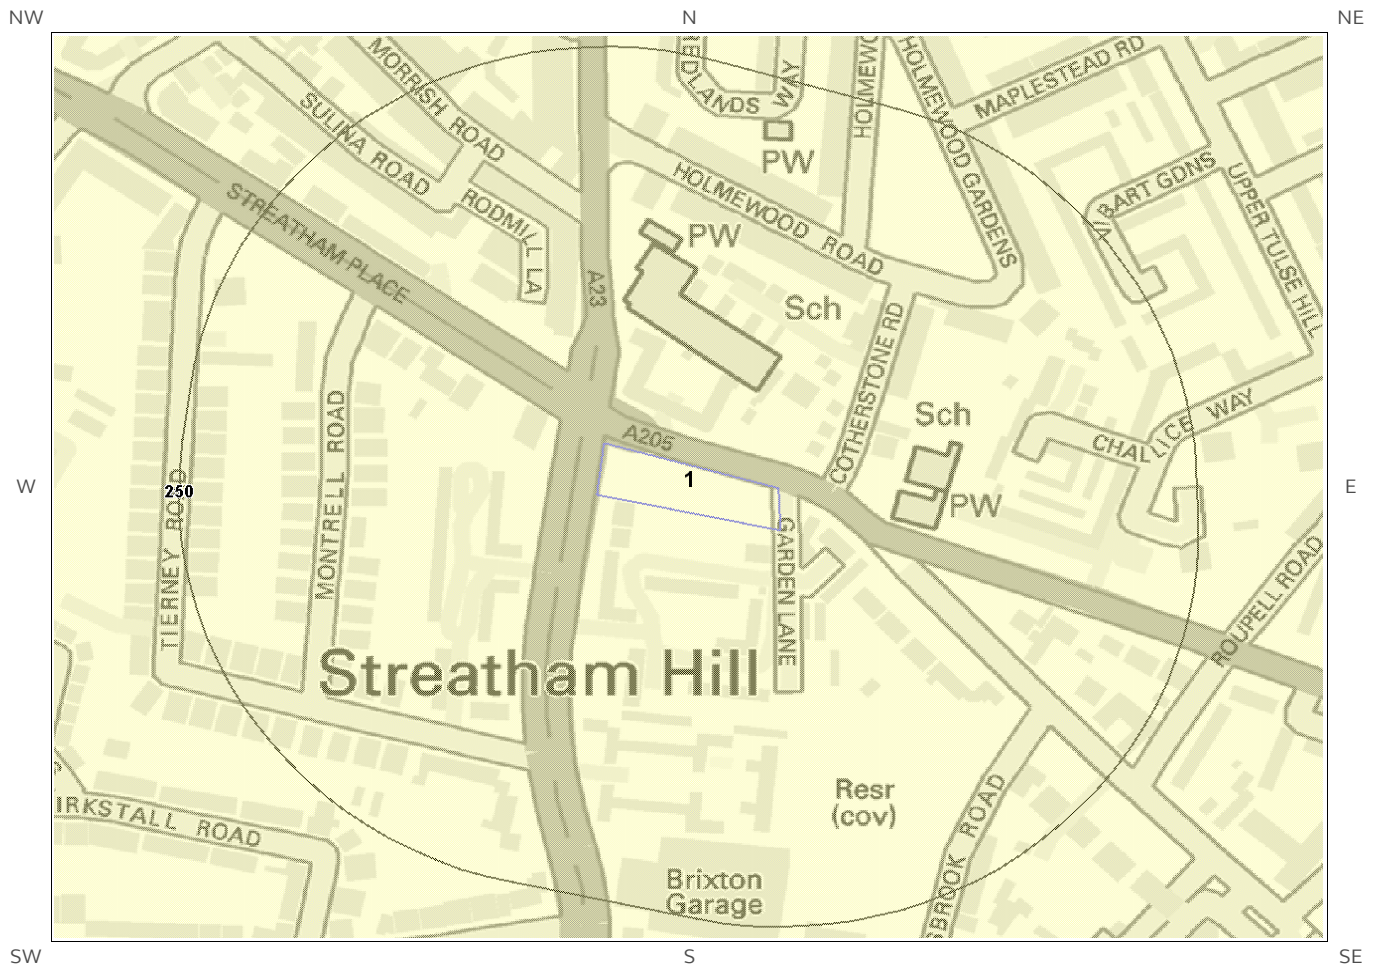
6.3 Ground Dissolution of Soluble Rocks Map

ID	Distance (m)	Direction	Hazard Rating	Details
1	0.0	On Site	Negligible	Soluble rocks are present, but unlikely to cause problems except under exceptional conditions. No special actions required to avoid problems due to soluble rocks. No special ground investigation required, and increased construction costs or increased financial risks are unlikely due to potential problems with soluble rocks.

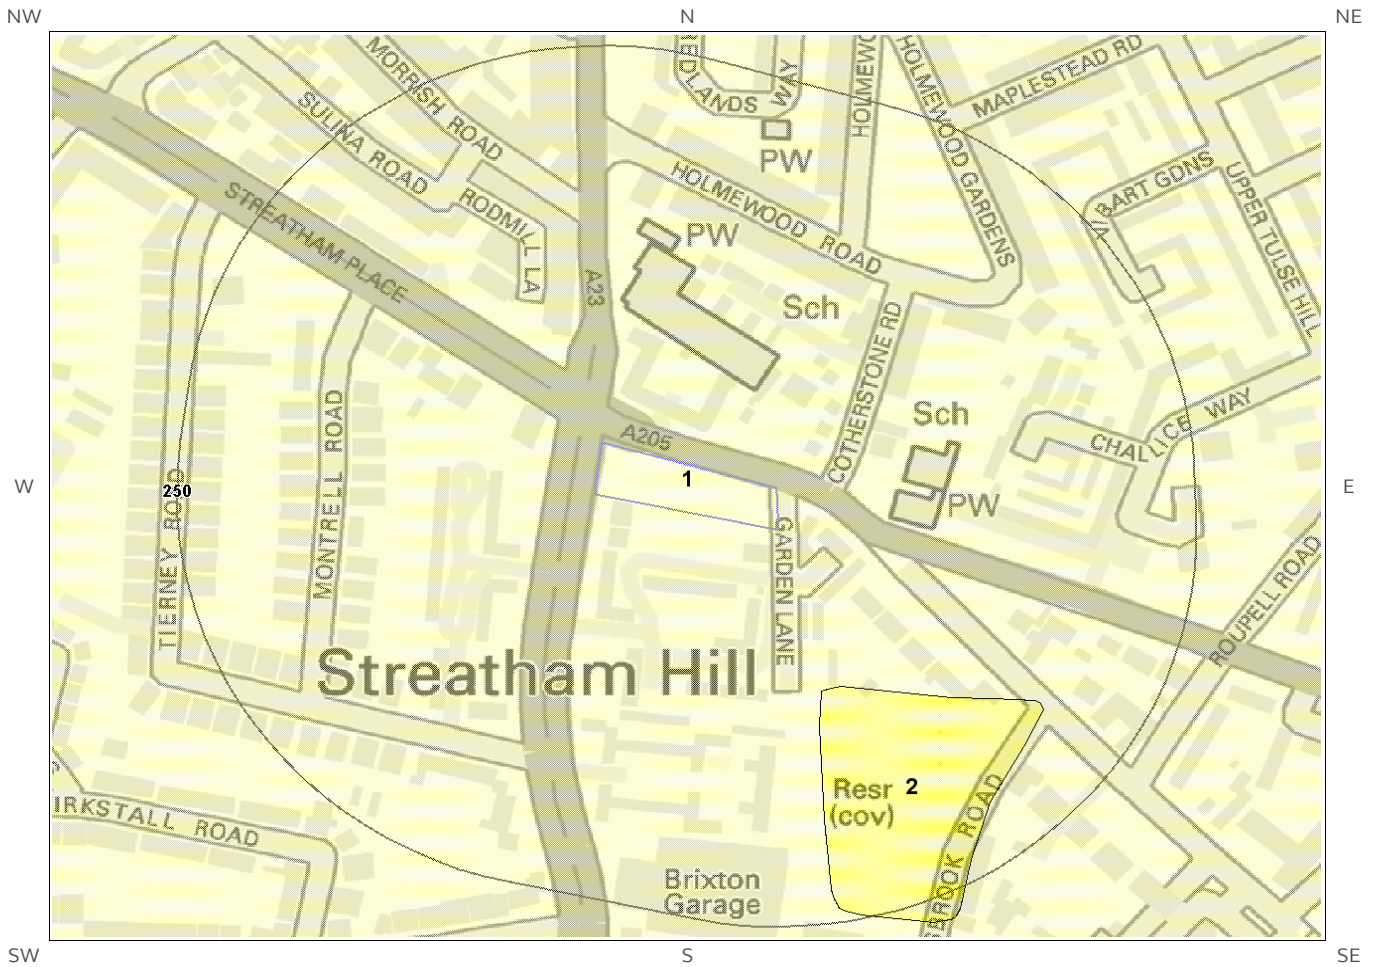
6.4 Compressible Deposits Map

ID	Distance (m)	Direction	Hazard Rating	Details
1	0.0	On Site	Negligible	No indicators for compressible deposits identified. No special actions required to avoid problems due to compressible deposits. No special ground investigation required, and increased construction costs or increased financial risks are unlikely due to potential problems with compressible deposits.

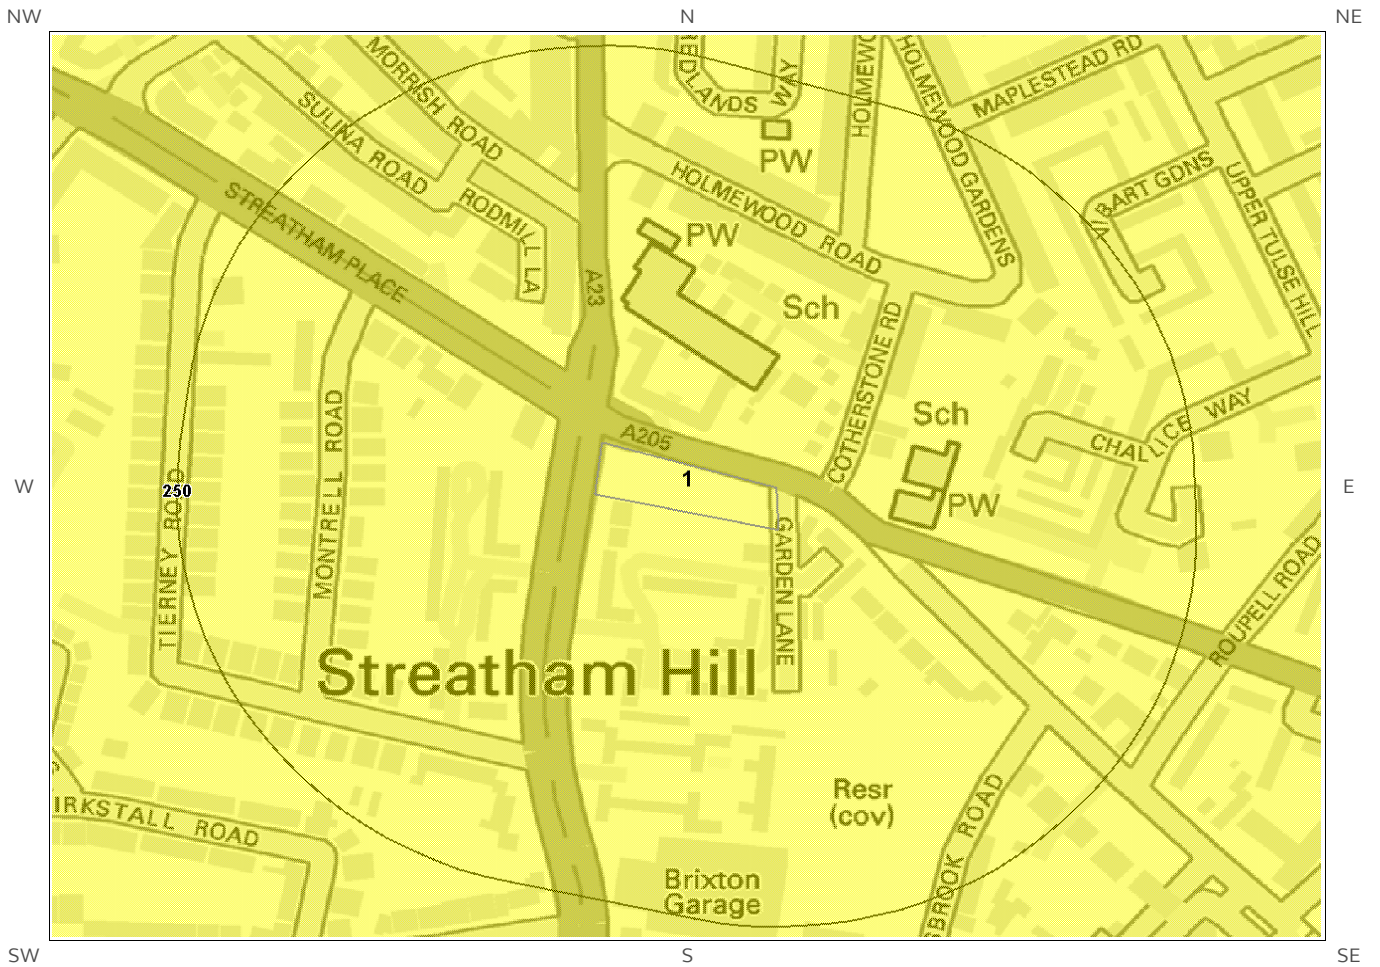
6.5 Collapsible Deposits Map

ID	Distance (m)	Direction	Hazard Rating	Details
1	0.0	On Site	Very Low	Deposits with potential to collapse when loaded and saturated are unlikely to be present. No special ground investigation required or increased construction costs or increased financial risk due to potential problems with collapsible deposits.

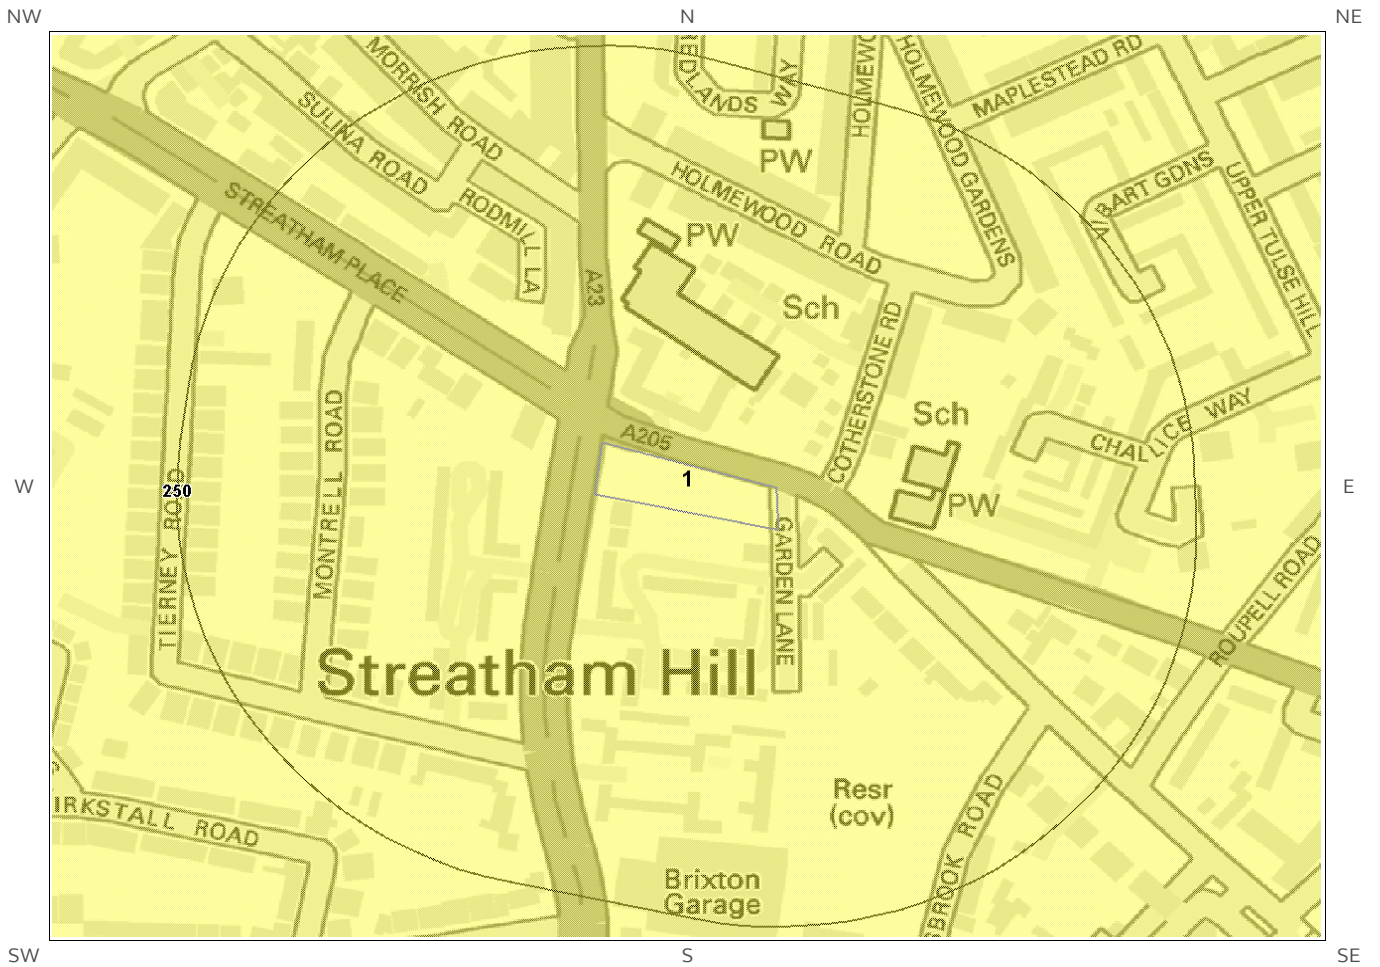
6.6 Running Sand Map

ID	Distance (m)	Direction	Hazard Rating	Details
1	0.0	On Site	Very Low	Very low potential for running sand problems if water table rises or if sandy strata are exposed to water. No special actions required, to avoid problems due to running sand. No special ground investigation required, and increased construction costs or increased financial risks are unlikely due to potential problems with running sand.

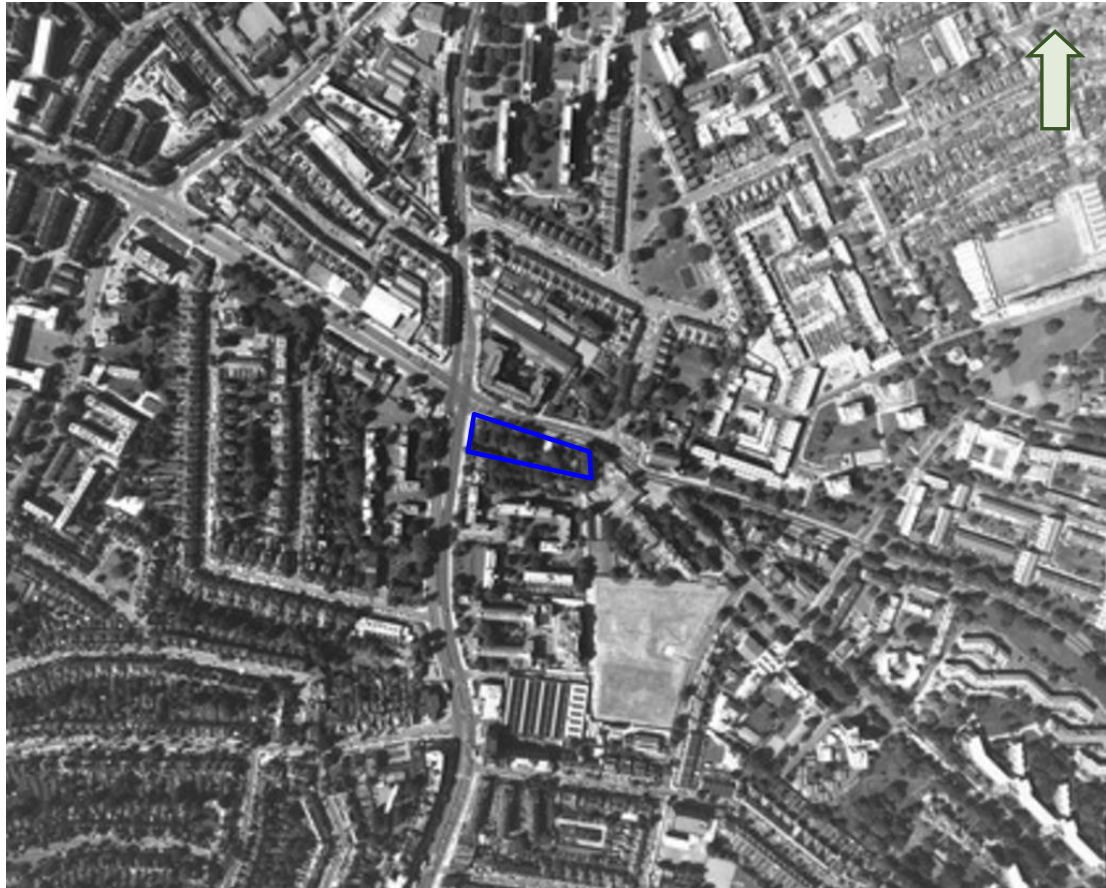
Plate 3	Aerial photograph, 11 th July 1987

The bungalows on the Site were demolished in the 1970s. Plate 3, an aerial photograph dated the 11th July 1987, shows that the Site now comprised heavily vegetated open ground.

The bungalows on the Site were demolished in the 1970s. Plate 3, an aerial photograph dated the 11th July 1987, shows that the Site now comprised heavily vegetated open ground.

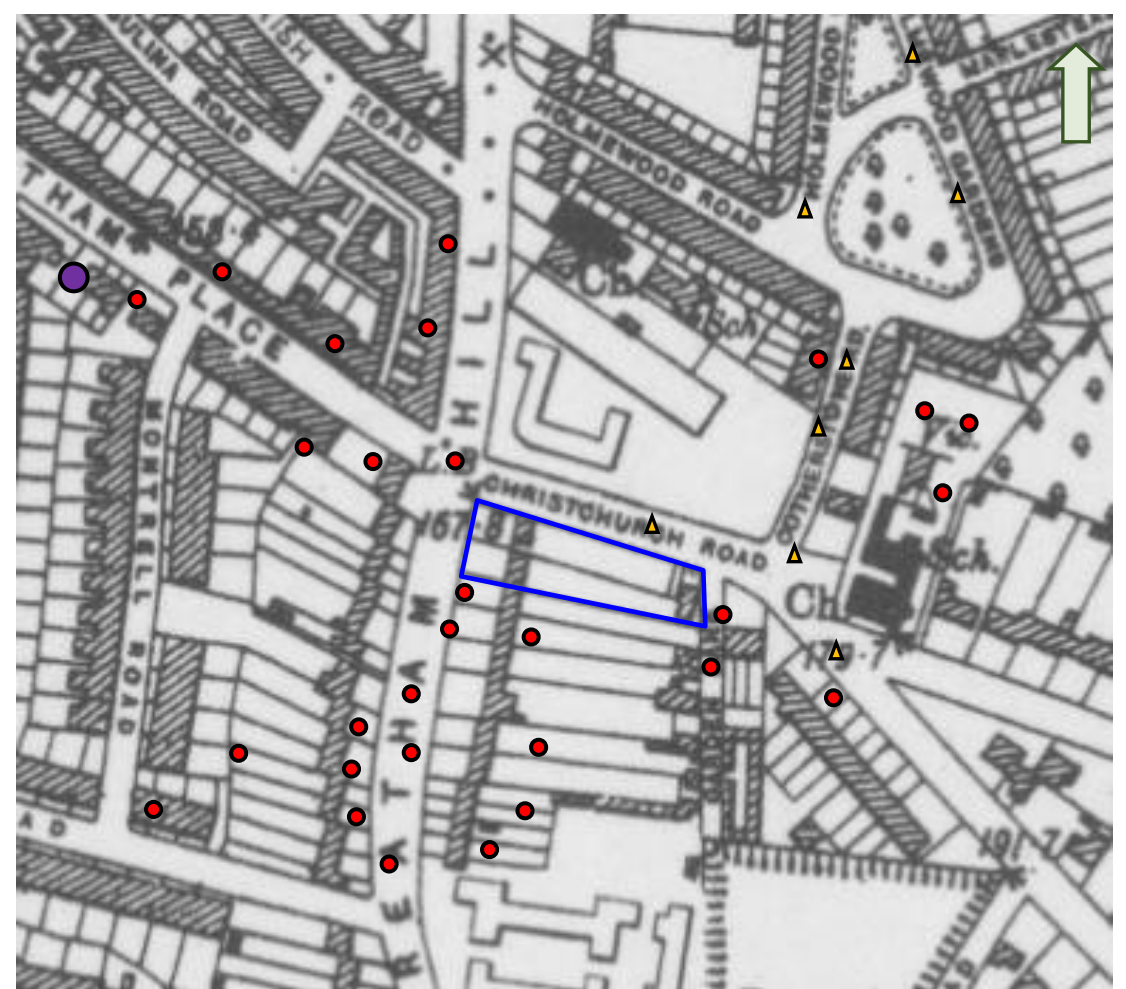
Figure 4 Compiled bomb impact map for the vicinity of the Site

Figure 4 is a map showing the approximate locations of recorded bomb impacts in the vicinity of the Site. IBs shown are indicative of large numbers of similar devices that fell within the given area. The map has been compiled from a number of different sources, including air raid incident reports, bomb census maps and historical aerial photographs.

Note that air raid incident reports did not always record precise locations, often only indicating on which street or area a bomb fell.

Figure 4 is a map showing the approximate locations of recorded bomb impacts in the vicinity of the Site. IBs shown are indicative of large numbers of similar devices that fell within the given area. The map has been compiled from a number of different sources, including air raid incident reports, bomb census maps and historical aerial photographs.

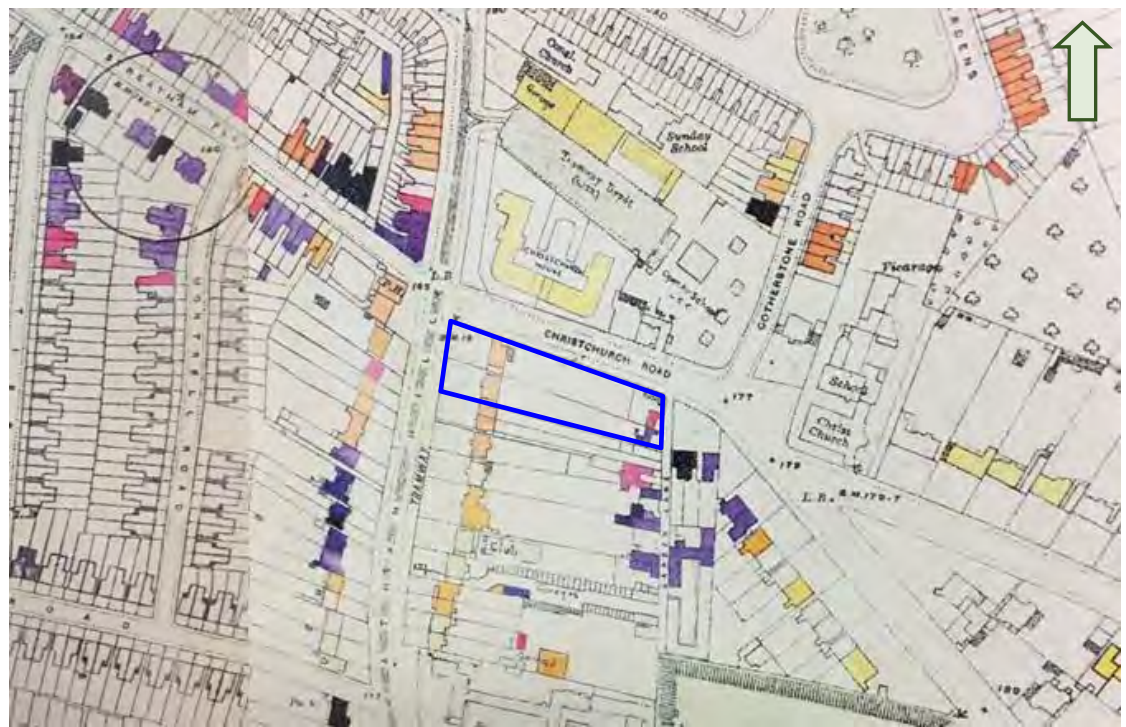
Figure 5 Extract from the London bomb damage map

Figure 5 is an extract from the London County Council (LCC) bomb damage map, compiled at the end of WWII, on which the colouring denotes the severity of damage to buildings.

The bomb damage map indicates that major damage occurred on and in close proximity to the eastern part of the Site. Blast damage is recorded on the western part of the Site.

Figure 5 is an extract from the London County Council (LCC) bomb damage map, compiled at the end of WWII, on which the colouring denotes the severity of damage to buildings.

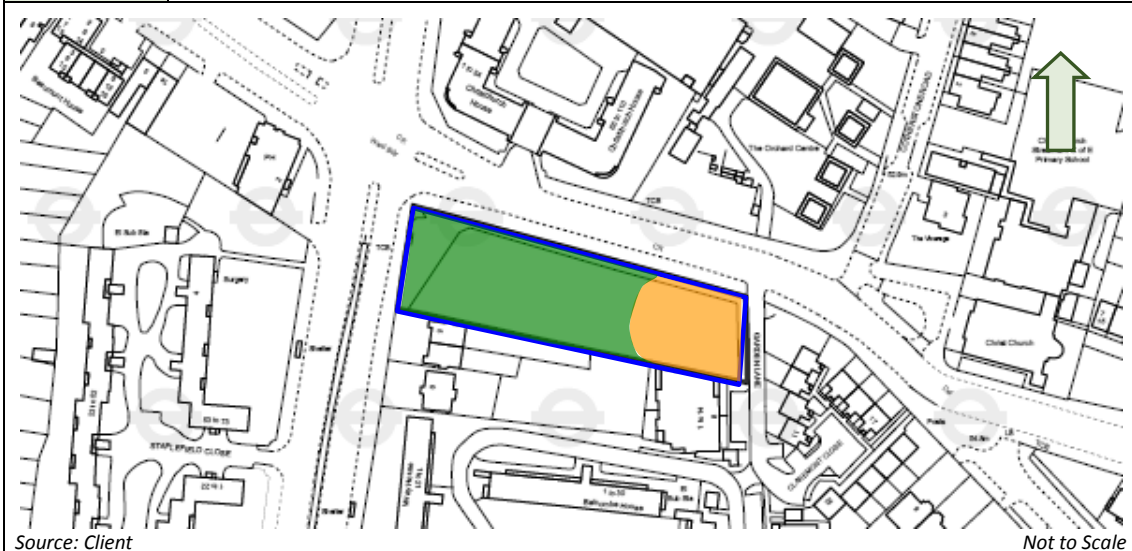
Figure 6 UXO hazard zone plan of the Site

Legend	Very Low	■	Low	■	Moderate	■
	High	■	Very High	■	Site boundary	—

The west and central areas of the Site are considered to have a 'moderate' potential of encountering unexploded ordnance (UXO). For future excavations or piling which may be proposed within the east of the Site (Moderate UXO hazard level), a non-intrusive UXO detection survey, or monitoring by an Explosive Ordnance Clearance (EOC) Engineer where a survey is impractical, is recommended to mitigate the potential UXO risks. Further details are in the UXO report which is included as an Appendix in the Preliminary Geotechnical and Geo Environmental Report (Ref 5).

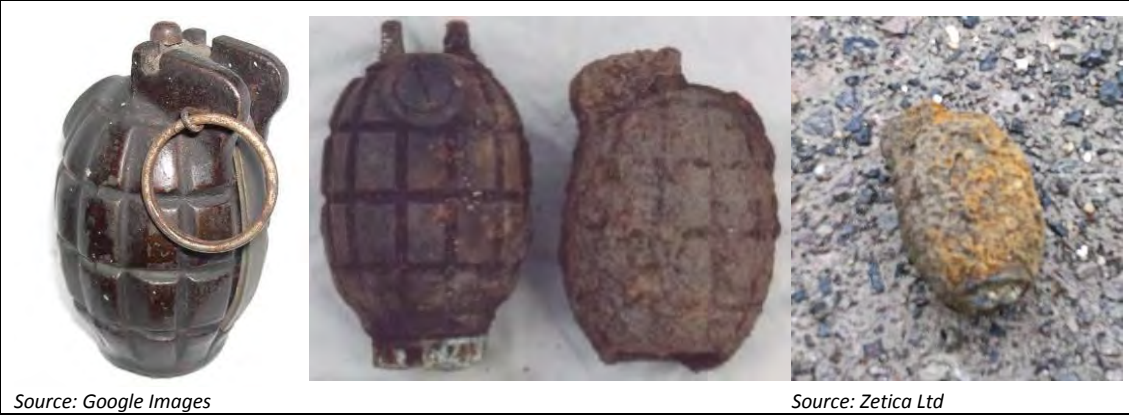
Some, such as smoke grenades, are activated instantly when the lever is released. The Plate below illustrates the typical character and condition of No. 36 hand grenades (Mills Bombs) that have been excavated from a site.

Plate Photographs of a typical and an excavated WWII No. 36 hand grenades

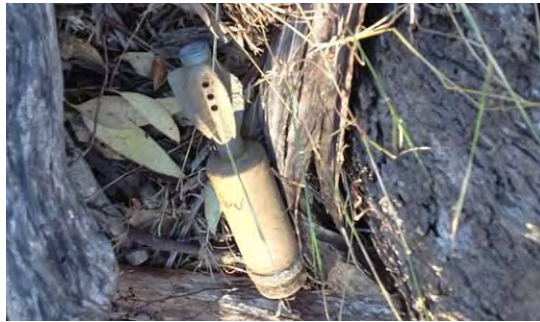
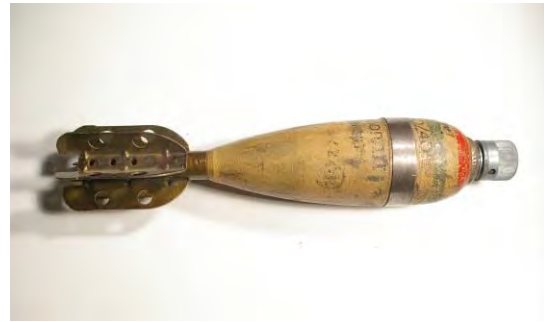
The Plate below shows a typical 2-inch mortar bomb found (left) and a demonstration 3-inch mortar bomb (right).

Plate	Photographs of WWII 2-inch and 3-inch mortars
--------------	---

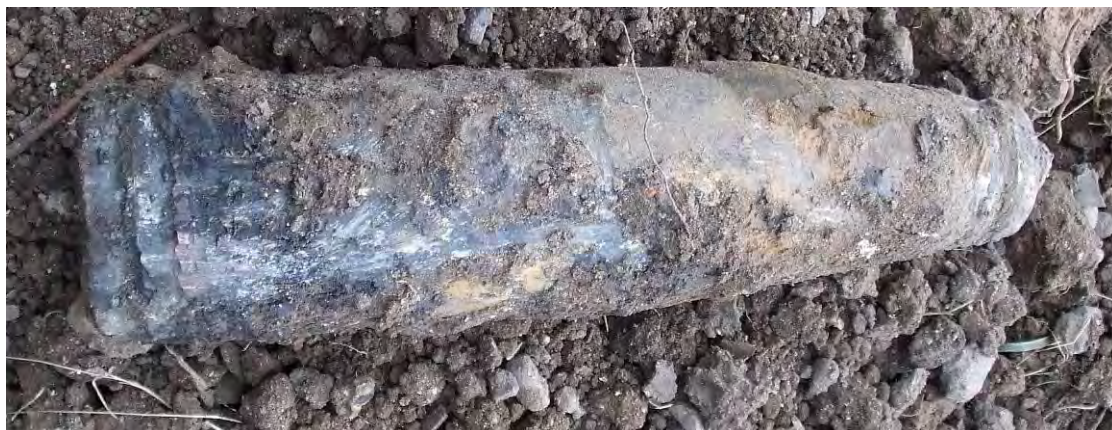
The Plate below is a photograph of a 3.7" UXAA shell found in Camberwell, London.

Plate	Photograph of a recently excavated 3.7" AA shell
--------------	--

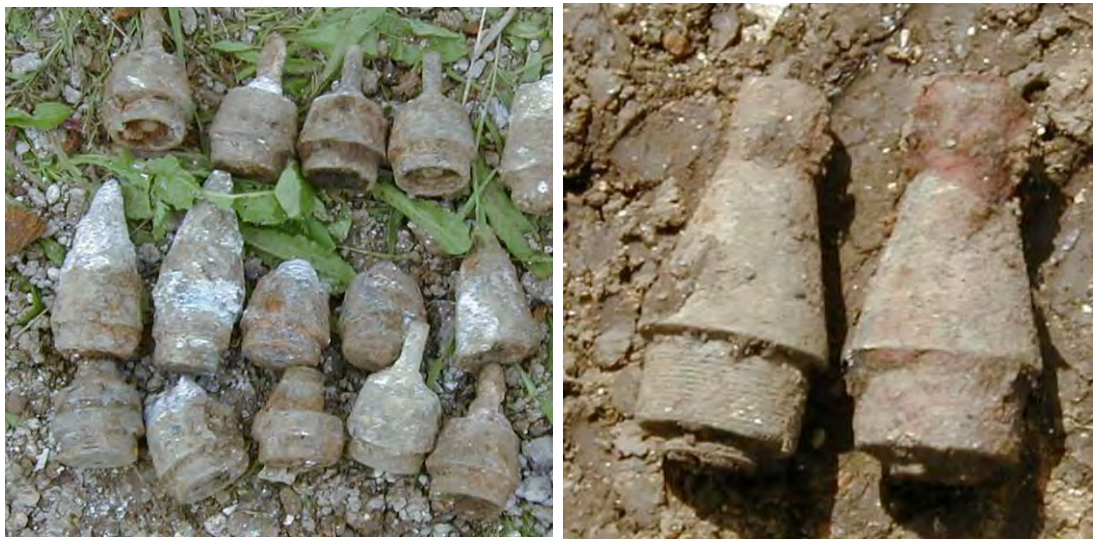
A wide variety of these components were used and examples of some common fuzes are shown in the Plate below.

Plate Photographs showing examples of WWII fuzes

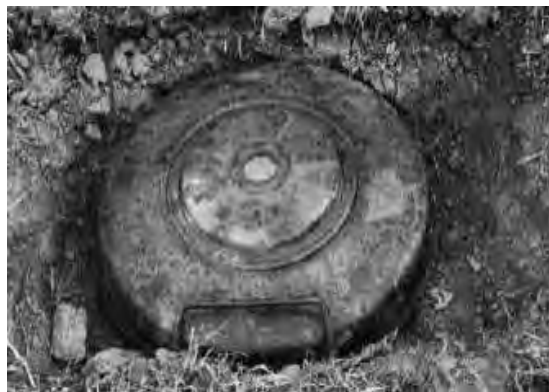
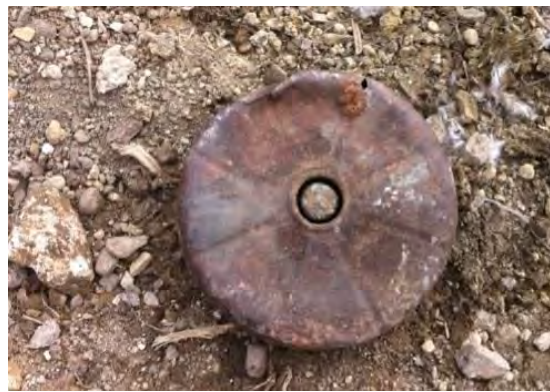
The Plate below is a photograph of a typical WWII land mine used on the land area, beaches and cliffs around Britain. This example was found at Gatwick Airport formerly RAF Gatwick.

Plate Photographs of original and recently excavated WWII land mines

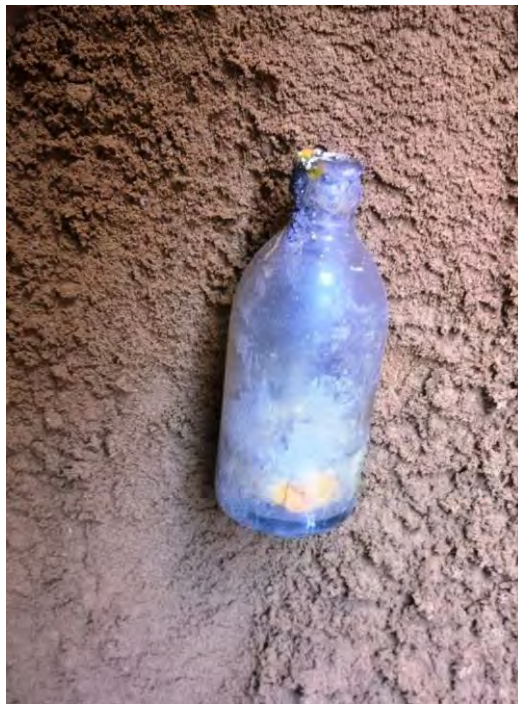
The Plate below is a photograph of a No. 76 SIP grenade (LHS) with an explanatory leaflet produced by ZeticaUXO for site staff (RHS).

Plate Photograph of the No. 76 SIP grenade

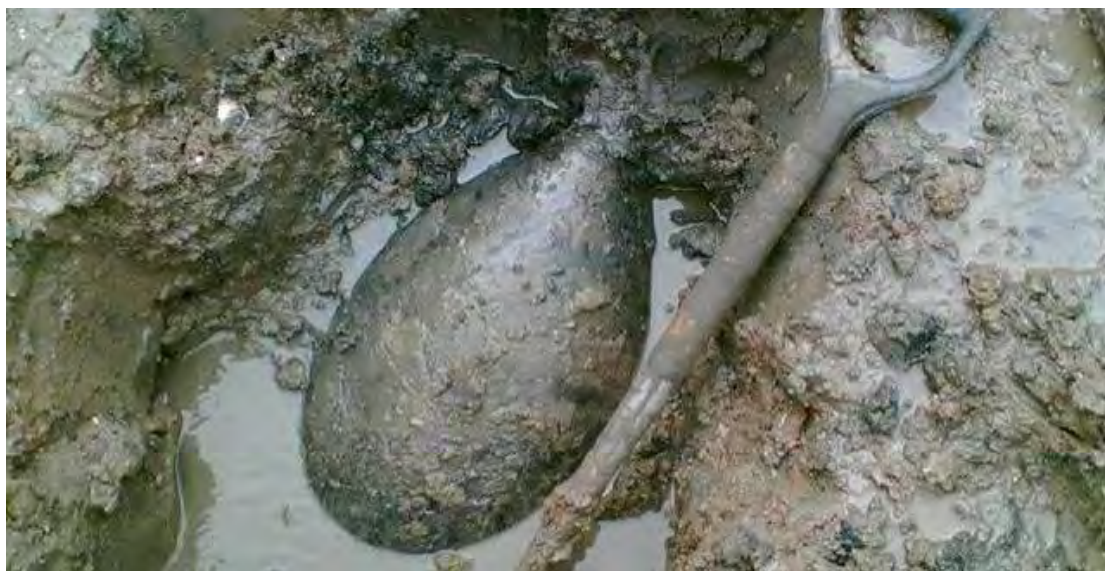
The Plate below is a photograph of the bomb in situ.

Plate Photograph of the 500kg WWII UXB at Bowers Marsh, 8th March 2010

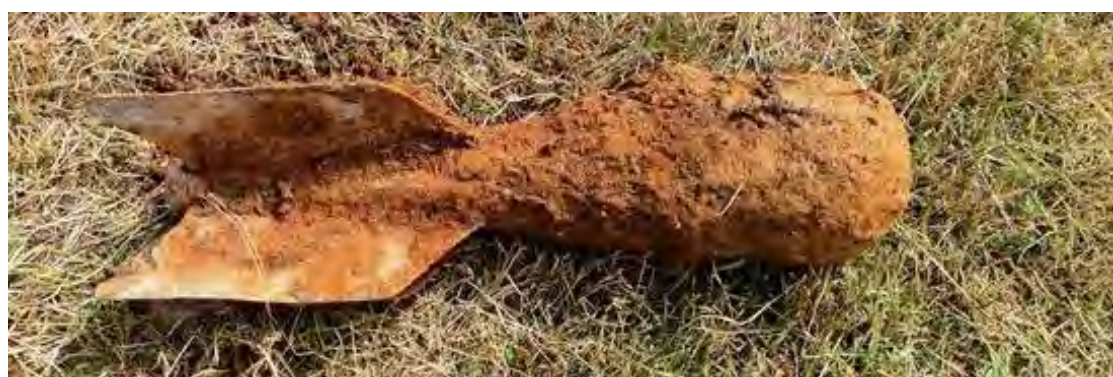
1No. WWI bomb (shown in the Plate below) was found on the Isle of Sheppey on the 2nd August 2012 during a geophysical survey following desk study research by Zetica Ltd which had established that a previously unknown WWI bombing range existed on the site. A further WWI bomb was found in the same location in August 2015.

Plate	Photograph of WWI bomb, Isle of Sheppey, 2 nd August 2012
--------------	--

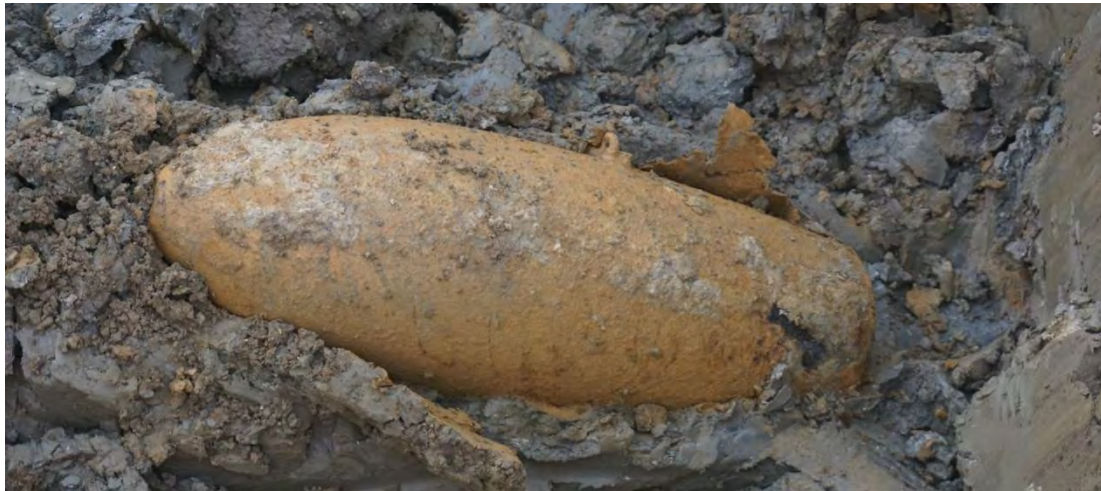
Plate

Photograph of a recently excavated WWII British 500lb GP bomb

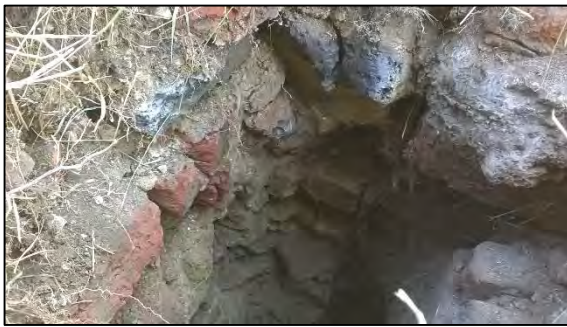
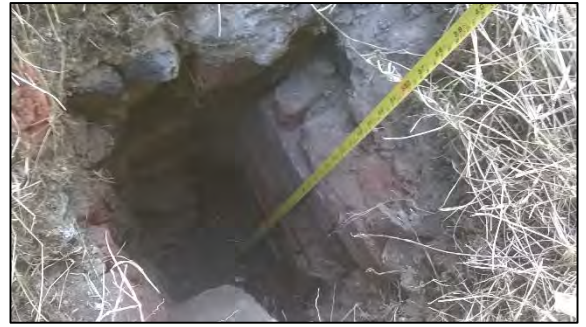
PHOTOGRAPHS

WS104 hand pit
Relic (foundation?)
brick structure

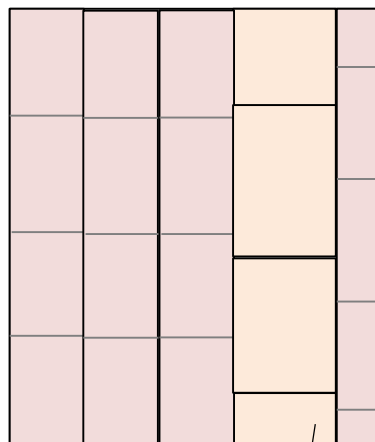
Final depth 1.0m
bgl.

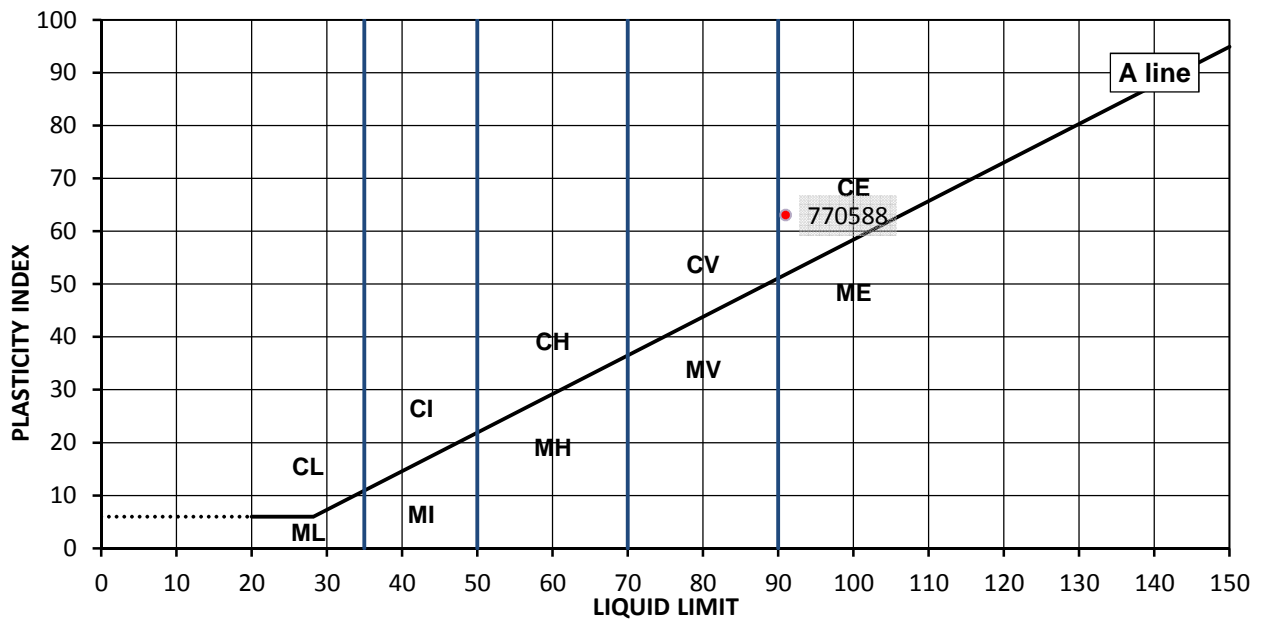
As Received Moisture Content [%]	Liquid Limit [%]	Plastic Limit [%]	Plasticity Index [%]	% Passing 425µm BS Test Sieve
32	91	28	63	100

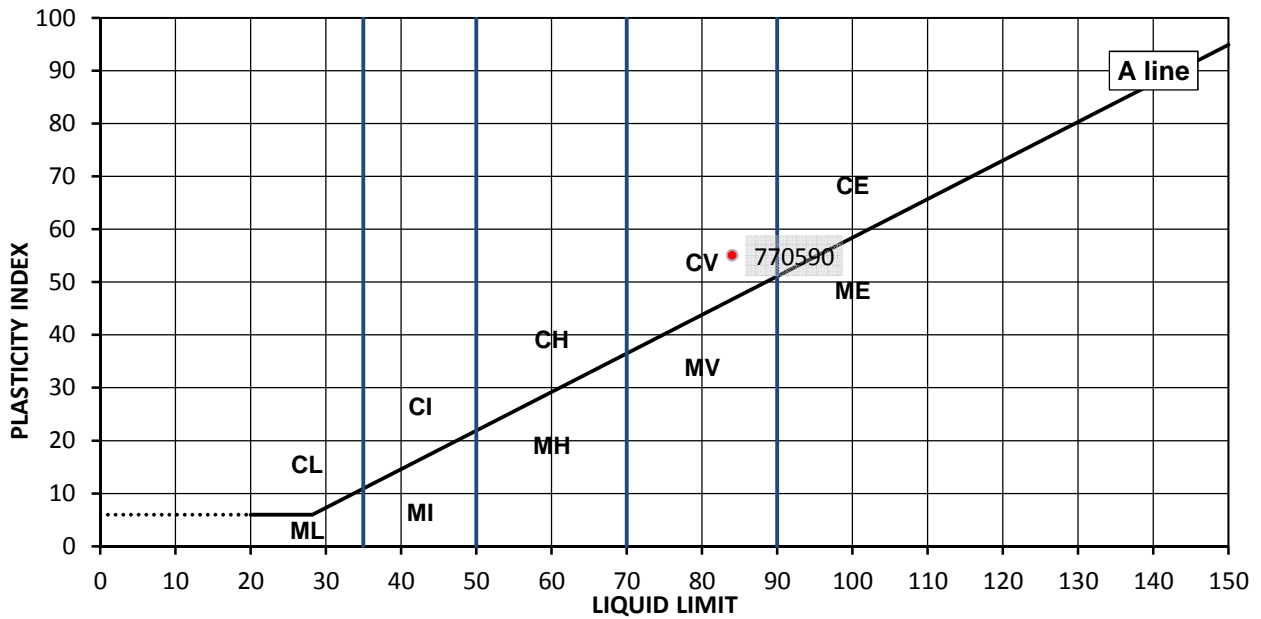
As Received Moisture Content [%]	Liquid Limit [%]	Plastic Limit [%]	Plasticity Index [%]	% Passing 425µm BS Test Sieve
29	84	29	55	79

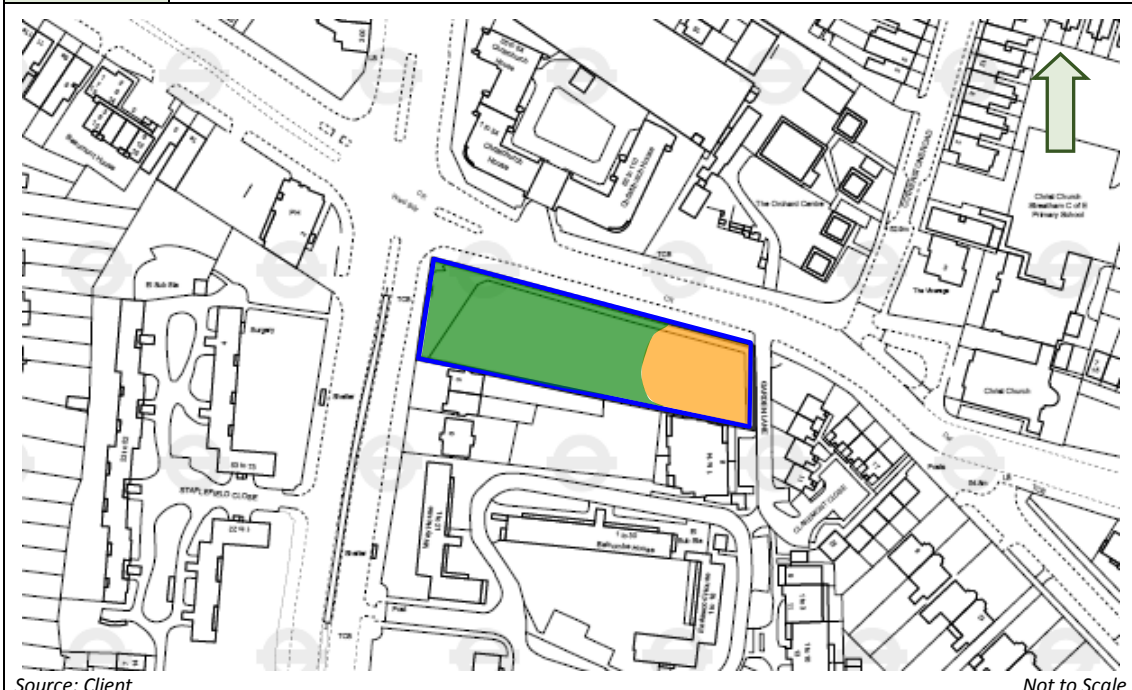
Figure UXO hazard zone plan of the Site

Legend	Very Low	■	Low	■	Moderate	■
	High	■	Very High	■	Site boundary	—

It should be noted that the UXO hazard will have been mitigated within the depth and extents of any post-WWII excavation, such as for building foundations. Outside the footprint of post-WWII construction, between piles and below shallow raft foundations and basements, the UXO hazard level remains unchanged to the depth of the likely maximum bomb penetration.

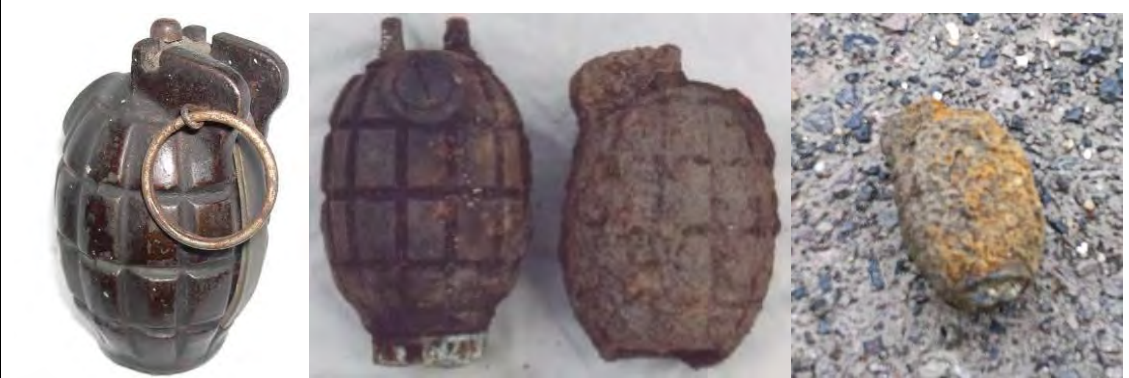
Some, such as smoke grenades, are activated instantly when the lever is released. The Plate below illustrates the typical character and condition of No. 36 hand grenades (Mills Bombs) that have been excavated from a site.

Plate Photographs of a typical and an excavated WWII No. 36 hand grenades

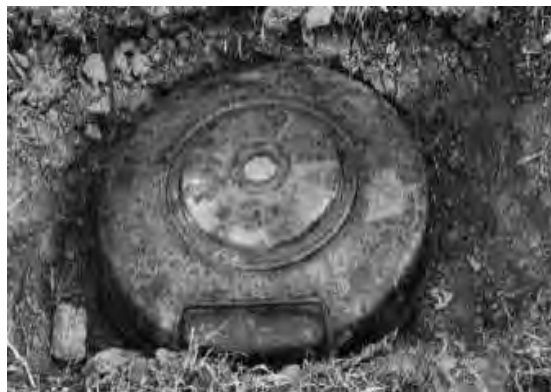
The Plate below is a photograph of a typical WWII land mine used on the land area, beaches and cliffs around Britain. This example was found at Gatwick Airport formerly RAF Gatwick.

Plate Photographs of original and recently excavated WWII land mines

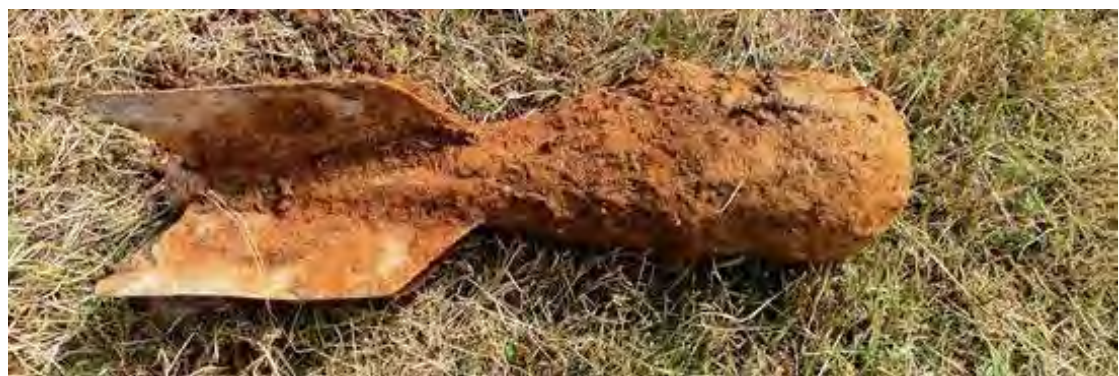
1No. WWI bomb (shown in the Plate below) was found on the Isle of Sheppey on the 2nd August 2012 during a geophysical survey following desk study research by Zetica Ltd which had established that a previously unknown WWI bombing range existed on the site. A further WWI bomb was found in the same location in August 2015.

Plate	Photograph of WWI bomb, Isle of Sheppey, 2 nd August 2012
--------------	--
