Photographs of Hindmans Way, Dagenham Dock (taken 4 Feb. 2019)

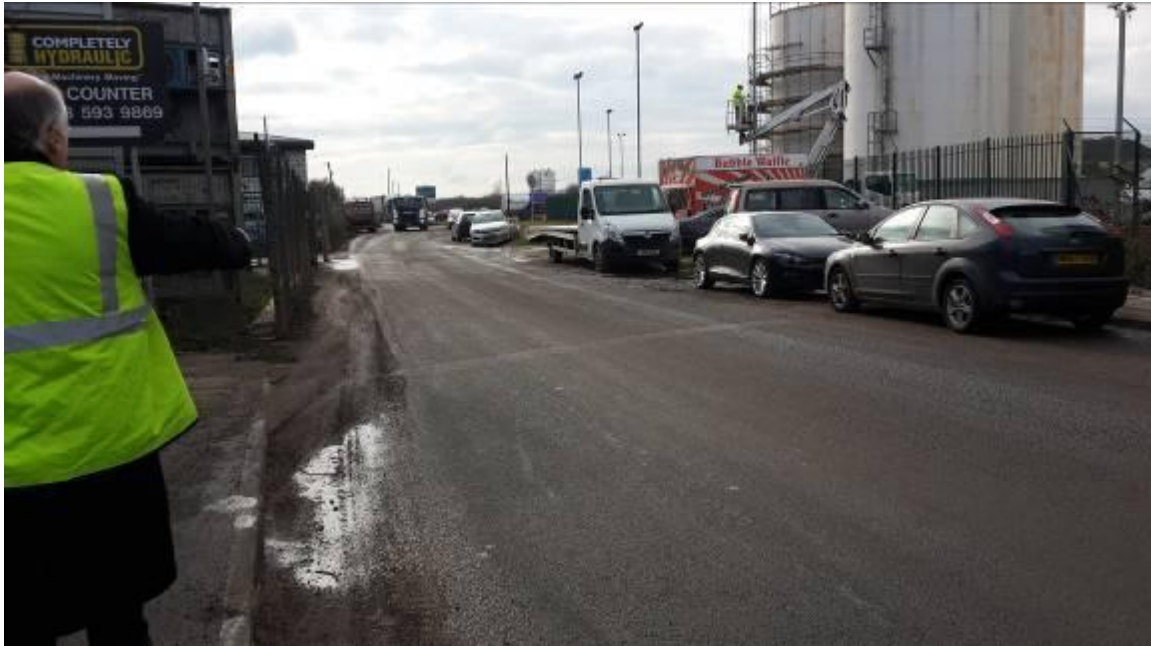
Pic. 1: The footpath in Hindmans Way (seen on the left of the picture) currently ends abruptly, with no safe crossing for pedestrians or cyclists.

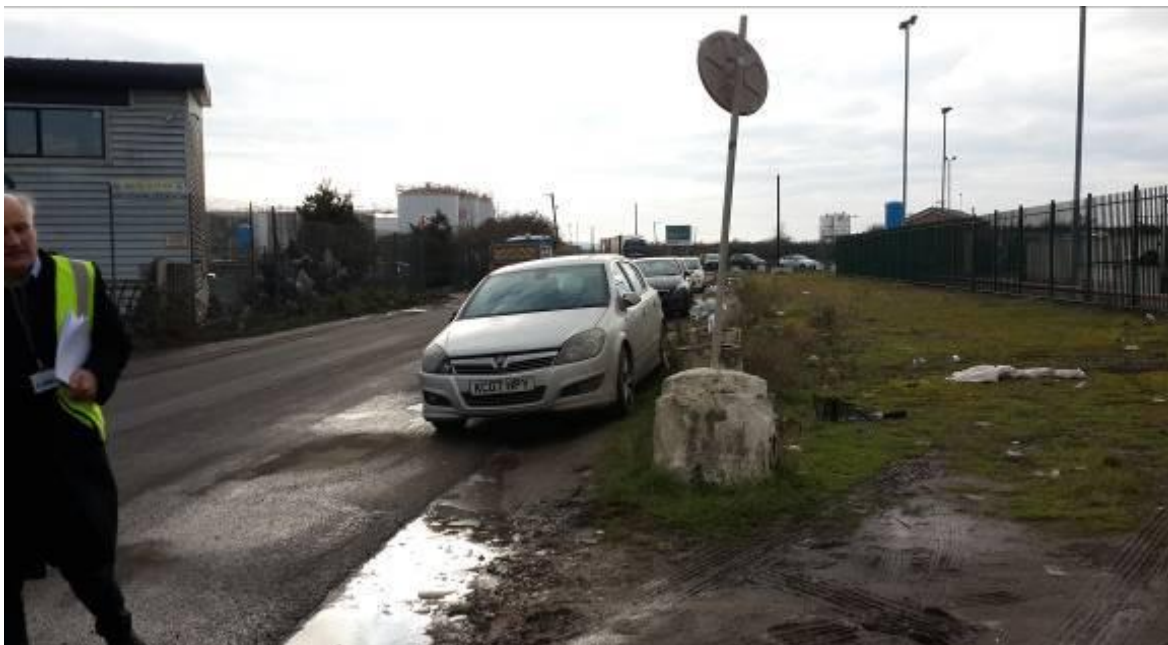
Pic. 2: Land on right of picture was transferred to GLAP's predecessor in title for the purpose of constructing Hindmans Way to an adoptable standard.

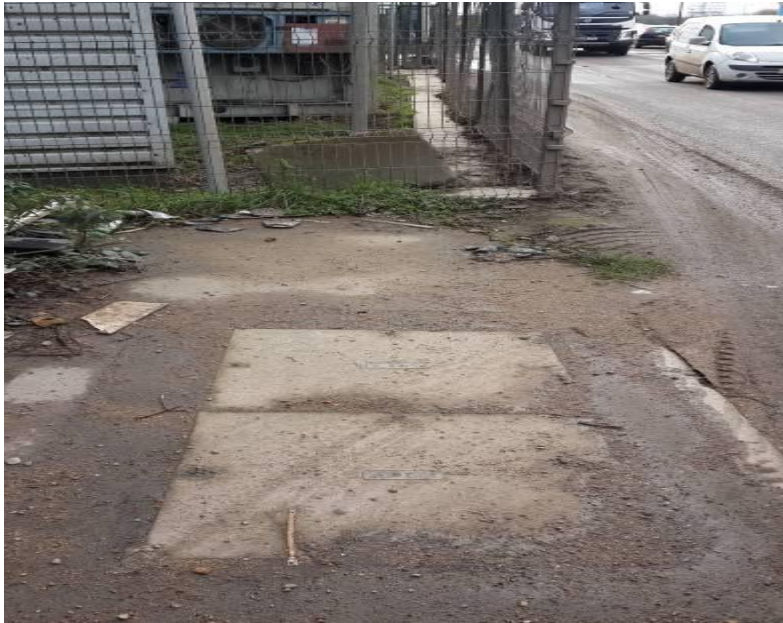
Pic 3.: BT chamber at end of the northern section of Hindmans Way. A road realignment (from this point) is required to ensure adequate space on both sides of the new highway for the footway / cycle path to avoid an existing building.
