**TFL_PSF_9131 SITE
INVESTIGATIONS: SMALL SITES
INITIATIVE
LAND AT BRIDGE VIEW ROAD,
LONDON BOROUGH OF
HAMMERSMITH AND FULHAM,
W6 9DD**

Geotechnical and Geo-Environmental Desk Study

LAND AT BRIDGE VIEW ROAD, LONDON BOROUGH OF HAMMERSMITH AND FULHAM, W6 9DD

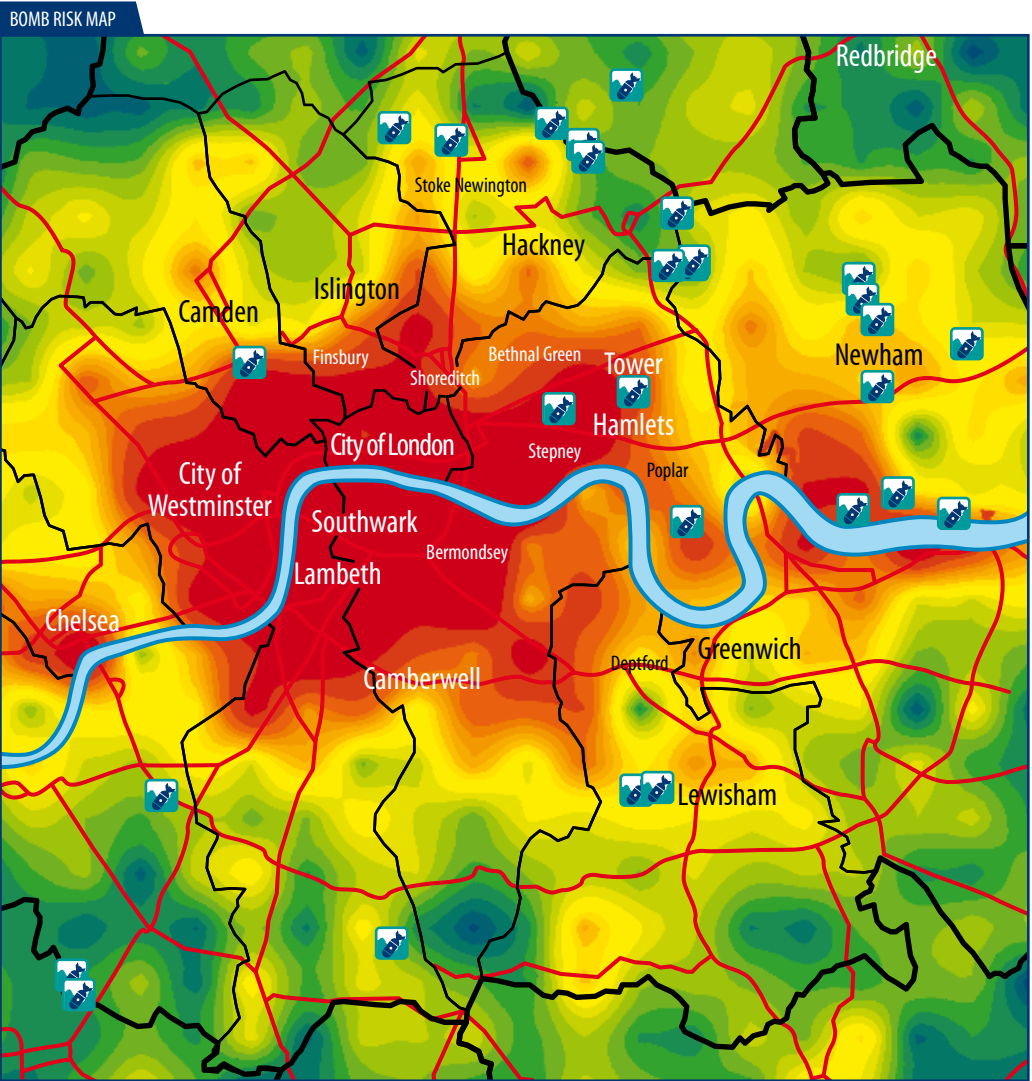
UXB hazard map
This map can be used as part of a preliminary risk assessment in line with CIRIA guidance (C681).

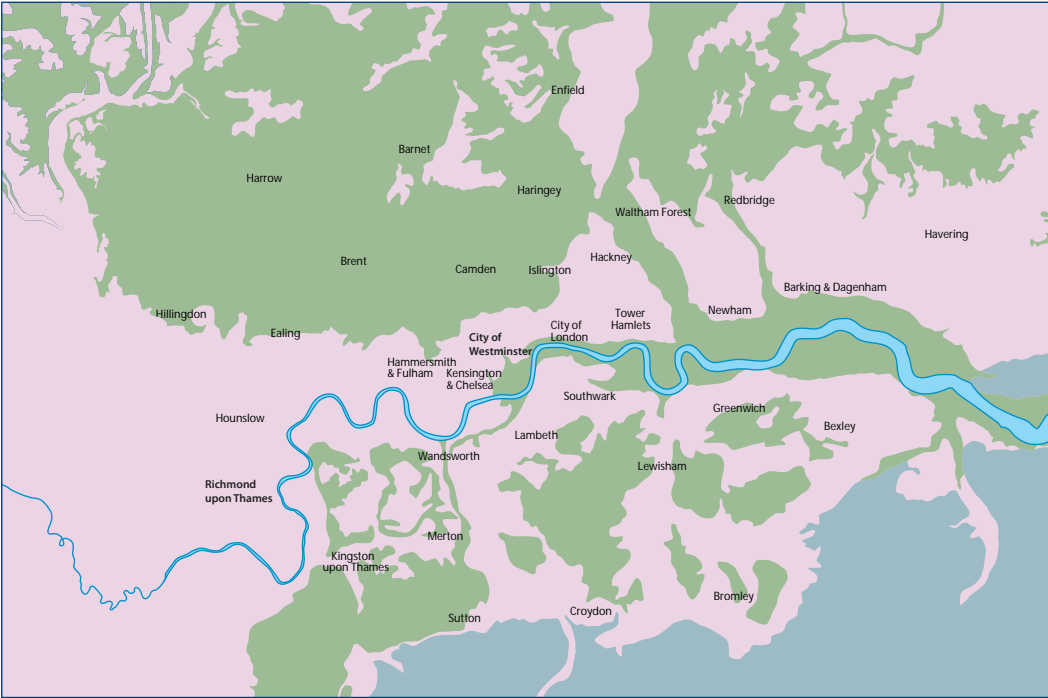
For the London area, the geology is extremely complex with a complicated succession that includes several units that are unsuitable for MagCone techniques. To give a first order approximation as to which technique might be appropriate for a site, a simplified map has been produced.

This map has been compiled from the BGS Solid and Drift map sheets 256, 257, 270 and 271. The complex geology has been reduced to three areas coloured grey, green and pink. Areas that involve units that are probably only suitable for MagDrill, which include gravels, are shown in pink. Areas that involve units probably suitable for MagCone, such as London Clay or alluvium, are coloured green. Where

chalk crops out at surface or there is negligible soil cover over chalk, it is shown in grey. This map is for indicative purposes only and specific site geology needs to be taken in to account, especially close to the boundaries shown on the map.
