Detailed Unexploded Ordnance (UXO) Threat & Risk Assessment

PROJECT NUMBER	9422	ORIGINATOR	L. Hayes
PROJECT	Kennedy Avenue	REVIEWED BY	B. Wilkinson
CLIENT	Arcadis	RELEASED BY	L. Gregory
VERSION	1.0	DATE	27 th January 2022
UXO RISK RATING	MEDIUM - This Study Site requires limited further action to reduce risk to ALARP during intrusive activities.

The Client has defined the Study Site as “Kennedy Avenue, London, EN3 4PB” and it is centred on NGR 535252, 195322.

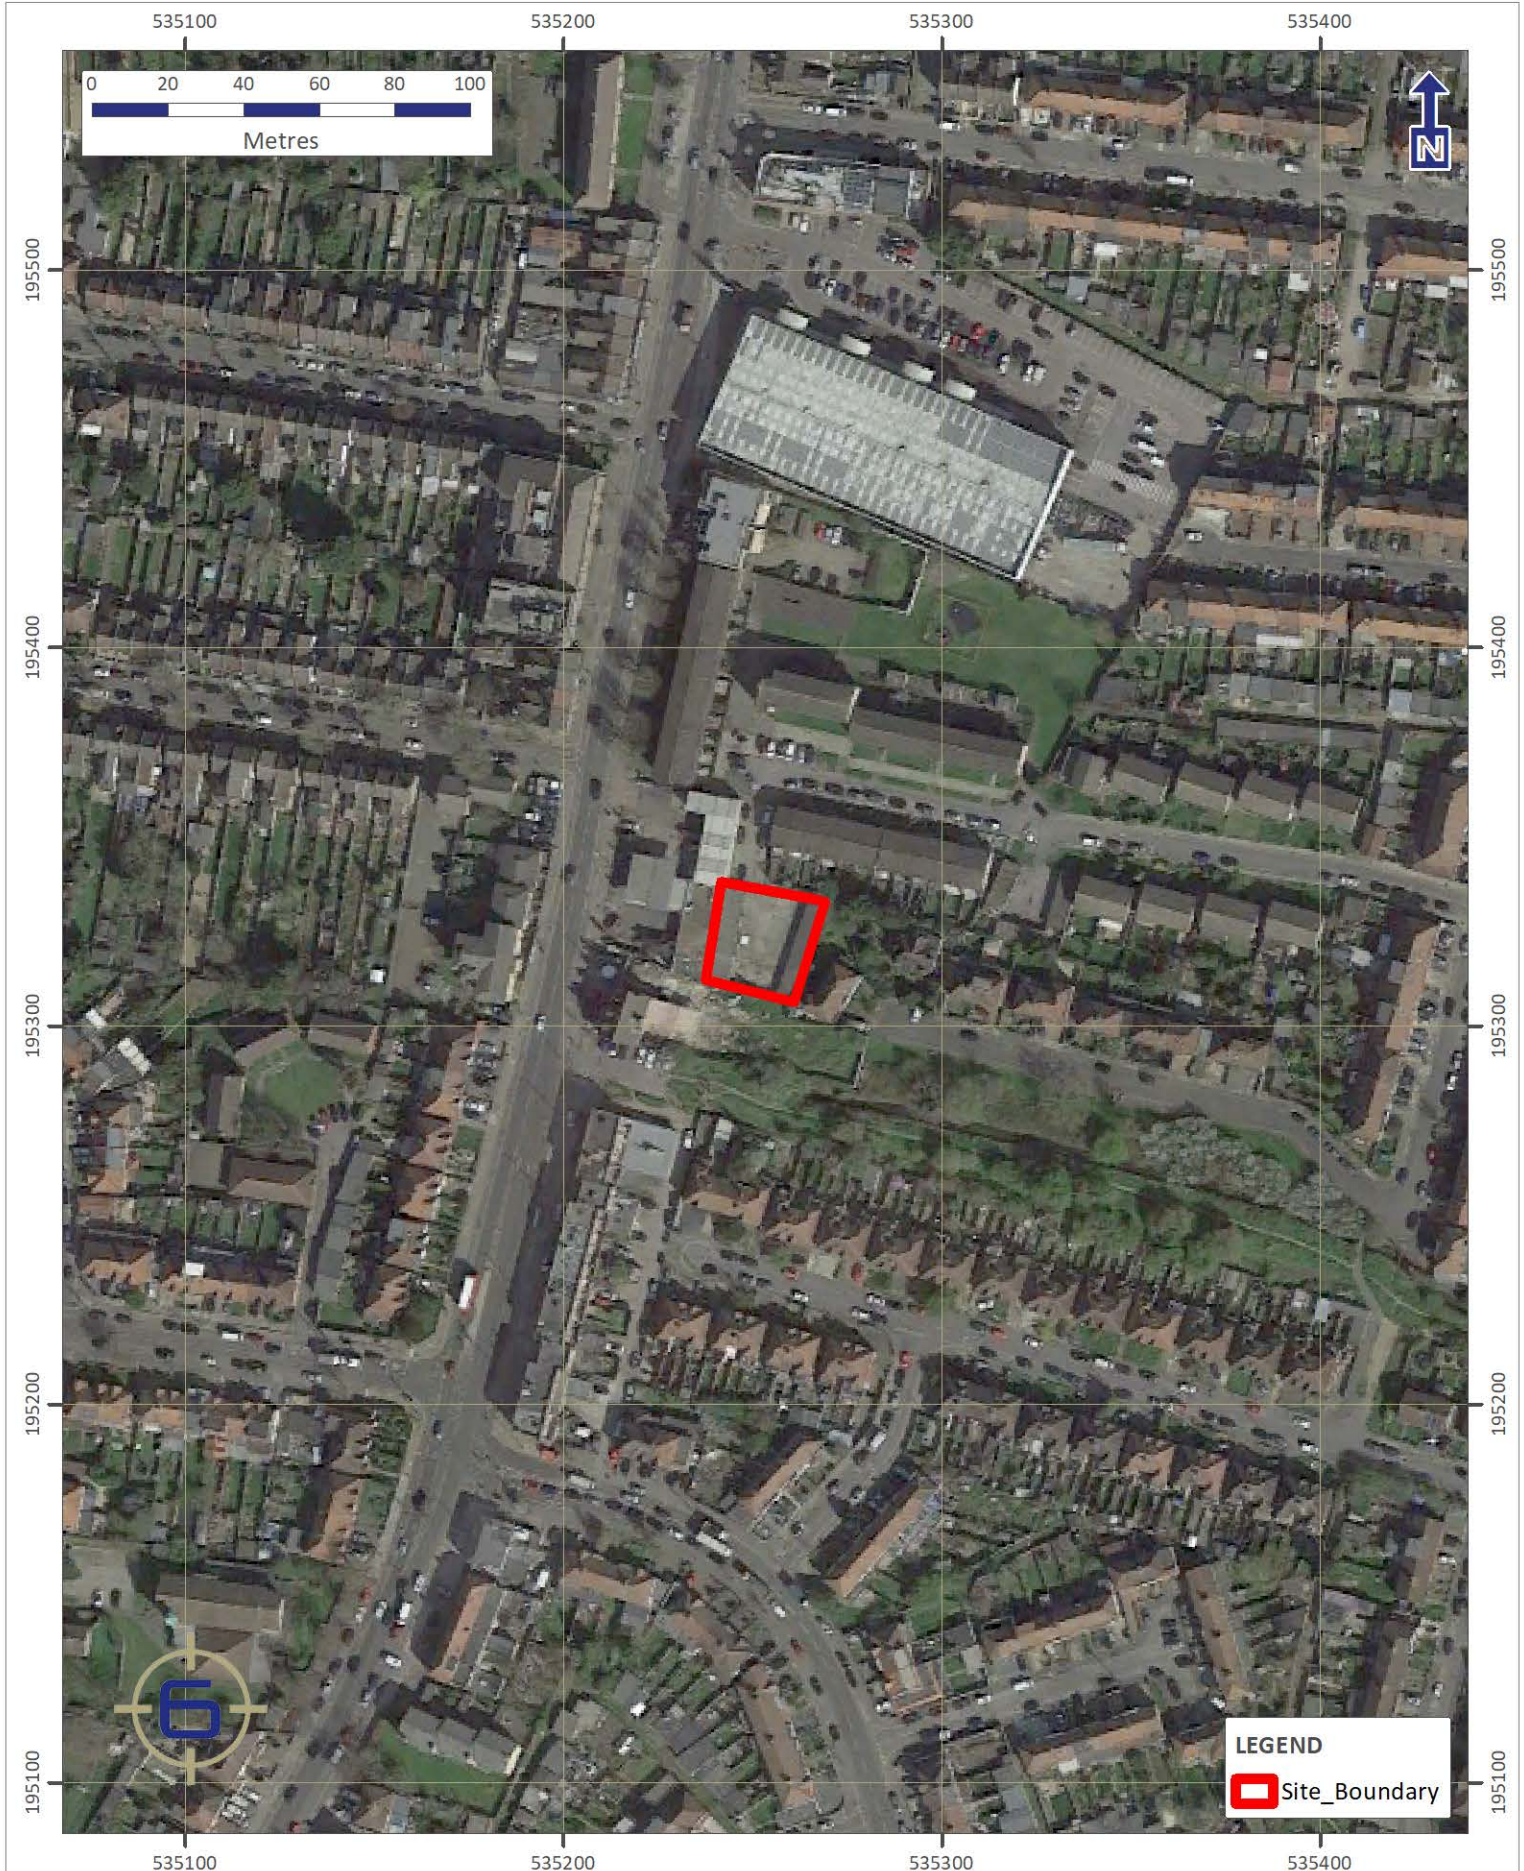
Figure Three - Aerial Photography (2021)

Current aerial photography corroborates the information above and shows that the Study Site is situated within a developed urban area. The Study Site itself consists of hard standing, with garages situated along its eastern and western boundaries.

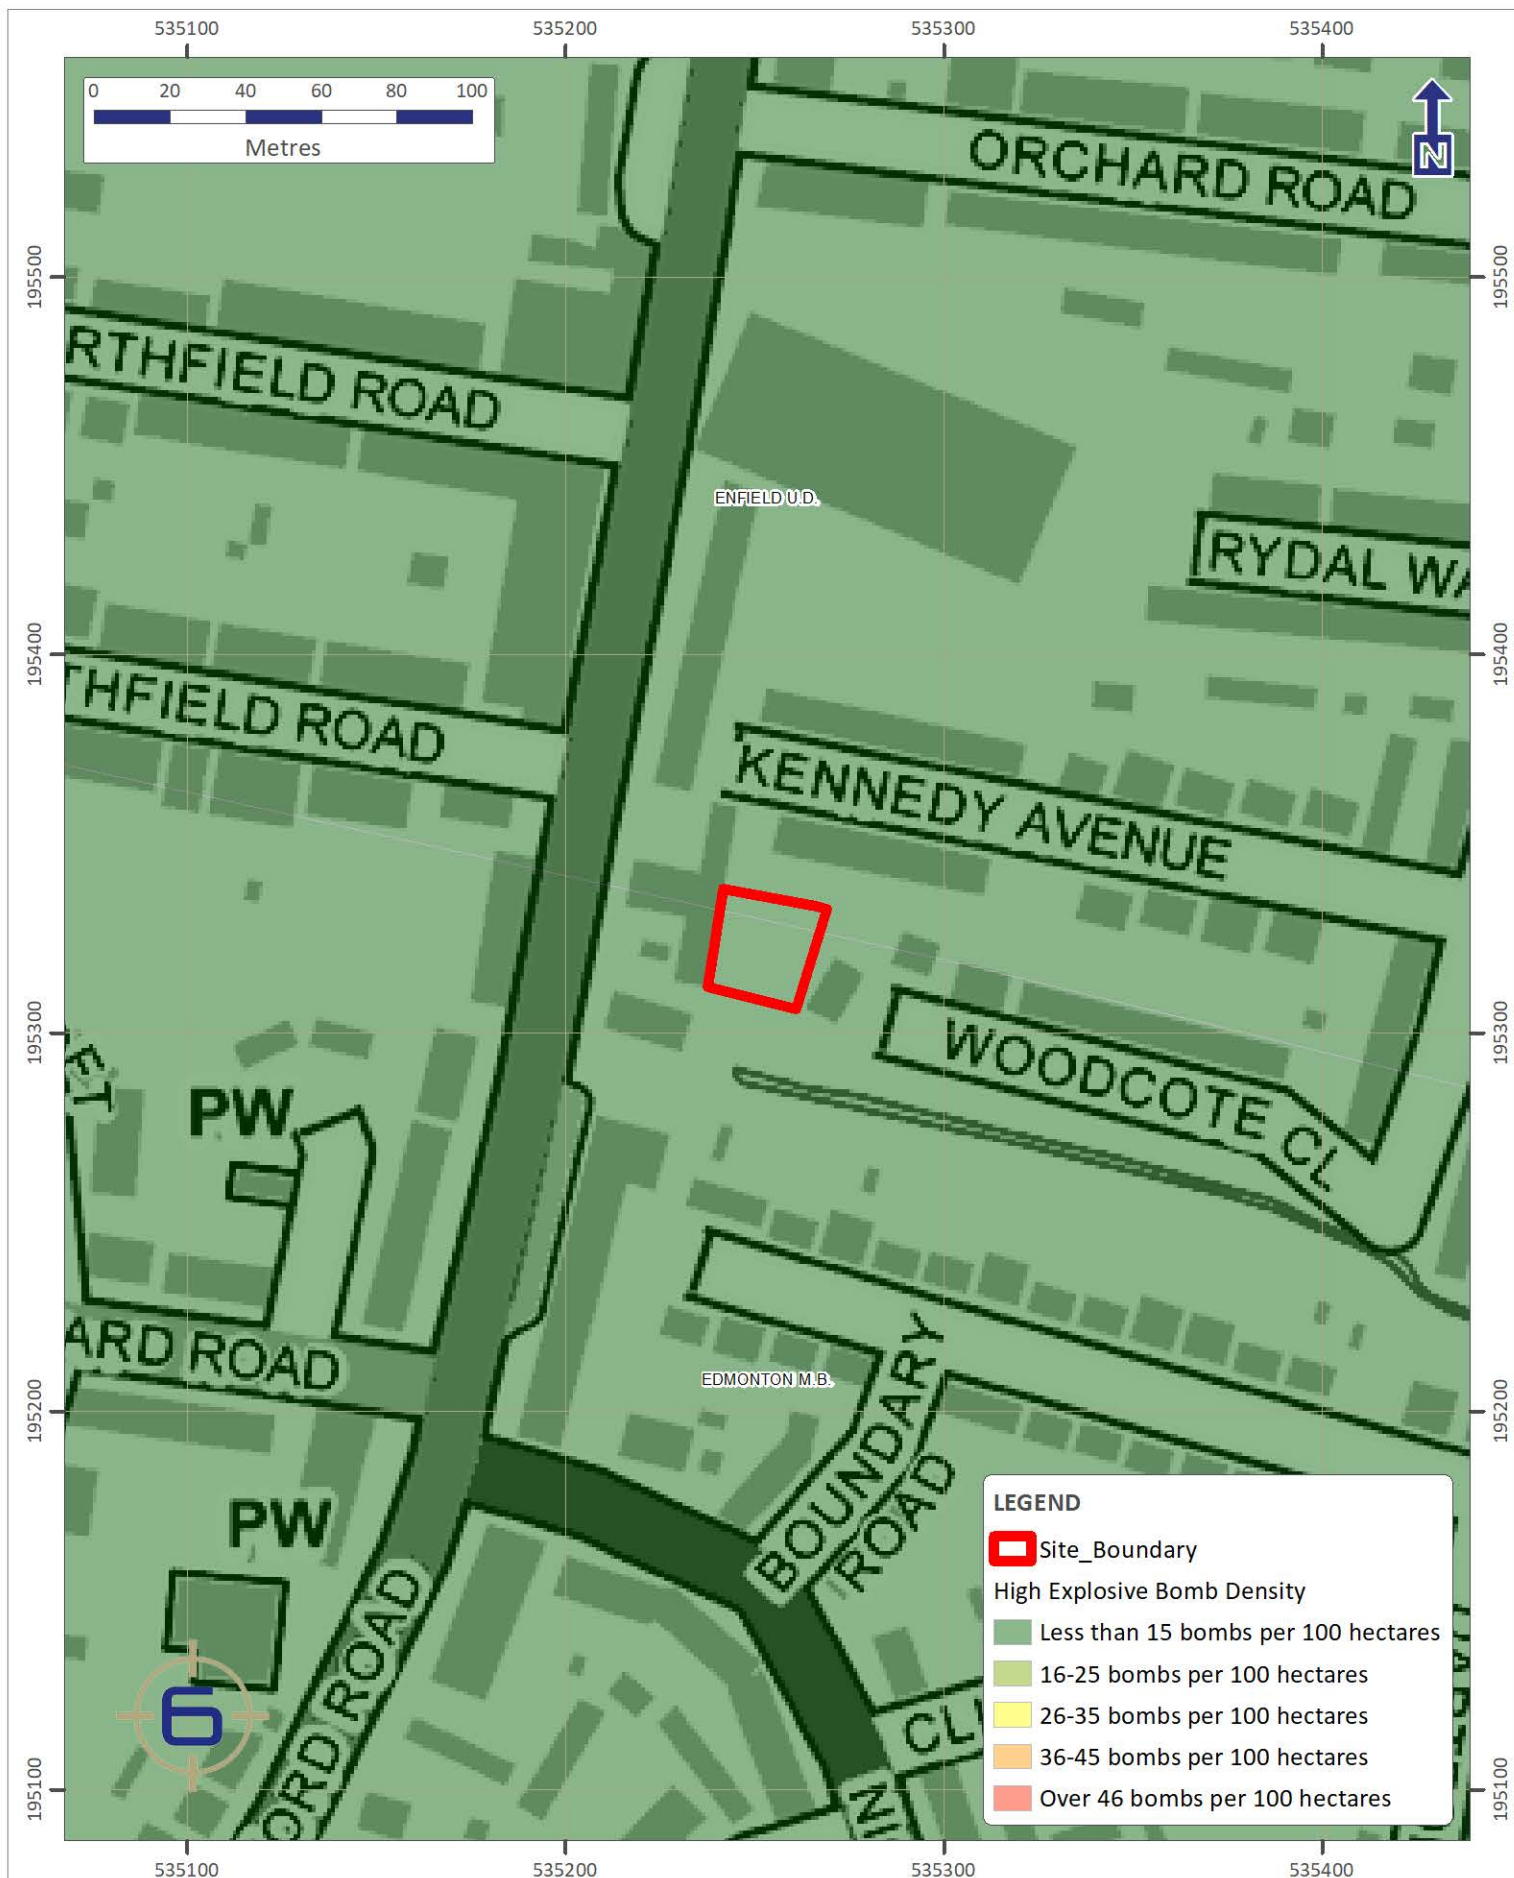
Figure Four - WWII High Explosive Bomb Density

The Study Site was located within *Enfield Urban District* and *Edmonton Municipal Borough*, which recorded seven and 14 HE bombs per 100 hectares respectively, both “very low” levels of bombing.

During WWII, the Study Site was situated within *Enfield Urban District* and *Edmonton Municipal Borough*, which recorded seven and 14 HE bomb strikes per 100 hectares respectively, both “very low” levels of bombing.

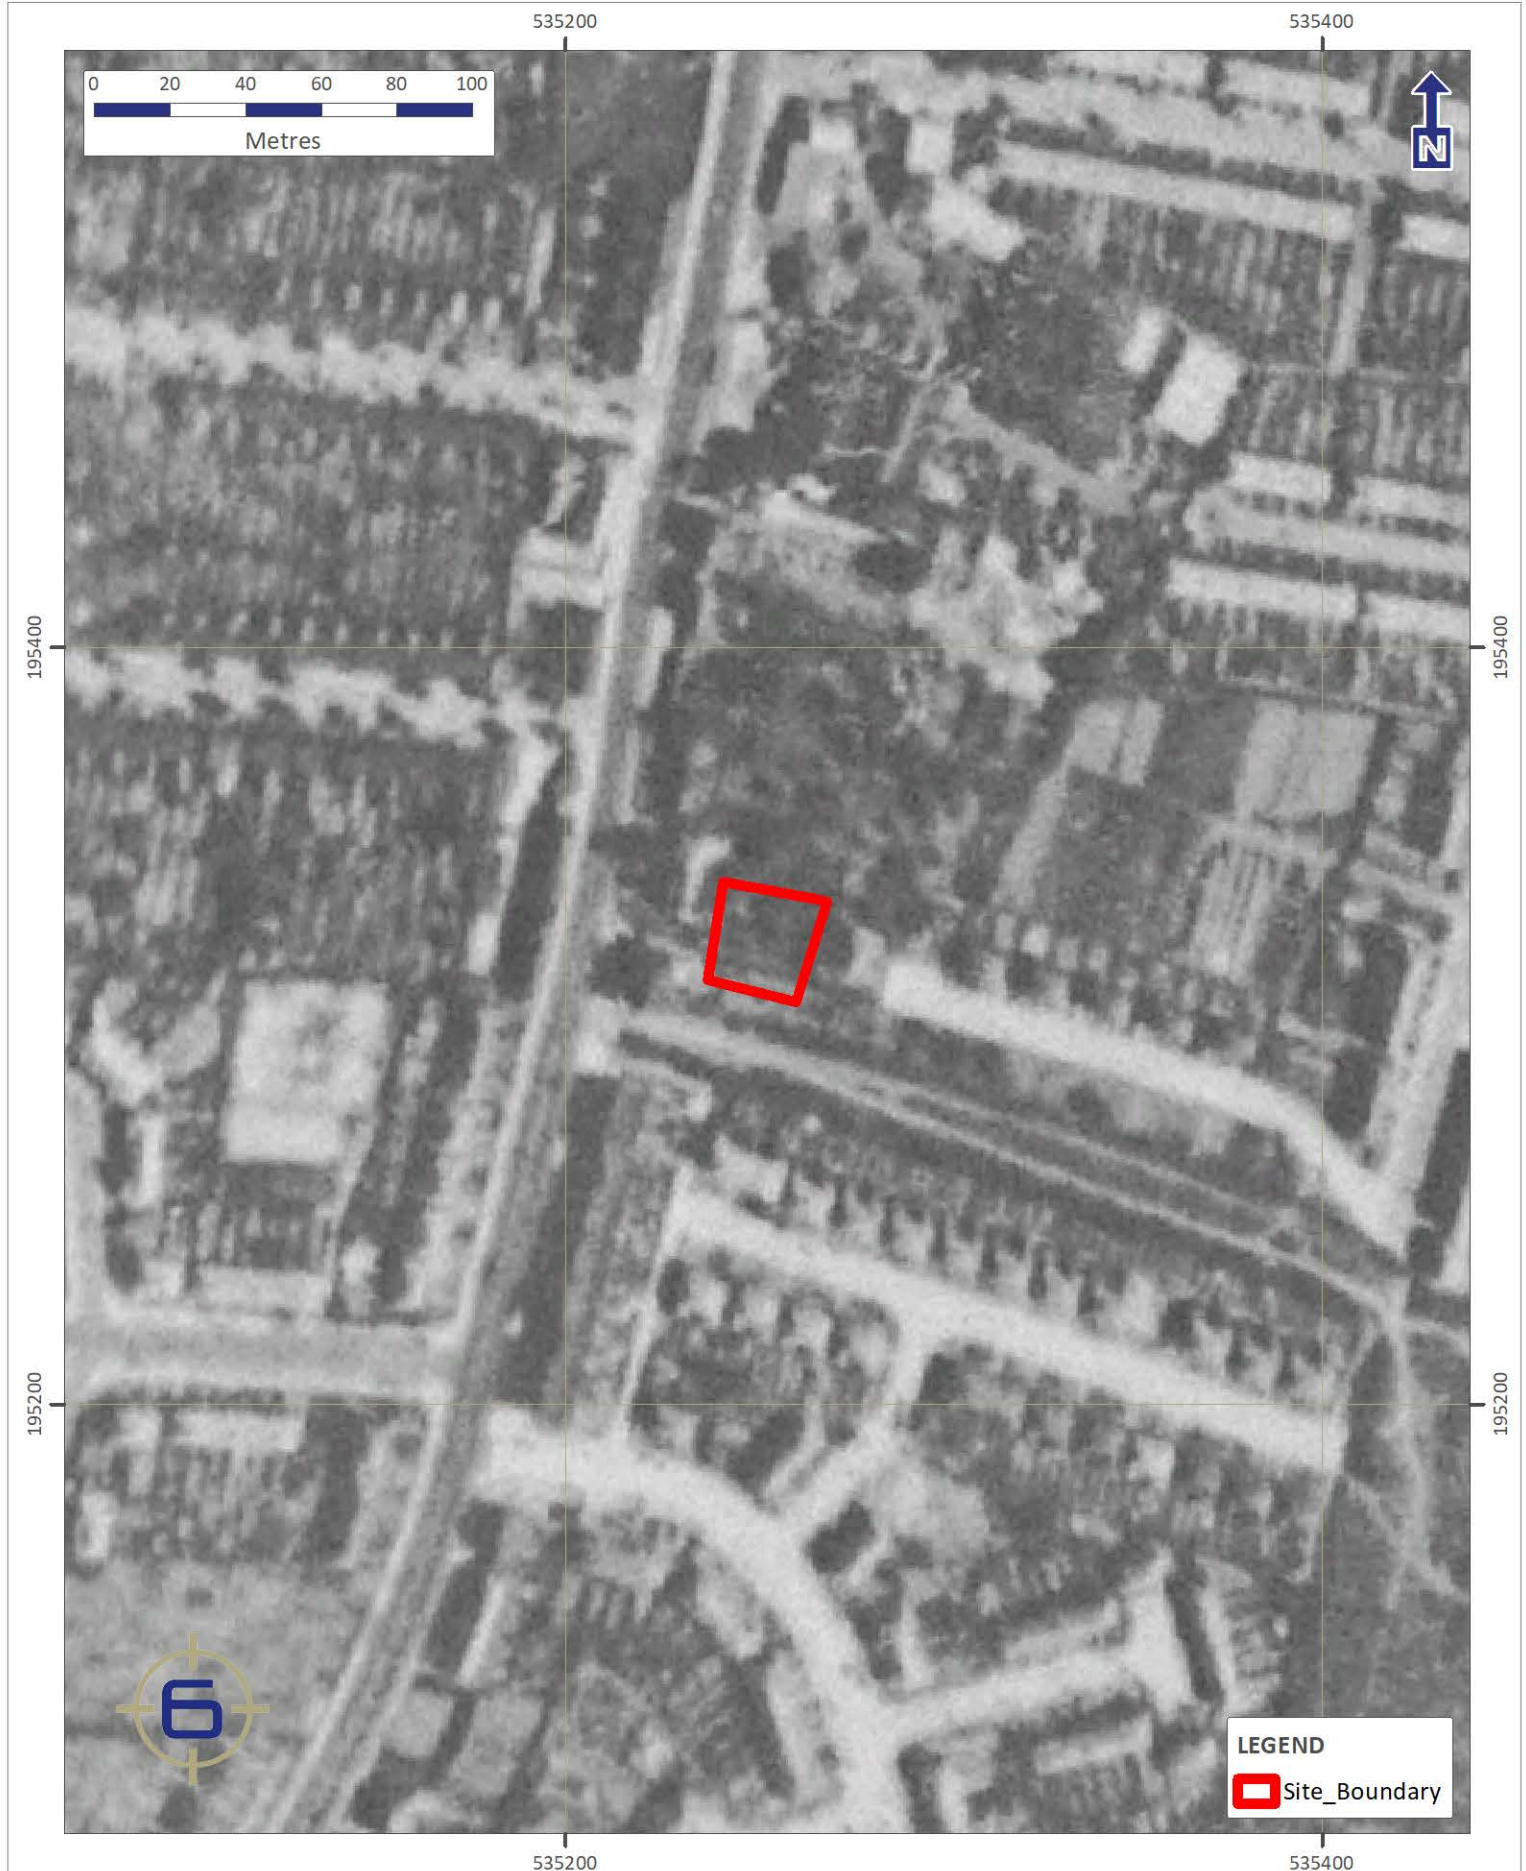
Figure Seven - Aerial Photography (1945)

The CS mapping prior to WWII (1938) and aerial photography (1945) shows that the Study Site was located in a developed urban area during WWII, with the Study Site comprising residential gardens. Therefore, it is probable that footfall within the Study Site would have been moderately high and as a result, a local resident would likely have observed and reported any UXB entry holes within the Study Site, which would have been dealt with at the time.

The CS mapping prior to WWII (1938) and aerial photography (1945) shows that the Study Site was located in a developed urban area during WWII, with the Study Site comprising residential gardens. Therefore, it is probable that footfall within the Study Site would have been moderately high and as a result, a local resident would likely have observed and reported any UXB entry holes within the Study Site, which would have been dealt with at the time.
