# Detailed Unexploded Ordnance (UXO) Threat & Risk Assessment

PROJECT NUMBER	9423	ORIGINATOR	M. Stott
PROJECT	Ivy Road	REVIEWED BY	B. Wilkinson
CLIENT	Arcadis	RELEASED BY	L. Gregory
VERSION	1.0	DATE	27 <sup>th</sup> January 2022
UXO RISK RATING	LOW - This Study Site requires no further action

The Client has defined the Study Site as “Ivy Road, London” and it is centred on NGR 529587, 194687. The Site itself is split across two areas either side of *Ivy Road*.

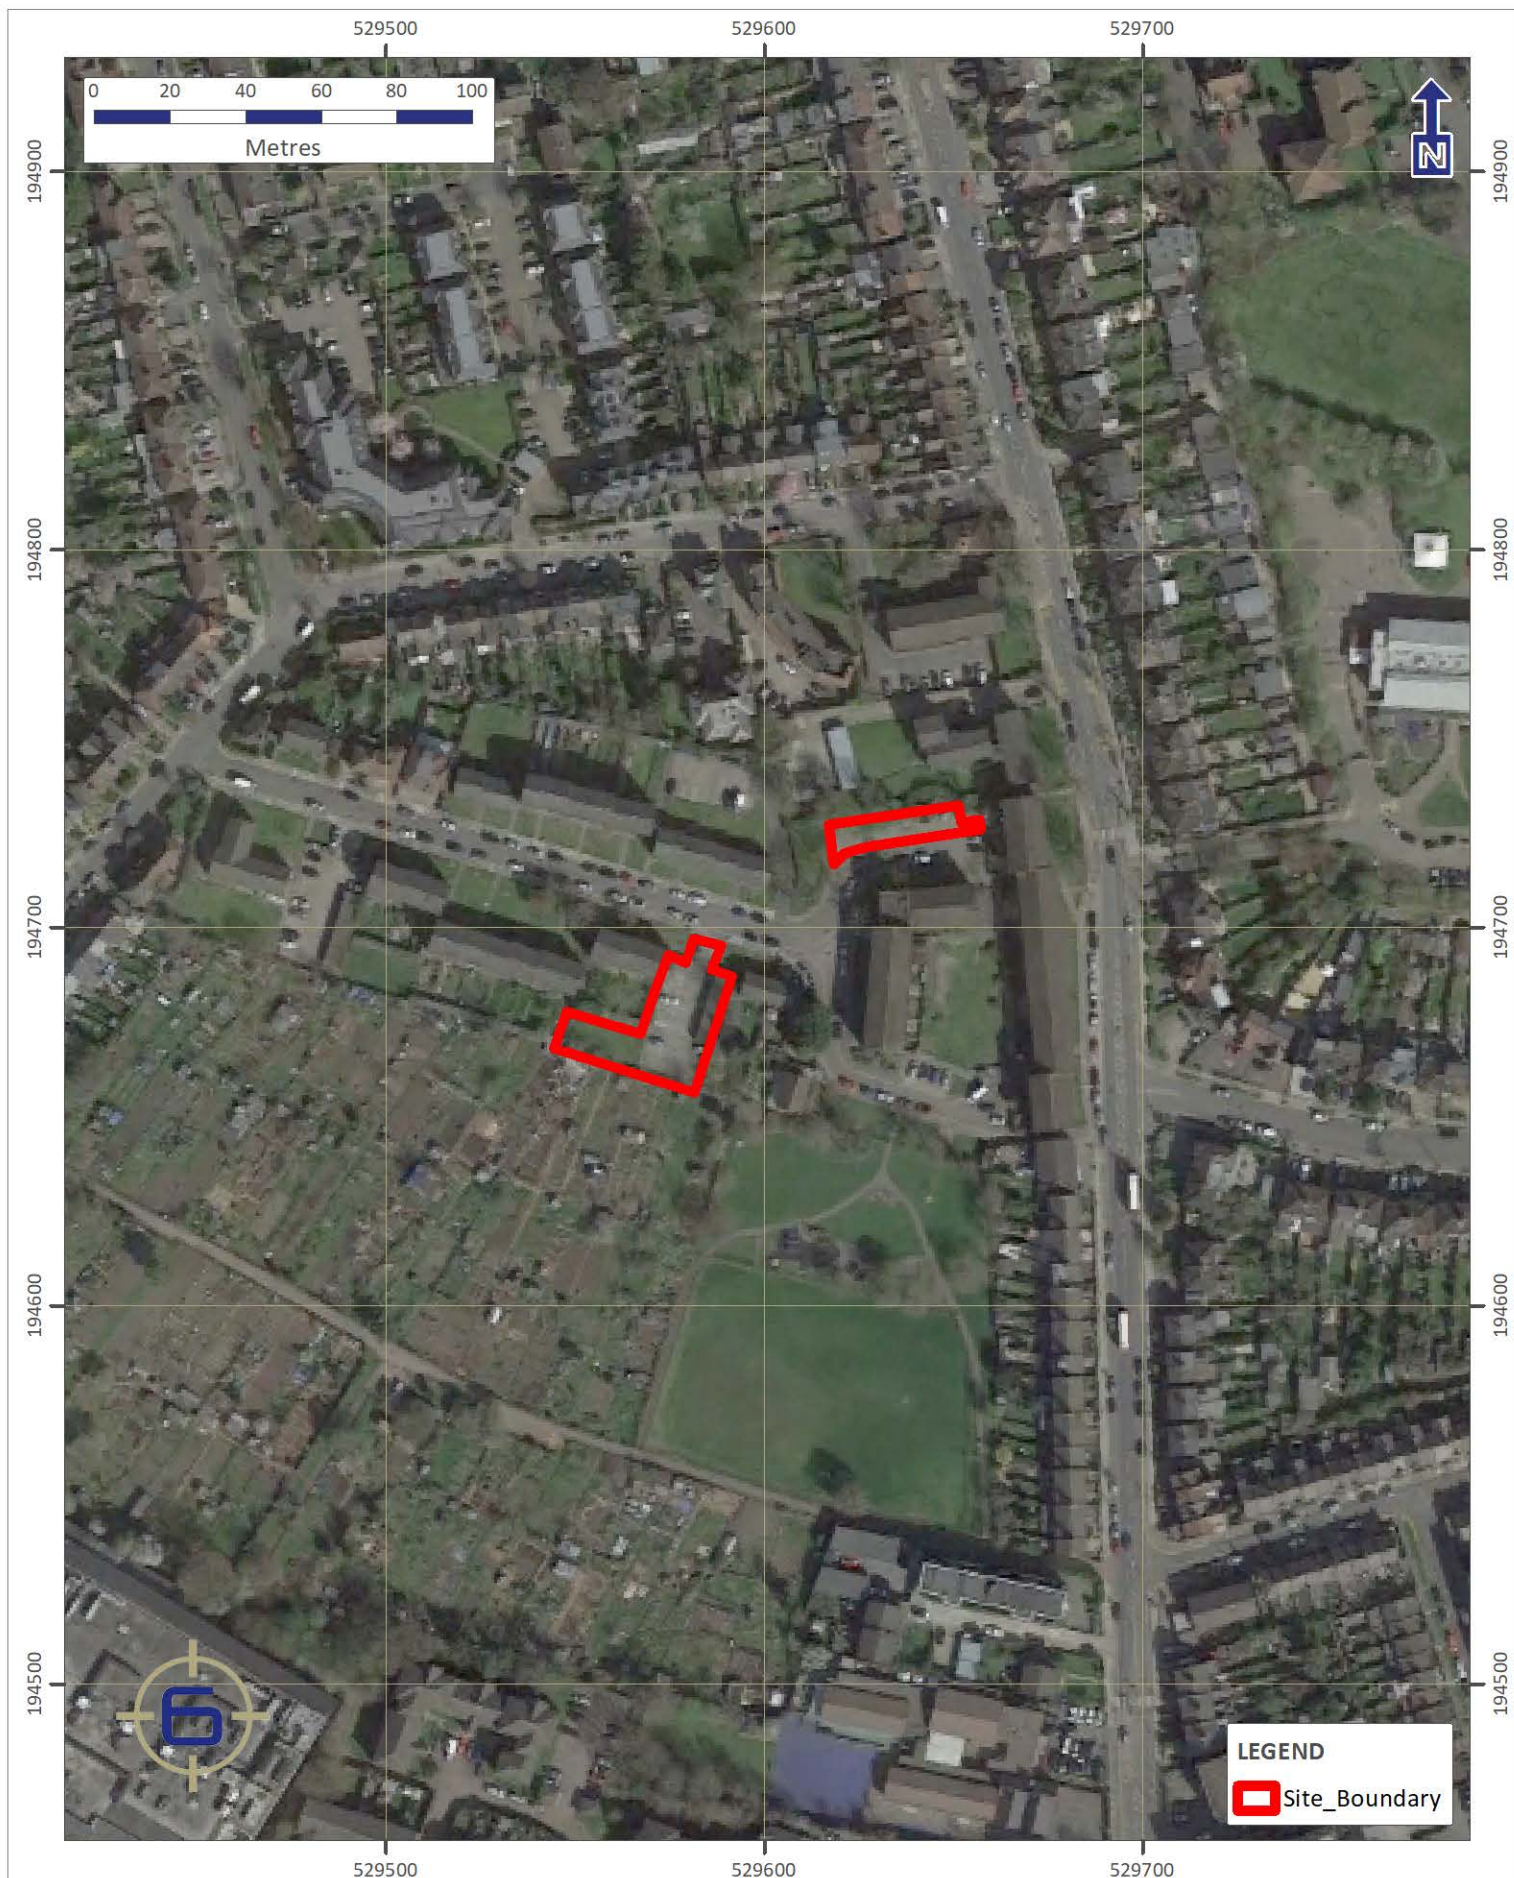
## Figure Three - Aerial Photography (2021)

Current aerial photography corroborates the information above and shows that the Study Site is situated within a densely developed urban area and is split into two areas across *Ivy Road*. The north-east extent of the Study Site consists of areas of hardstanding car parking and multiple small garage structures. The south-west extent of the Site also consists of a hardstanding car park and small garage structures.

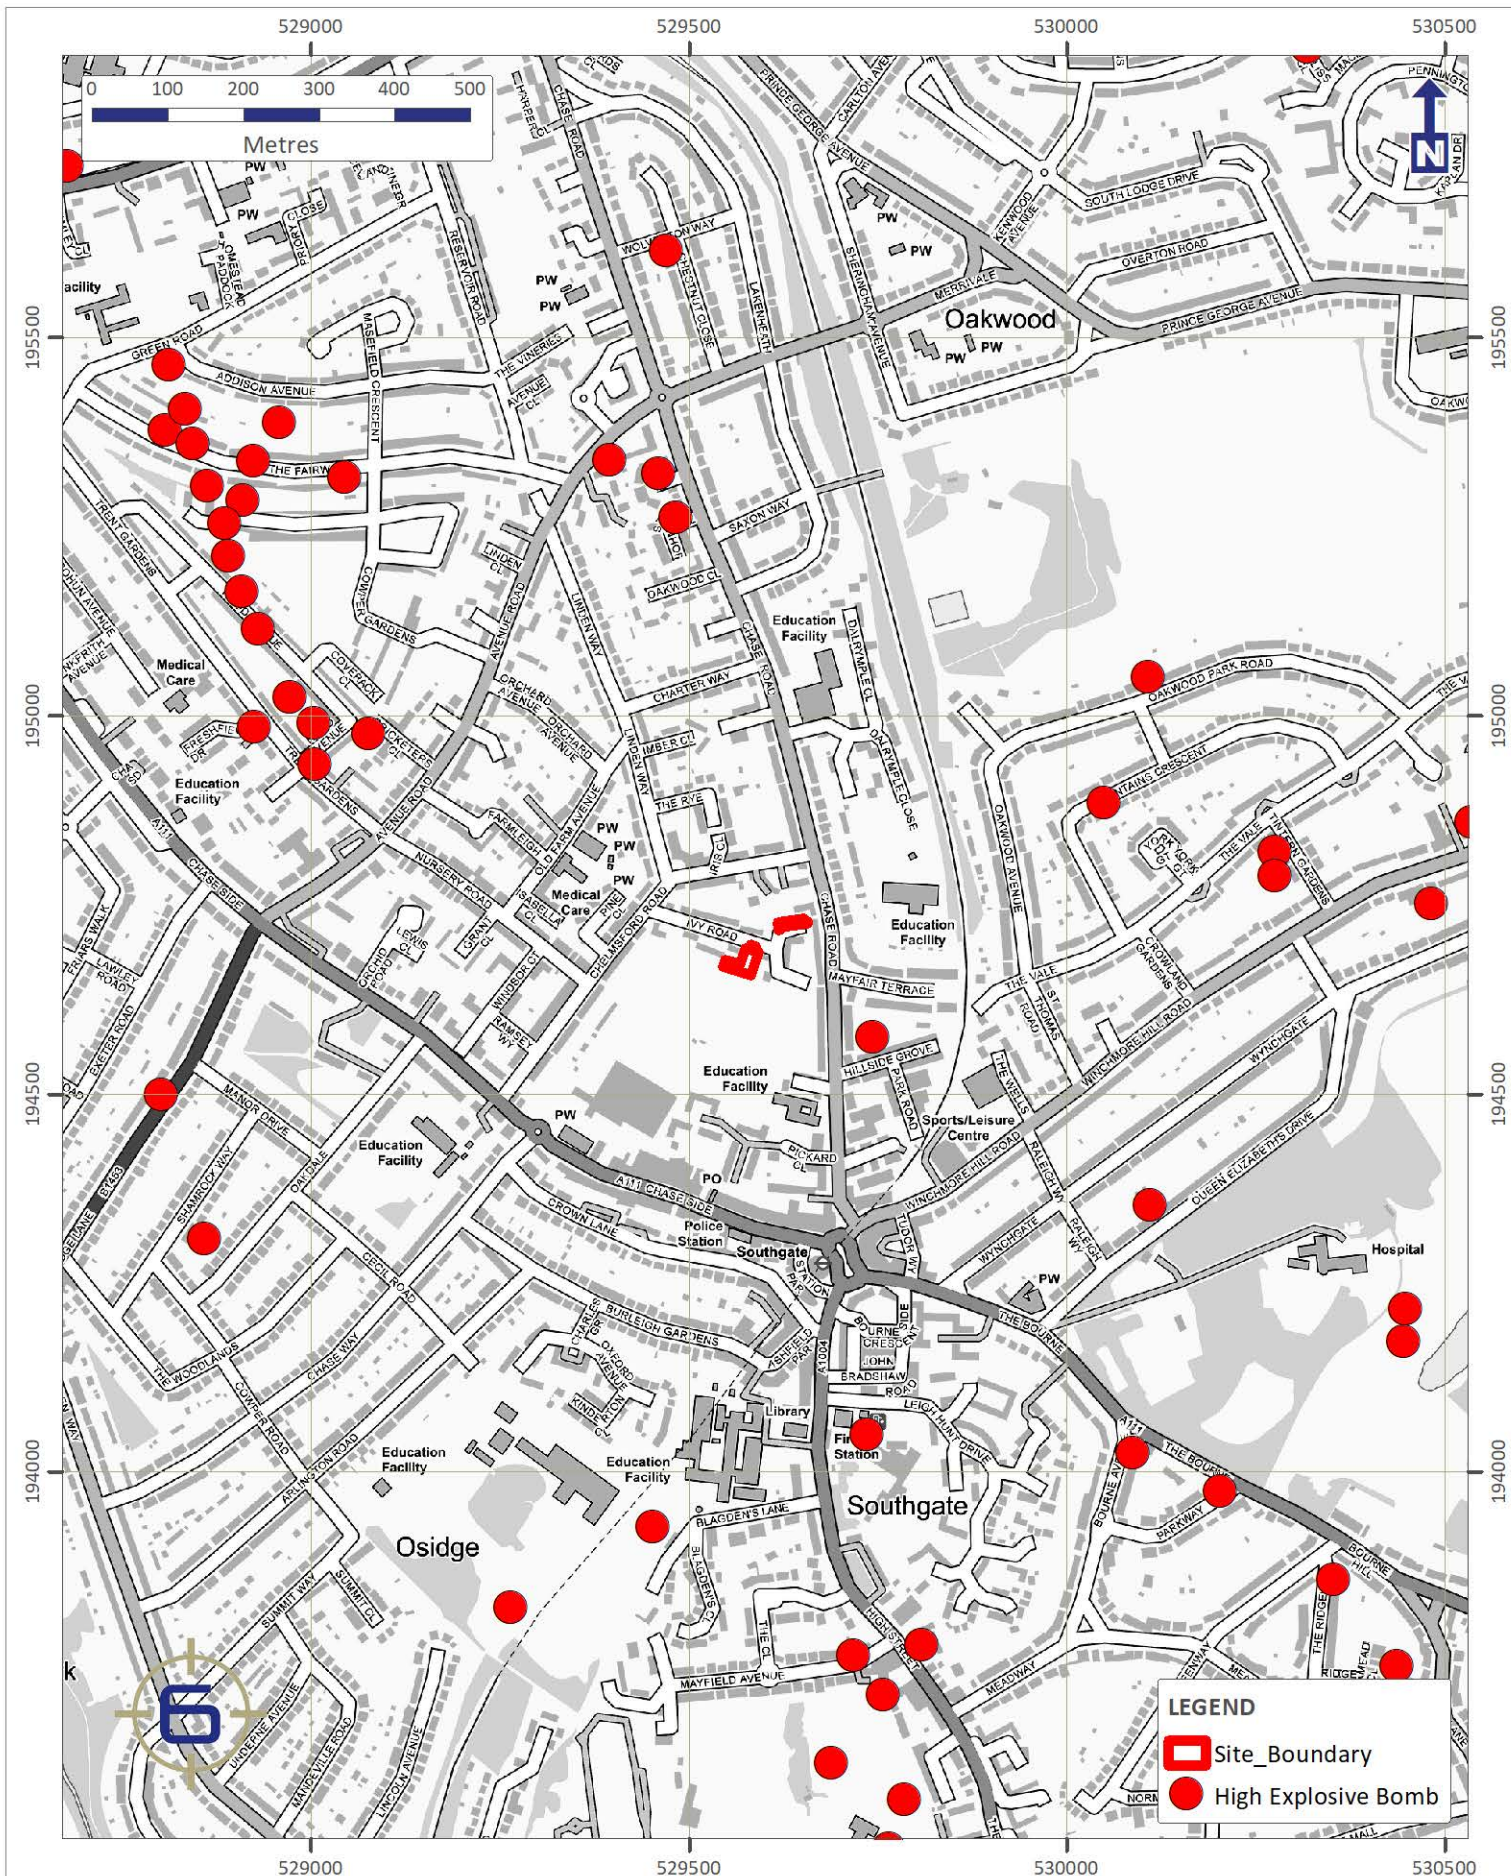
## Figure Five - WWII High Explosive Bomb Strikes

ARP records associated with the Study Site did not note any HE bomb strikes within it. However, five were recorded within 580m, the closest being identified 180m to the south-east of the Study Site boundary.

During WWII, ARP wardens compiled detailed logs of bomb strikes across their respective districts. ARP records associated with the Study Site did not note any HE bomb strikes within it. Nonetheless, five were recorded in the wider area; 180m to the south-east, 420m to the north-east, 550m to the north-north-west, 555m to the north-east and 580m to the north-west of the Study Site boundary. Furthermore, whilst IBs may have fallen within the Study Site, they were generally dropped in such large numbers that accurate record keeping was either non-existent or perfunctory. Nonetheless, no IB strikes were noted on-site or within 1,000m of the Study Site boundary.
