Arboricultural Survey Report and Impact Assessment Antoneys Close, Harrow

May 2020

For: London Borough of Harrow

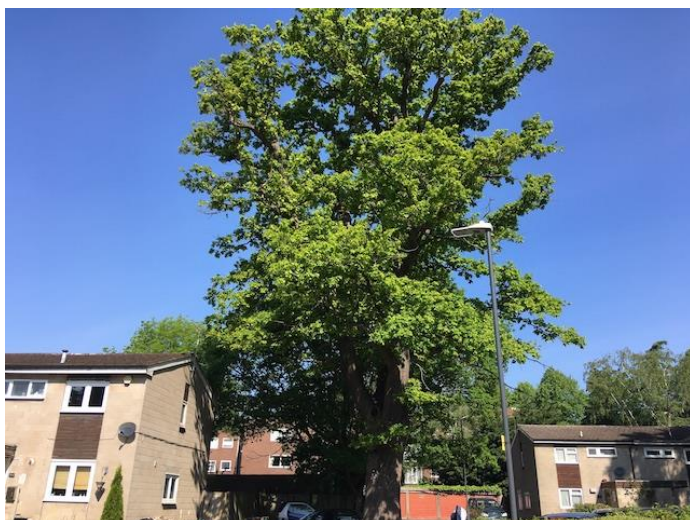
- 2.1 Trees were positioned on the boundaries of the site or adjacent to the access road. The parking area was surrounded by G1, G2 and T3, all recorded under Category C (Table 2.1).
- 2.2 Trees T1 and T2 provided good street and townscape value, being adjacent to Antoneys Close road. It is unclear if T2 is still under the TPO designation as the tree seems to have been replaced.

Photo 1: T1 Providing good townscape value.

- 3.3 It is unlikely that any impact will occur to T1 and T2. However, protection will be required for construction traffic. G1 and G2 are third party trees and will require protection and some limb management to enable the development to proceed.

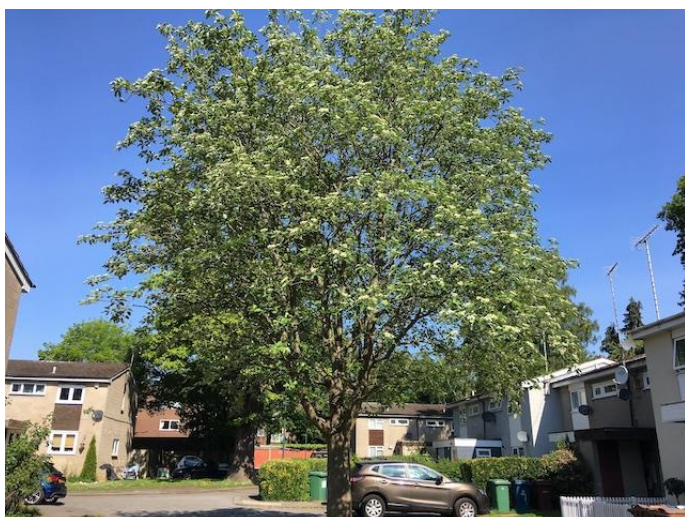
- 1.8 A number of Tree Preservation Orders were located close to the site. TPO-25 covered the street trees along Antoneys Close. This included TPO-25 (T9), which has been removed and TPO-25(T8) which was recorded as an ash, however this seems to have been replaced by the whitebeam (T2 in report). T1 (Sessile oak), does not seem to be covered by this TPO.
- 1.9 TPO-26 covered a number of trees within the woodland. However, it is very unlikely these will be impacted by the proposed development.

Photo 2: T2 probable replacement for TPO ash tree.

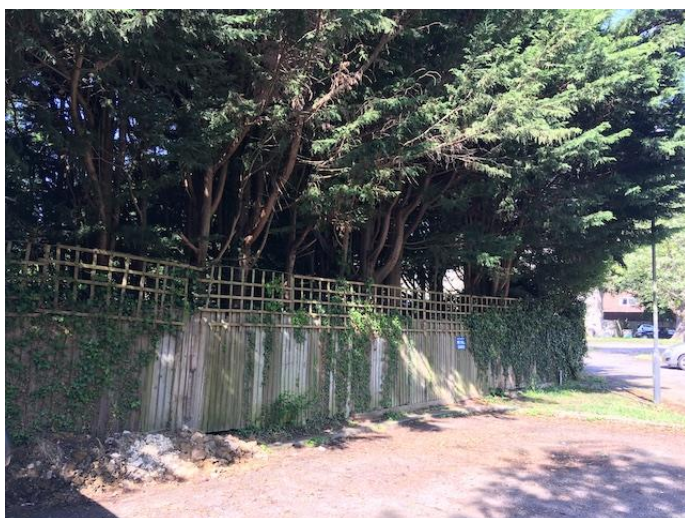
Photo 3: G1 third-party trees on southwestern boundary.
