Asbestos Demolition Survey

**Antoneys Close
Pinner
HA5 3LP**

London Borough of Harrow

Project Number:	Survey Date:	Issue Date:
N-20740	17 March 2020	20 March 2020

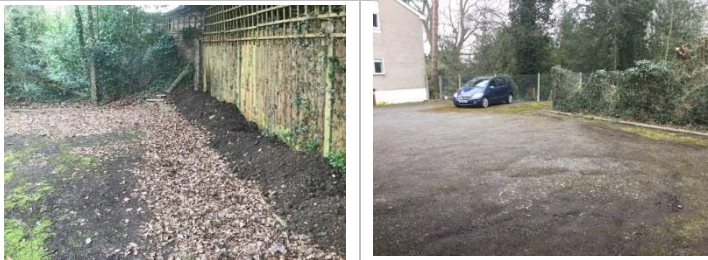
Building: Antoneys Close			
Location:	Construction Overview	Photos	
	<p>The car park area consisted of a tarmac floor, concrete curbs, metal drains, general building debris, mud flower beds, fenced off over grown area, timber fence panels.</p>

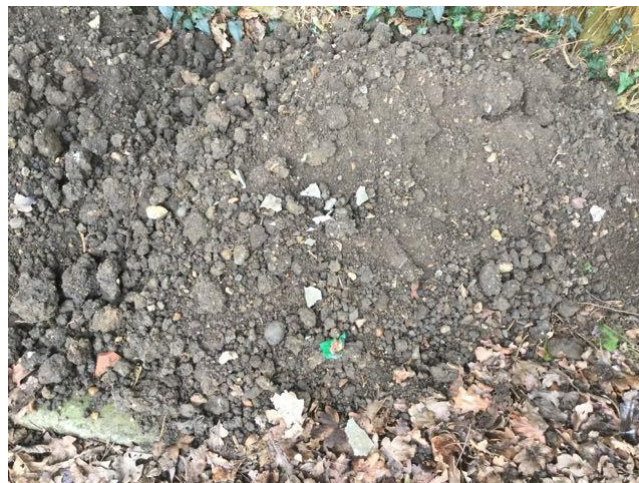
Building	Antoneys Close
Floor	External
Room	99 - Car park
Description	Cement debris within car park
Sample Reference	S001
Quantity	1 m ²
Accessibility	Easy

Analysis Result	No Asbestos Detected	0
Product Type	Cement	1
Condition	High Damage	3
Surface Treatment	Unsealed Cement	1

Material Risk Assessment Score
0
Risk Assessment Description
No ACMs Detected

Presumed to be through mounds of mud

No asbestos was detected within the sample collected and as such no further action is required.

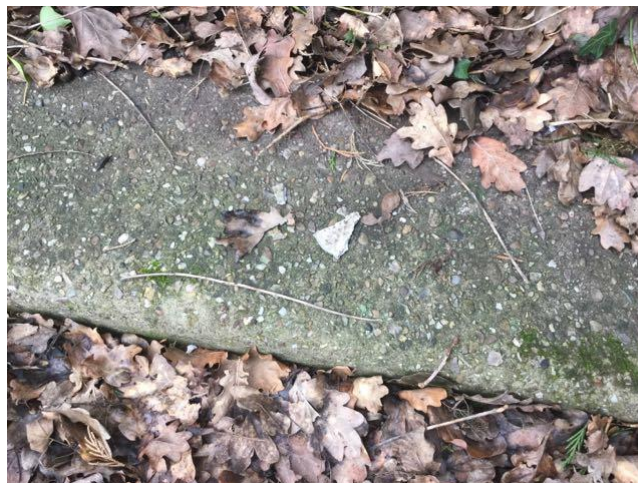
Building	Antoneys Close
Floor	External
Room	99 - Car park
Description	Cement debris within car park
Sample Reference	S002
Quantity	1 m ²
Accessibility	Easy

Analysis Result	No Asbestos Detected	0
Product Type	Cement	3
Condition	High Damage	3
Surface Treatment	Unsealed Cement	1

Material Risk Assessment Score
0
Risk Assessment Description
No ACMs Detected

Comments
N/A
Recommendations
No asbestos was detected within the sample collected and as such no further action is required.
