Main Investigation Report

Plot Adjacent to 35 Balcorne Street, Hackney, London E9 7JW

Hackney London Borough Council

Reference: I8536/MIR_R27
September 2020

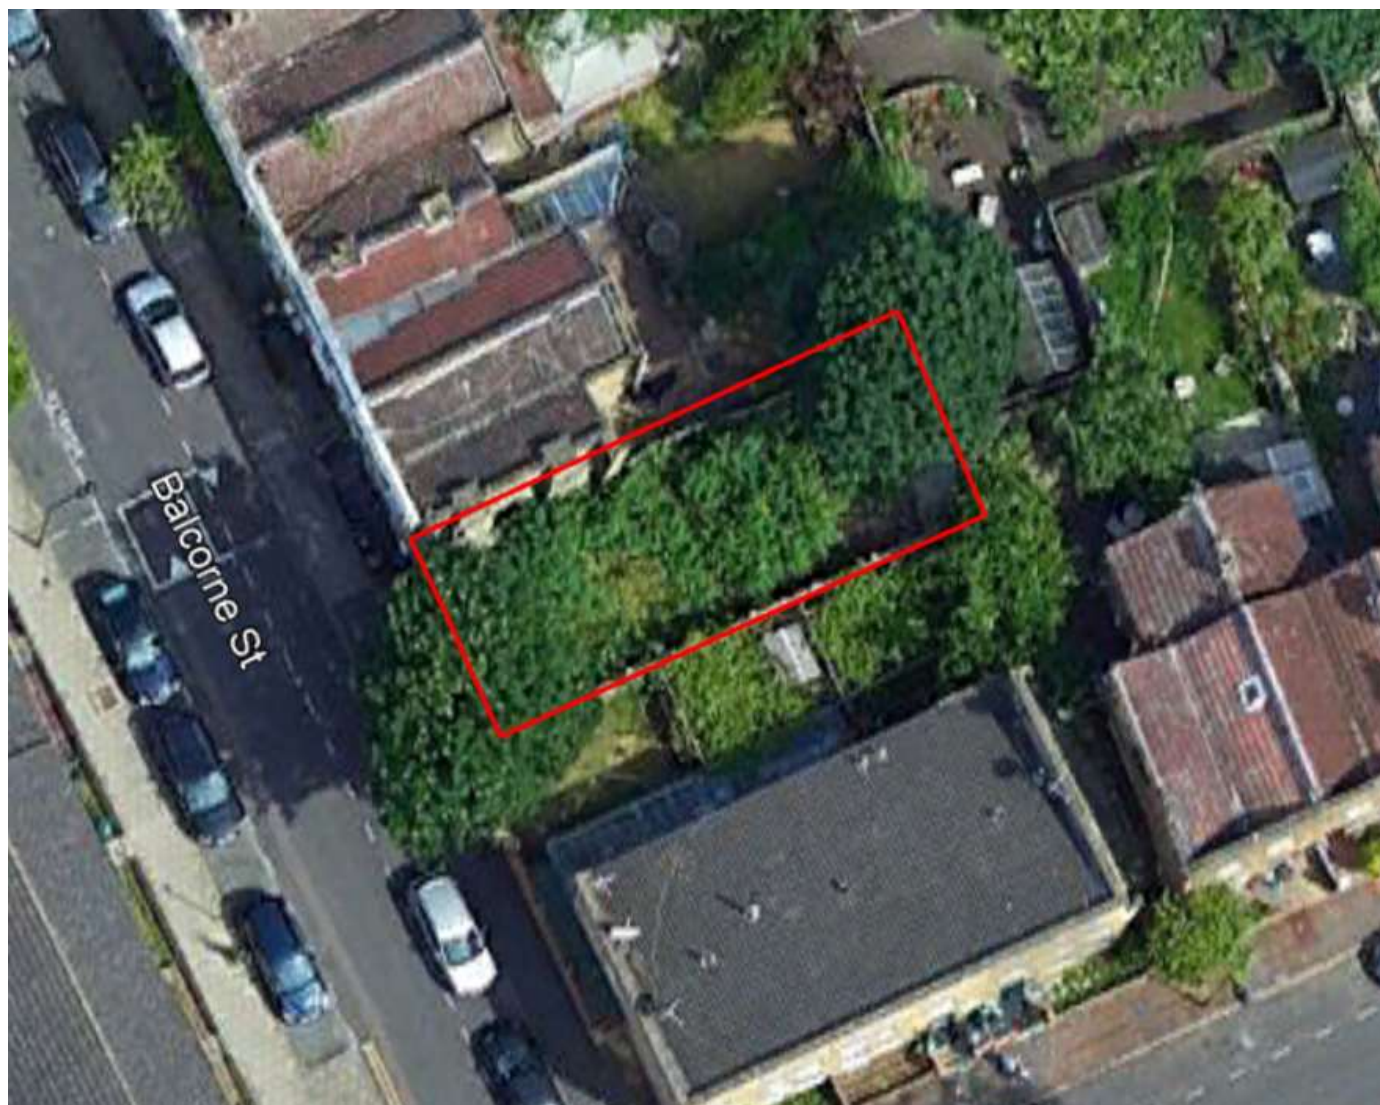
Figure 3 – Trial Hole Plan

The approximate trial hole locations are shown on Figure 3.

All trial hole locations have been presented in Figure 3.

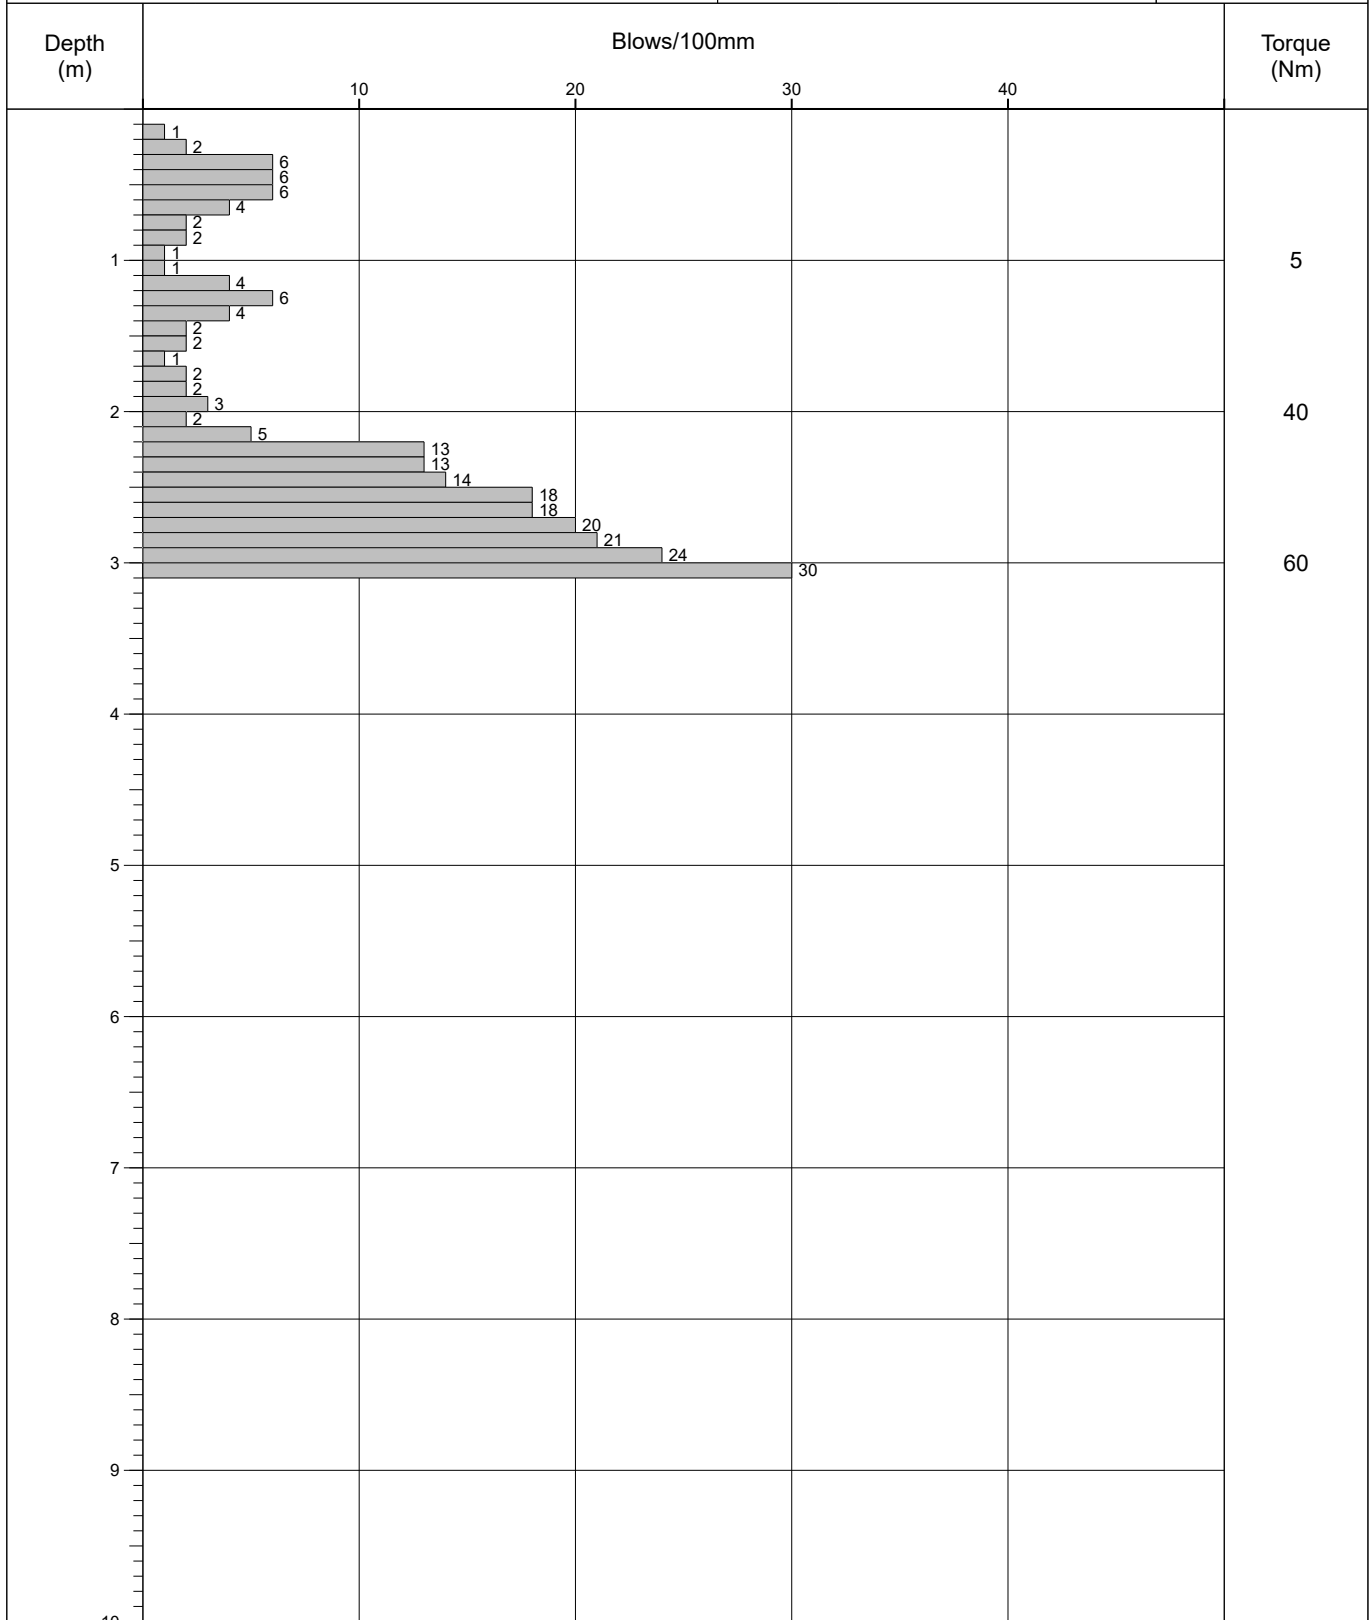
Project Name:	Balcorne Street	Project No.	18536	Co-ords:		Hole Type	DP
Location:	Hackney, London E9 7JW	Level:	m AOD	Scale	1:50	Logged By	
Client:	Hackney London Borough Council	Dates:	24/07/2020

Remarks Refused at 3.00m bgl due to high blow counts.	Fall Height	760mm	Cone Base Diameter	50.5mm
	Hammer Weight	63.5kg	Final Depth	3m
	Probe Type	DPSH	Energy Ratio (Er)	78.58%

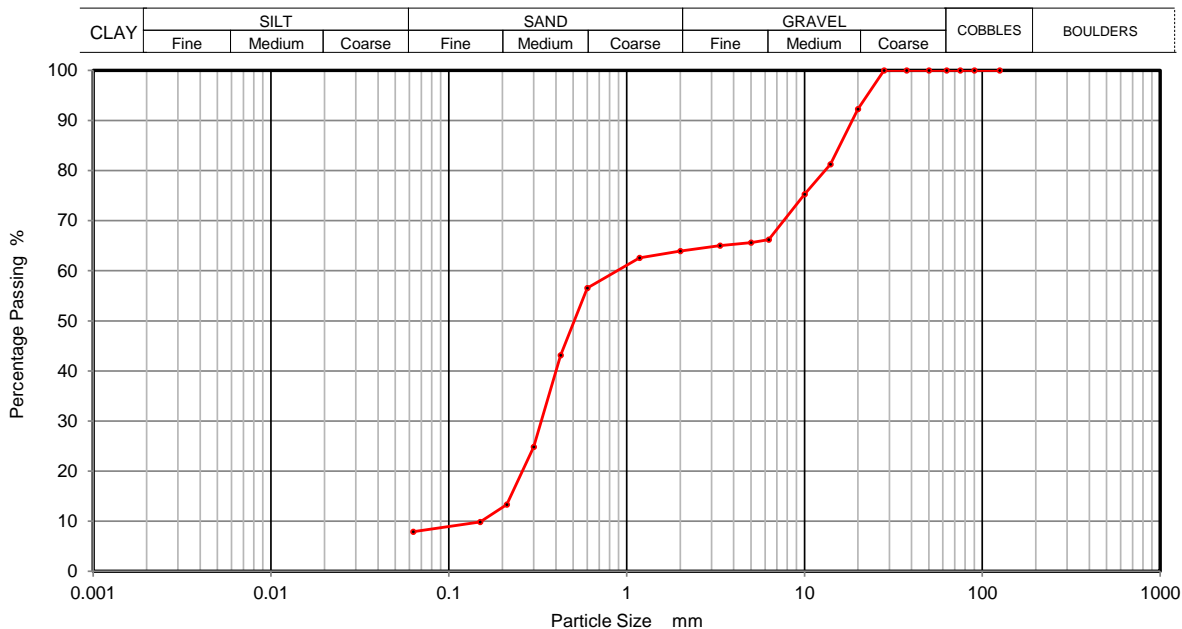
Sieving		Sedimentation	
Particle Size mm	% Passing	Particle Size mm	% Passing
125	100		
90	100		
75	100		
63	100		
50	100		
37.5	100		
28	100		
20	92		
14	81		
10	75		
6.3	66		
5	66		
3.35	65		
2	64		
1.18	63		
0.6	57		
0.425	43		
0.3	25		
0.212	13		
0.15	10		
0.063	8

Sample Proportions	% dry mass
Cobbles	0
Gravel	36
Sand	56
Silt and Clay	8

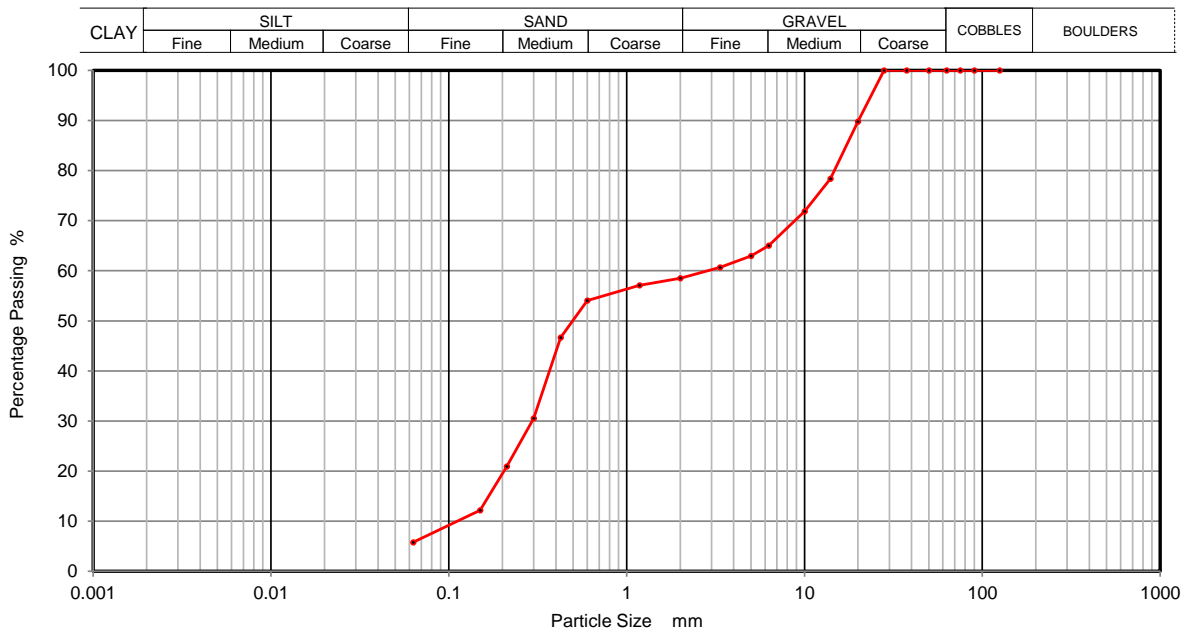
Sieving		Sedimentation	
Particle Size mm	% Passing	Particle Size mm	% Passing
125	100		
90	100		
75	100		
63	100		
50	100		
37.5	100		
28	100		
20	90		
14	78		
10	72		
6.3	65		
5	63		
3.35	61		
2	59		
1.18	57		
0.6	54		
0.425	47		
0.3	31		
0.212	21		
0.15	12		
0.063	6

Sample Proportions	% dry mass
Cobbles	0
Gravel	41
Sand	53
Silt and Clay	6

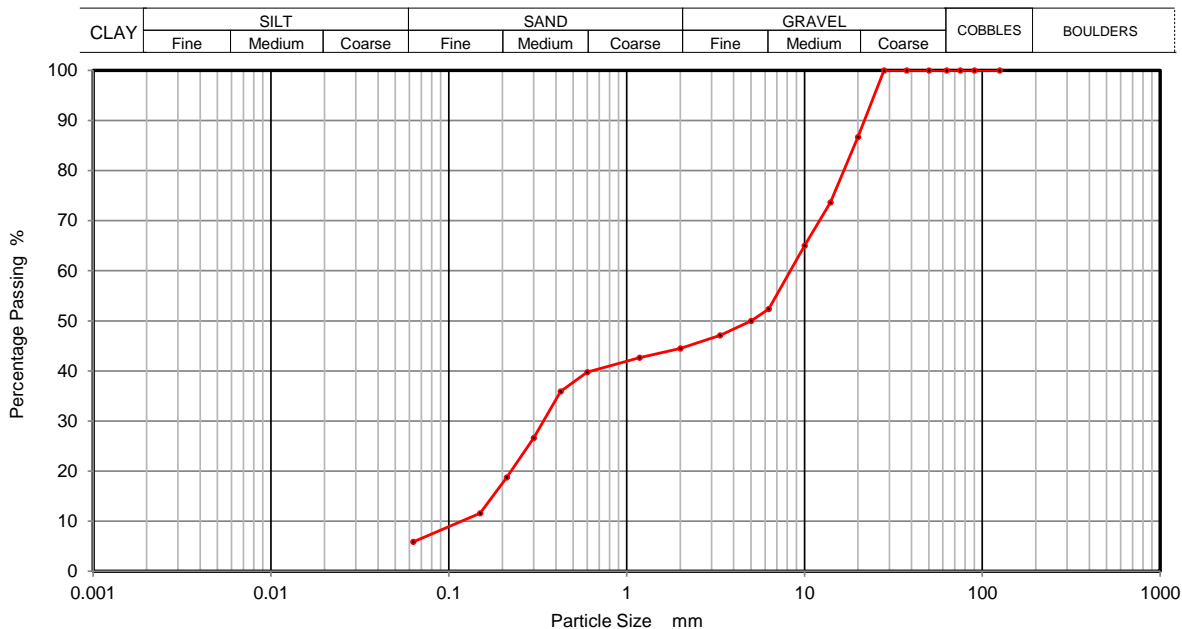
Sieving		Sedimentation	
Particle Size mm	% Passing	Particle Size mm	% Passing
125	100		
90	100		
75	100		
63	100		
50	100		
37.5	100		
28	100		
20	87		
14	74		
10	65		
6.3	52		
5	50		
3.35	47		
2	44		
1.18	43		
0.6	40		
0.425	36		
0.3	27		
0.212	19		
0.15	12		
0.063	6

Sample Proportions	% dry mass
Cobbles	0
Gravel	56
Sand	38
Silt and Clay	6
