# **CABLE STREET**

# **TECHNICAL INFORMATION**

**LAND AT CABLE STREET & ROYAL MINT STREET, E1 8LG**

**Site Investigation Summary Report**

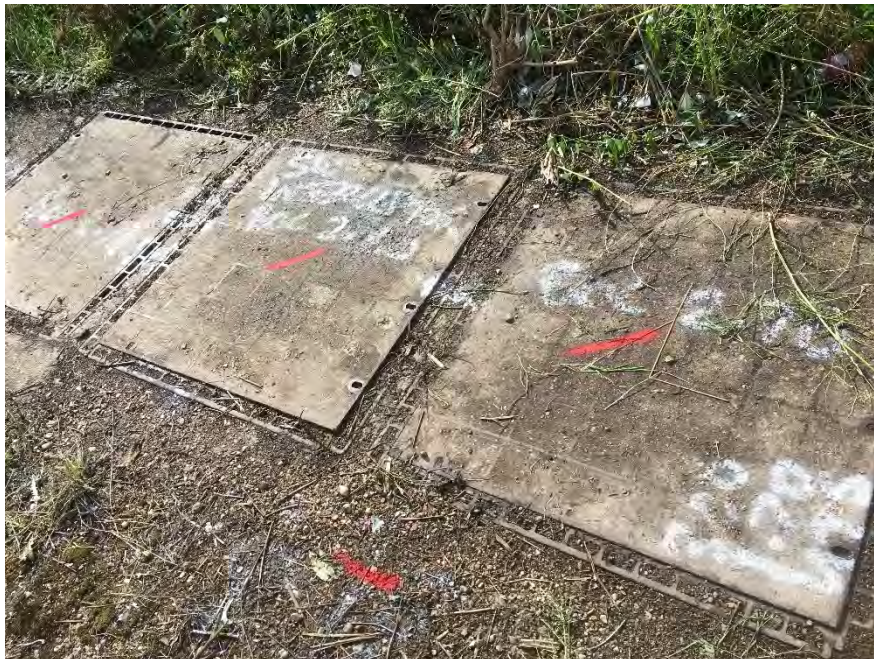
**Photo 2**

**Description: View of Interceptor manhole covers.**

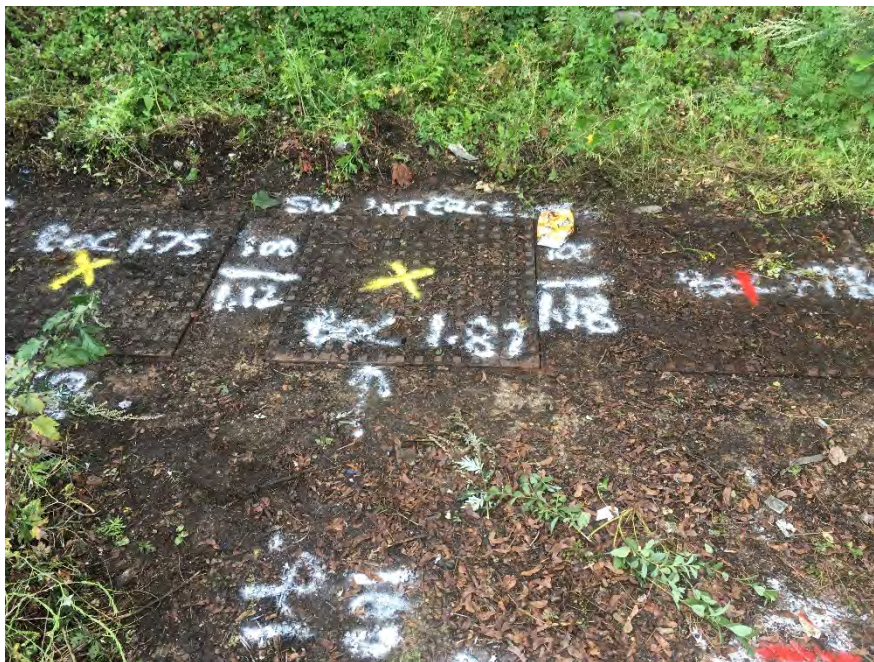
**Photo 8**

**Description:** View of Interceptor manhole covers.

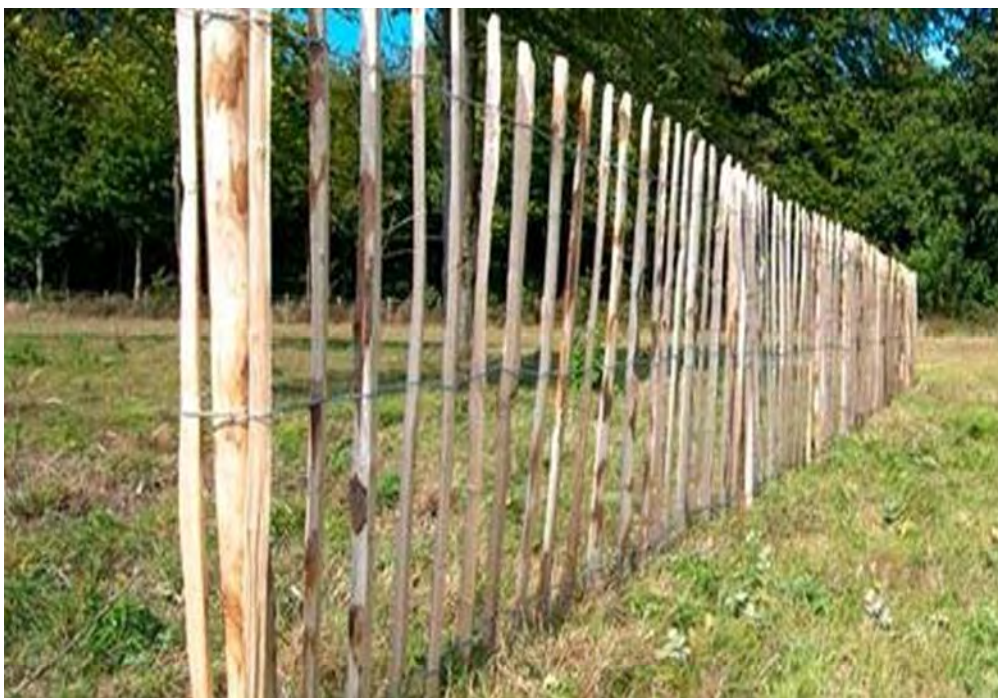
Figure C1 Tree Protection fencing example for low use areas

The system illustrated in Figure C1 is adequate to define areas of protected vegetation and exclude traffic, and comprises Cleft Chestnut Pale Fence in accordance with *BS 1722 Part 4: Specification for cleft chestnut pale fences (British Standards Institution, 1991)* supported by 150mm wooden stakes. Assembled with galvanized 14-gauge (2 mm) wire, four strands per row, peeled and pointed one end. Approximate spacing of pales 75 mm.

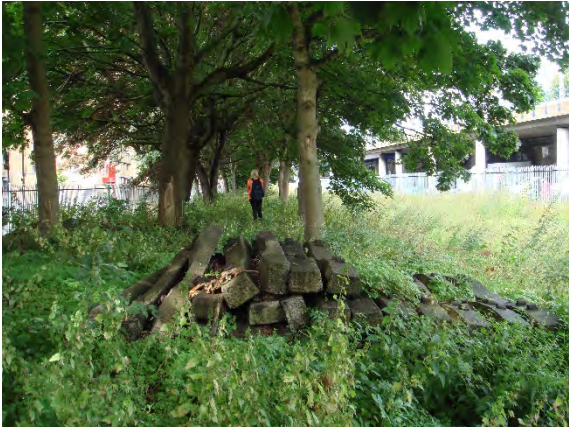
Tree No.	Description	Photograph
N/A - multiple	View of the trees at the south of the site viewed from the east to the west

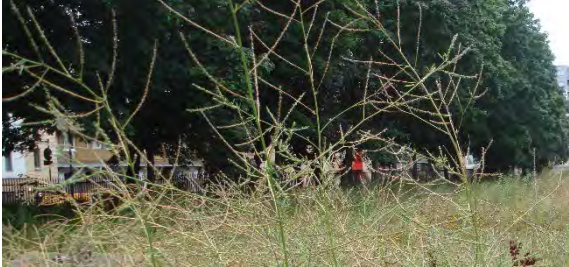
N/A - multiple	Tree line on site viewed from the north

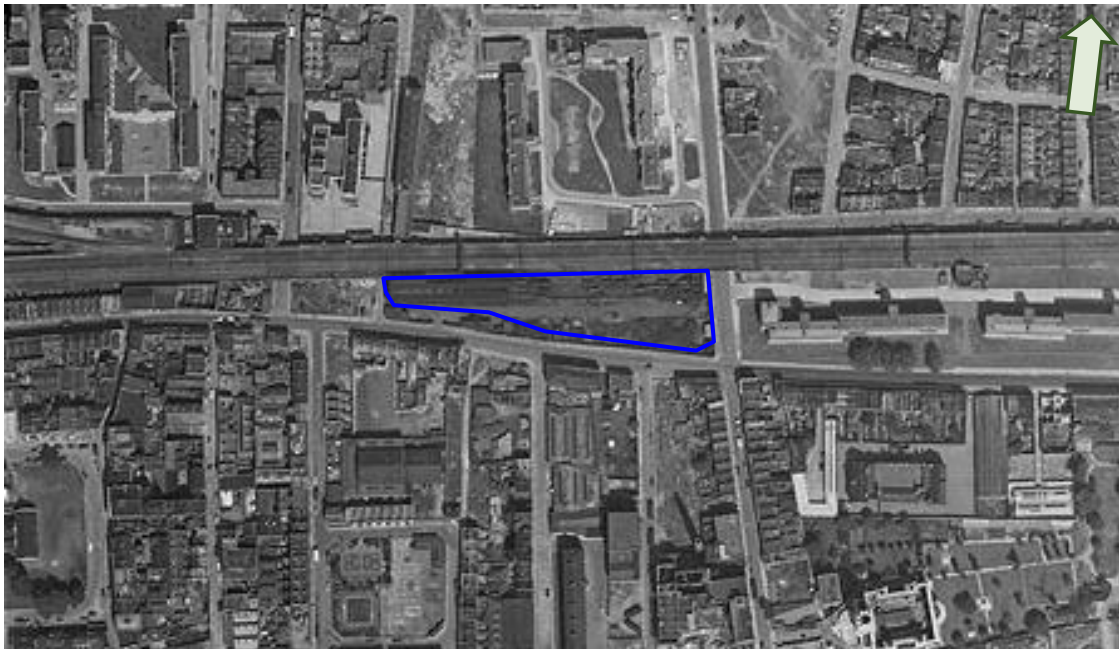
**Plate 3** Aerial photograph, 6<sup>th</sup> June 1955

Plate 3, an aerial photograph dated the 6<sup>th</sup> June 1955, shows that there had been no significant development on the Site by the mid-20<sup>th</sup> century.

Plate 3, an aerial photograph dated the 6<sup>th</sup> June 1955, shows that there had been no significant development on the Site by the mid-20<sup>th</sup> century.

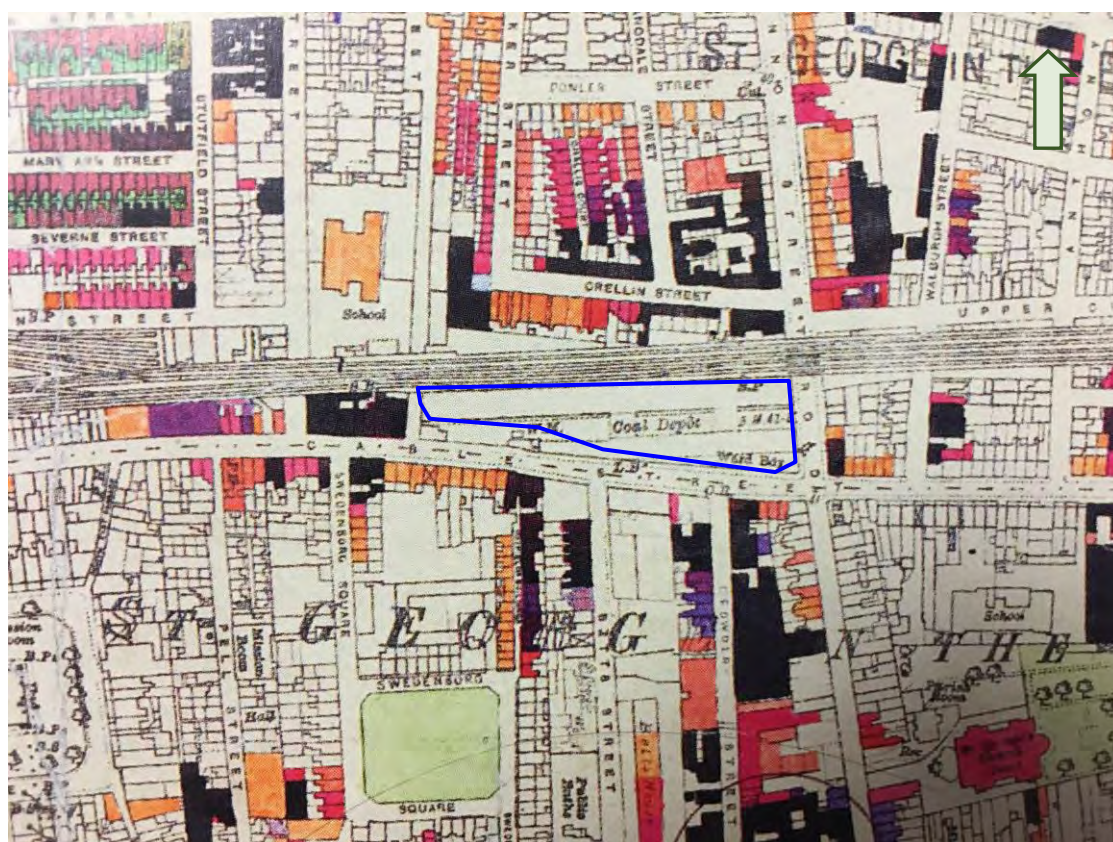
**Figure 4** Extract from the London Bomb Damage Map

Figure 4 is an extract from the London Bomb Damage Map, compiled at the end of WWII, on which the colouring denotes the severity of damage to buildings. Black indicates a destroyed building, purple and red indicate severe damage, while orange and yellow indicate blast damage. The pale green indicate areas cleared of rubble.

The map indicates that several buildings in close proximity to the Site, including buildings adjacent to the western boundary of the Site, were recorded as demolished.

Figure 4 is an extract from the London Bomb Damage Map, compiled at the end of WWII, on which the colouring denotes the severity of damage to buildings. Black indicates a destroyed building, purple and red indicate severe damage, while orange and yellow indicate blast damage. The pale green indicate areas cleared of rubble.

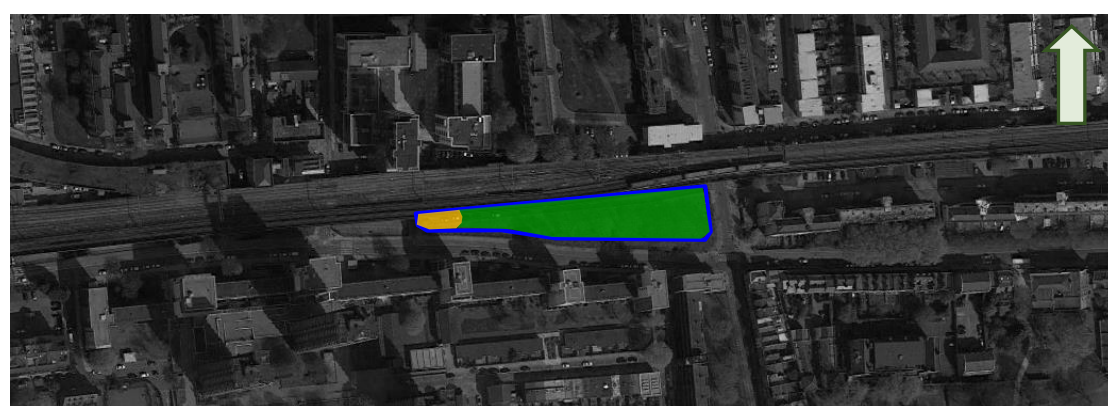
**Figure 5** UXO hazard zone plan of the Site

Given this, it is considered that the UXO hazard level on the Site can be zoned from low to moderate, as shown in Figure 5.

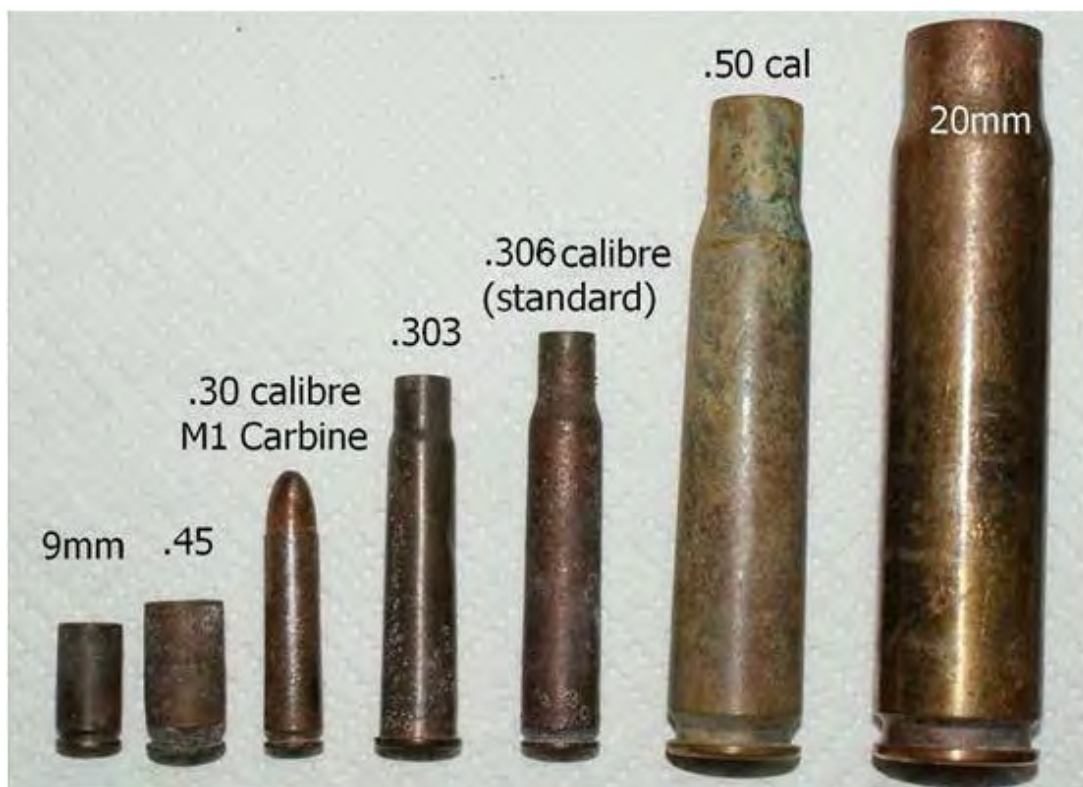
**Plate** Photograph of typical WWII small arms ammunition

Generally small arms ordnance has a relatively low risk as UXO, although the larger calibre categories may have the same detonation risk as larger high explosive ordnance. SAA is often associated with discarded ammunition boxes around firing practice ranges. The Plate below illustrates some common SAA.

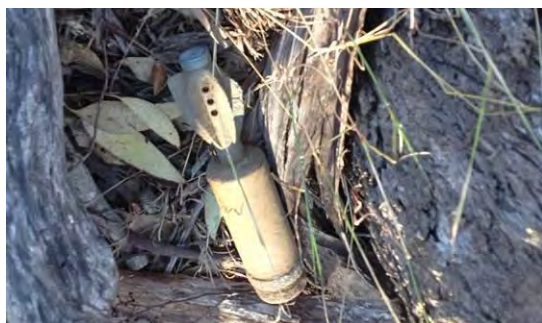
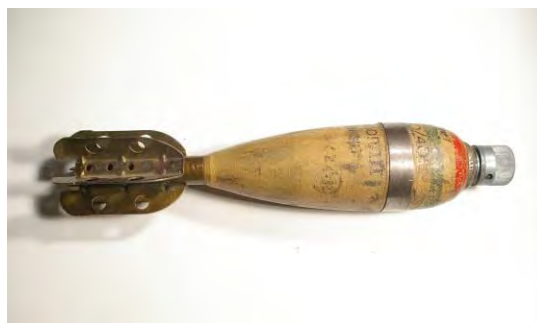
Plate	Photographs of WWII 2-inch and 3-inch mortars
-------	---

The Plate below shows a typical 2-inch mortar bomb found (left) and a demonstration 3-inch mortar bomb (right).

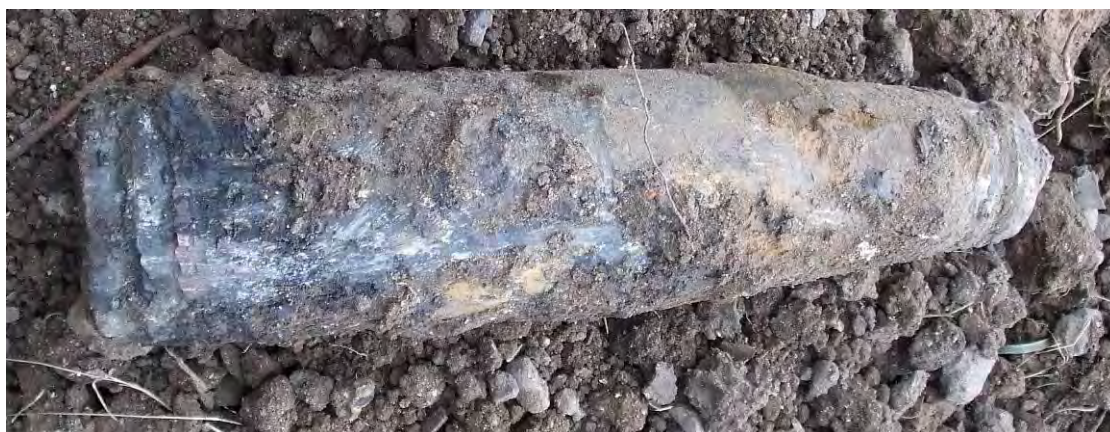
Plate	Photograph of a recently excavated 3.7" AA shell
-------	--

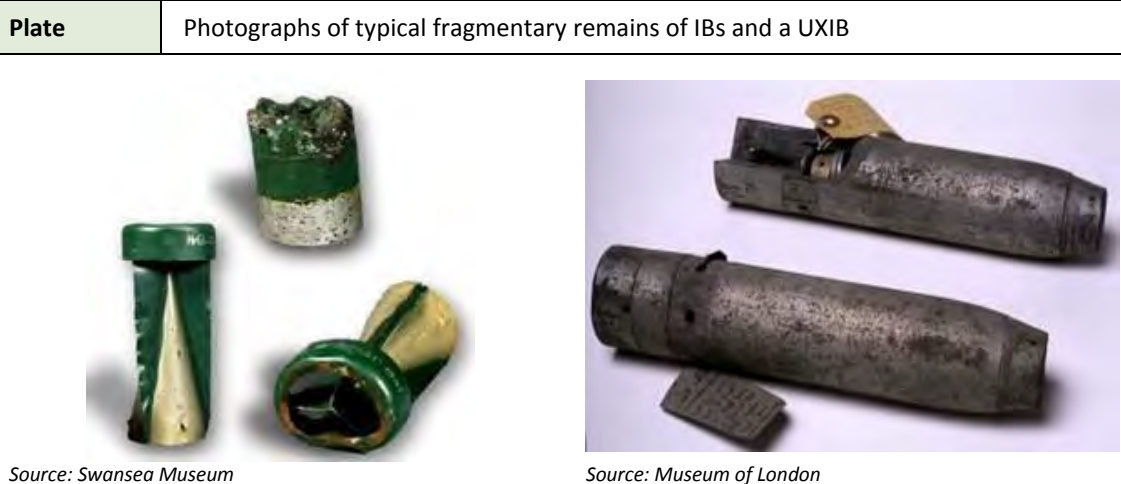
The Plate below shows a typical variety of fragmentary remains of IBs and 2No. IBs recovered by the Civil Defence during WWII.

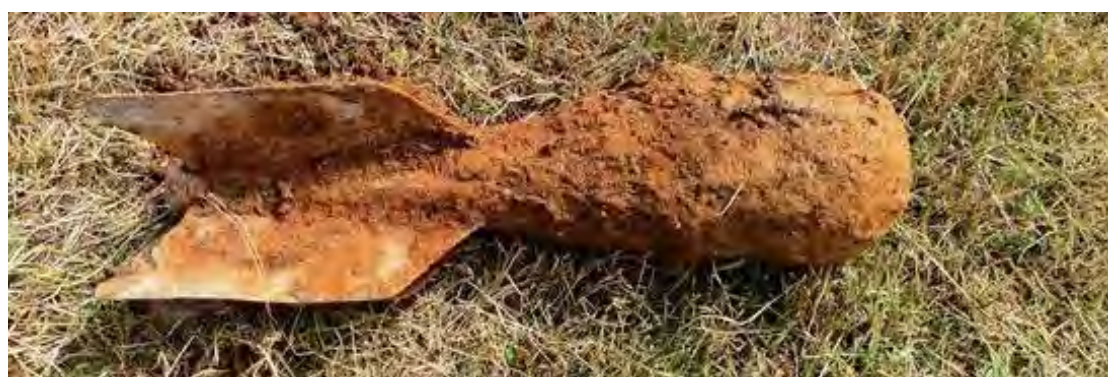
<b>Plate</b>	Photograph of WWI bomb, Isle of Sheppey, 2 <sup>nd</sup> August 2012
--------------	--

1No. WWI bomb (shown in the Plate below) was found on the Isle of Sheppey on the 2<sup>nd</sup> August 2012 during a geophysical survey following desk study research by Zetica Ltd which had established that a previously unknown WWI bombing range existed on the site. A further WWI bomb was found in the same location in August 2015.

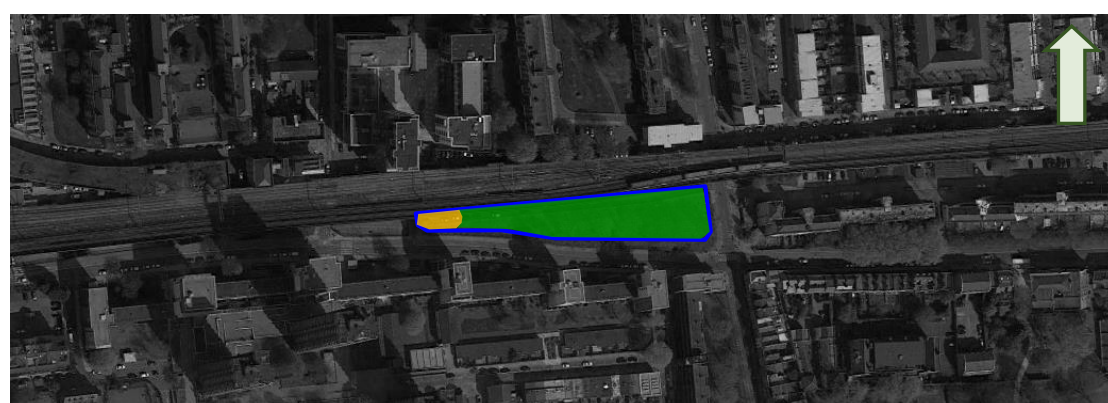
**Figure 5** UXO hazard zone plan of the Site

Given this, it is considered that the UXO hazard level on the Site can be zoned from low to moderate, as shown in Figure 5.

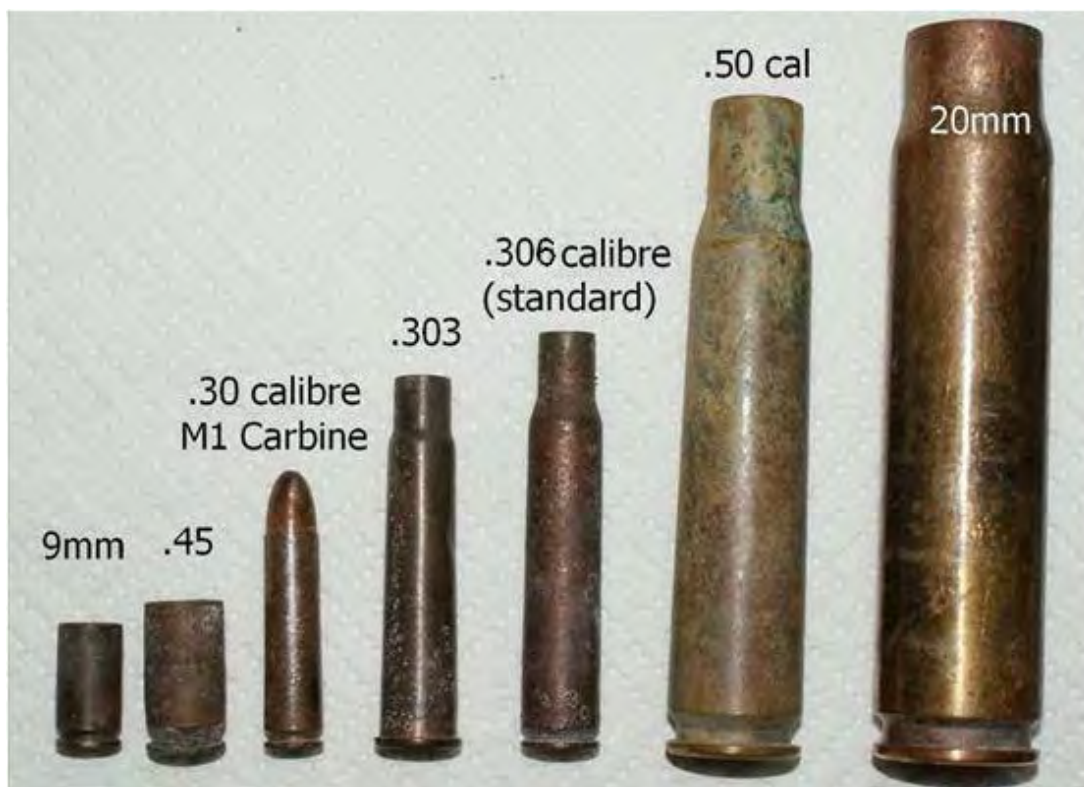
**Plate** Photograph of typical WWII small arms ammunition

Generally small arms ordnance has a relatively low risk as UXO, although the larger calibre categories may have the same detonation risk as larger high explosive ordnance. SAA is often associated with discarded ammunition boxes around firing practice ranges. The Plate below illustrates some common SAA.

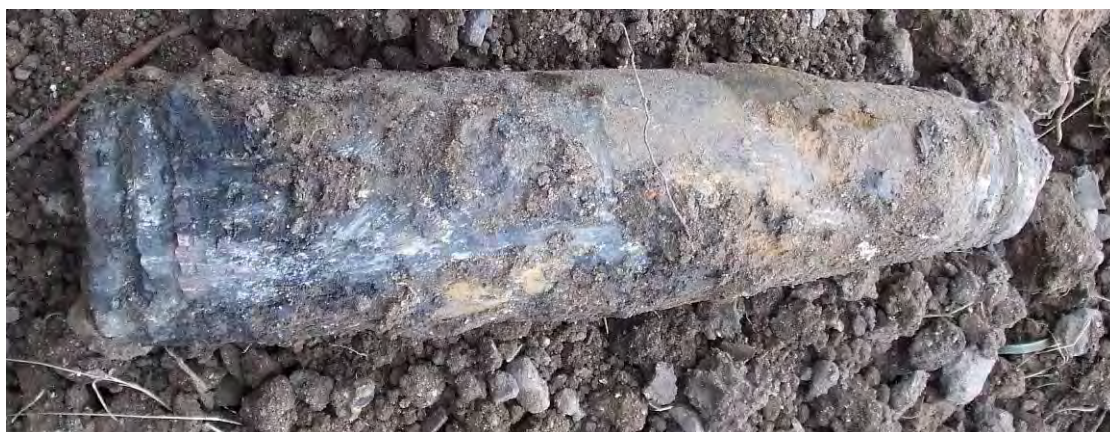
Plate	Photograph of a recently excavated 3.7" AA shell
-------	--

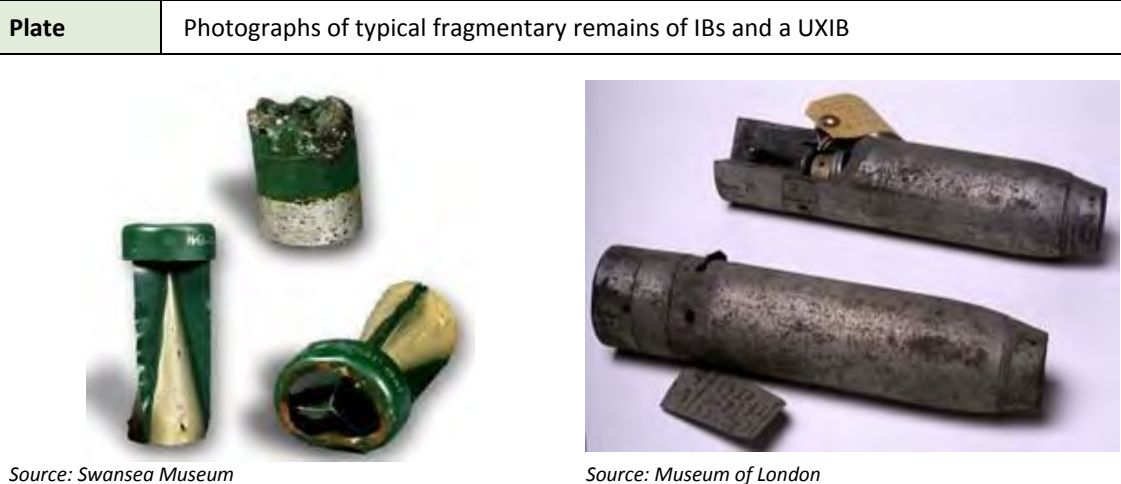
The Plate below shows a typical variety of fragmentary remains of IBs and 2No. IBs recovered by the Civil Defence during WWII.
