Cable Street, Whitechapel - UXO Desk Study & Risk Assessment

Document Title UXO Desk Study & Risk Assessment
Document Ref. P7005-17-R1
Revision A
Project Location Cable Street, Whitechapel
Client Arcadis
Date 13th July 2017

UXO DESK STUDY & RISK ASSESSMENT

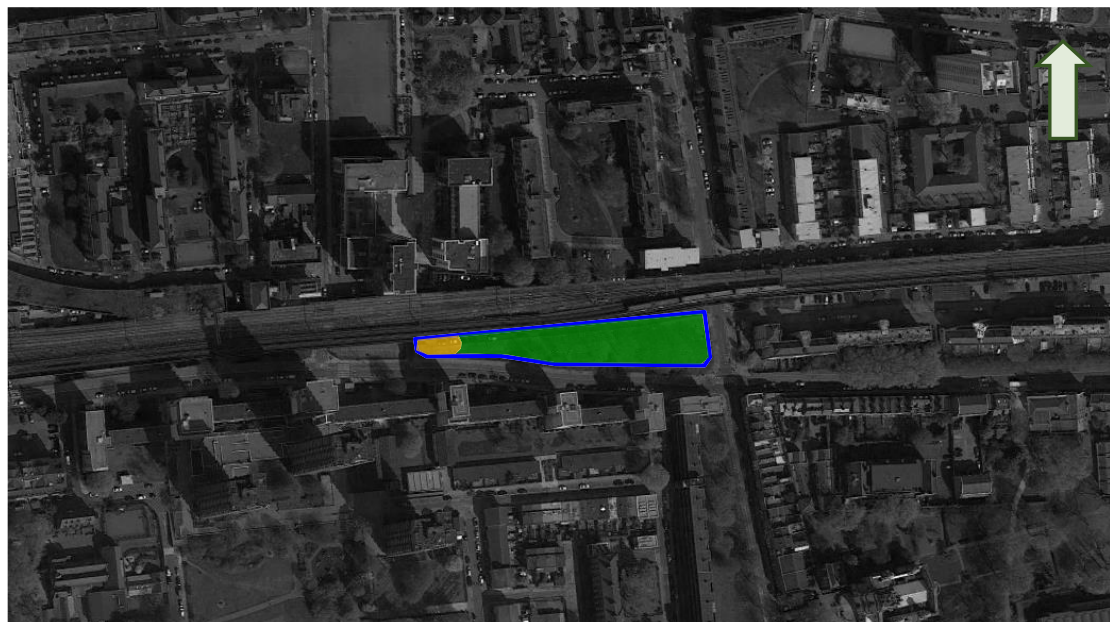
Figure UXO hazard zone plan of the Site

Given this, it is considered that the UXO hazard level on the Site can be zoned from low to moderate, as shown in the following Figure, reproduced as Figure 5 in the main report.

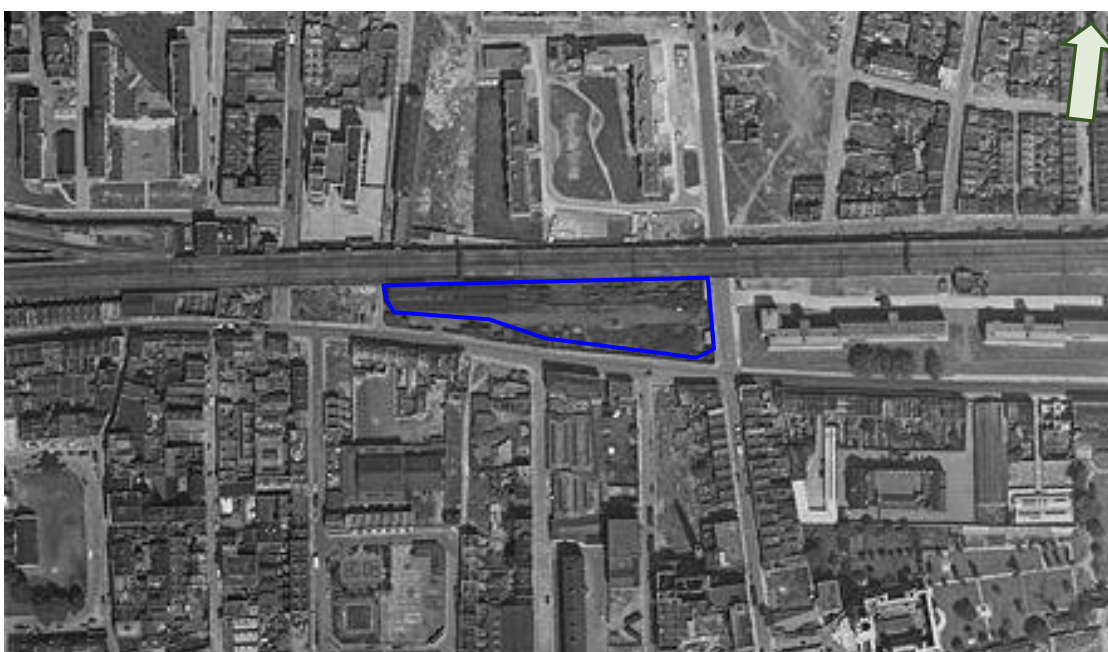
Plate 3 Aerial photograph, 6th June 1955

Plate 3, an aerial photograph dated the 6th June 1955, shows that there had been no significant development on the Site by the mid-20th century.

Buildings throughout the surrounding area had been destroyed by bombing during WWII (see Section 3).

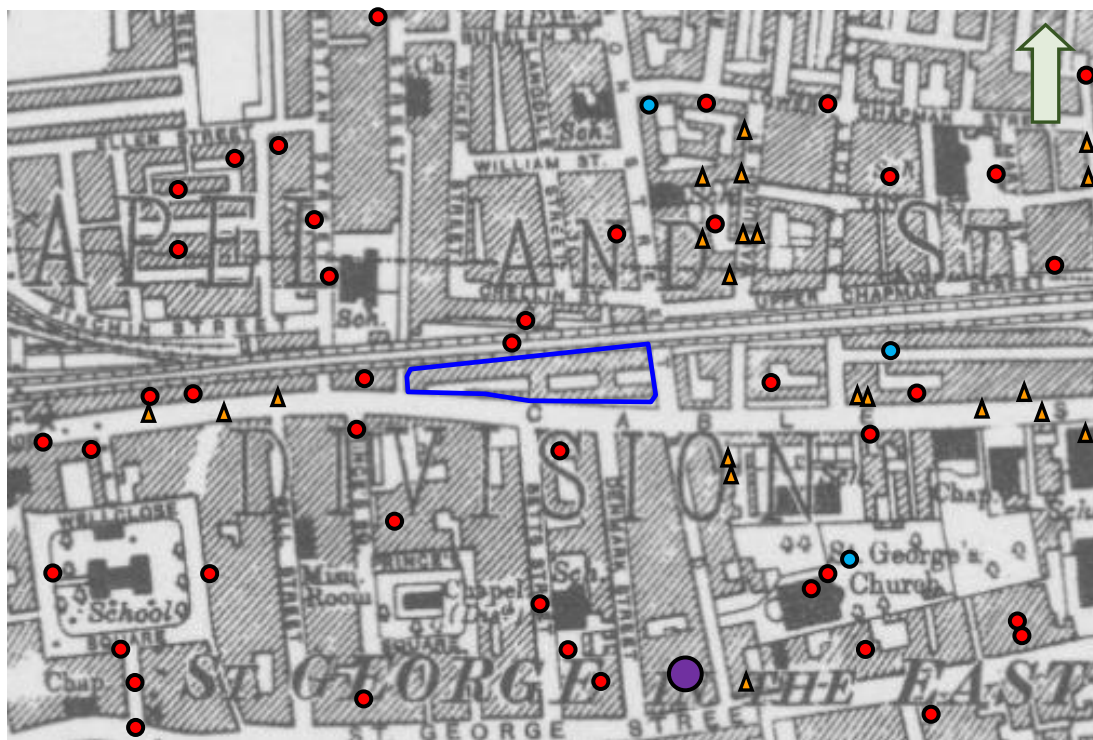
Figure 3 Compiled bomb impact map for the vicinity of the Site

Note that air raid incident reports did not always record precise locations, often only indicating on which street, area or farm a bomb fell.

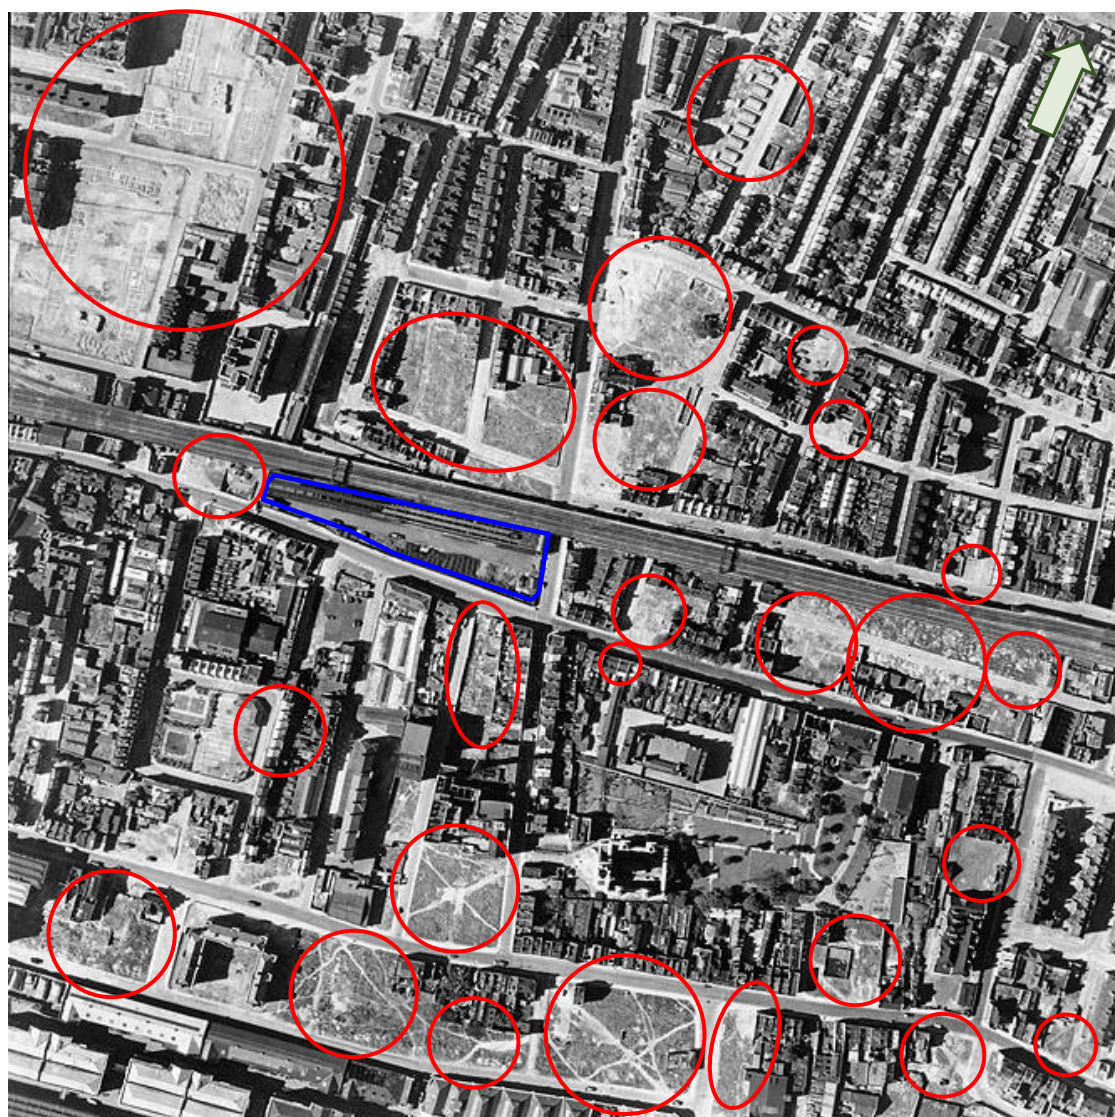
Plate 6 is an aerial photograph of the Site dated the 18th May 1948. No significant damage has been identified on the Site. Extensive bomb damage, characterised by demolished buildings and damaged roofing, has been identified throughout the surrounding area.

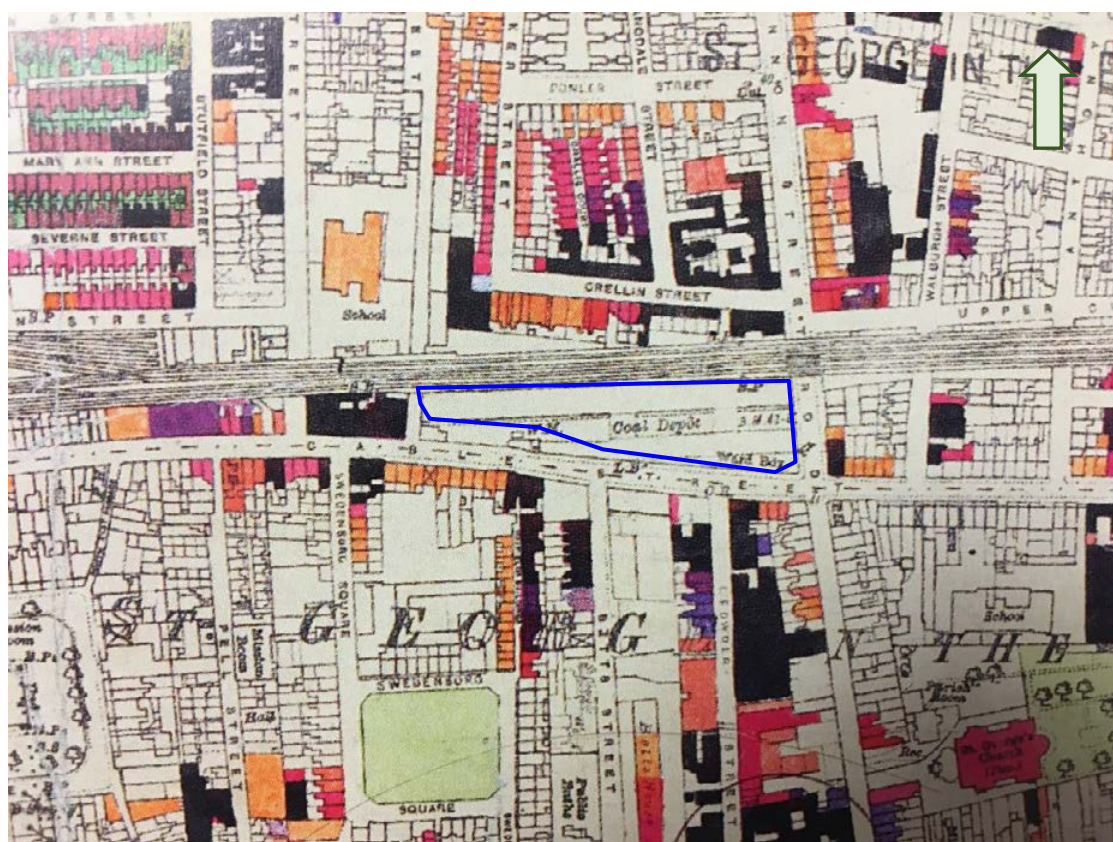
Figure 4 Extract from the London Bomb Damage Map

Figure 4 is an extract from the London Bomb Damage Map, compiled at the end of WWII, on which the colouring denotes the severity of damage to buildings. Black indicates a destroyed building, purple and red indicate severe damage, while orange and yellow indicate blast damage. The pale green indicate areas cleared of rubble.

The map indicates that several buildings in close proximity to the Site, including buildings adjacent to the western boundary of the Site, were recorded as demolished.

Records indicate that buildings adjacent to the western boundary of the Site were demolished by HE bombing. It is considered possible that this damage masked the impact of a UXB, which may have offset beneath the western end of the Site and remain in situ.

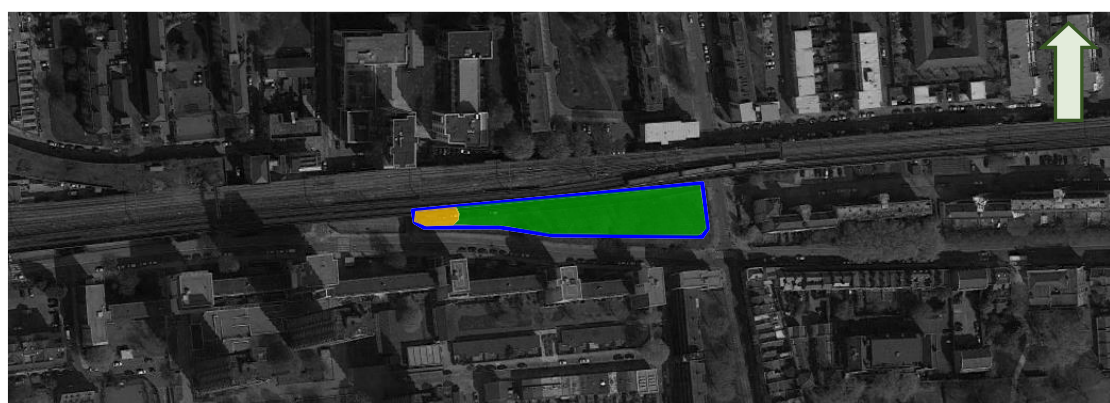
Figure 5 UXO hazard zone plan of the Site

Records have been found indicating that buildings adjacent to the western boundary of the Site were demolished by 1No. HE bomb during WWII.

It is considered that this may have masked the impact of a UXB, which may have offset beneath the western end of the Site and remain in situ. Consequently, the western end of the Site is assigned a moderate UXO hazard level.

No records have been found indicating that the Site was bombed and no other significant sources of UXO hazard have been identified on the remainder of the Site. The central and eastern parts of the Site are assigned a low UXO hazard level.

Given this, it is considered that the UXO hazard level on the Site can be zoned from low to moderate, as shown in Figure 5.

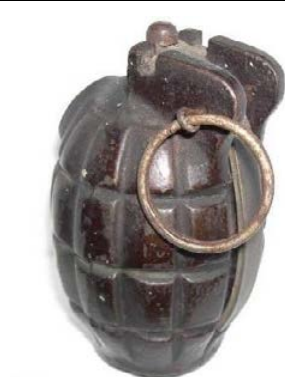
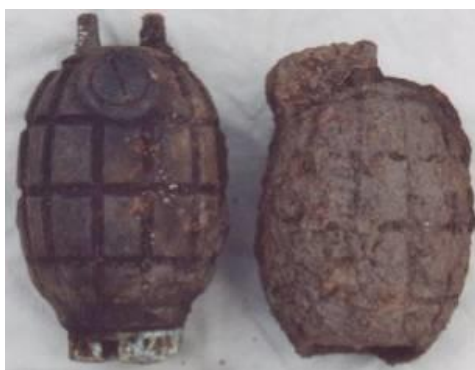
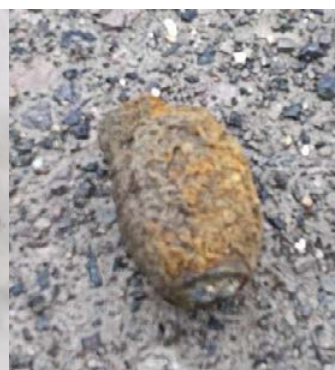
Plate	Photographs of a typical and an excavated WWII No. 36 hand grenades
--------------	---

Hand grenades can be filled with explosives or chemicals and have 3No. main parts, a body, a fuze with a pull ring and a safety-clip assembly. Fragmentation grenades are the most common and have a metal or plastic body filled with an explosive. Most use a burning delay fuze that functions for 3 to 5 seconds after the safety lever is released.

Some, such as smoke grenades, are activated instantly when the lever is released. The Plate below illustrates the typical character and condition of No. 36 hand grenades (Mills Bombs) that have been excavated from a site.

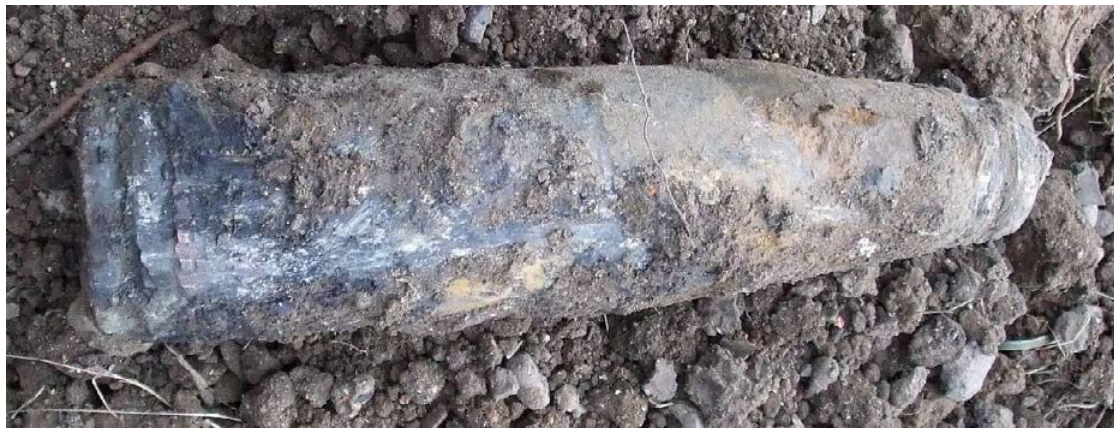
Plate	Photograph of a recently excavated 3.7" AA shell
--------------	--

The Plate below is a photograph of a 3.7" UXAA shell found in Camberwell, London.

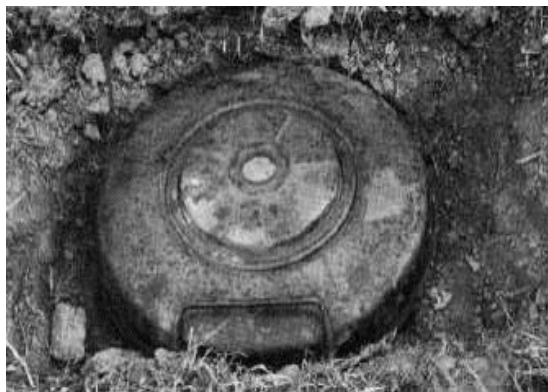
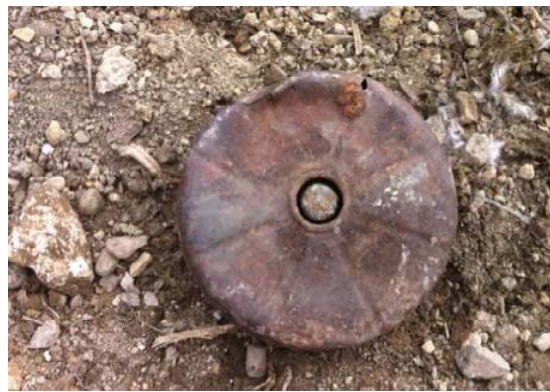
Plate	Photographs of original and recently excavated WWII land mines
--------------	--

The Plate below is a photograph of a typical WWII land mine used on the land area, beaches and cliffs around Britain. This example was found at Gatwick Airport formerly RAF Gatwick.

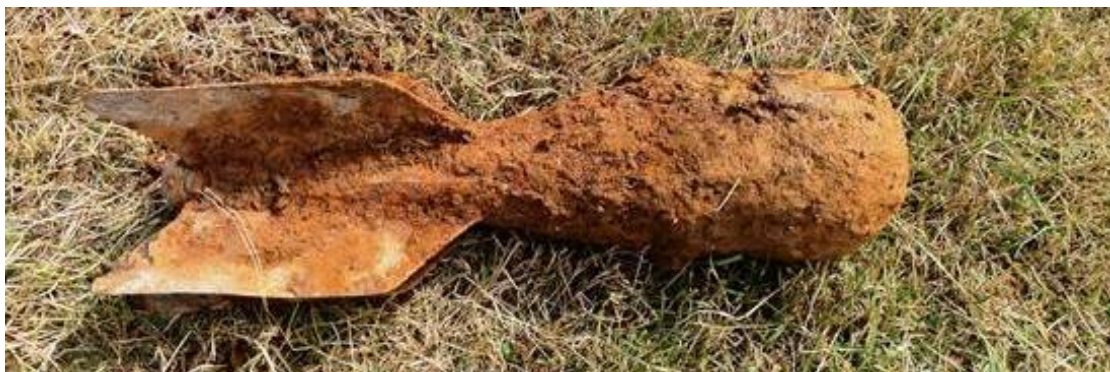
Plate	Photograph of WWI bomb, Isle of Sheppey, 2 nd August 2012
--------------	--

1No. WWI bomb (shown in the Plate below) was found on the Isle of Sheppey on the 2nd August 2012 during a geophysical survey following desk study research by Zetica Ltd which had established that a previously unknown WWI bombing range existed on the site. A further WWI bomb was found in the same location in August 2015.
