Christchurch Road, Brixton - UXO Desk Study & Risk Assessment

Document Title UXO Desk Study & Risk Assessment
Document Ref. P6931-17-R1
Revision A
Project Location Christchurch Road, Brixton
Client Arcadis
Date 13th June 2017

UXO DESK STUDY & RISK ASSESSMENT

Christchurch Road, Brixton

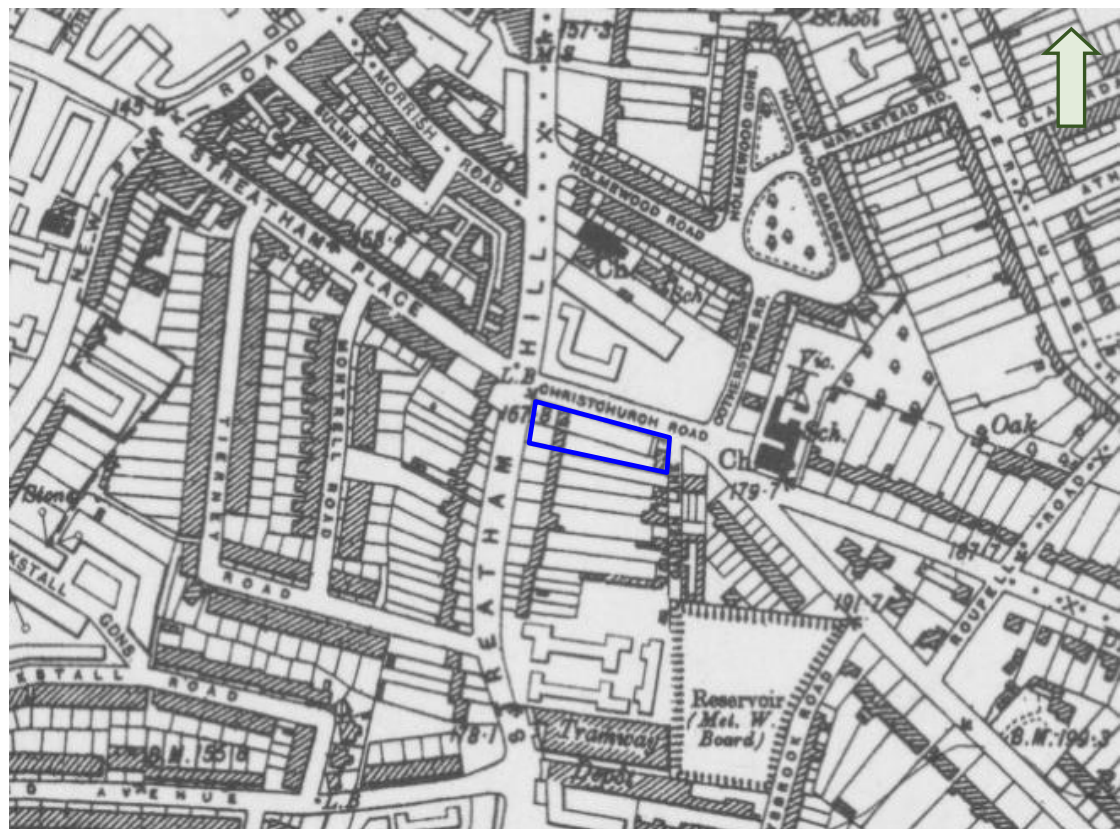
Figure 3 Historical map, 1938

The historical map of 1938 (Figure 3) shows that there had been no changes on the Site prior to WWII.

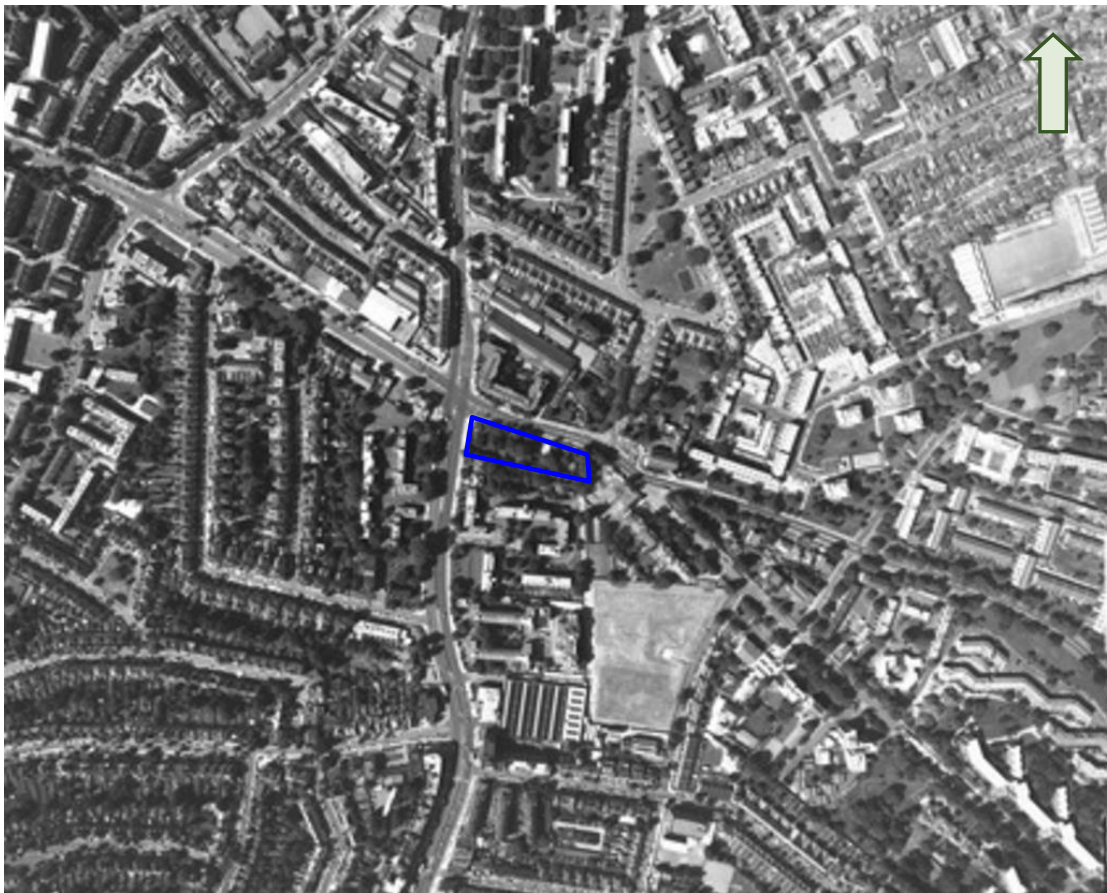
Plate 3	Aerial photograph, 11 th July 1987

The bungalows on the Site were demolished in the 1970s. Plate 3, an aerial photograph dated the 11th July 1987, shows that the Site now comprised heavily vegetated open ground.

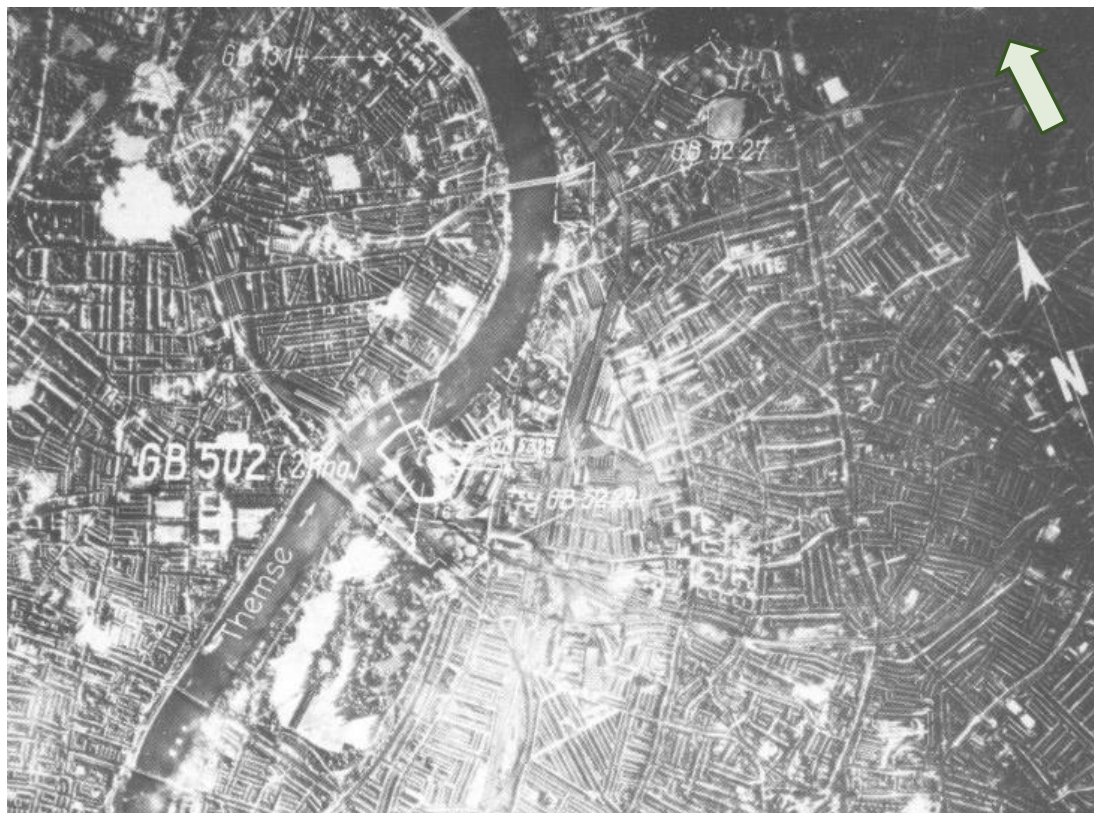
Plate 4 Luftwaffe target photograph of Battersea and Lambeth

Plate 4 is a Luftwaffe target photograph of the Battersea and Lambeth area. The target photo identifies Battersea Power Station (Target GB 50 2), Nine Elm Gas Works (GB 52 24) and Vauxhall Gas Works (Target GB 52 27).

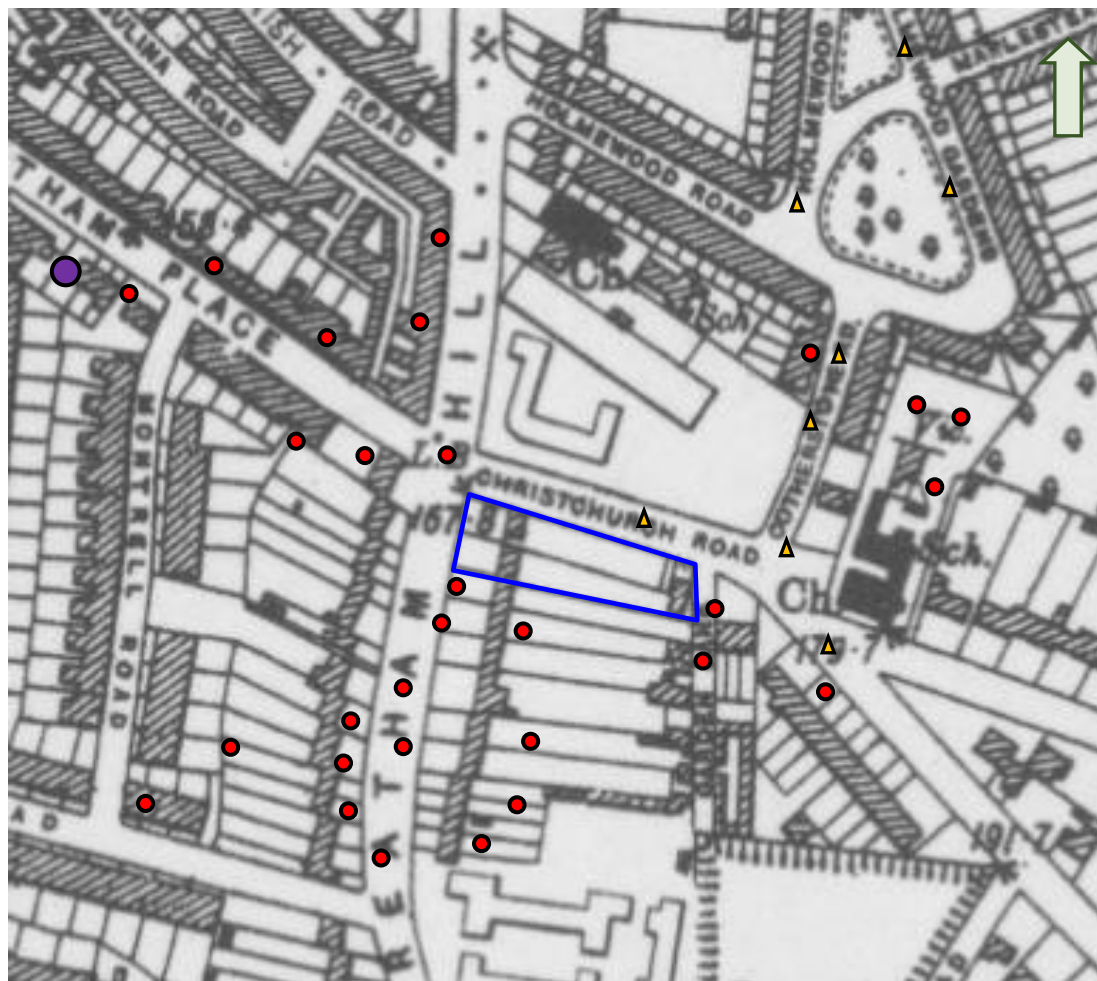
Figure 4 Compiled bomb impact map for the vicinity of the Site

Note that air raid incident reports did not always record precise locations, often only indicating on which street or area a bomb fell.

Records indicate that 16No. bombs fell within 0.1km of the Site, which resulted in severe damage to the buildings on the eastern part of the Site. It is considered that this damage may have masked the impact of a UXB during the heavy air raids in the region.

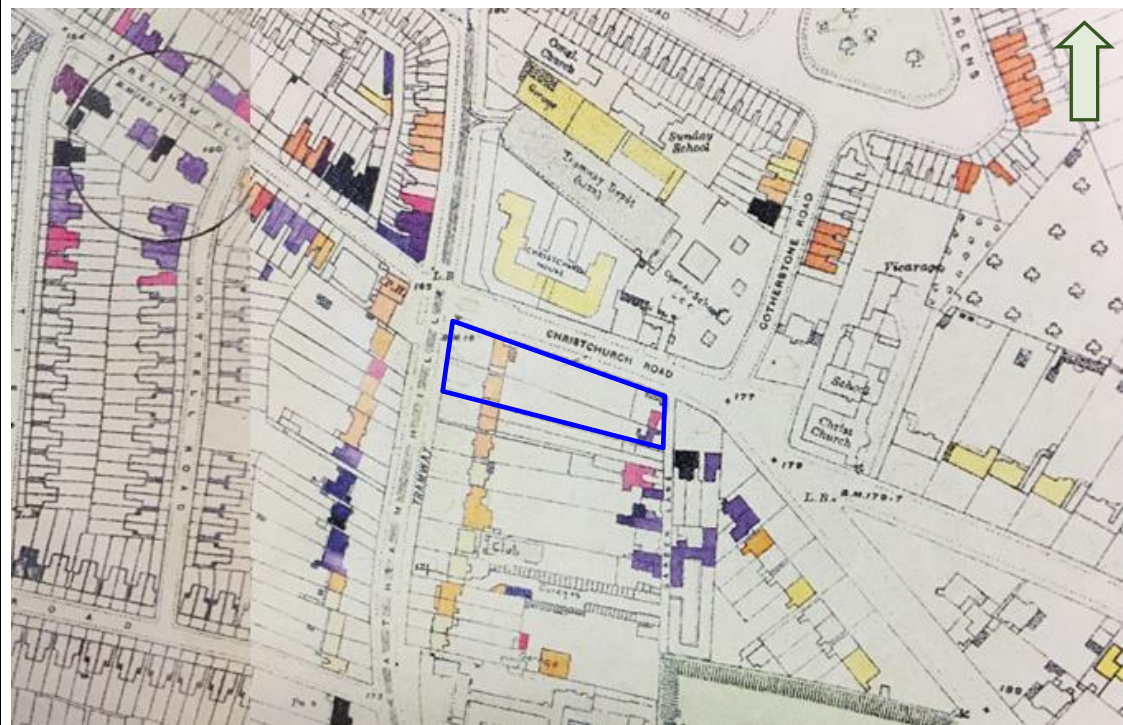
Figure 5 Extract from the London bomb damage map

Figure 5 is an extract from the London County Council (LCC) bomb damage map, compiled at the end of WWII, on which the colouring denotes the severity of damage to buildings.

Black indicates a destroyed building; purple, red and pink indicate structural damage, while orange and yellow indicate blast damage.

The bomb damage map indicates that major damage occurred on and in close proximity to the eastern part of the Site. Blast damage is recorded on the western part of the Site.

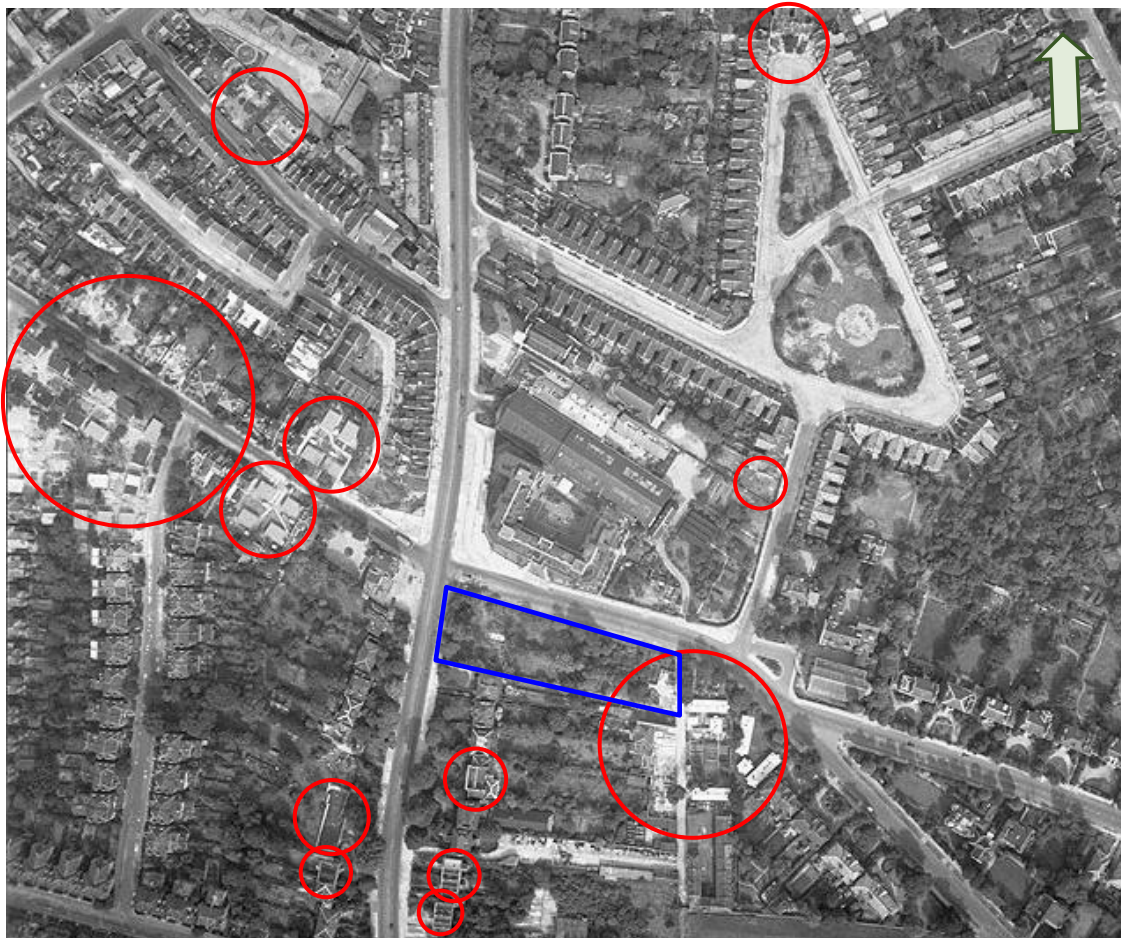
Plate 5 Aerial photograph, 13th March 1945

Plate 5 is an aerial photograph dated the 13th March 1945. It shows that the buildings on and adjacent to the eastern part of the Site had been demolished after sustaining bomb damage.

There is no evidence of significant damage on the western part of the Site.

Extensive bomb damage, characterised by demolished areas and prefabricated buildings, is evident in the immediate vicinity of the Site.

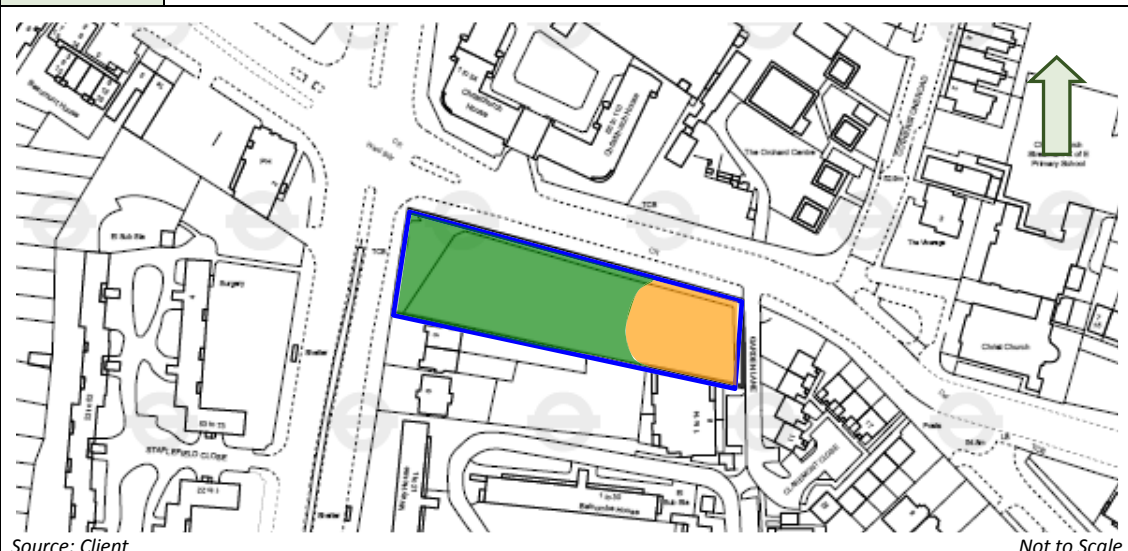
Figure 6 UXO hazard zone plan of the Site

Records have been found indicating that during WWII, 16No. HE bombs fell within 100m of the Site. The bombing caused significant damage to buildings on the eastern part of the Site, which may have masked the impact of a UXB during subsequent heavy raids. Given this, it is considered prudent to assign the eastern part of the Site a moderate UXO hazard level.

No evidence of any significant bomb damage or other sources of UXO hazard have been identified on the remainder of the Site, which is assigned a low UXO hazard level.

It is considered that the UXO hazard level on the Site can be zoned from low to moderate, as shown in Figure 6.

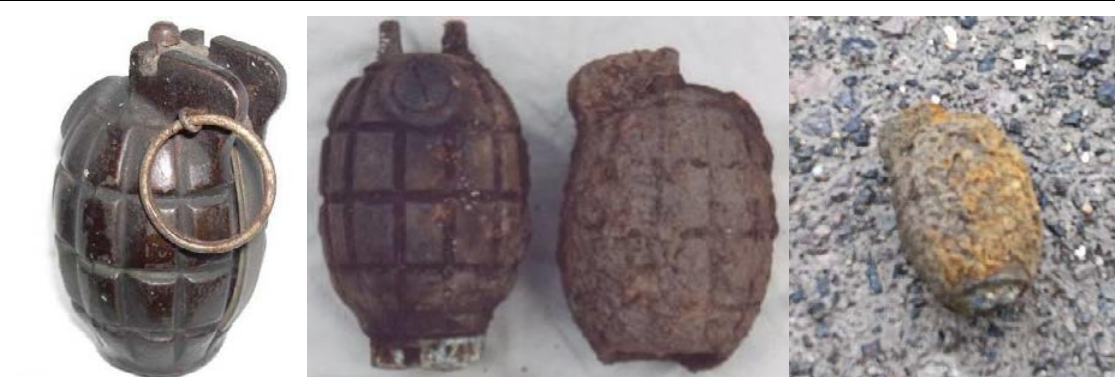
Plate	Photographs of a typical and an excavated WWII No. 36 hand grenades
--------------	---

Hand grenades can be filled with explosives or chemicals and have 3No. main parts, a body, a fuze with a pull ring and a safety-clip assembly. Fragmentation grenades are the most common and have a metal or plastic body filled with an explosive. Most use a burning delay fuze that functions for 3 to 5 seconds after the safety lever is released.

Some, such as smoke grenades, are activated instantly when the lever is released. The Plate below illustrates the typical character and condition of No. 36 hand grenades (Mills Bombs) that have been excavated from a site.

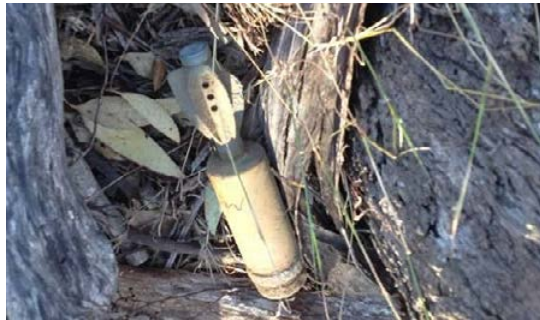
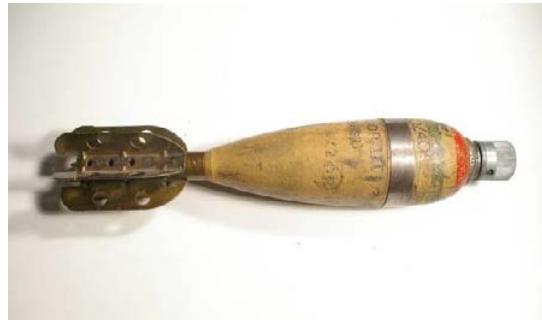
Plate	Photographs of WWII 2-inch and 3-inch mortars
--------------	---

The Plate below shows a typical 2-inch mortar bomb found (left) and a demonstration 3-inch mortar bomb (right).

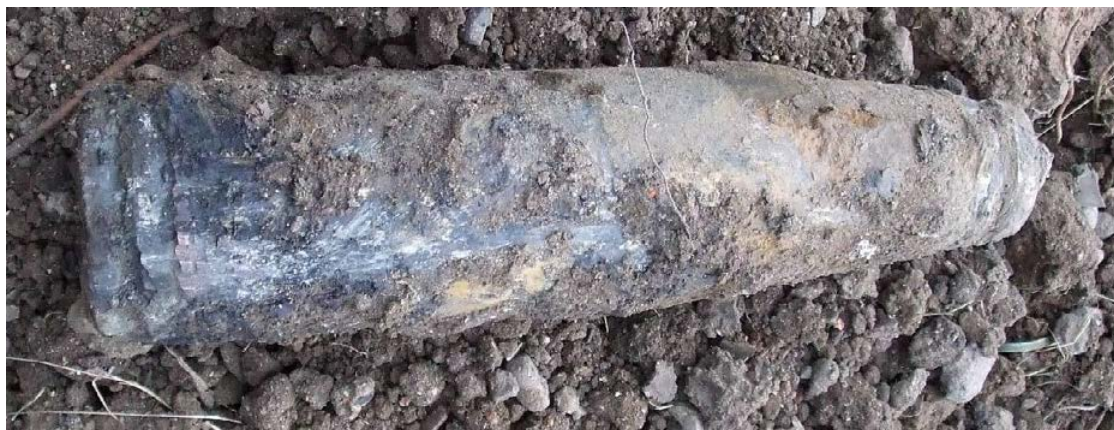
Plate	Photograph of a recently excavated 3.7" AA shell
--------------	--

The Plate below is a photograph of a 3.7" UXAA shell found in Camberwell, London.

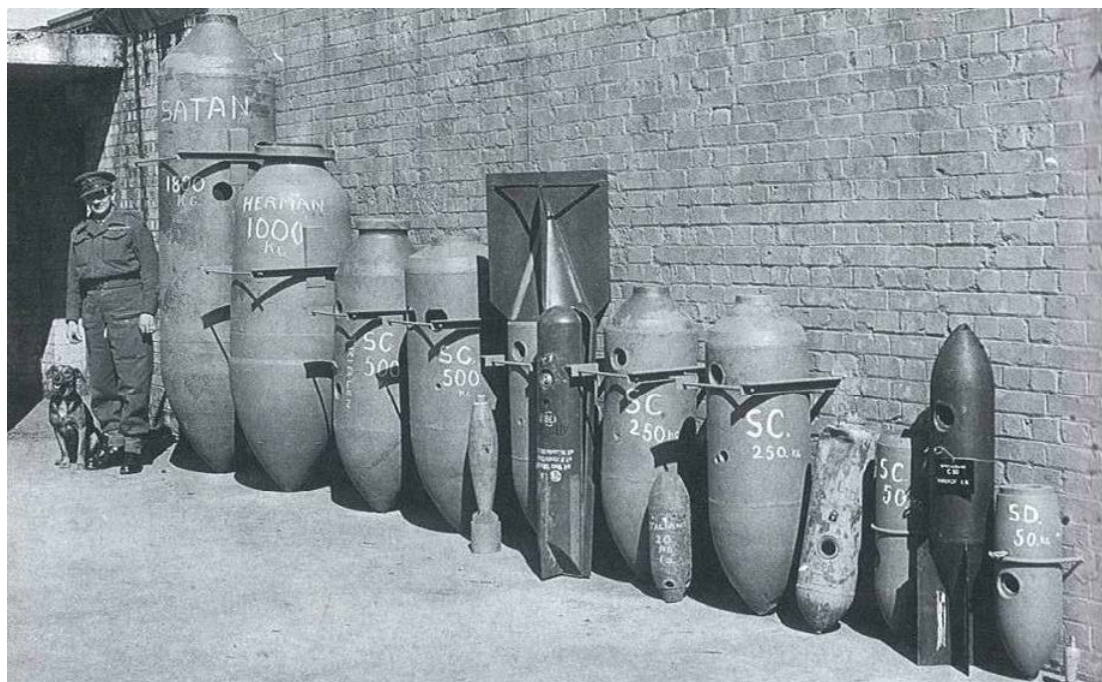
Plate	Photograph of a variety of UXB recovered by the Civil Defence during WWII
-------	---

The Plate below shows the variety of UXB recovered by the Civil Defence during WWII.

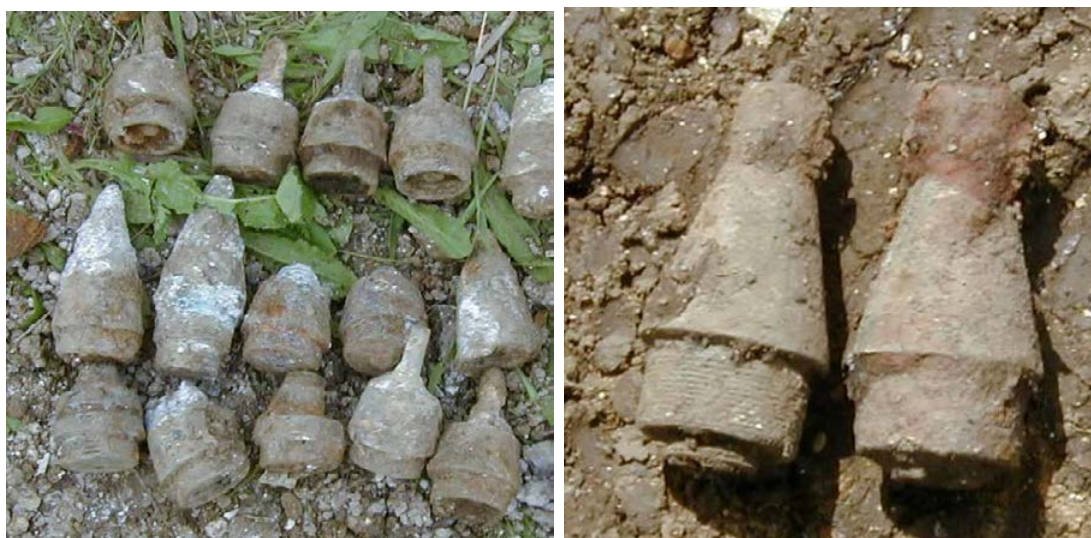
Plate	Photographs showing examples of WWII fuzes
-------	--

A wide variety of these components were used and examples of some common fuzes are shown in the Plate below.

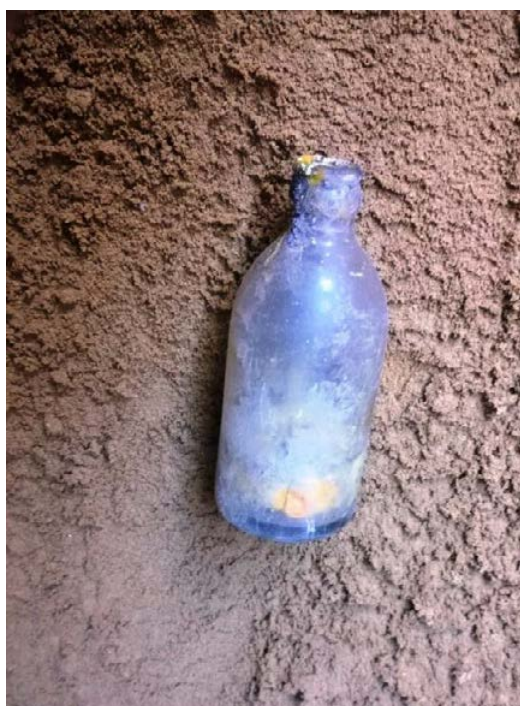
Plate Photograph of the No. 76 SIP grenade

The Plate below is a photograph of a No. 76 SIP grenade (LHS) with an explanatory leaflet produced by ZeticaUXO for site staff (RHS).

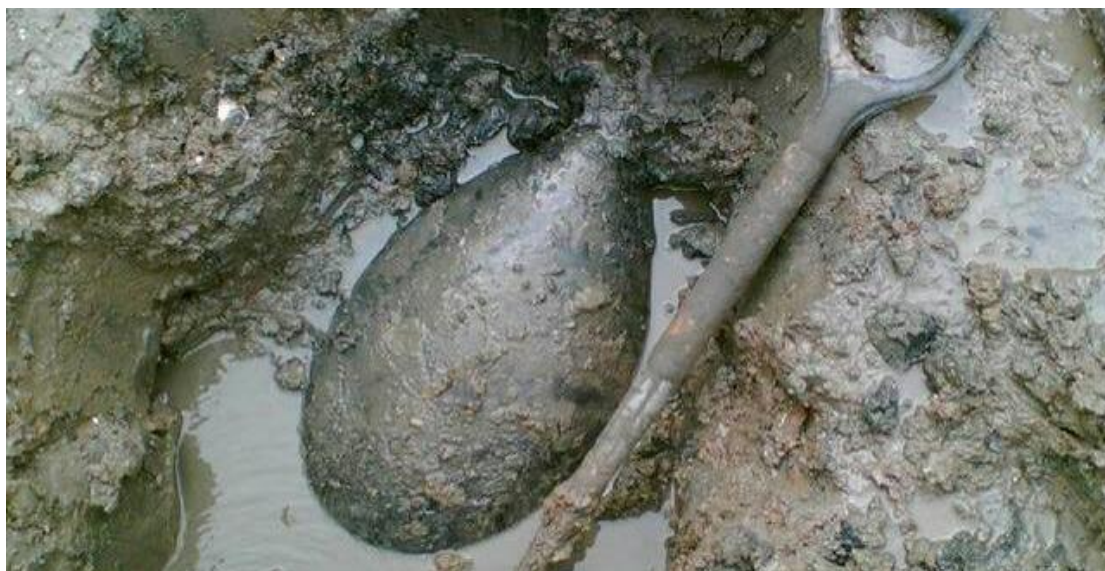
Plate Photograph of the 500kg WWII UXB at Bowers Marsh, 8th March 2010

The Plate below is a photograph of the bomb in situ.

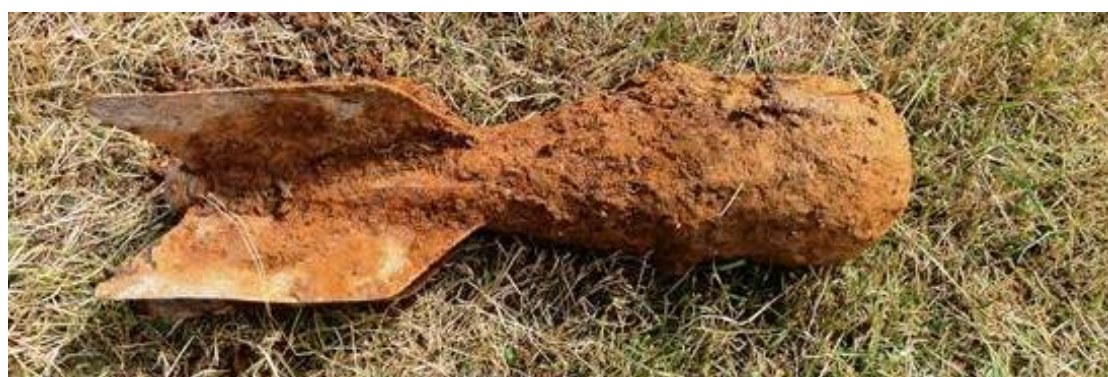
Plate	Photograph of WWI bomb, Isle of Sheppey, 2 nd August 2012
--------------	--

1No. WWI bomb (shown in the Plate below) was found on the Isle of Sheppey on the 2nd August 2012 during a geophysical survey following desk study research by Zetica Ltd which had established that a previously unknown WWI bombing range existed on the site. A further WWI bomb was found in the same location in August 2015.
