# **TFL\_PSF\_9131 SITE INVESTIGATIONS: SMALL SITES INITIATIVE LAND AT CHRISTCHURCH ROAD & BRIXTON HILL, LAMBETH, SW2 4AP**

**Site Ref. 901**

## **Preliminary Geotechnical and Geo-Environmental Report**

NOVEMBER 2017

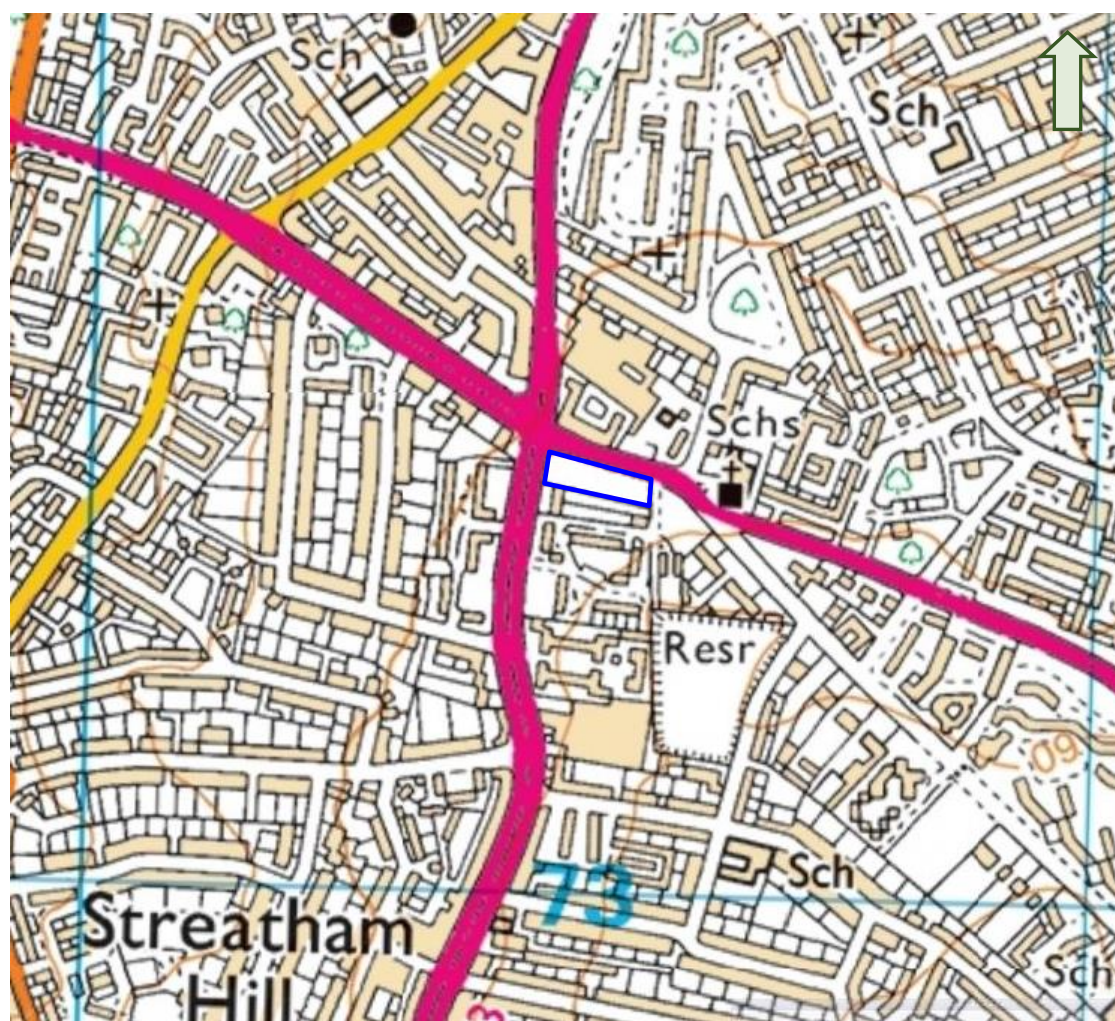
**Figure 1** Site location map

Figure 1 is a Site location map and Plate 1 is a recent aerial photograph of the Site.

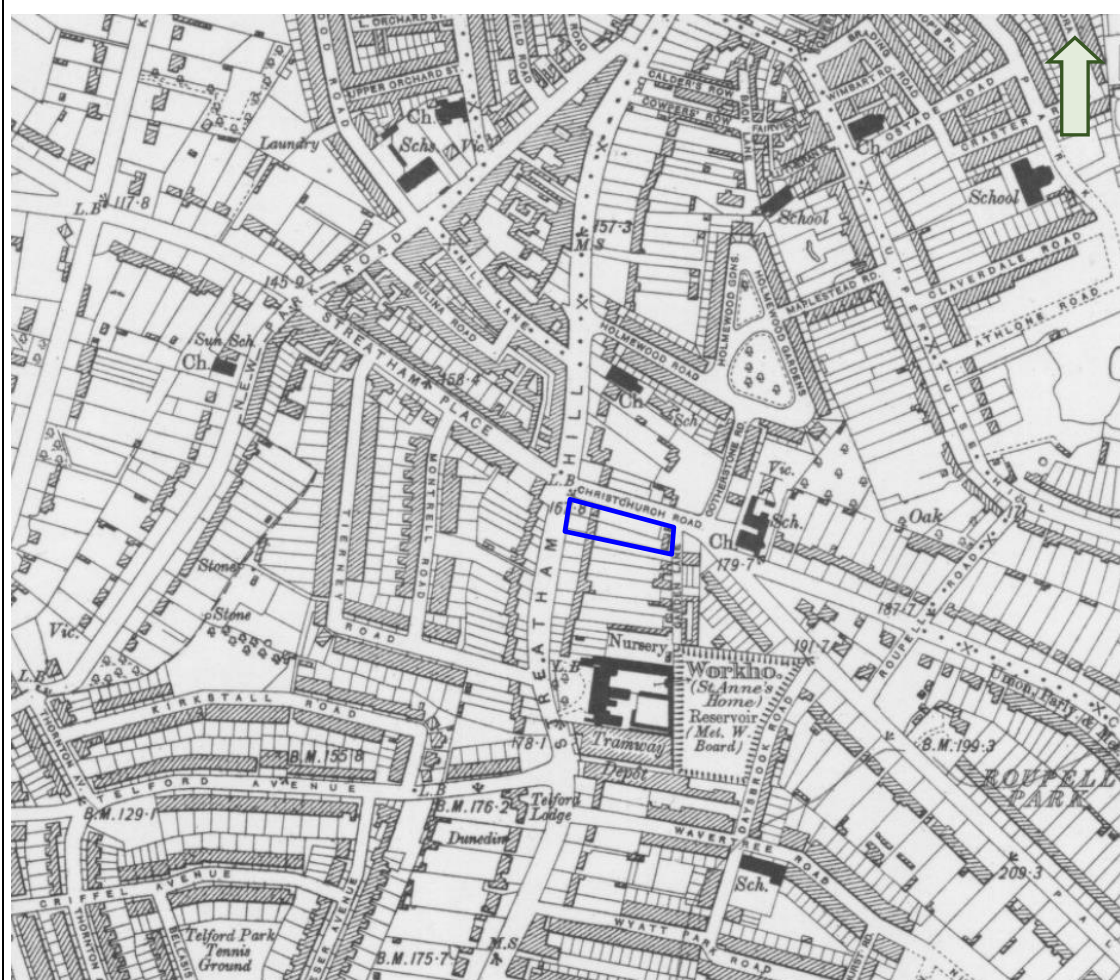
**Figure 2** Historical map, 1914

The historical map of 1914 (Figure 2) shows that the Site comprised residential properties and associated gardens on Christchurch Road, which ran adjacent to the northern boundary of the Site.

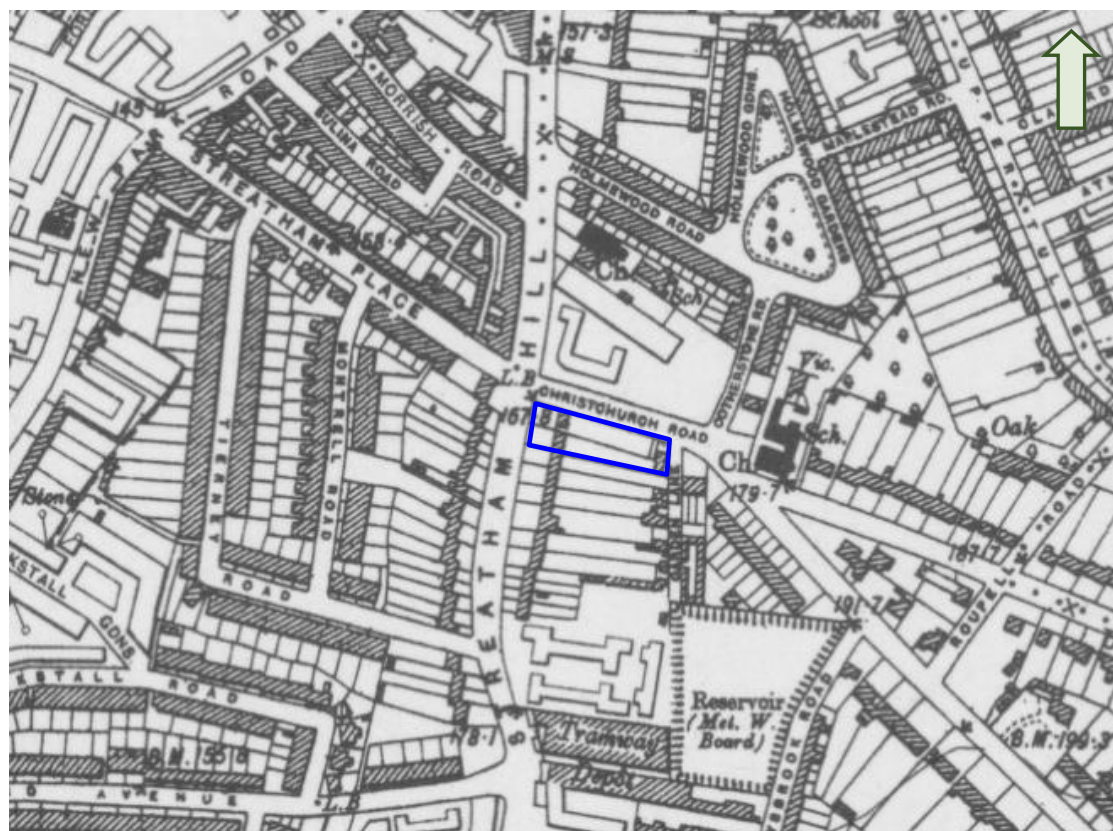
**Figure 3** Historical map, 1938

The historical map of 1938 (Figure 3) shows that there had been no changes on the Site prior to WWII.

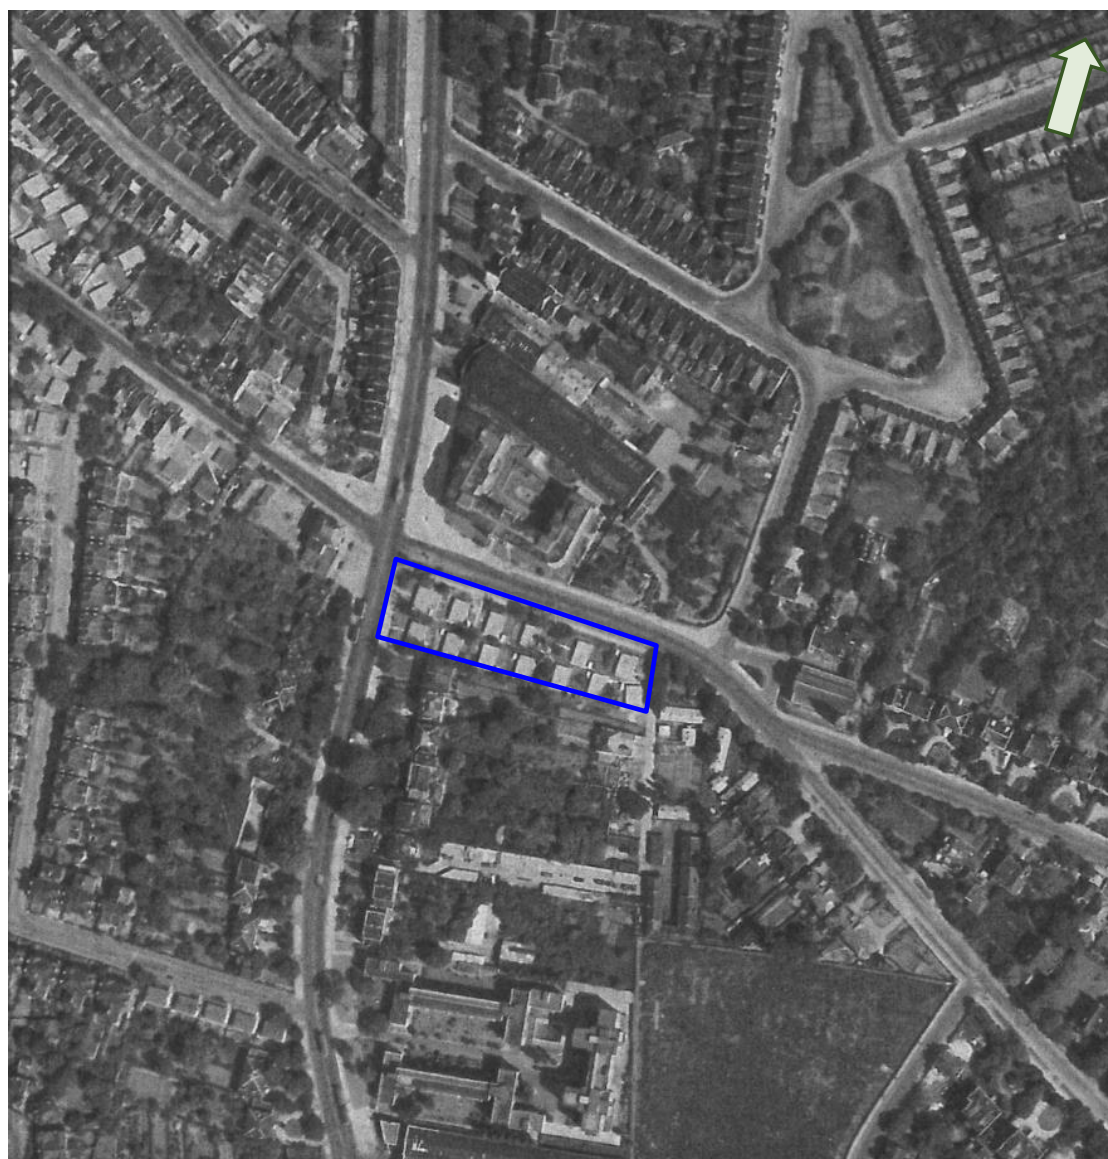
**Plate 2**

Plate 2, an aerial photograph dated the 29<sup>th</sup> May 1947, shows that a series of bungalows had been constructed on the Site as part of an emergency housing programme post-WWII.

Aerial photograph, 29<sup>th</sup> May 1947

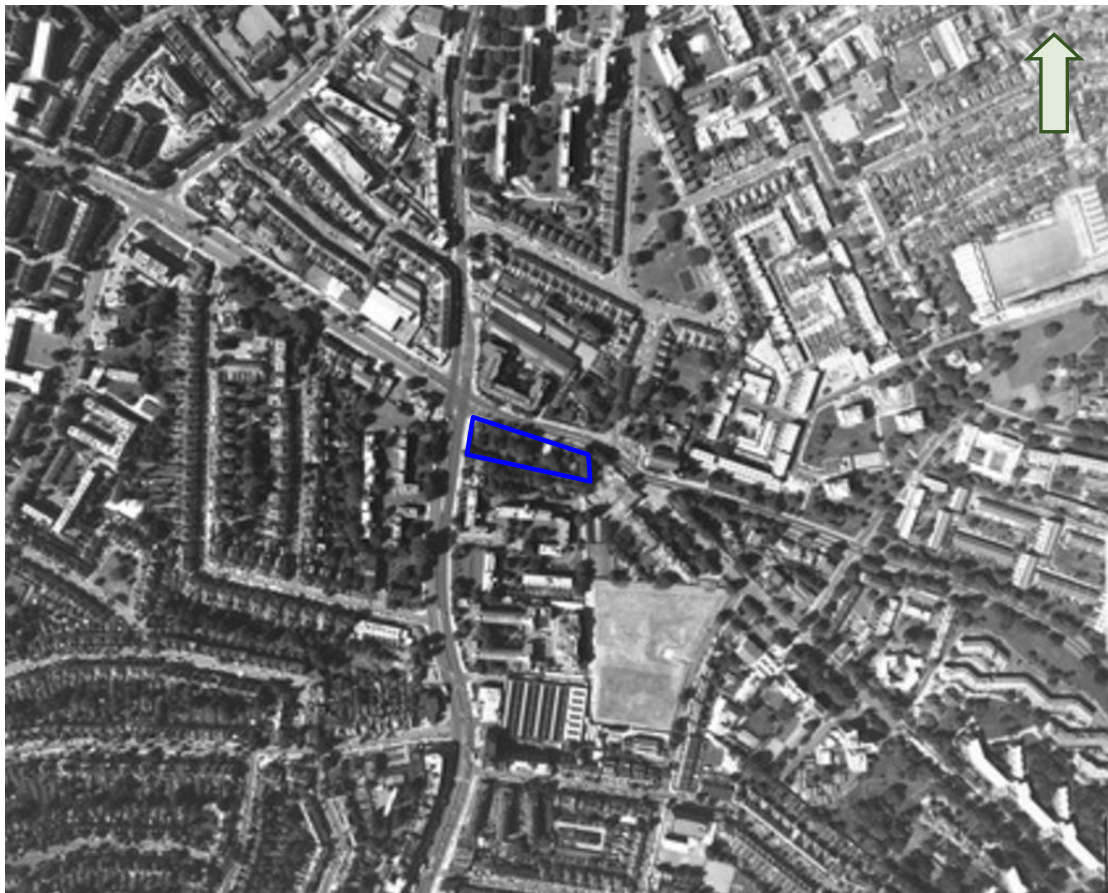
<b>Plate 3</b>	Aerial photograph, 11 <sup>th</sup> July 1987

The bungalows on the Site were demolished in the 1970s. Plate 3, an aerial photograph dated the 11<sup>th</sup> July 1987, shows that the Site now comprised heavily vegetated open ground.

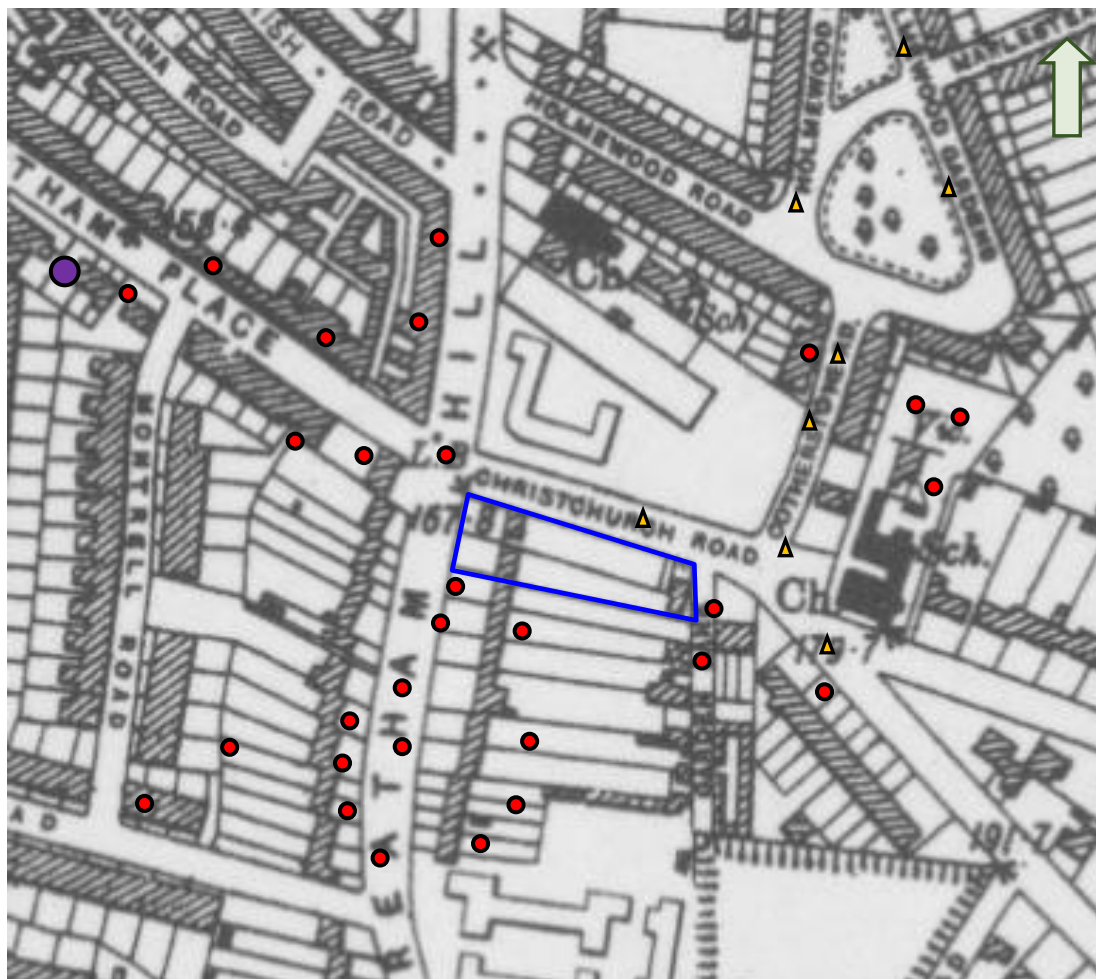
**Figure 4** Compiled bomb impact map for the vicinity of the Site

Figure 4 is a map showing the approximate locations of recorded bomb impacts in the vicinity of the Site. IBs shown are indicative of large numbers of similar devices that fell within the given area. The map has been compiled from a number of different sources, including air raid incident reports, bomb census maps and historical aerial photographs.

Note that air raid incident reports did not always record precise locations, often only indicating on which street or area a bomb fell.

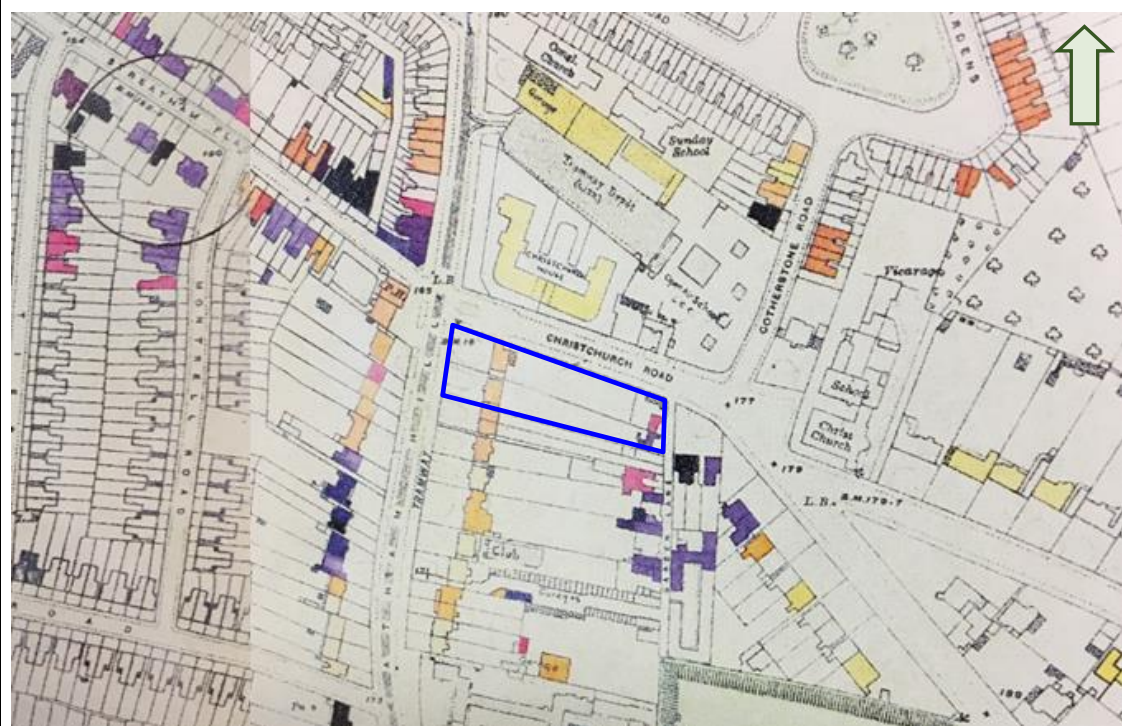
**Figure 5** Extract from the London bomb damage map

Extensive bomb damage, characterised by demolished areas and prefabricated buildings, is evident in the immediate vicinity of the Site.

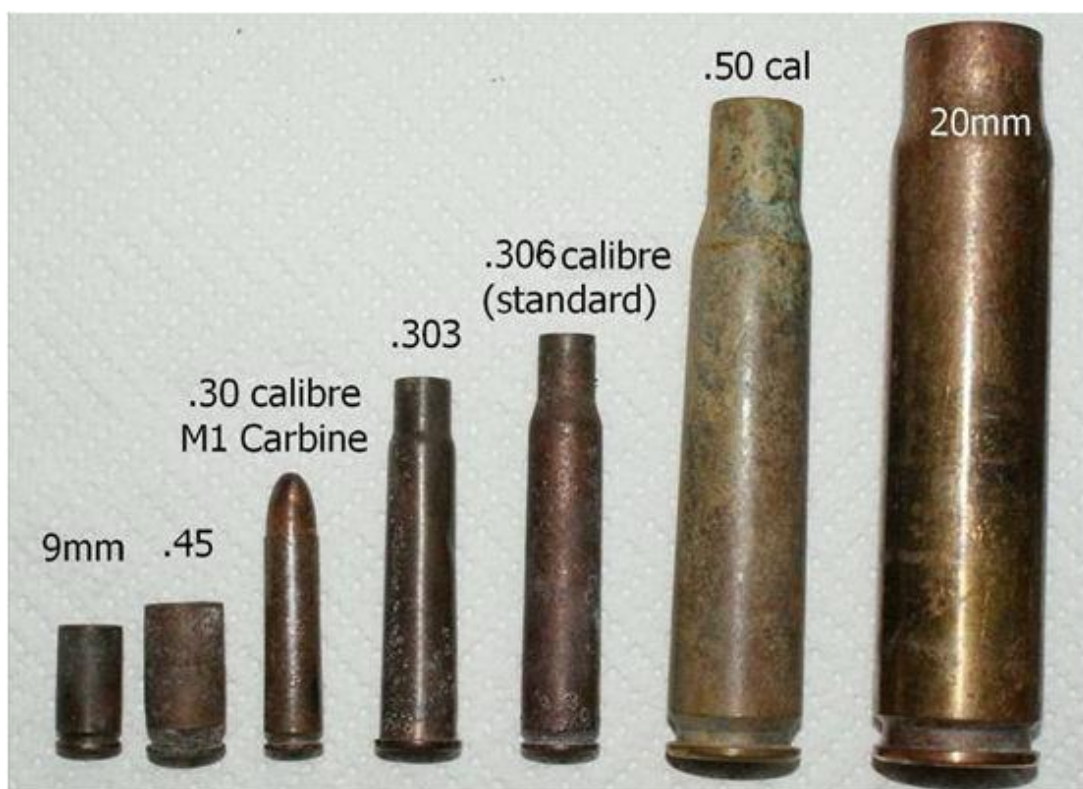
**Plate** Photograph of typical WWII small arms ammunition

Generally small arms ordnance has a relatively low risk as UXO, although the larger calibre categories may have the same detonation risk as larger high explosive ordnance. SAA is often associated with discarded ammunition boxes around firing practice ranges. The Plate below illustrates some common SAA.

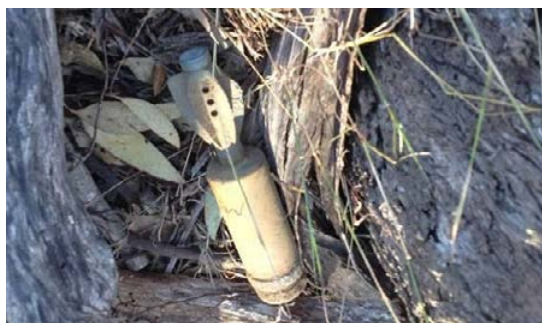
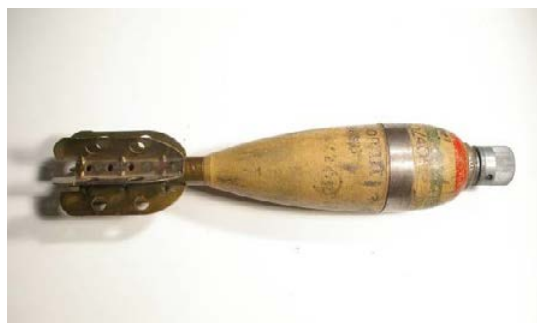
<b>Plate</b>	Photographs of WWII 2-inch and 3-inch mortars
--------------	---

The Plate below shows a typical 2-inch mortar bomb found (left) and a demonstration 3-inch mortar bomb (right).

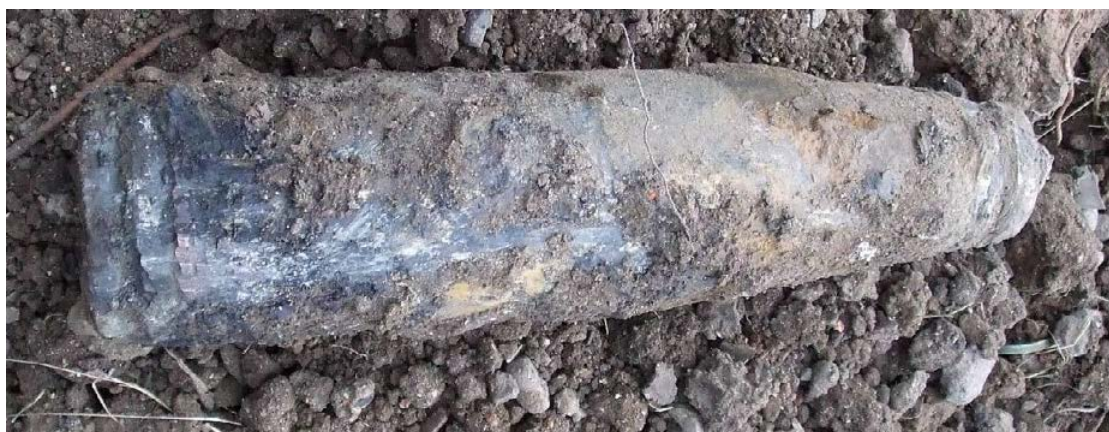
<b>Plate</b>	Photograph of a recently excavated 3.7" AA shell
--------------	--

The Plate below is a photograph of a 3.7" UXAA shell found in Camberwell, London.

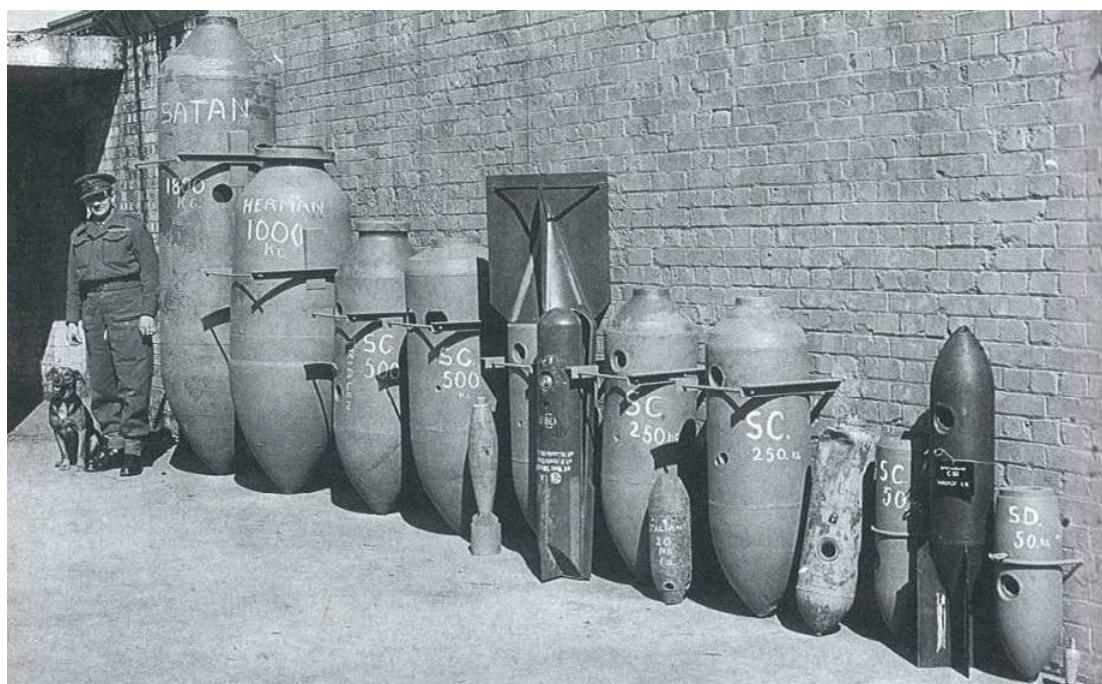
Plate	Photograph of a variety of UXB recovered by the Civil Defence during WWII
-------	---

The Plate below shows the variety of UXB recovered by the Civil Defence during WWII.

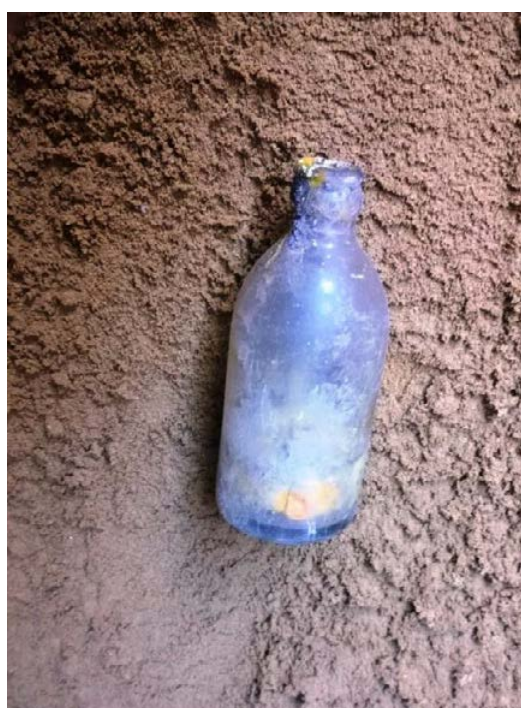
**Plate** Photograph of the No. 76 SIP grenade

The Plate below is a photograph of a No. 76 SIP grenade (LHS) with an explanatory leaflet produced by ZeticaUXO for site staff (RHS).

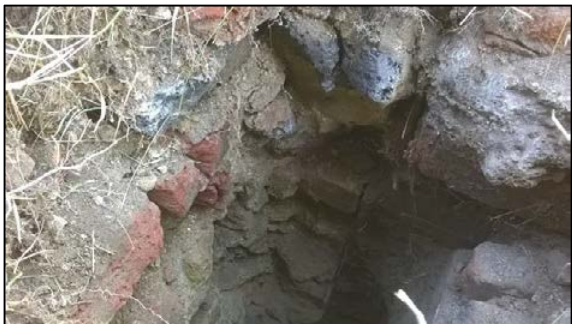
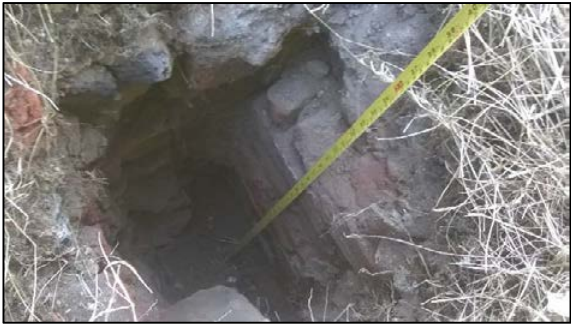
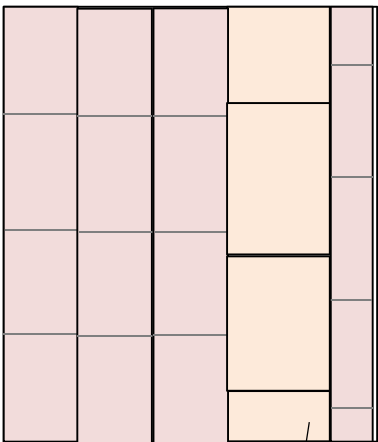
PHOTOGRAPHS

WS104 hand pit  
Relic (foundation?)  
brick structure

Final depth 1.0m  
bgl.

Red and grey  
bricks

Yellow bricks

- In WS104, Made Ground comprising gravelly sand was recorded to 0.1m which was underlain by light brown gravelly sand with some flint, within a brick structure. Chiselling and breaking out of the structure using hand tools proceeded to 1.0m bgl. A sketch of the void created is shown as Drawing 101-UA009686 in Appendix D. The excavation appeared to be within or next to a relict brick structure as bricks were observed on all four sides of the inspection pit. The pit was terminated at 1.0m when further progress was not possible. The full depth of the brick structure was not confirmed.
- No groundwater was encountered during excavation of the exploratory holes with the exception of a slight seepage at 2.65m in WS103 associated with the gravel layer from the Head Deposits at this location.
- No visual or olfactory evidence of contamination was encountered during the investigation.

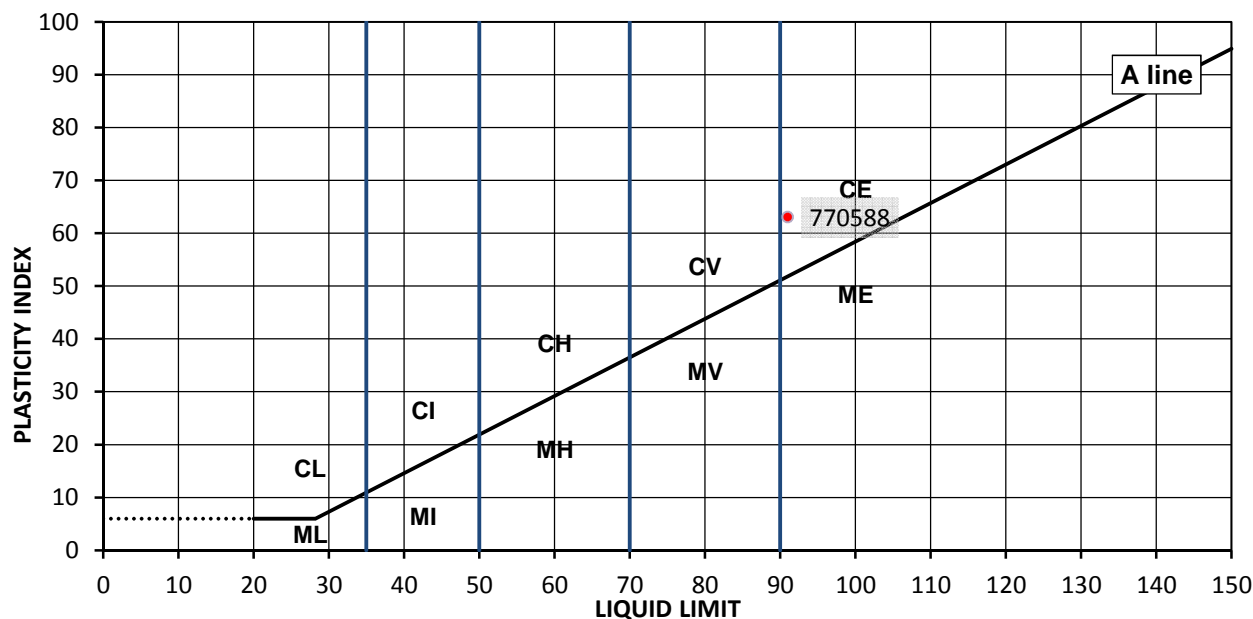
As Received Moisture Content [%]	Liquid Limit [%]	Plastic Limit [%]	Plasticity Index [%]	% Passing 425µm BS Test Sieve
32	91	28	63	100

Parameter	Number of Tests	Values	Average	Assessment
Natural Moisture Content (%)	2	29 to 32	30.5	-
Liquid Limit (%)	2	91 to 95	93	Extremely high plasticity clay. Modified plasticity index of high volume change potential.
Plastic Limit (%)	2	28 to 32	30	
Plasticity Index (%)	2	63	-	
% passing 425µm sieve	2	100	-

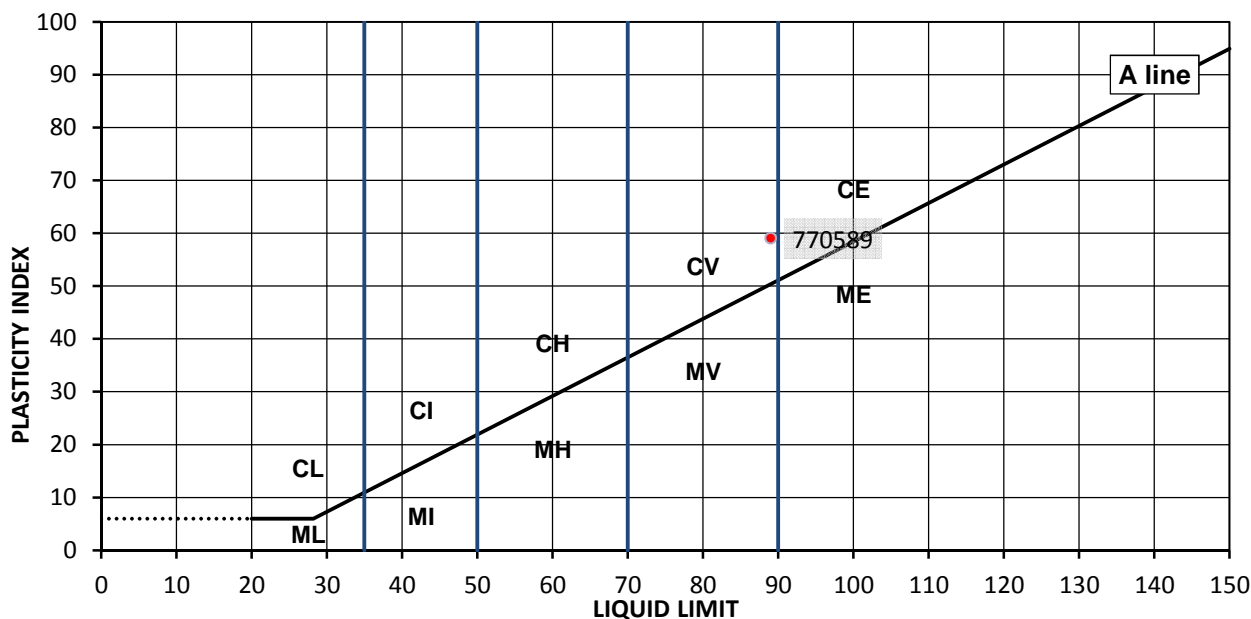
As Received Moisture Content [%]	Liquid Limit [%]	Plastic Limit [%]	Plasticity Index [%]	% Passing 425µm BS Test Sieve
29	89	30	59	100

Parameter	Number of Tests	Values	Average	Assessment
Natural Moisture Content (%)	2	29	-	-
Liquid Limit (%)	2	84 to 89	86.5	Very high plasticity clay Modified plasticity index of high volume change potential
Plastic Limit (%)	2	29 to 30	29.5	
Plasticity Index (%)	2	55 to 59	57	
% passing 425µm sieve	2	79 to 100	89.5	
SPT N Values – coarse soils	2	23 to 27	25	Medium dense
SPT N Values – fine soils	6*	8 to 22	12	Soft to stiff (firm)

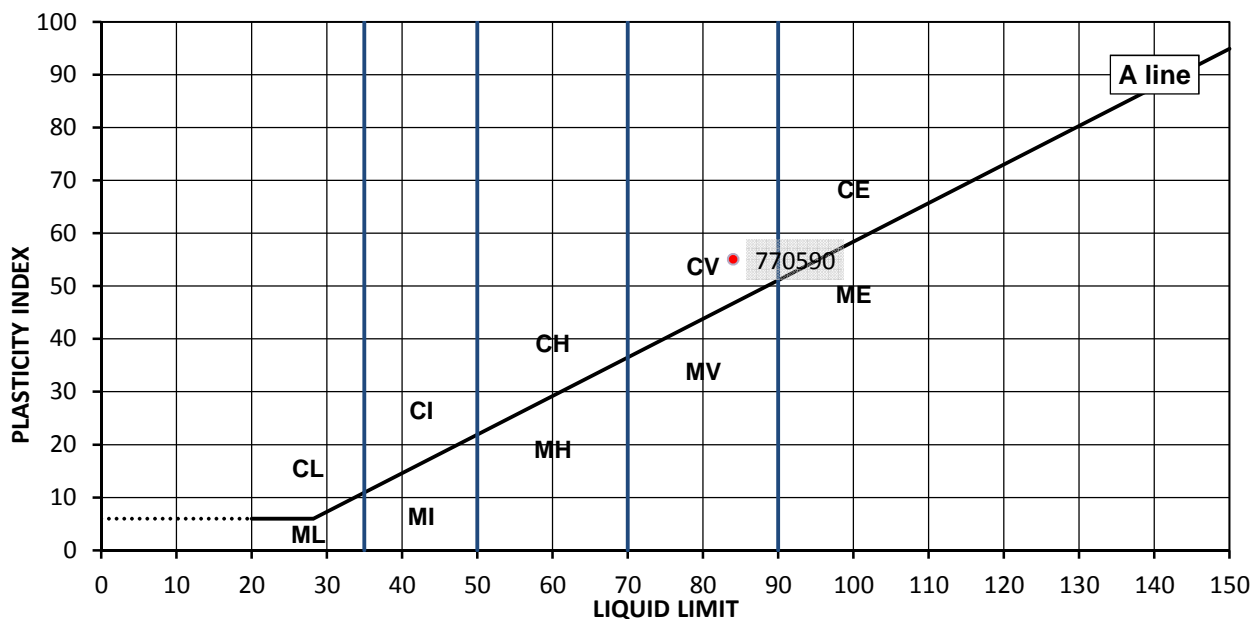
As Received Moisture Content [%]	Liquid Limit [%]	Plastic Limit [%]	Plasticity Index [%]	% Passing 425µm BS Test Sieve
29	84	29	55	79

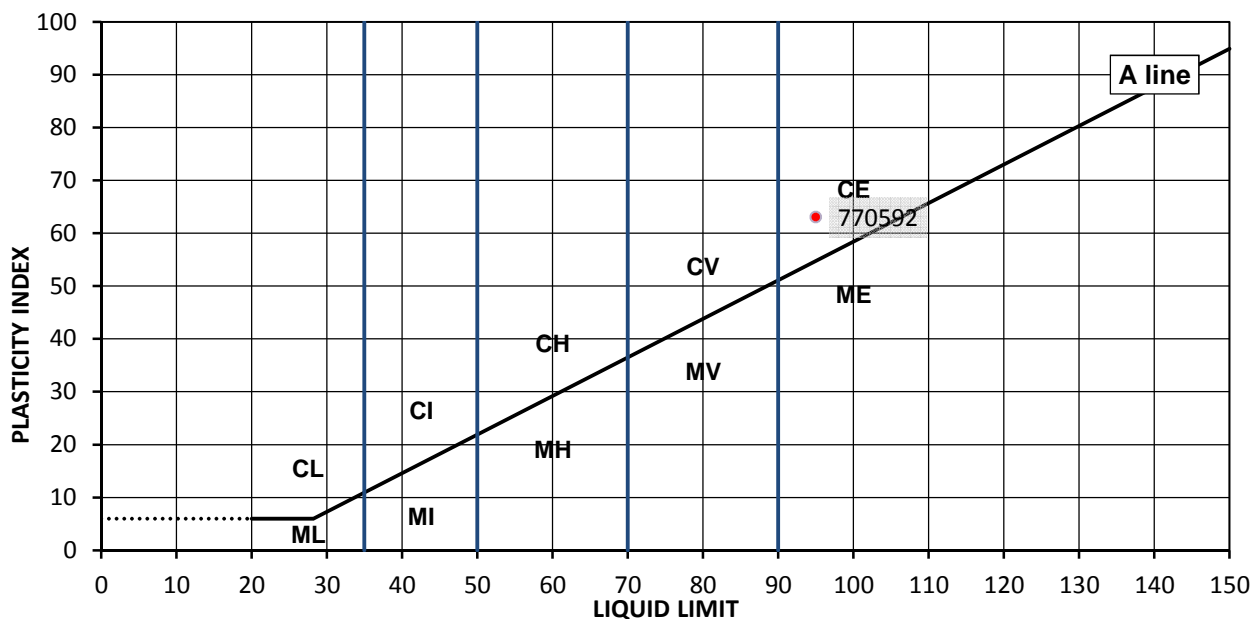
As Received Moisture Content [%]	Liquid Limit [%]	Plastic Limit [%]	Plasticity Index [%]	% Passing 425µm BS Test Sieve
29	95	32	63	100
