TFL_PSF_9131 SITE INVESTIGATIONS: SMALL SITES INITIATIVE SITE OPPOSITE COLLIERS WOOD STATION, MERTON, SW19 2BN

Preliminary Geotechnical and Geo-Environmental Report

Site Opposite Colliers Wood Station, Merton, SW19 2BN

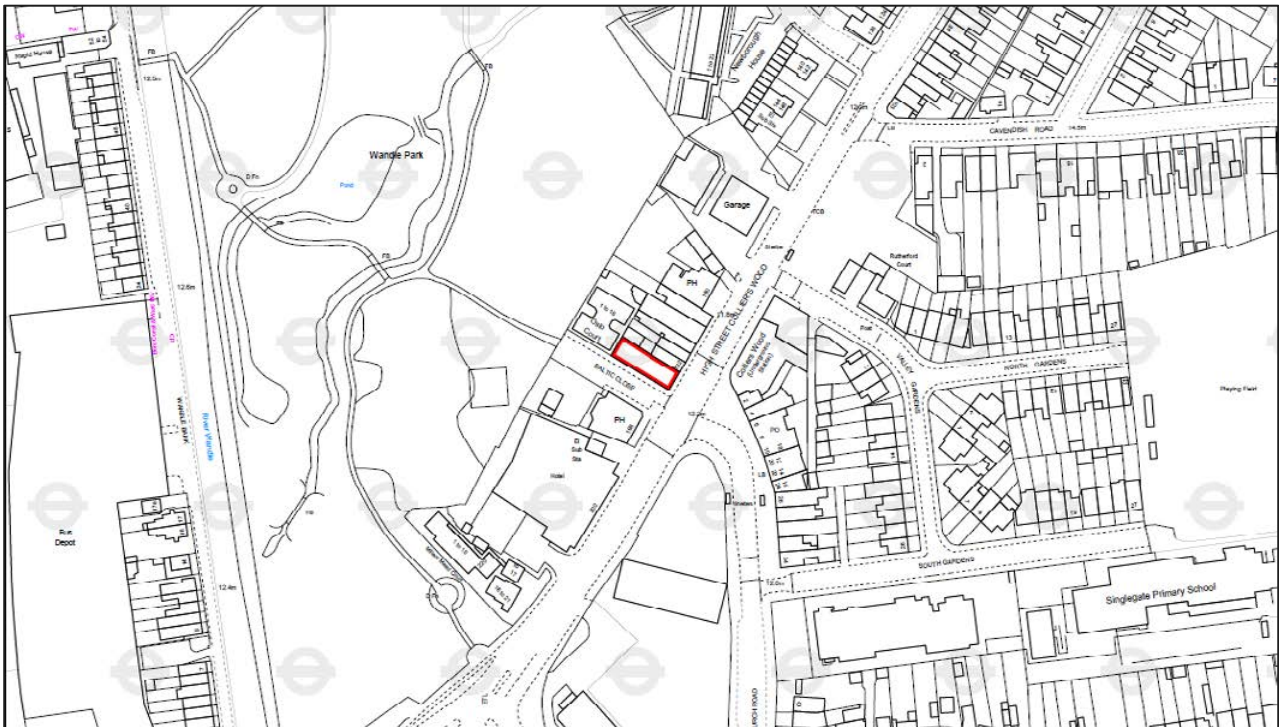
Figure 1: Site Opposite Colliers Wood Station Location Plan provided by TfL

The Site location is shown in Figure 1 below.

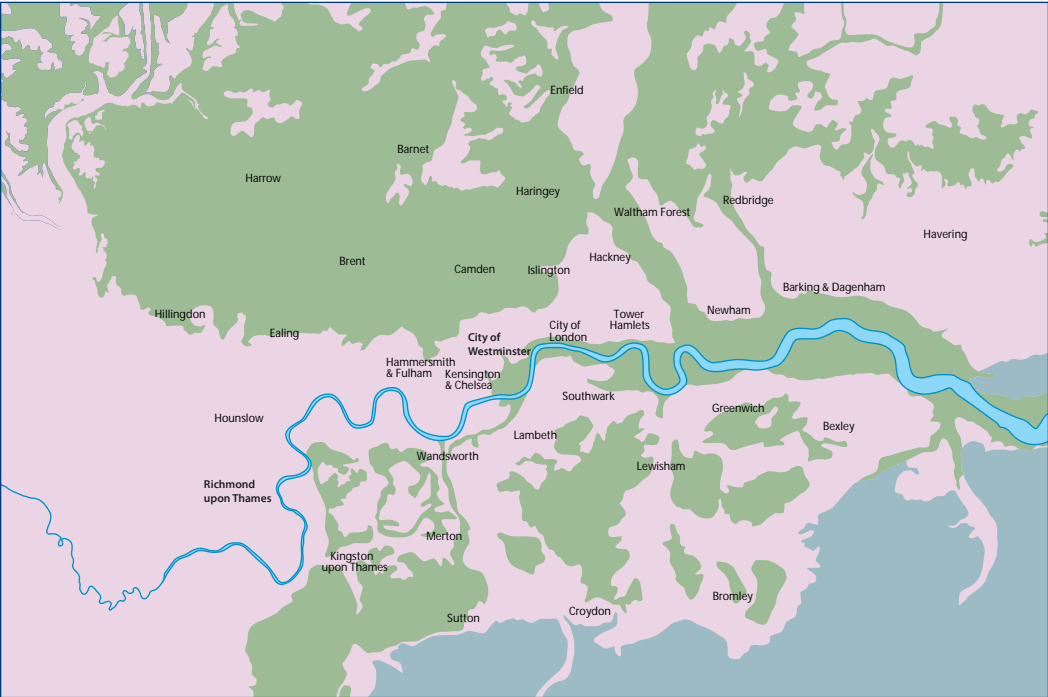
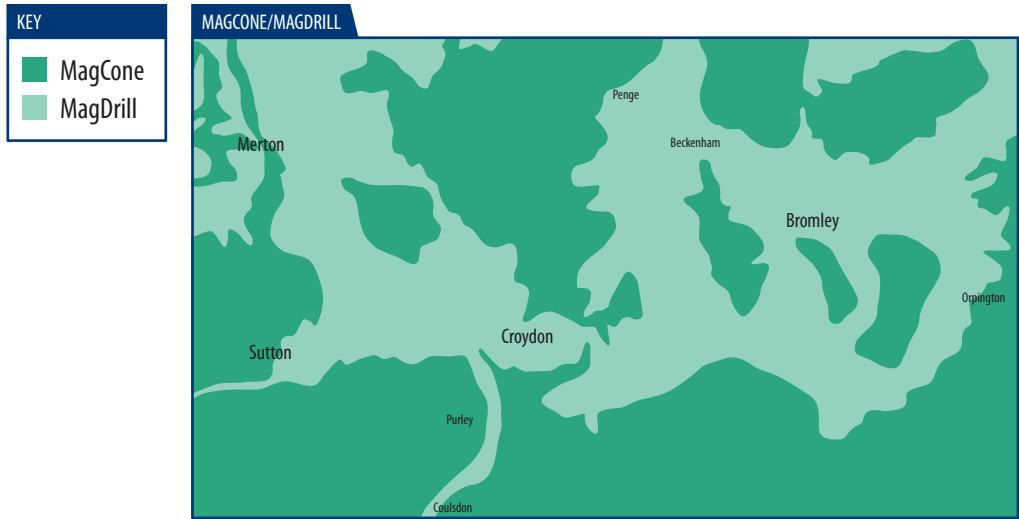
MagCone/MagDrill map

For the London area, the geology is extremely complex with a complicated succession that includes several units that are unsuitable for MagCone techniques. To give a first order approximation as to which technique might be appropriate for a site, a simplified map has been produced. This map has been compiled from the BGS Solid and Drift map sheets 256, 257, 270 and 271. The complex geology has been reduced to three areas coloured grey, green and pink. Areas that involve units that are probably only suitable for MagDrill, which include gravels, are shown in

pink. Areas that involve units probably suitable for MagCone, such as London Clay or alluvium, are coloured green. Where chalk crops out at surface or there is negligible soil cover over chalk,

it is shown in grey. This map is for indicative purposes only and specific site geology needs to be taken in to account, especially close to the boundaries shown on the map.

This map compilation provides a guide to appropriate intrusive UXB detection methods.
