Arboricultural Survey Report and Impact Assessment Eaton Close, Harrow

May 2020

For: London Borough of Harrow

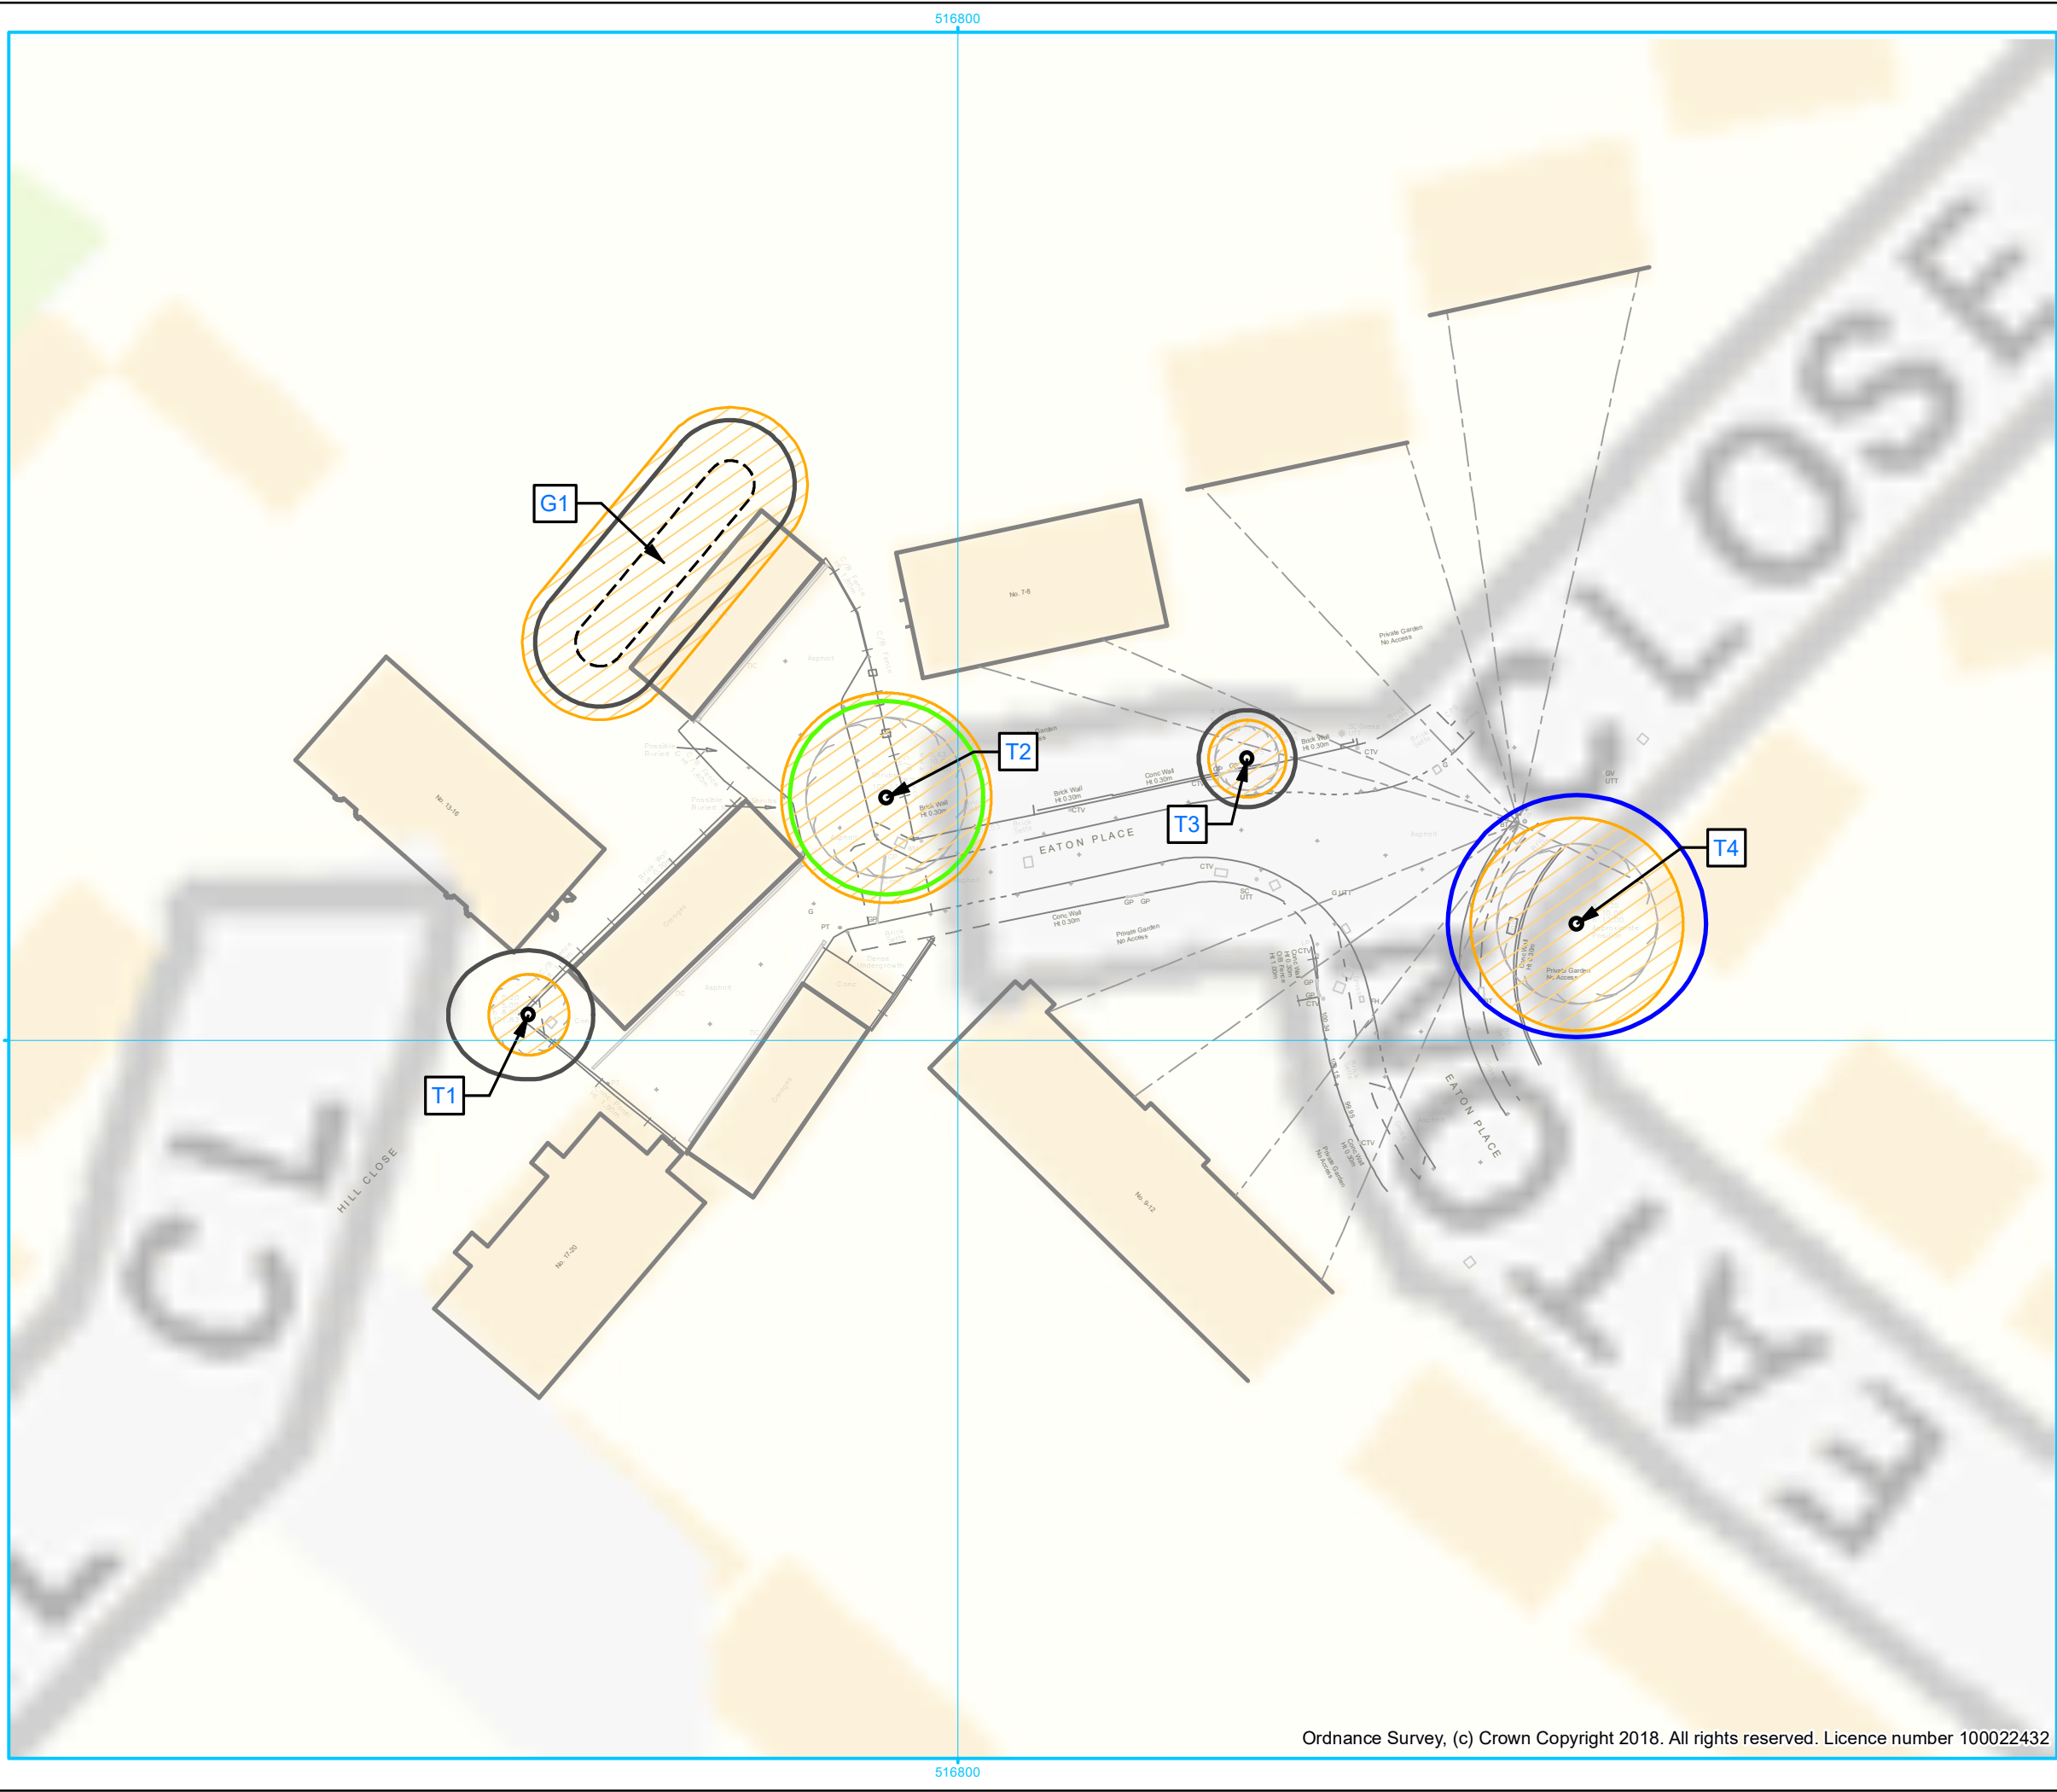
Title: **Appendix 2 – Tree Constraints**

- 3.3 T2 and G1 are adjacent to the garage area and are likely to be impacted from any development. It is unlikely that the RPA's follow the spread highlighted on the Constraints Plan (Appendix 2), due to the hard standing. This should be considered in the design, due to its position. A root investigation survey may be required to identify the exact spread and direction of growth beneath the hard standing.

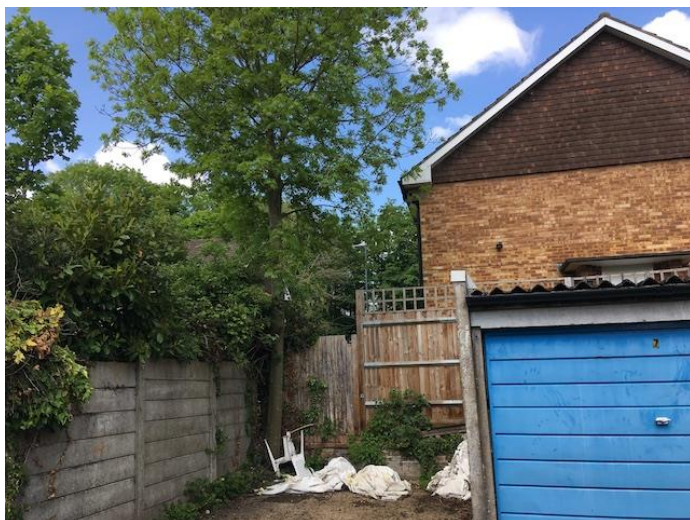
| Ref. | Species | Height (m) | Stem dia. (mm) | stem No. | Branch spread (m) | | | | Crown height (m) | Age | Condition | Comments | BS5873 Tree Qual. Ass. | Ret. Cat. | Life Expect. (yrs) |
|---|---|---|---|---|---|---|---|---|---|---|---|---|---|---|---|
| T1 | Ash (<i>Fraxinus excelsior</i>) | 12.0 | 210 | 1 | 4.0 | 5.0 | 4.0 | 4.0 | 2.0 | Semi | Fair | Developing tree in corner of site, growing through the hard standing. | C | 1 | >10 |

Photo 1: T1 self-set ash in corner of site.

- 3.2 It is likely that T1 will be removed to allow any future development. This was self-set in the corner of the site, growing through the hard standing and is unlikely to provide any long-term value to the wider environment.

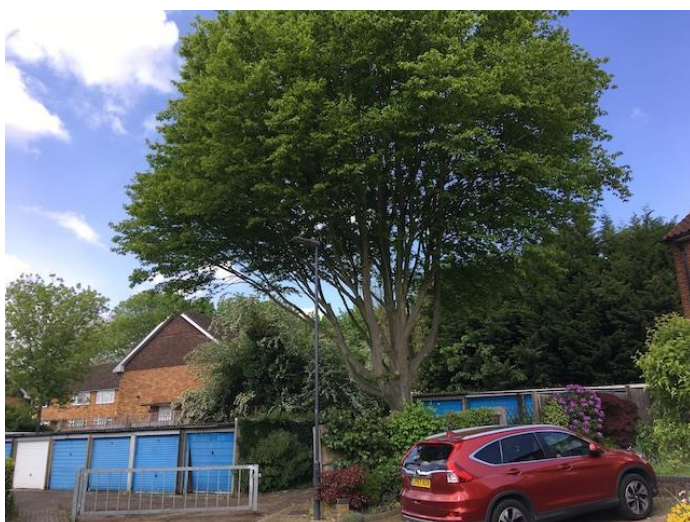
Photo 2: T1 showing position to the garages and wider site.

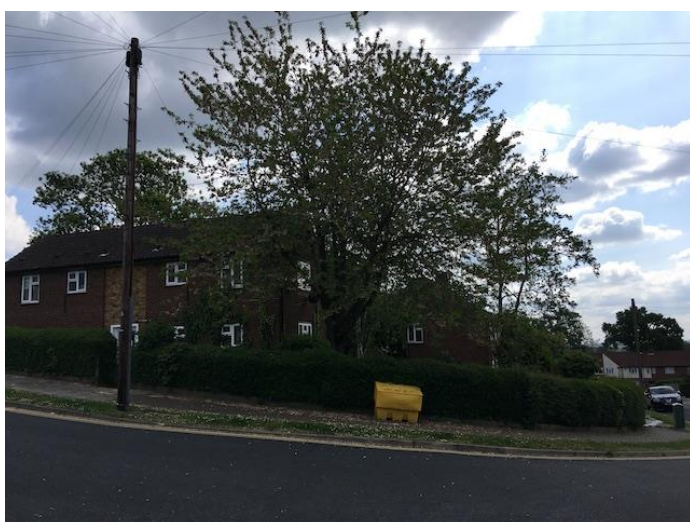
| Ref. | Species | Height (m) | Stem dia. (mm) | stem No. | Branch spread (m) | | | | Crown height (m) | Age | Condition | Comments | BS5873 Tree Qual. Ass. | Ret. Cat. | Life Expect. (yrs) |
|---|---|---|---|---|---|---|---|---|---|---|---|---|---|---|---|
| T4 | Cherry # (<i>Prunus avium</i>) | 10.0 | 550 | 1 | 8.0 | 8.0 | 8.0 | 8.0 | 2.0 | Mat | Good | Maturing tree within residential garden opposite cul-de-sac. | B | 1 | +30 |

Photo 3: T4 within the garden of property opposite access road.
