Portobello Road - UXO Desk Study & Risk Assessment

Document Title UXO Desk Study & Risk Assessment
Document Ref. P9364-20-R5
Revision A
Project Location Portobello Road
Client Arcadis
Date 7th February 2020

UXO DESK STUDY & RISK ASSESSMENT

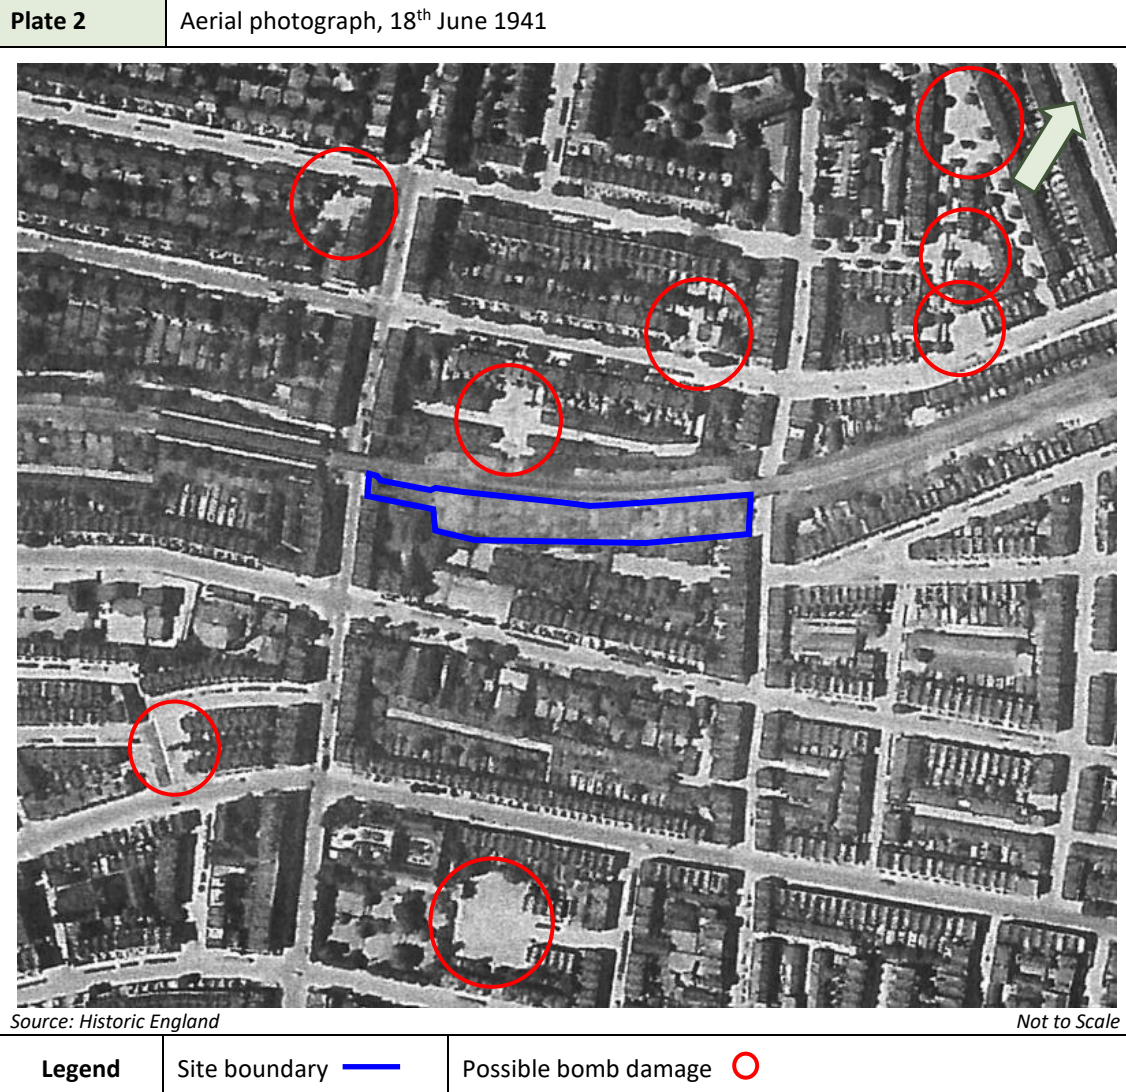
Plate 2 is an aerial photograph dating from 18th June 1941. No bomb damage has been identified on the Site.

Several areas of possible bomb damage, characterised by demolished buildings, have been identified in the vicinity of the Site.

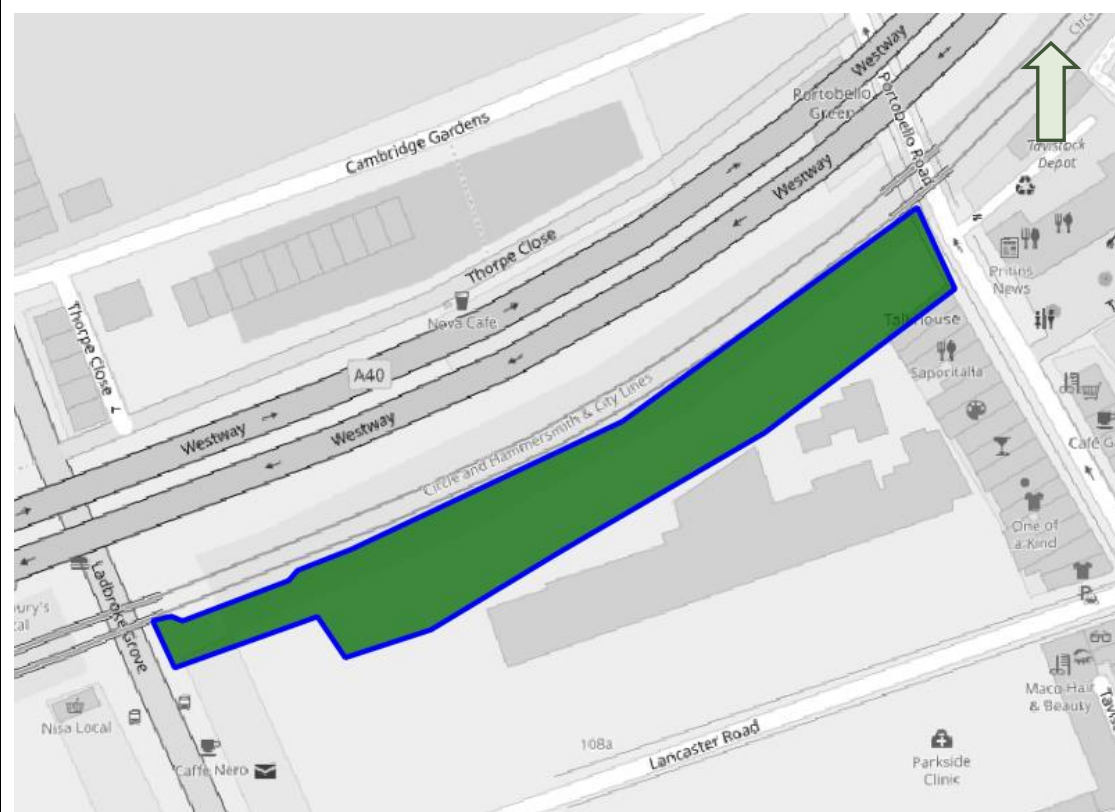
Figure 4 UXO hazard zone plan of the Site

No records have been found indicating that the Site was bombed and no other significant sources of UXO hazard have been identified on the Site.

Given this, it is considered that the Site has a low UXO hazard level, as shown in Figure 4.

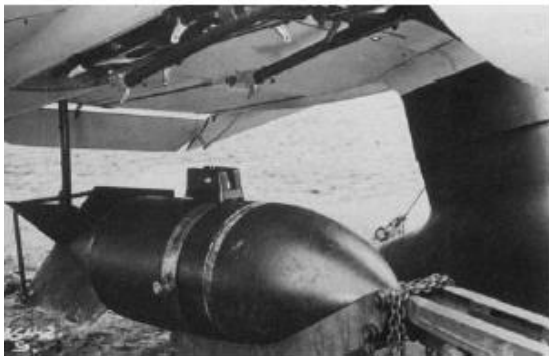
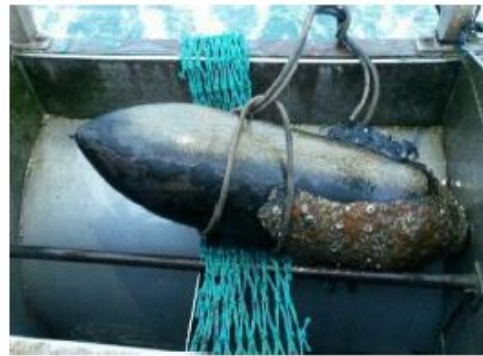
Description Thick nose welded to steel body. Nose may be attached to Kopfring (triangular section steel ring) or spike. Sheet metal tail attached to body with rivets/screws. Suspension eye bolt in the nose/body. Originally painted green-grey with a yellow stripe on the tail. TNT; amatol; TNT and aluminium powder, naphthalene, ammonium nitrate and wax/ wood meal filling.

Function Designed to maximise shock waves through air, water and earth and general demolition. Used against railway installations, large buildings, ammunition depots and below-ground installations (to 8m). Spike bombs/ 'Stabo' (SC 50 with spikes attached to nose) used against rail lines and country roads.

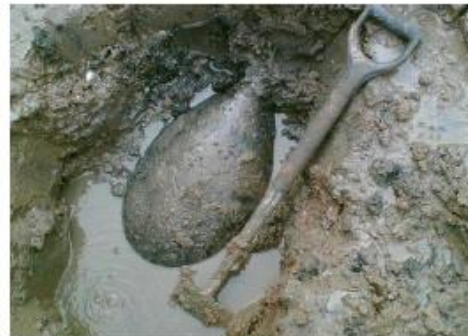
Description Thick nose welded to steel body. Nose may be attached to Kopfring (triangular section steel ring). Tail either steel sheet or drum-shaped. Suspension band. Originally painted green-grey/ buff (some later versions sky blue) with yellow stripe on tail. Filled with amatol, TNT or trialen.

Function Designed to maximise shock waves through air, water and earth and for general demolition. Used against railway property, large buildings, shipping and below-ground installations.

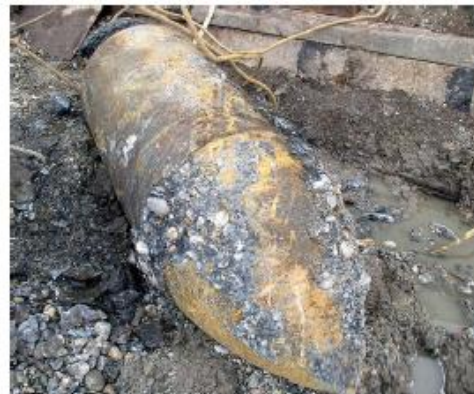
Description Thick nose welded to steel body. Nose attached to Kopfring (triangular section steel ring). Drum-shaped tail made of magnesium alloy. Suspension band. Originally painted sky-blue. Filled with amatol, TNT/aluminium/wood meal or trialen.

Function Designed to maximise shock waves through air, water and earth and for general demolition.

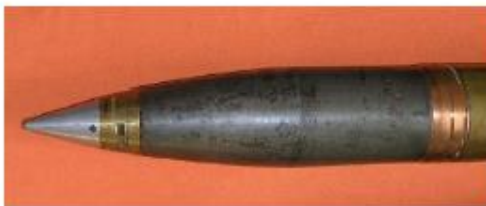
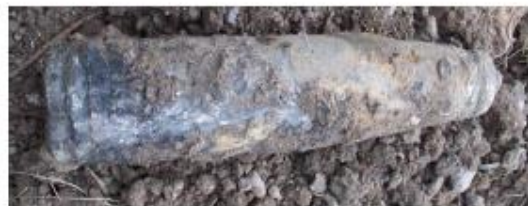
Description Brass cartridge case. Square-based shell with tapered nose, filled with Amatol, TNT or RDX/TNT. MK6 had forward centring bands and a wider driving band.

Function Used as a defence against enemy aircraft, fired from fixed batteries and mobile mountings. Could fire approximately 20 rounds per minute with a maximum ceiling of 41,000ft and horizontal range of 20,600 yards.

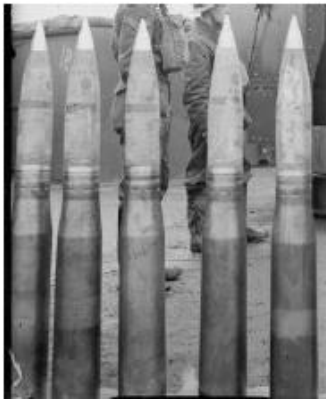
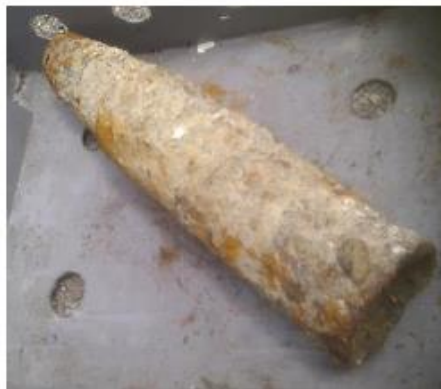
Description Square-based, tapered-nosed shell filled with TNT or Amatol. Steel casing, rotating band of either copper or gilding metal located 3.5" in front of the base end with single groove.

Function Used as field artillery and adapted for use in anti-aircraft defence from fixed batteries. Rate of fire of 8 rounds per minute, maximum ceiling of 44,000ft and horizontal range of 22,800 yards.

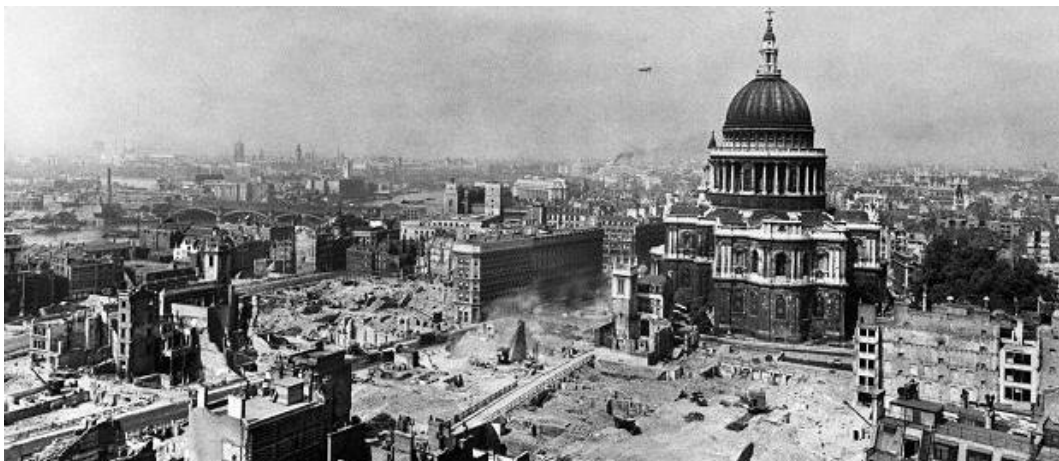
Incendiary devices ranged from small 1kg thermite filled, magnesium bodied Incendiary Bombs (IBs) to a 250kg 'Oil Bomb' (OB) and a 500kg 'C300' IB. In some cases the IBs were fitted with a bursting charge. This exploded after the bomb had been alight for a few minutes causing burning debris to be scattered over a greater area. The C300 bombs were similar in appearance to 500kg HE bombs, although their design was sufficiently different to warrant a specially trained unit of the Royal Engineers to deal with their disposal.

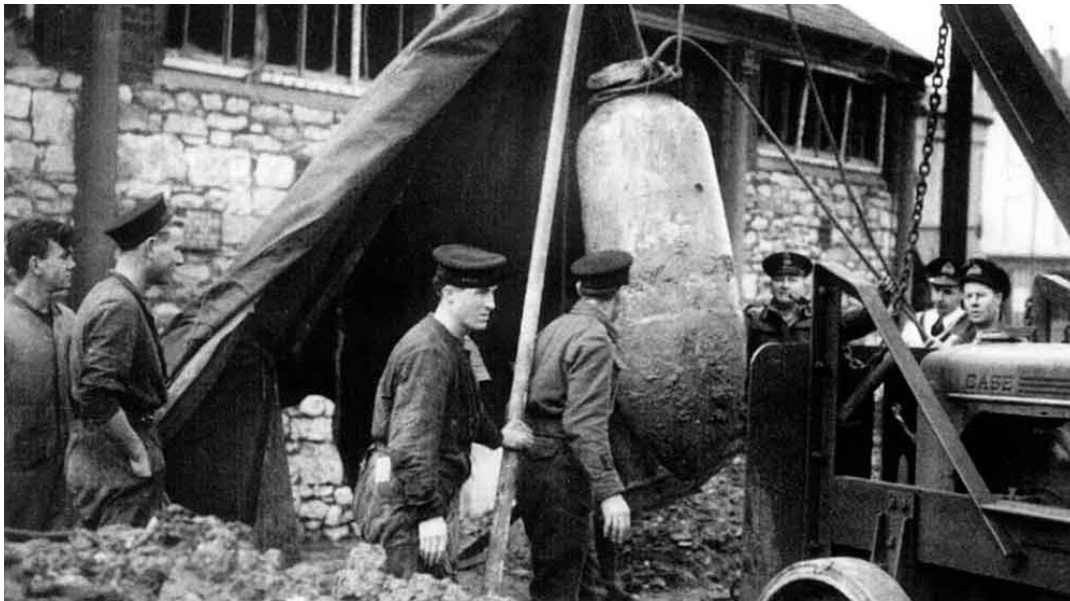
WWII bomb targeting was inaccurate, especially in the first year of the war. A typical bomb load of 50kg HE bombs mixed with IBs which was aimed at a specific location might not just miss the intended target but fall some considerable distance away.

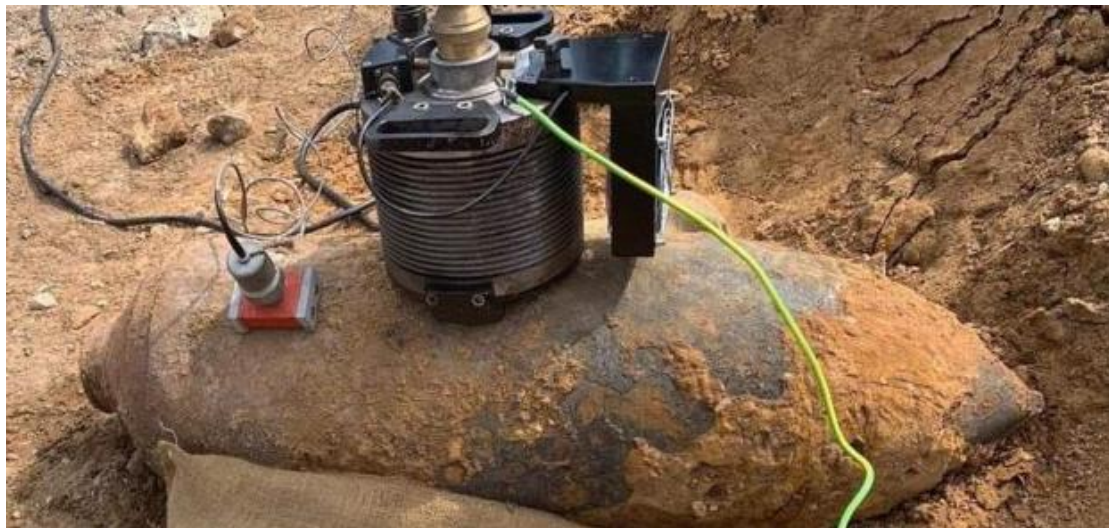
On the 23rd May 2019 a 250kg German UXB was found by workers on a building site at Kingston University in London (see plate below). The UXB could not be safely removed and was consequently destroyed in situ by an EOD team.
