Queensbury Car Park - UXO Desk Study & Risk Assessment

Document Title UXO Desk Study & Risk Assessment
Document Ref. P9364-20-R6
Revision A
Project Location Queensbury Car Park
Client Arcadis
Date 31st January 2020

UXO DESK STUDY & RISK ASSESSMENT

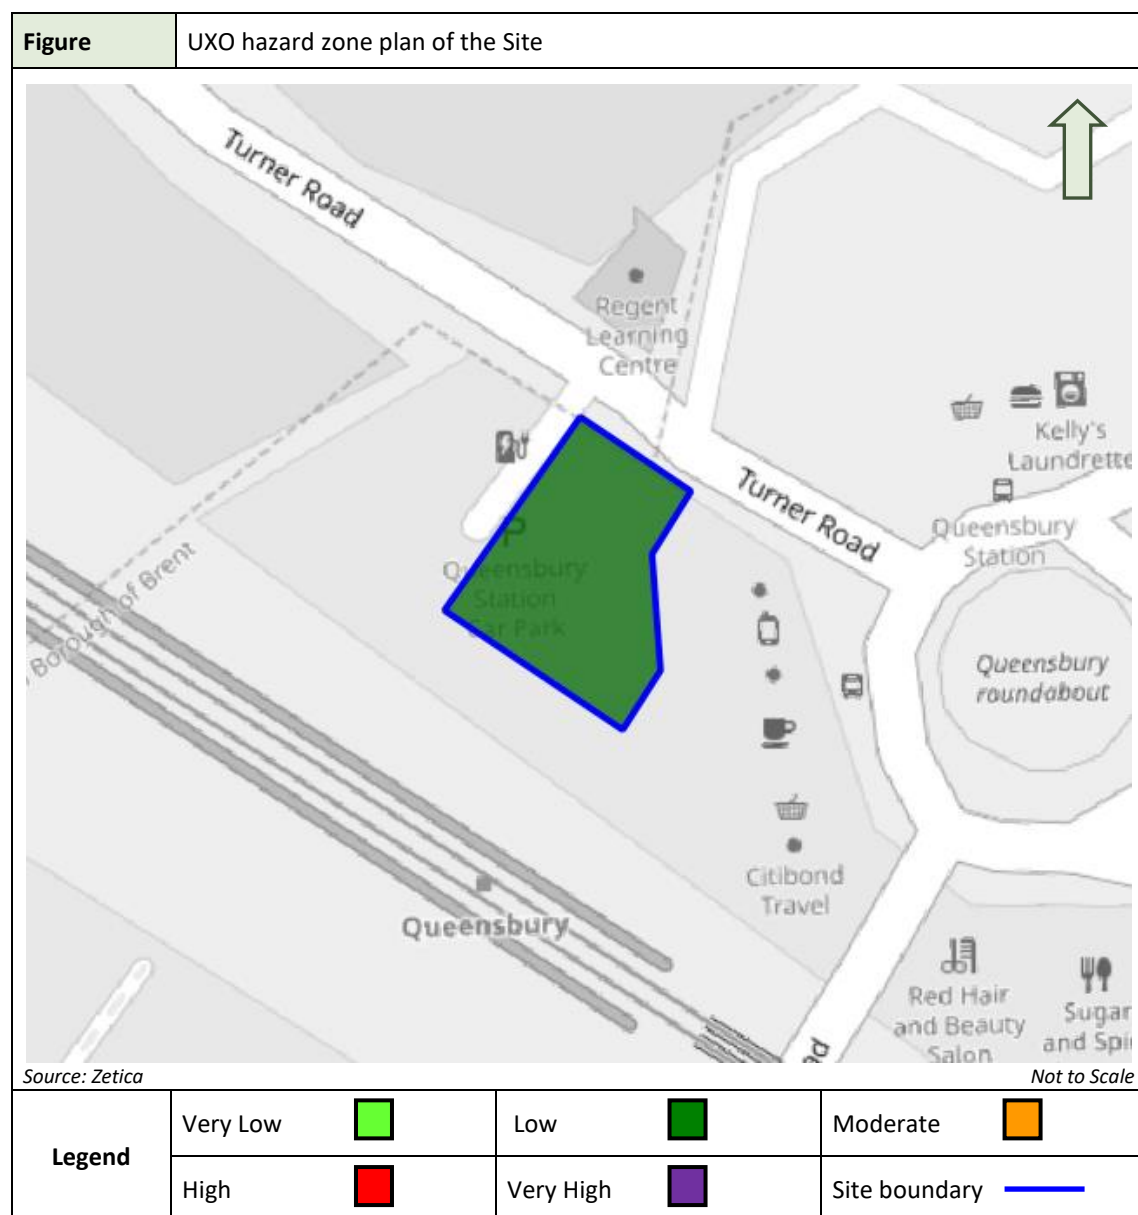
Given this, it is considered that the Site has a low UXO hazard level, as shown in the following Figure, reproduced as Figure 5 in the main report.

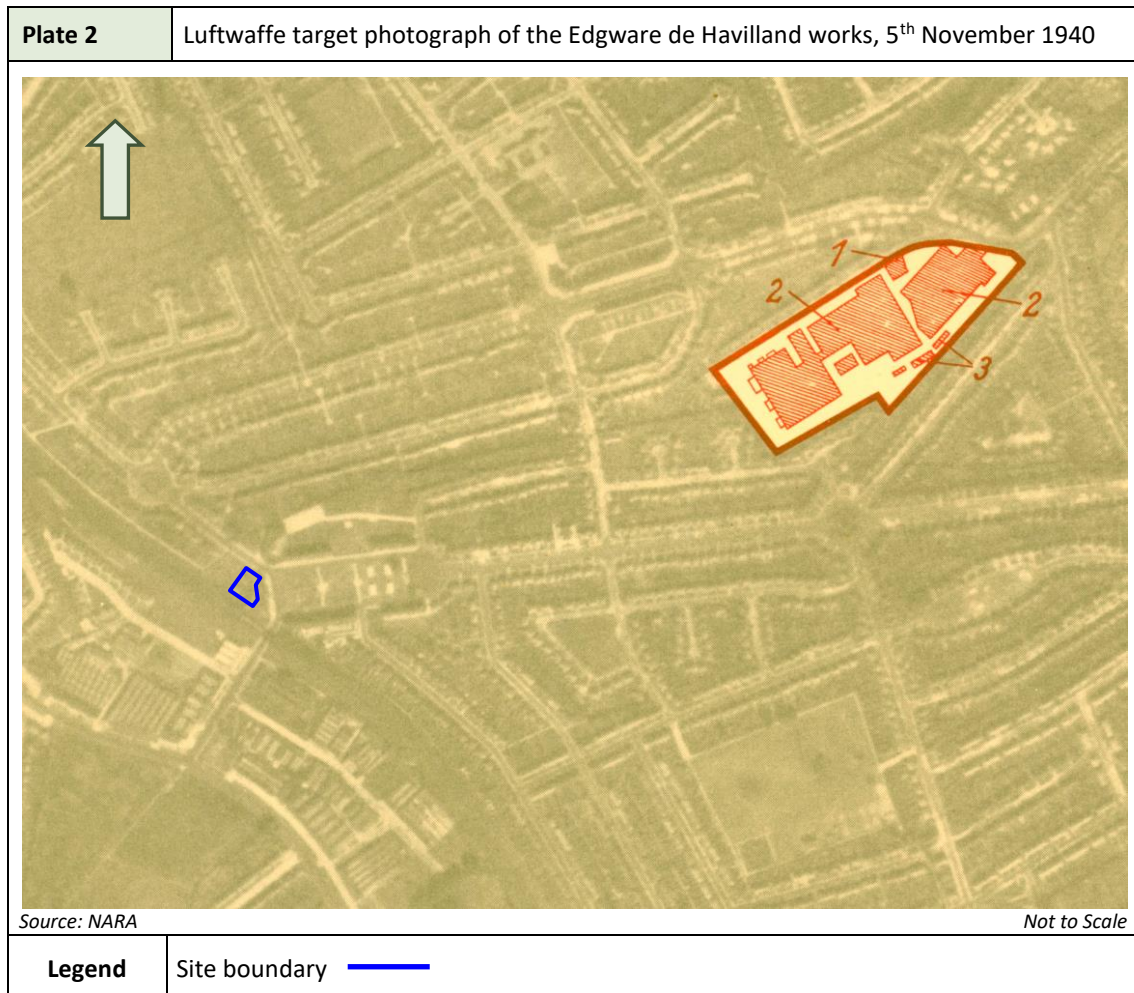
Plate 2 is a Luftwaffe target photograph, dated the 5th November 1940, showing the Edgware de Havilland works approximately 0.7km east-northeast of the Site.

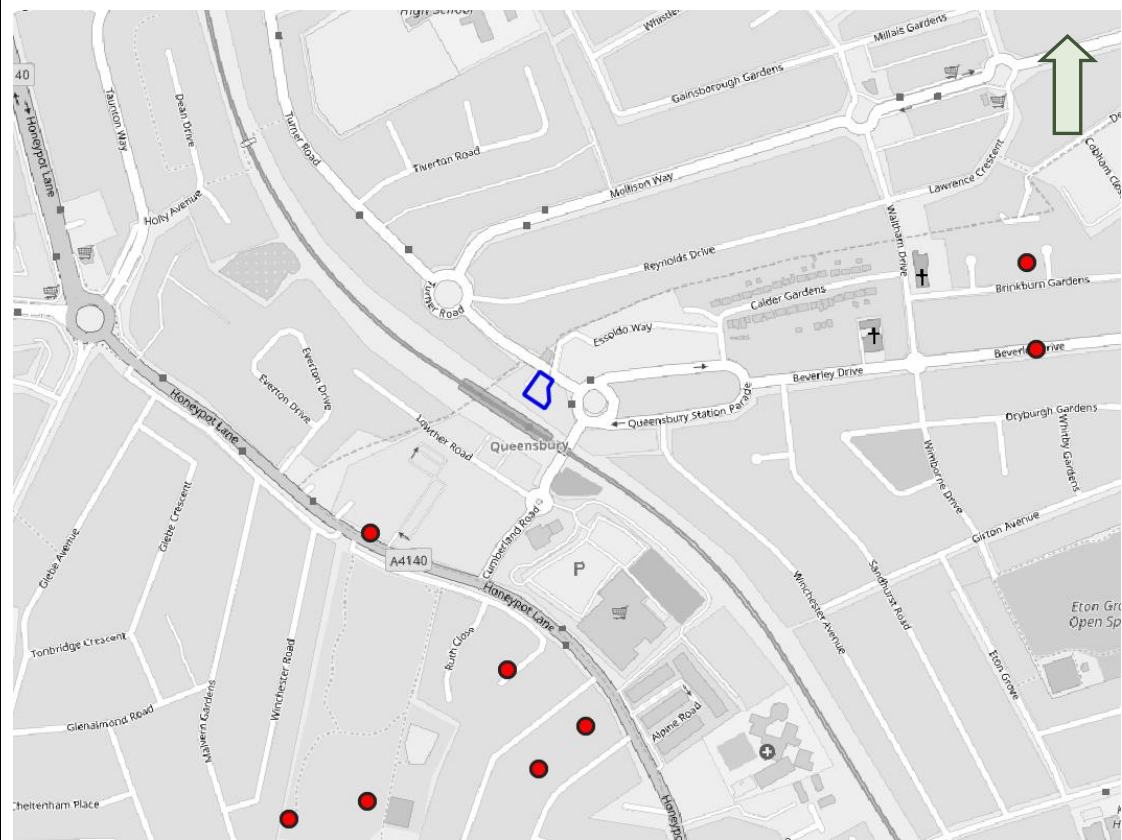
Figure 2 Compiled bomb impact map for the vicinity of the Site

The map has been compiled from a number of different sources, including air raid incident reports, historical aerial photographs and bomb census maps.

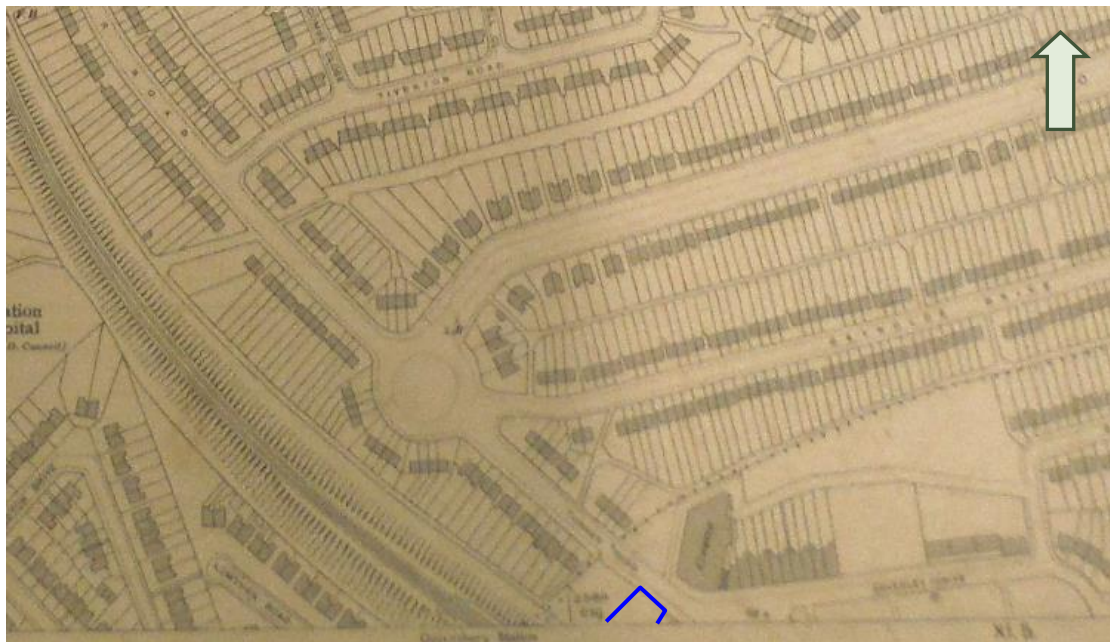
Figure 3 Extract from the Middlesex Bomb Damage Map (northern part of the Site)

Figures 3 and 4 are extracts from the Middlesex Bomb Damage map, compiled at the end of WWII, on which the colouring denotes the severity of damage to buildings. Yellow equates to blast damage, orange to moderate damage and pink and red to severe damage.

No bomb damage is recorded on the Site. Blast damage is recorded to buildings to the south of the Site.

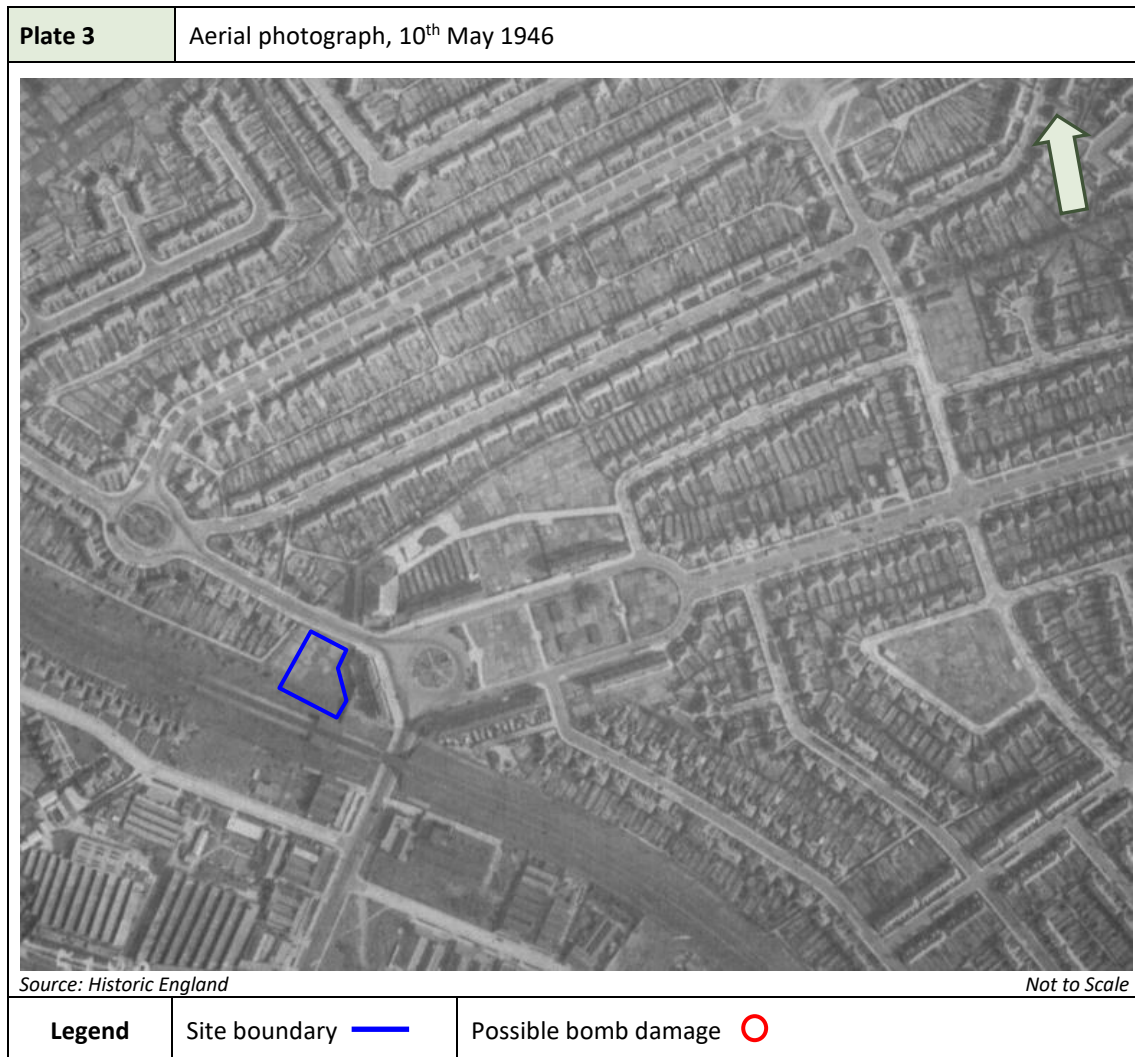
Plate 3 is an aerial photograph dated the 10th May 1946. No bomb damage has been identified on or in the vicinity of the Site.

No records have been found indicating that the Site was bombed and no bomb damage has been identified on the Site on historical aerial photography.

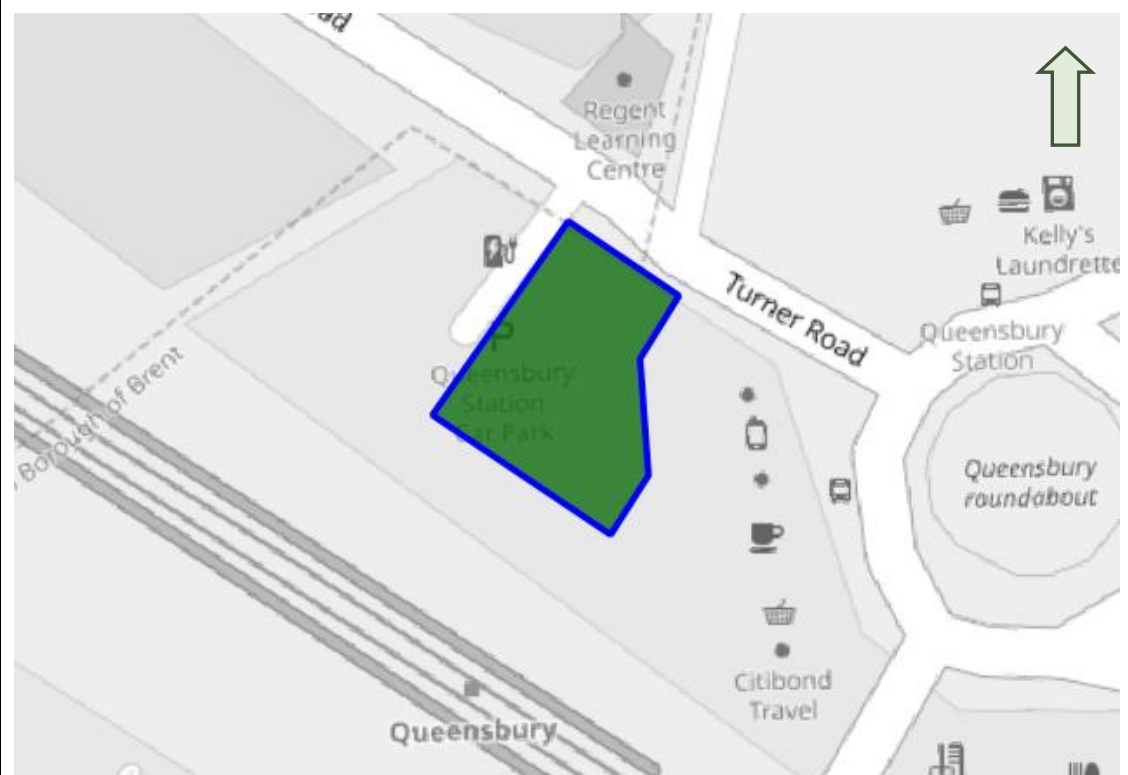
Figure 5 UXO hazard zone plan of the Site

No records have been found indicating that the Site was bombed and no other significant sources of UXO hazard have been identified on the Site.

Given this, it is considered that the Site has a low UXO hazard level, as shown in Figure 5.

No records have been found indicating that the Site was bombed and no other significant sources of UXO hazard have been identified on the Site.

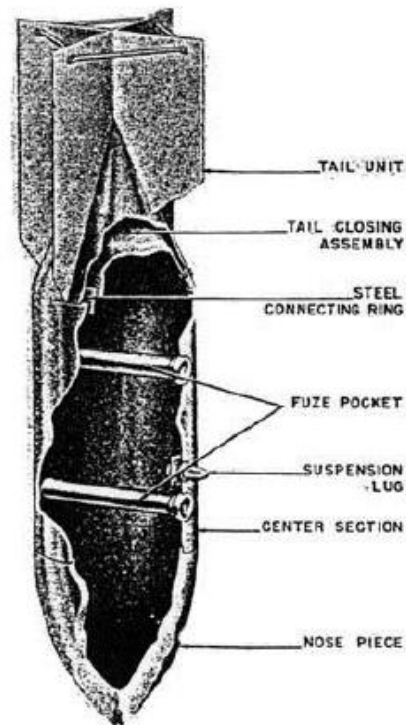
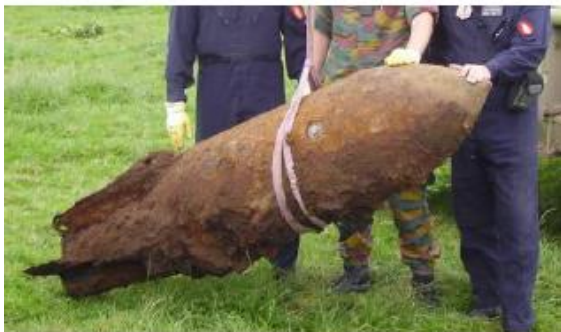
Description Thick nose welded to steel body. Nose may be attached to Kopfring (triangular section steel ring). Tail either steel sheet or drum-shaped. Suspension band. Originally painted green-grey/ buff (some later versions sky blue) with yellow stripe on tail. Filled with amatol, TNT or trialen.

Function Designed to maximise shock waves through air, water and earth and for general demolition. Used against railway property, large buildings, shipping and below-ground installations.

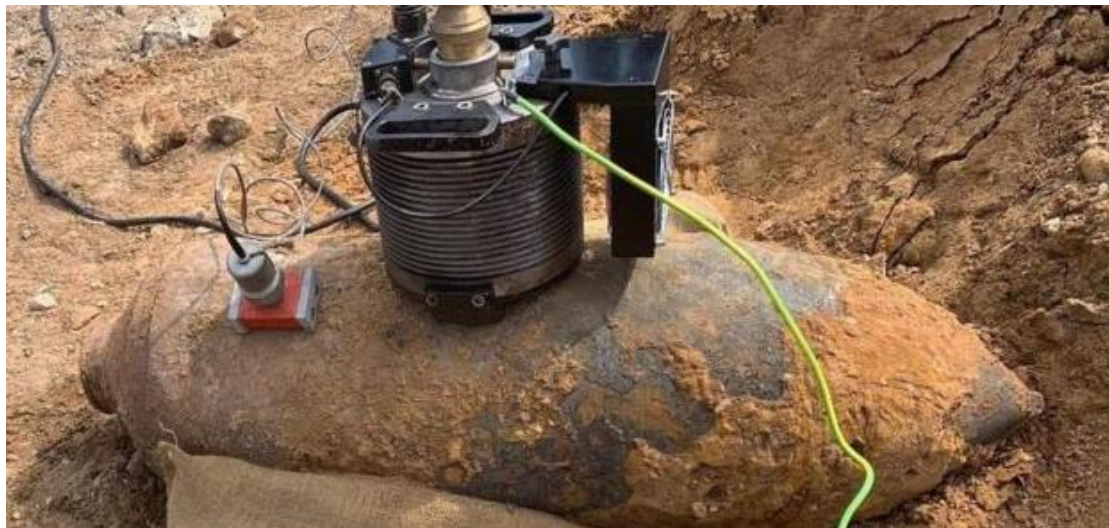
On the 23rd May 2019 a 250kg German UXB was found by workers on a building site at Kingston University in London (see plate below). The UXB could not be safely removed and was consequently destroyed in situ by an EOD team.
