**London Borough of Hounslow Surveys
Garage Blocks at rear of 1-18 Swann
Court, Isleworth (Site 12)**

Utility Mapping Survey

Site Report

Project No. 1716

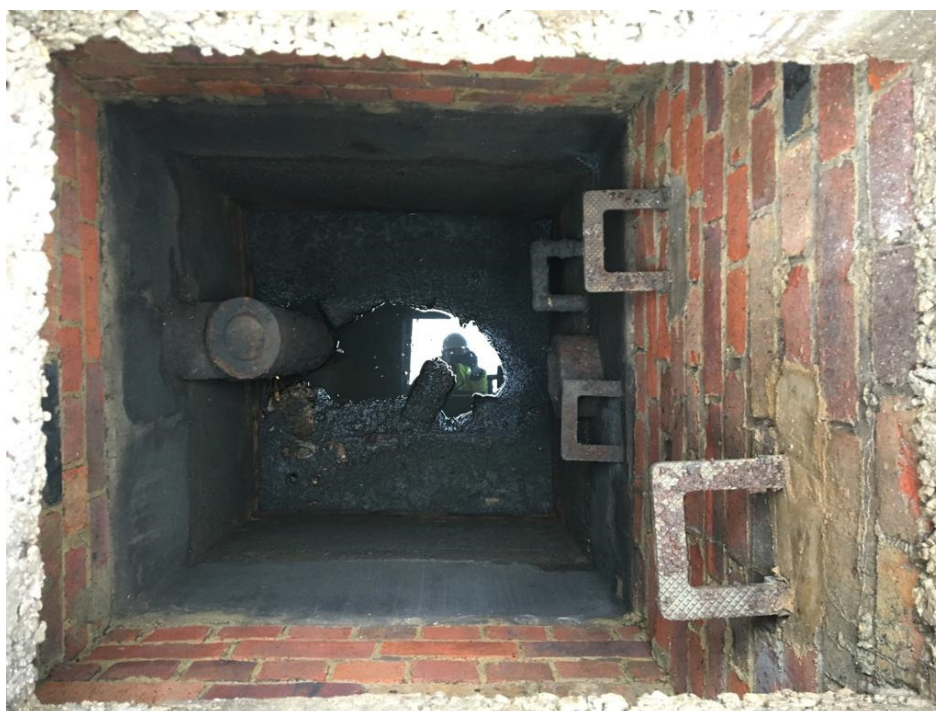
Photo 3

Other	1	Fuel interceptor identified within survey area (see photo 3).
GPR Scans	1	The radar reflects changes in the electrical properties of materials in the sub-surface. The data prevents definition of unknown targets.
	2	A PAS128 M3P GPR survey has been carried out across the site where possible.
	3	Several unknown targets detected within the survey extents although only partially in some areas due to losses of reflection. Unable to associate any fittings or features in the vicinity to help establish utility types.
	4	Poor quality image results encountered within reinforced areas. Limited data may occur.
	5	GPR images shown within this report are not necessarily indicative of actual routes / anomalies detected.

Description: Fuel interceptor chamber.

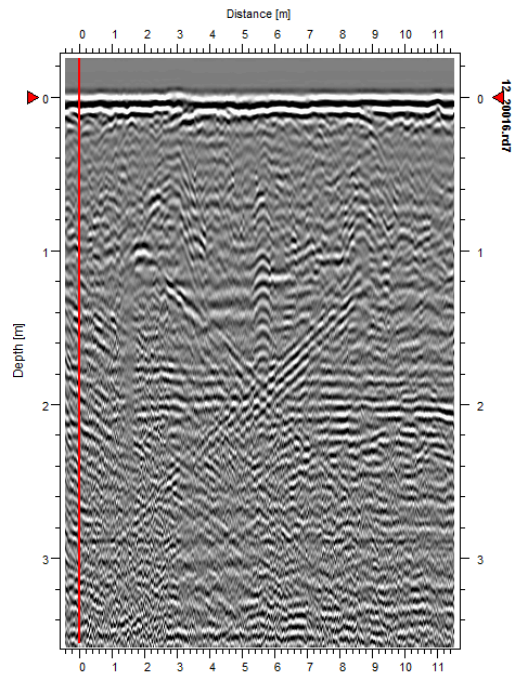
GPR 1

Description: Ground Penetrating Radar Scan 1.

4. Numerous unknown routes were detected by GPR, although it was not possible to decipher function. Future intrusive works (eg: trial pits) are recommended to gather further information.

6. Radar depth achieved to a maximum of 1.10 metres in the tarmac areas and 1.00 metre in the grassed areas. Care should be taken, as non-metallic services may be present at greater depths.

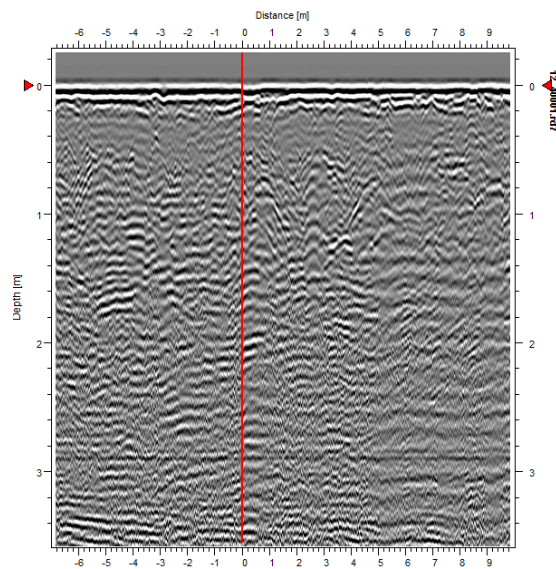
GPR 2

Description: Ground Penetrating Radar Scan 2.
