## Wapping Wharf - UXO Desk Study & Risk Assessment

**Document Title** UXO Desk Study & Risk Assessment  
**Document Ref.** P7985-18-R1  
**Revision** B  
**Project Location** Wapping Wharf  
**Client** Arcadis  
**Date** 19<sup>th</sup> October 2018

Zetica Ltd was commissioned by Arcadis to carry out an Unexploded Ordnance (UXO) Desk Study and Risk Assessment for 3No. adjoining areas totalling approximately 0.25 hectares (ha) centred on Cinnamon Street, Wapping, London Borough of Tower Hamlets ('the Site').

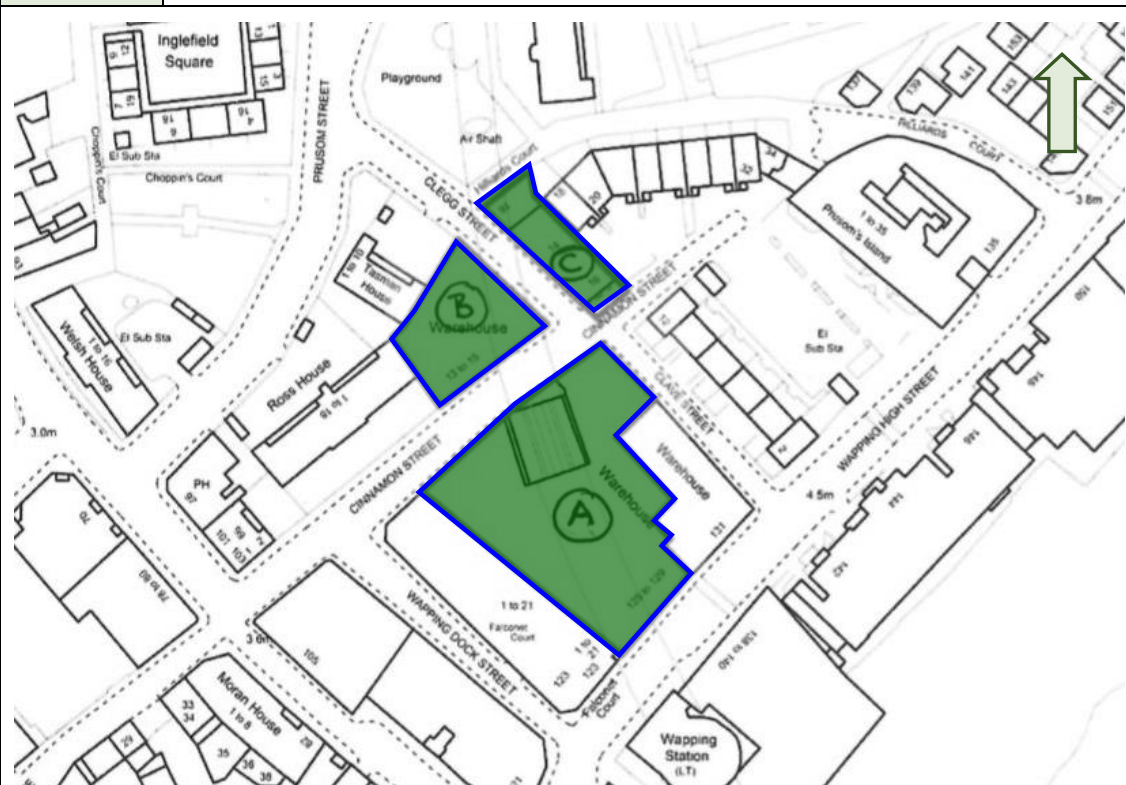
**Figure** UXO hazard zone plan of the Site

Given this, it is considered that the Site has a low UXO hazard level, as shown in the following Figure, reproduced as Figure 6 in the main report.

9 UXO HAZARD ASSESSMENT			
9.1 UXO Hazard Level			
The definitions for the levels of UXO hazard are provided below.			
Definitions of UXO Hazard Level for a Site			
Hazard Level	Definition		
Very Low	There is positive evidence that UXO is not present, e.g. through physical constraints or removal.		
Low	There is no positive evidence that UXO is present, but its occurrence cannot be totally discounted.		
Moderate	There is positive evidence that ordnance was present and that other uncharted ordnance may be present as UXO.		
High	There is positive evidence that UXO is present.		
Very High	As high, but requires immediate or special attention due to the potential hazard.		
No records have been found indicating that the Site was bombed and no other significant sources of UXO hazard have been identified on the Site.			
Given this, it is considered that the Site has a low UXO hazard level, as shown in Figure 6.

Figure 6	UXO hazard zone plan of the Site		
Legend	Very Low	Low	Moderate
	High	Very High	Site boundary

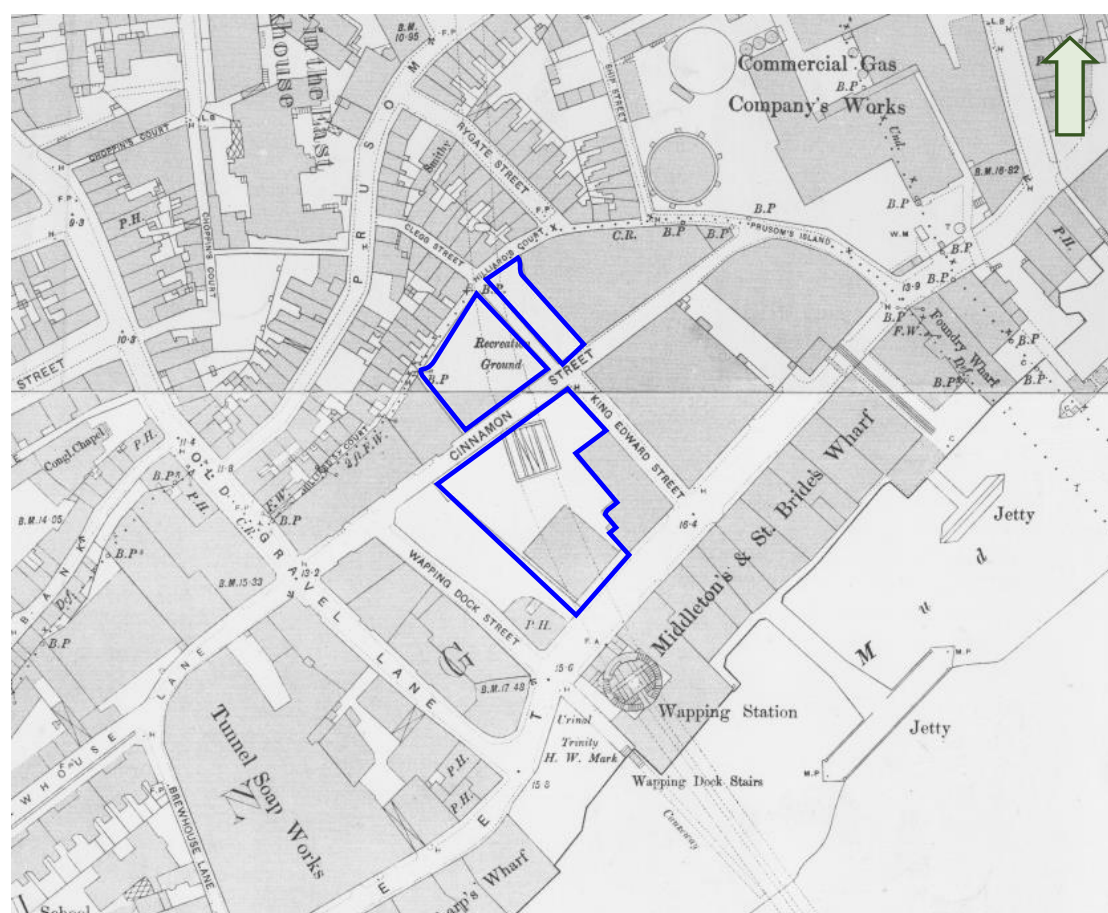
**Figure 2** Historical map, 1896

The northern part of the Site comprised a recreation ground and open land.

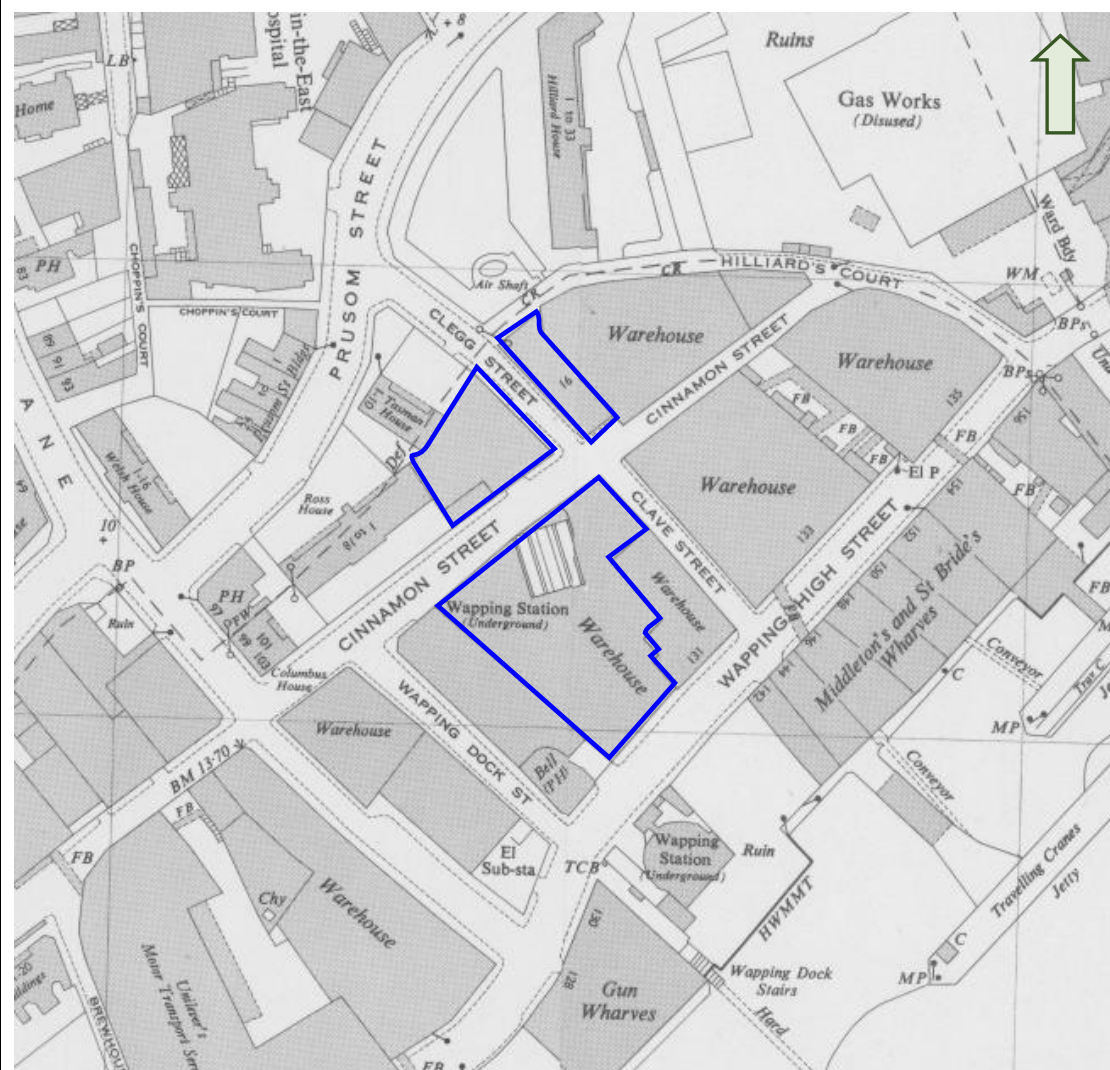
**Figure 3** Historical map, 1949

Several ruins and areas cleared of buildings in the vicinity of the Site are indicative of WWII bomb damage.

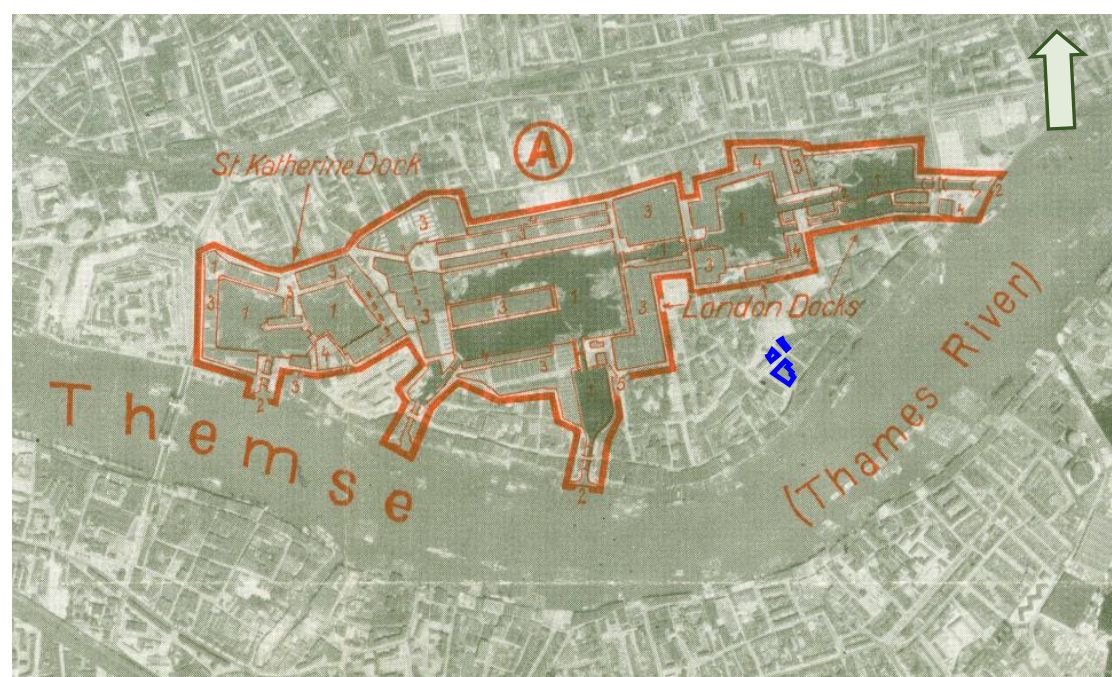
**Plate 4** Luftwaffe target photograph of St Katharine's and London Docks, 4<sup>th</sup> June 1939

Plate 4 is a Luftwaffe target photograph of St Katharine's Dock and the London Docks, dated the 4<sup>th</sup> June 1939. The identified targets are listed in Table 1.

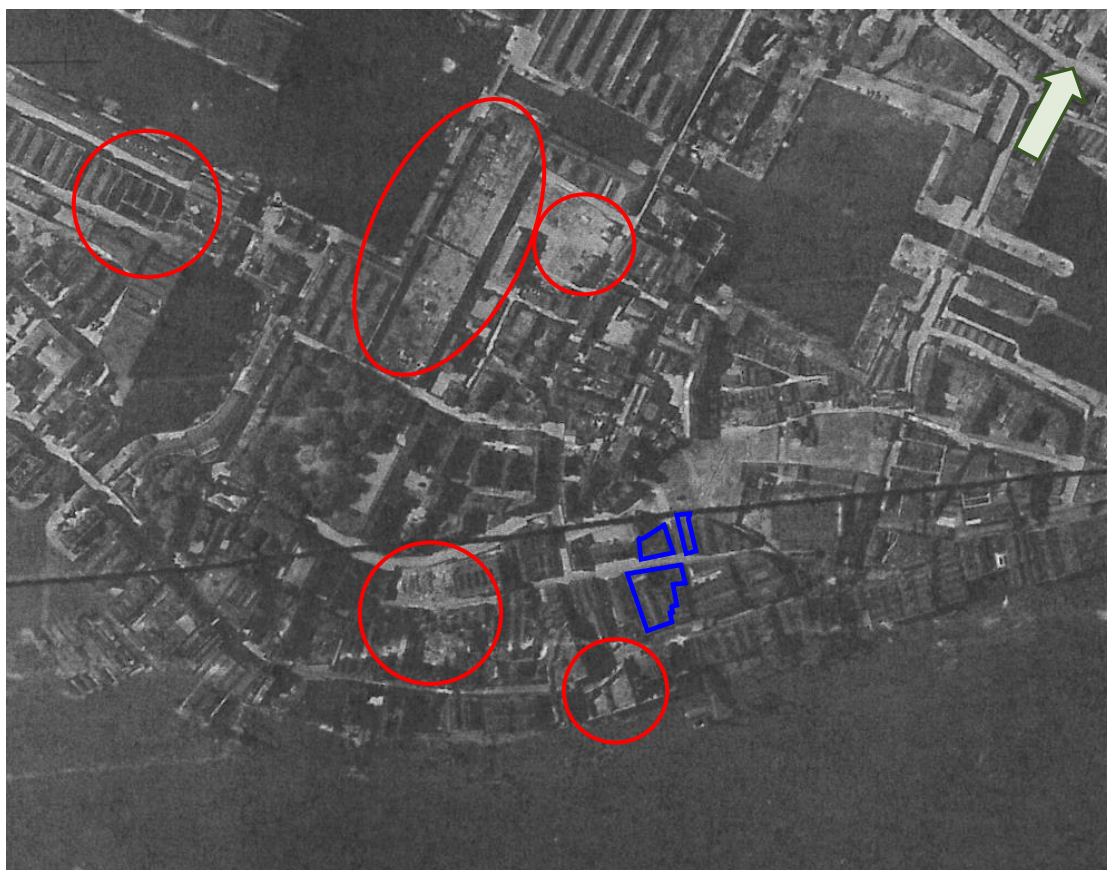
**Plate 5** Aerial photograph, 18<sup>th</sup> June 1941

Plate 5 is an aerial photograph dated the 18<sup>th</sup> June 1941. No bomb damage has been identified on the Site.

Possible bomb damage, characterised by demolished and ruined buildings, has been identified in the vicinity of the Site.

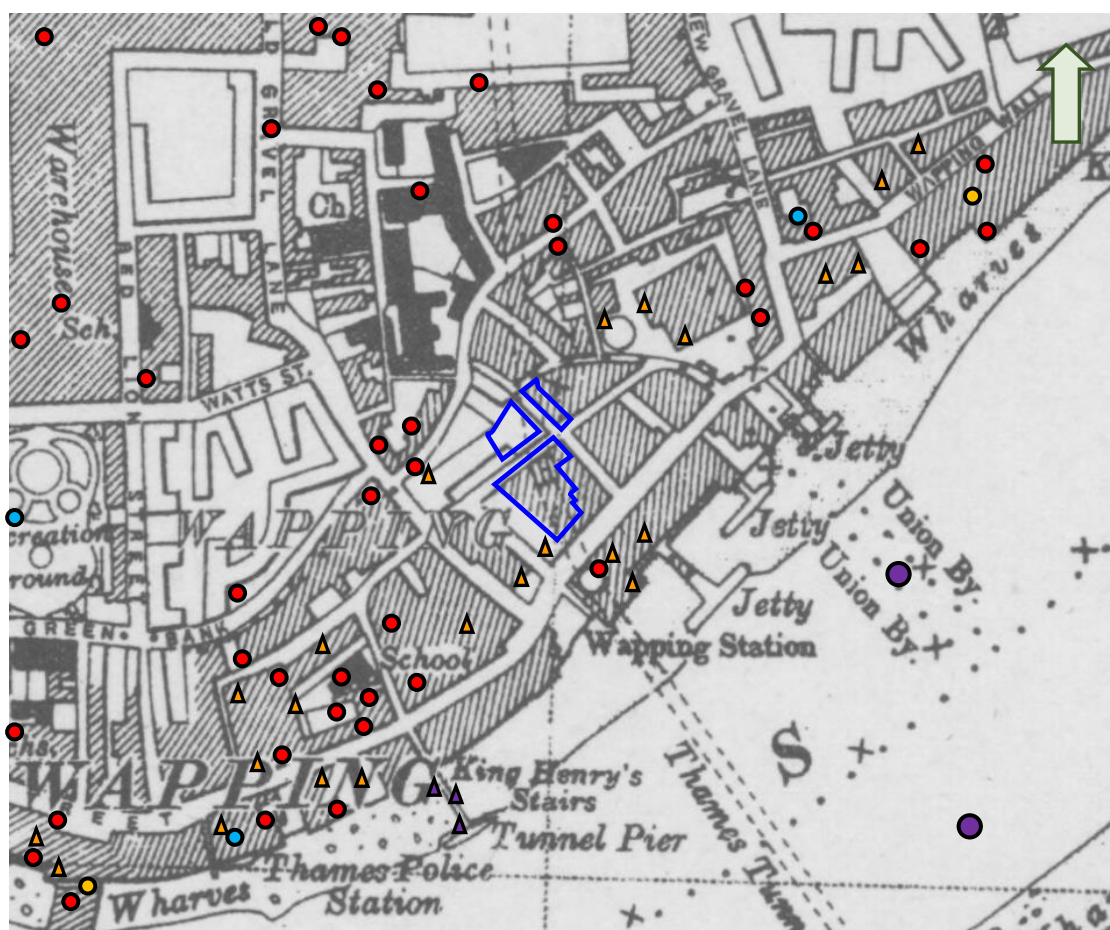
**Figure 4** Compiled bomb impact map for the vicinity of the Site

Note that air raid incident reports did not always record precise locations, often only indicating on which street or area a bomb fell.

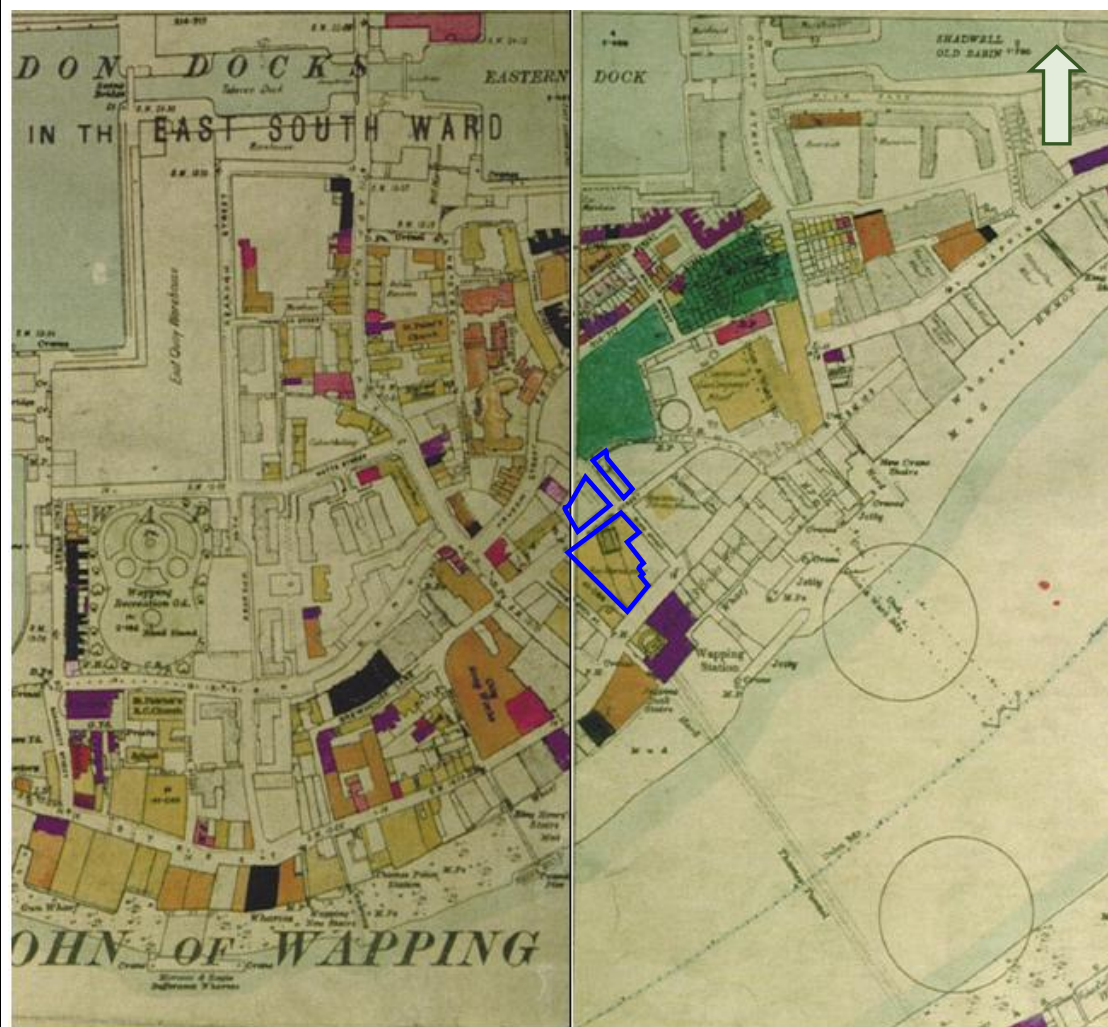
**Figure 5** Extract from the London Bomb Damage Map

Figure 5 is an extract from the London Bomb Damage Map compiled at the end of WWII, on which the colouring denotes the severity of damage to buildings. Black indicates total destruction, purple indicates damage beyond repair, red indicates serious damage (doubtful if repairable), pink indicates serious damage (repairable at cost), orange indicates moderate blast damage and yellow indicates minor blast damage.

The map shows that no significant bomb damage was recorded on the Site. Buildings on the southern part of the Site sustained minor blast damage, likely the result of nearby HE bomb impacts.

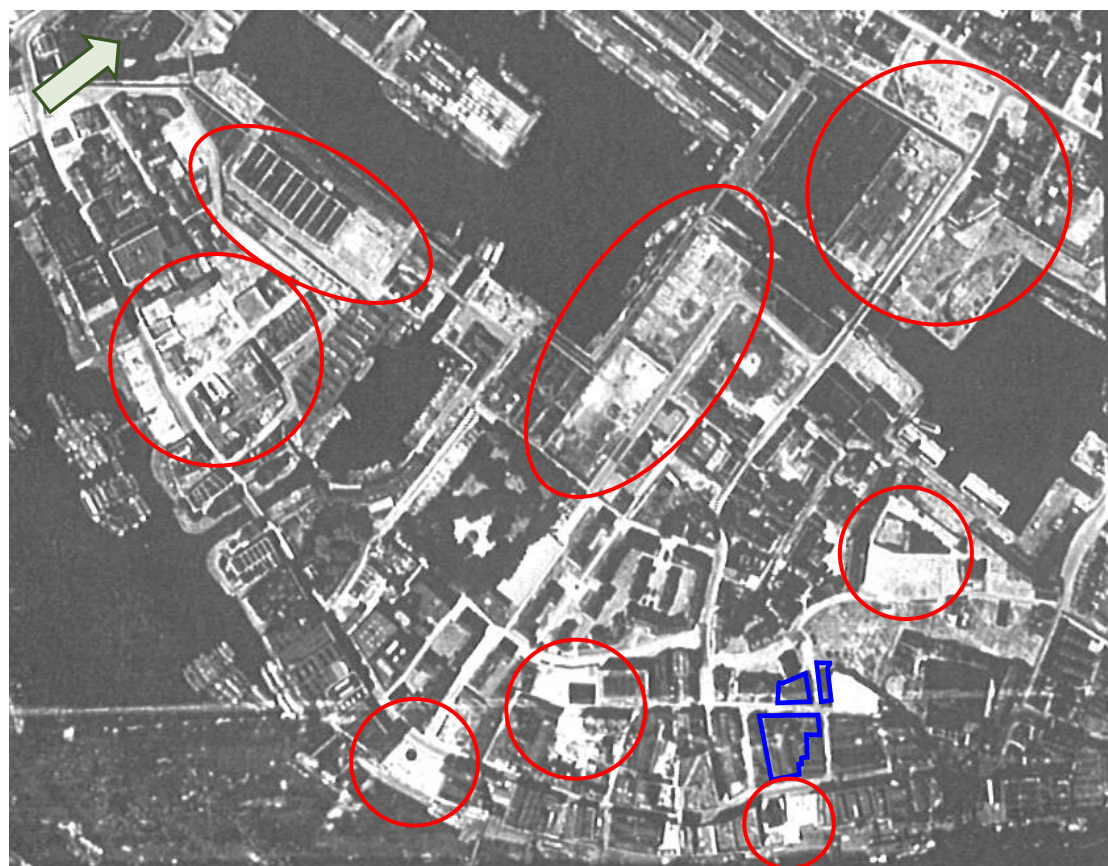
**Plate 6** Aerial photograph, 7<sup>th</sup> August 1944

Plate 6 is an aerial photograph dated the 7<sup>th</sup> August 1944. No bomb damage has been identified on the Site.

Possible bomb damage has been identified in the vicinity of the Site, largely corroborating the bomb damage map above.

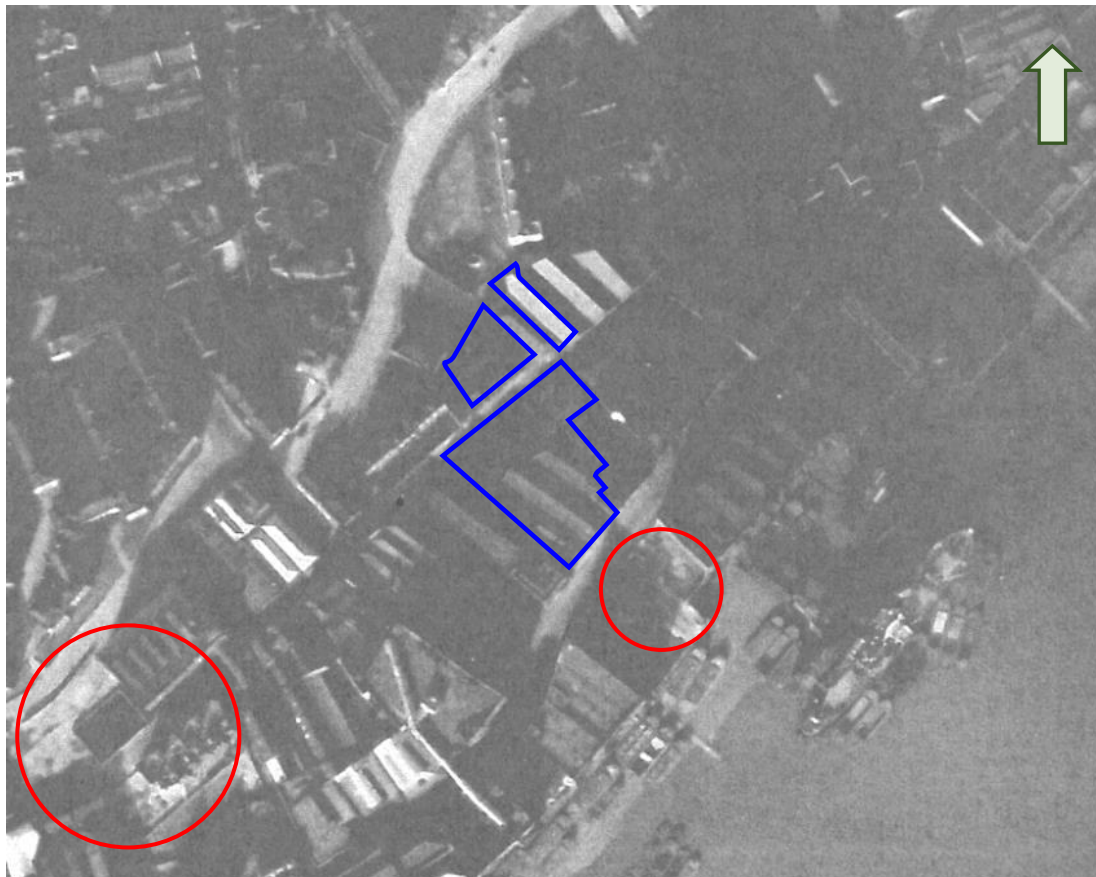
Plate 7	Aerial photograph, 18 <sup>th</sup> February 1949

Plate 7 is an aerial photograph dated the 18<sup>th</sup> February 1949. No residual bomb damage has been identified on the Site, which appears to remain occupied by the same warehouses that were present pre-WWII.

Possible residual bomb damage has been identified to the southeast and southwest of the Site.

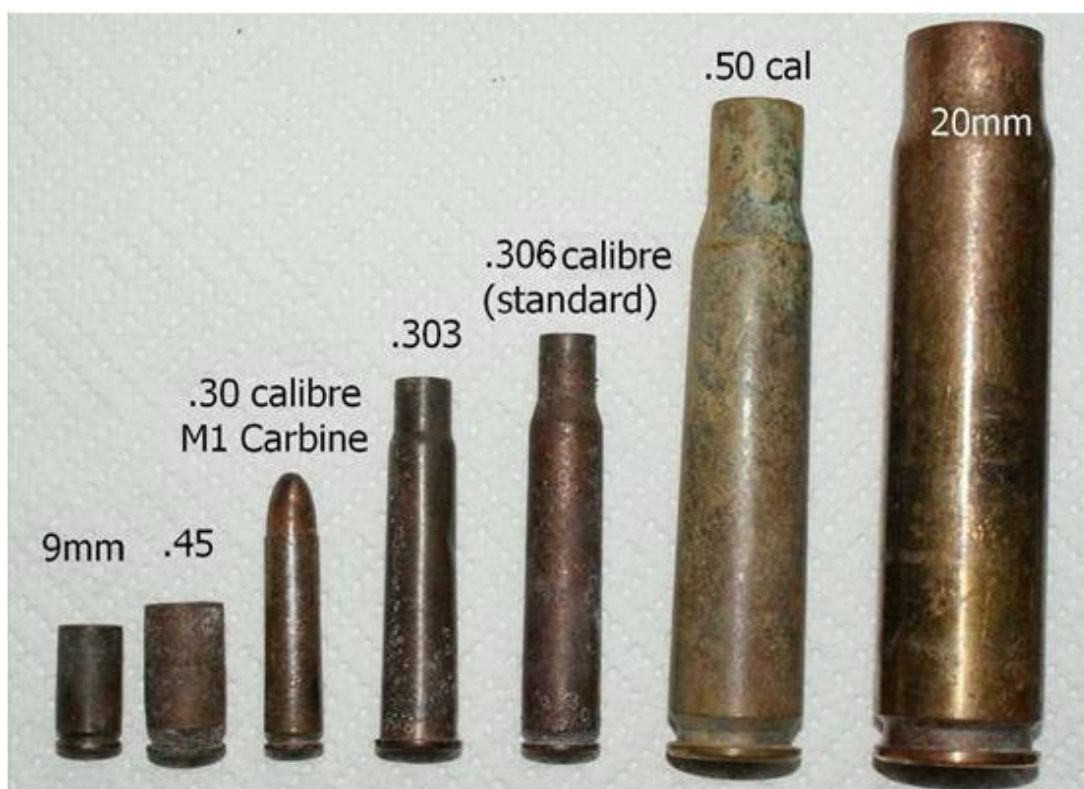
#### Plate

Photograph of typical WWII small arms ammunition

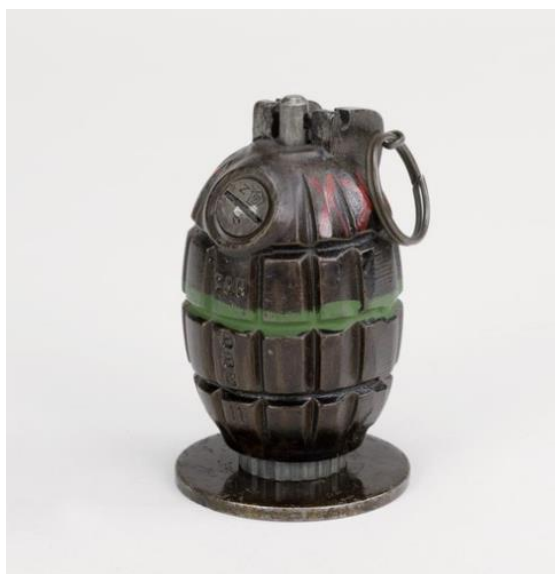
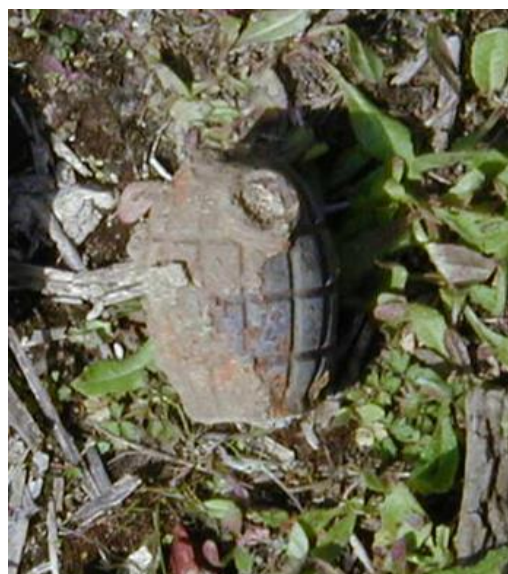
<b>Plate</b>	Photographs of a typical and an excavated WWII No. 36 hand grenade
--------------	--

Hand grenades can be filled with explosives or chemicals and have 3No. main parts, a body, a fuze with a pull ring and a safety-clip assembly. Fragmentation grenades are the most common and have a metal or plastic body filled with an explosive. Most use a burning delay fuze that functions for 3 to 5 seconds after the safety lever is released. Some, such as smoke grenades, are activated instantly when the lever is released.

The Plate below illustrates the typical character and condition of the most commonly found No. 36 hand grenades (Mills Bombs).

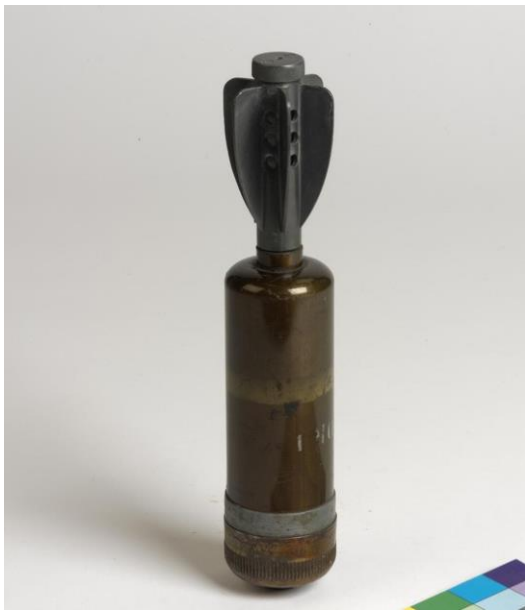
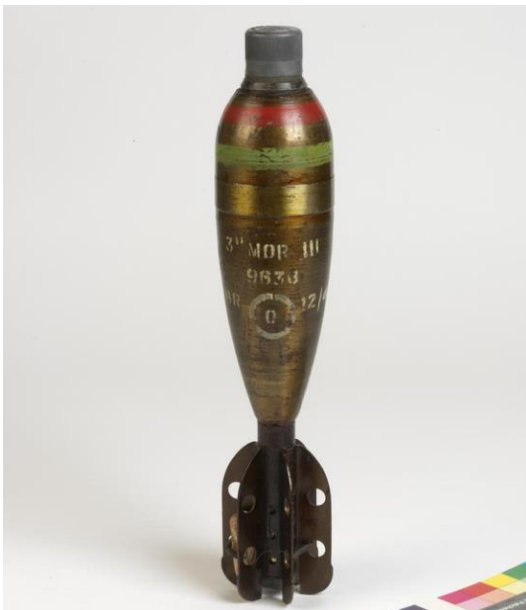
Plate	Photographs of WWII 2-inch and 3-inch mortars
<div data-bbox="252 344 778 952">

The Plate below shows typical 2-inch (left) and 3-inch (right) mortar bombs.

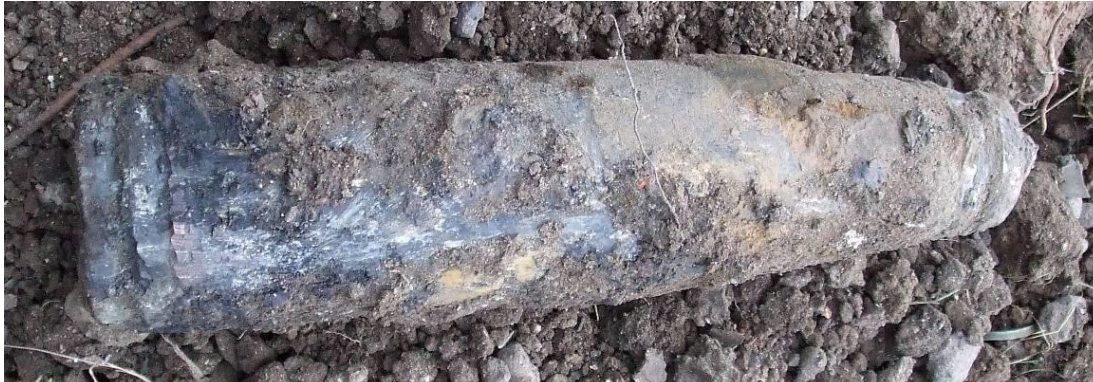
</div>	
A2.5 Shells	
<p>Shells are a projectile containing an explosive charge designed to burst the casing that can contain High Explosives, pyrotechnic compounds or other chemicals.</p> <p>Shells can be found in a range of sizes, from &lt;20mm to several times this size. The most likely shells to be found on the Site are Small Arms Ammunition (SAA) or UXAA shells that have fallen back to the ground unexploded.</p> <p>Most commonly used anti-aircraft shells were 2" and 3.7" HE shells.</p> <p>If fired and found as UXO, shells can offer a particular hazard from accidental detonation as they can have sensitive fuze mechanisms. A fuze is a device which incorporates mechanical, electrical, chemical or hydrostatic components to initiate a train of fire or detonation.</p> <p>The Plate below is a photograph of a 3.7" UXAA shell found in Camberwell, London.</p>

Plate	Photograph of a recently excavated 3.7" AA shell
<div data-bbox="252 1541 1348 1921">

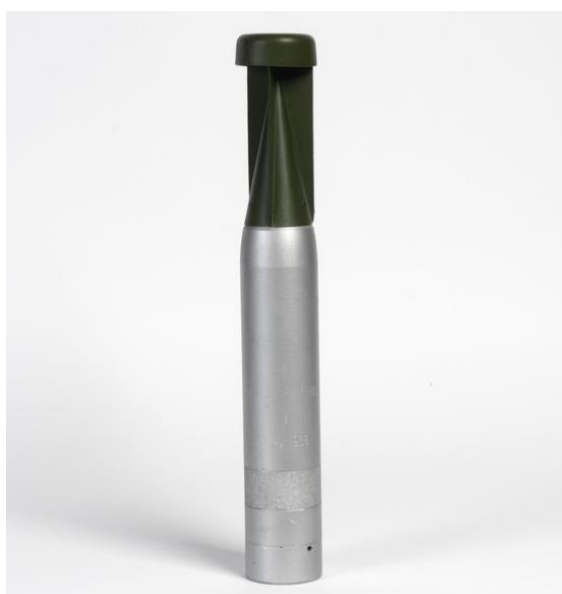
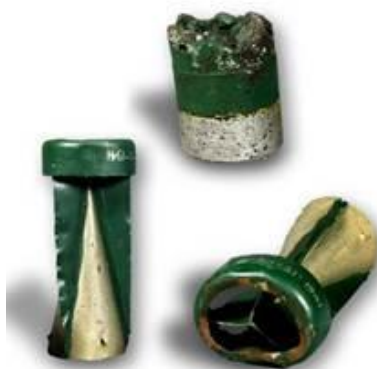
**Plate** Photographs of a 1kg IB and IB fragments

The Plate below shows a 1kg IB and a variety of fragmentary remains of IBs recovered by the Civil Defence during WWII.

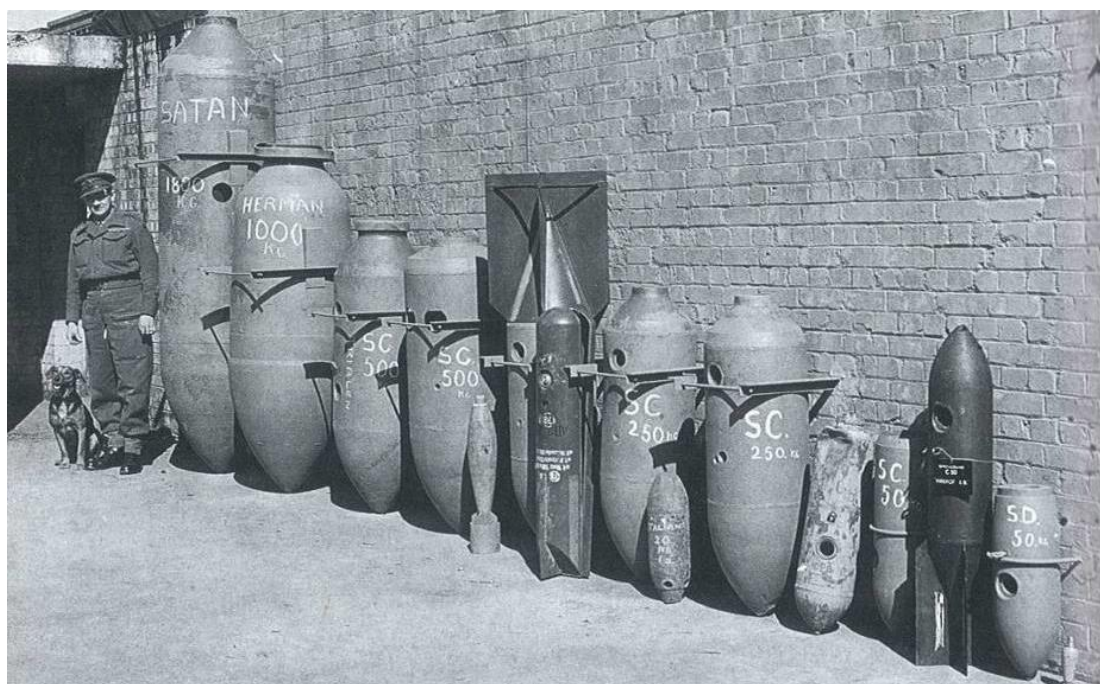
**Plate** Photograph of a variety of UXB recovered by the Civil Defence during WWII

The Plate below shows the variety of UXB recovered by the Civil Defence during WWII.

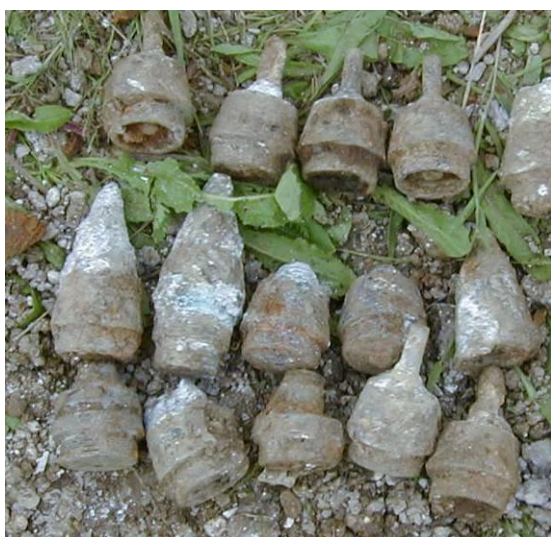
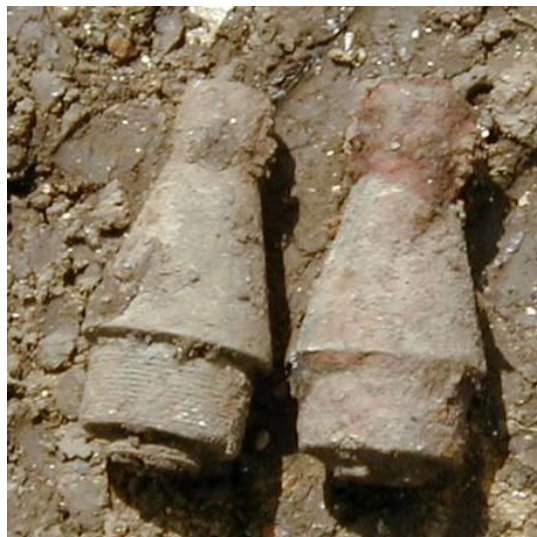
Plate	Photographs showing examples of WWII fuzes
-------	--

A wide variety of these components were used and examples of some common fuzes are shown in the Plate below.

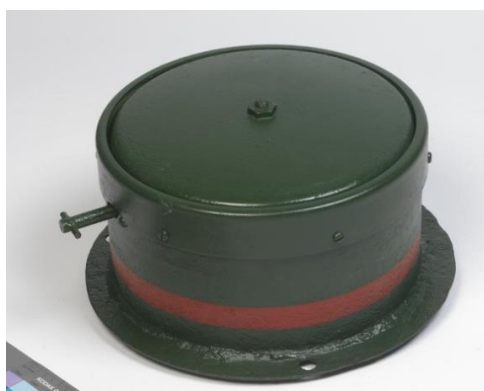
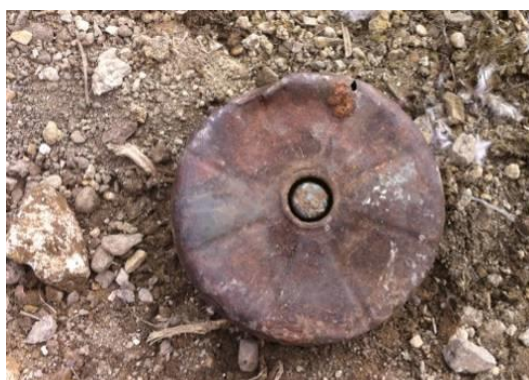
Plate	Photographs of original and recently excavated WWII land mines
-------	--

The Plate below is a photograph of a typical WWII land mine used on the land area, beaches and cliffs around Britain. The example on the right was found at Gatwick Airport, formerly RAF Gatwick.

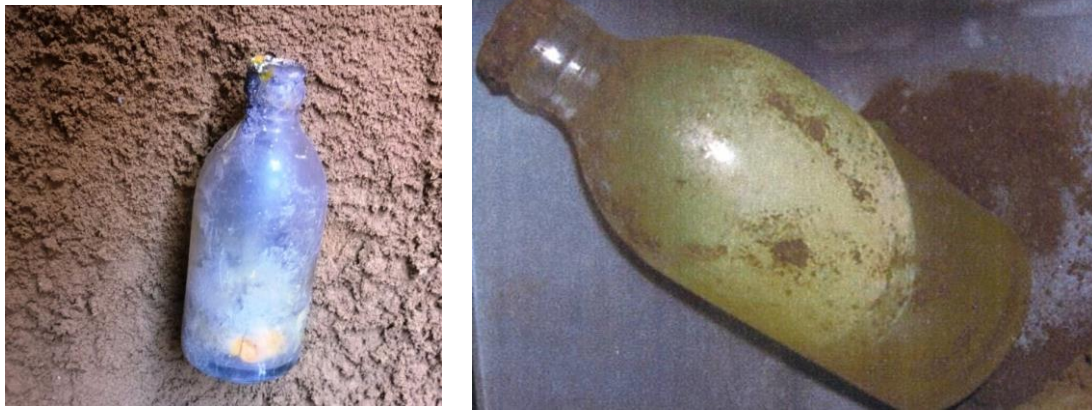
Plate	Photograph of No. 76 SIP grenades

The Plate below shows 2No. recently discovered SIP grenades.

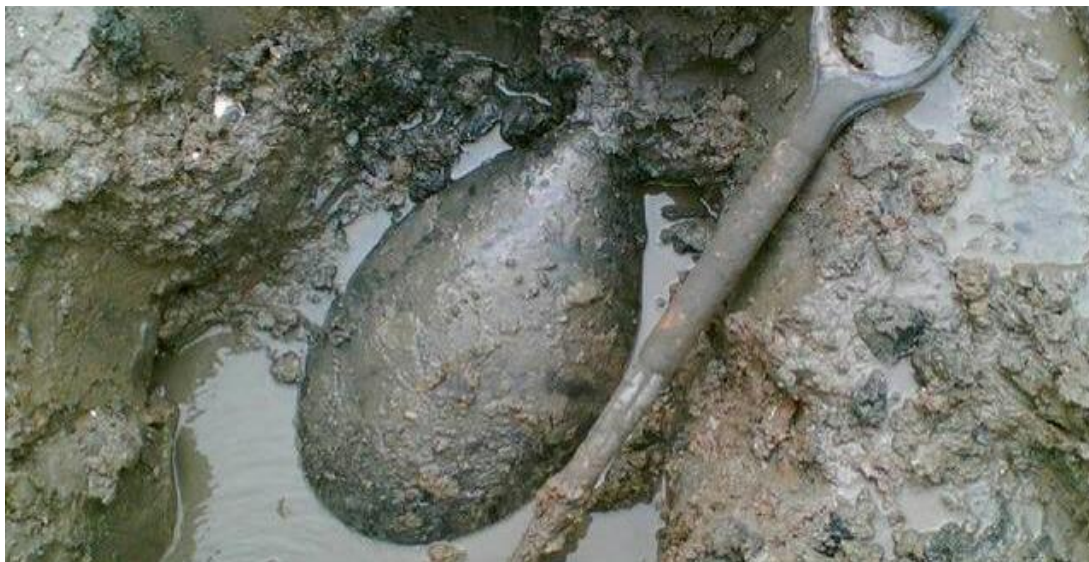
The Plate below is a photograph of the bomb in situ.

<b>Plate</b>	Photograph of the 500kg WWII UXB at Bowers Marsh, 8 <sup>th</sup> March 2010
--------------	--

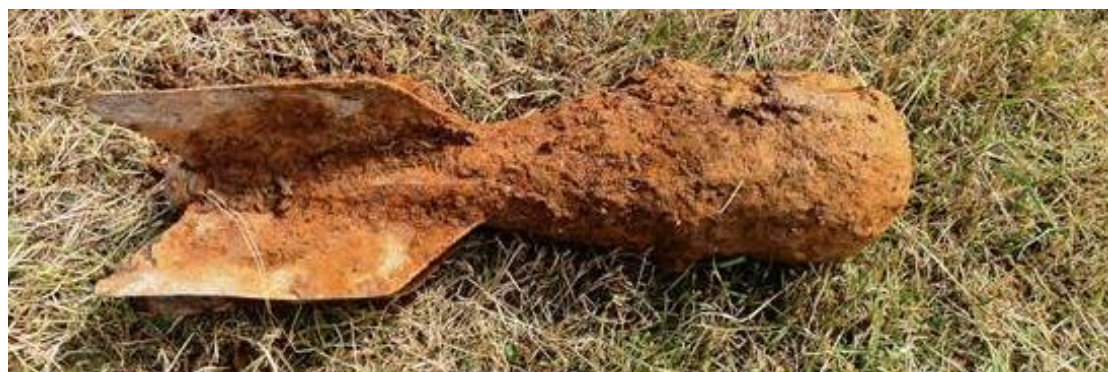
<b>Plate</b>	Photograph of WWI bomb, Isle of Sheppey, 2 <sup>nd</sup> August 2012
--------------	--

1No. WWI bomb (shown in the Plate below) was found on the Isle of Sheppey on the 2<sup>nd</sup> August 2012 during a geophysical survey following desk study research by Zetica Ltd which had established that a previously unknown WWI bombing range existed on the site. A further WWI bomb was found in the same location in August 2015.

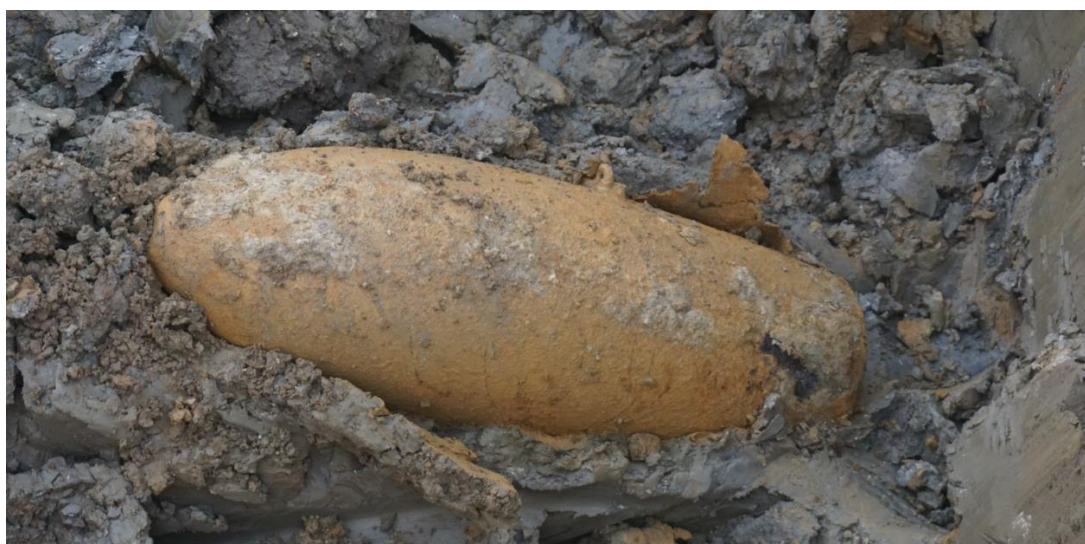
**Plate** Photograph of a recently excavated WWII British 500lb GP bomb

In January 2016, Zetica discovered 3No. 500lb British UXB at a former airfield in Cambridgeshire. These were destroyed in controlled explosions. The Plate below is a photograph of one of the bombs.
