Wadham Road, Wandsworth - UXO Desk Study & Risk Assessment

Document Title UXO Desk Study & Risk Assessment
Document Ref. P9364-19-R7
Revision A
Project Location Wadham Road, Wandsworth
Client Arcadis
Date 29th January 2020

UXO DESK STUDY & RISK ASSESSMENT

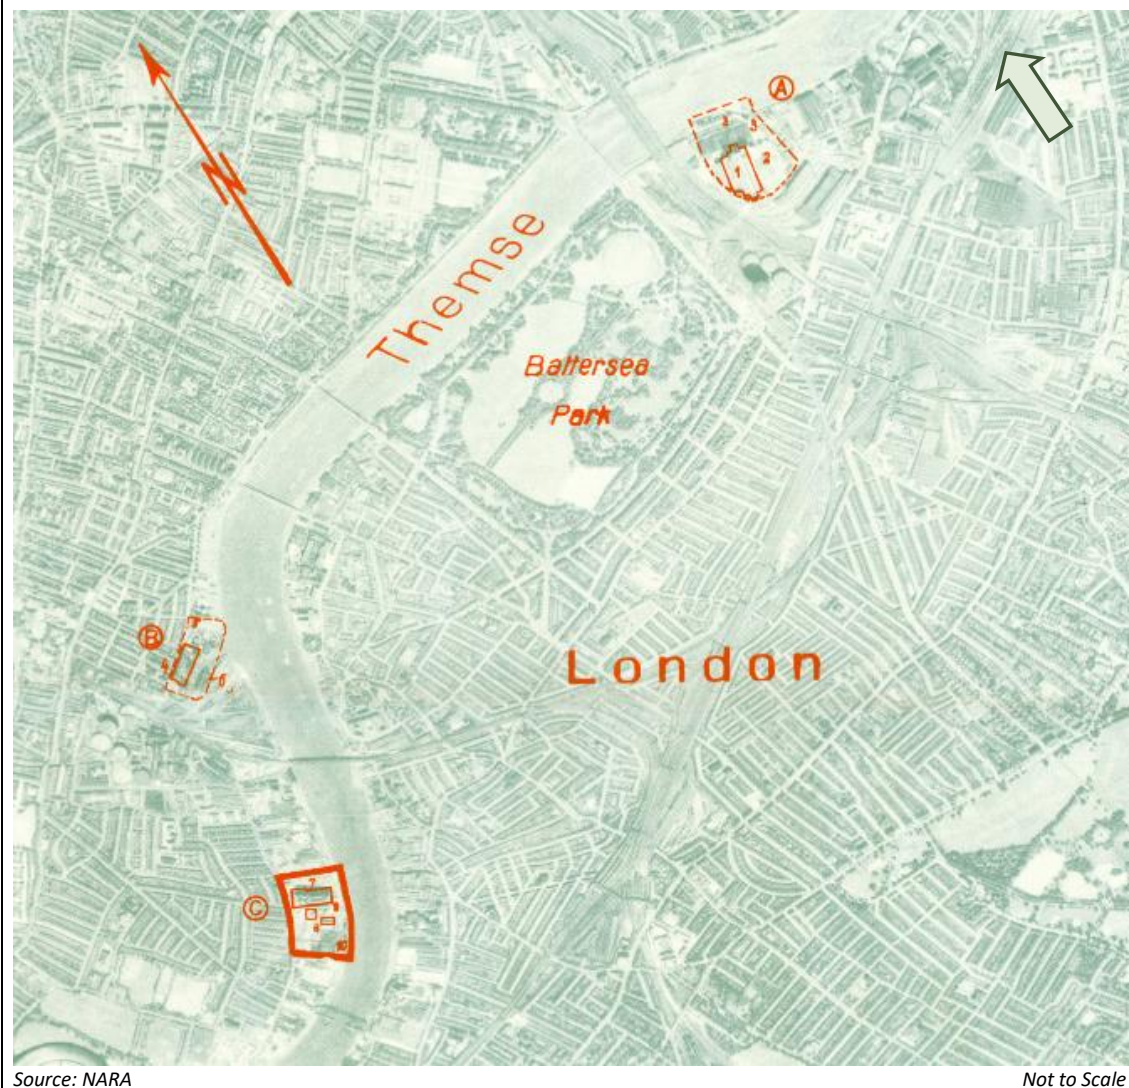
Plate 2 Luftwaffe target photograph of Fulham and Battersea

Plate 2 is a Luftwaffe target photograph of Fulham and Battersea. This shows Battersea Power Station (Target A), engineering works (Target B) and Fulham Power Station (Target C).

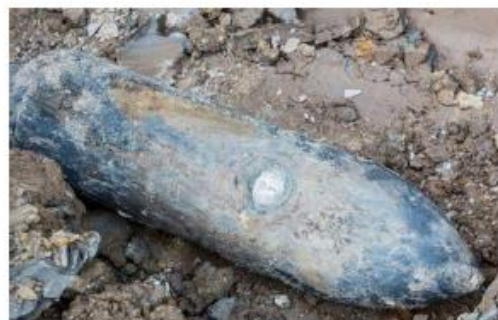
Description Thick nose welded to a steel body. Nose may be attached to Kopfring (a triangular section steel ring) or spike. Suspension bolt in eye/body and sheet metal tail attached to body with rivets/screws. Originally painted green-grey with a yellow stripe on the tail. Cast TNT, Amatol or Trialen filling.

Function Designed to maximise shock waves through air, water and earth and for general demolition. Used against easily damageable targets, including roads, aircraft hangars, rolling stock and small buildings. Spike bombs/ 'Stabo' (SC 50 with spikes attached to nose) were used against rail lines and country roads, with Kopfring used against naval targets.

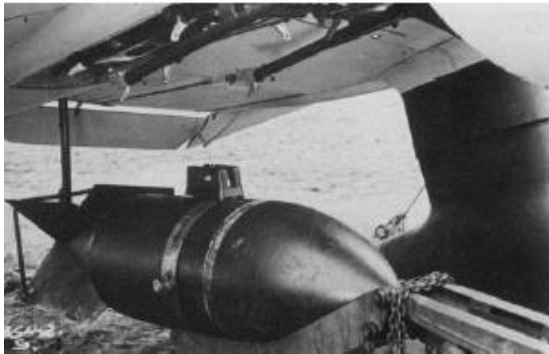
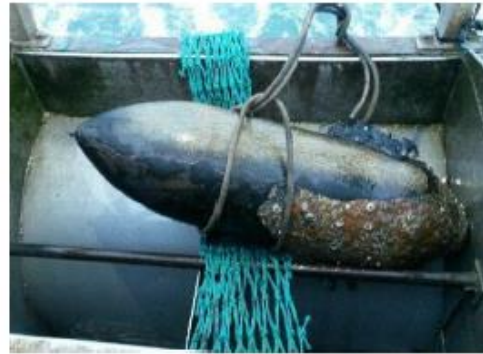
Category Bomb
Type Sprengbombe-Cylindrisch (SC) 250kg

Description Thick nose welded to steel body. Nose may be attached to Kopfring (triangular section steel ring) or spike. Sheet metal tail attached to body with rivets/screws. Suspension eye bolt in the nose/body. Originally painted green-grey with a yellow stripe on the tail. TNT; amatol; TNT and aluminium powder, naphthalene, ammonium nitrate and wax/ wood meal filling.

Function Designed to maximise shock waves through air, water and earth and general demolition. Used against railway installations, large buildings, ammunition depots and below-ground installations (to 8m). Spike bombs/ 'Stabo' (SC 50 with spikes attached to nose) used against rail lines and country roads.

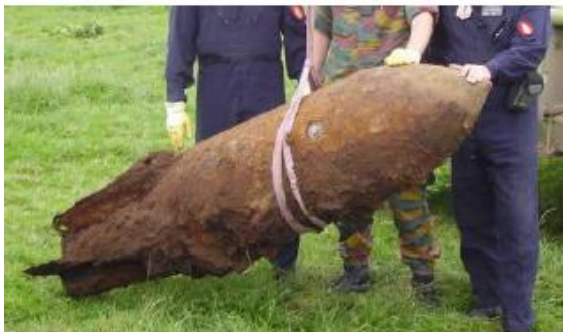
Description Thick nose welded to steel body. Nose may be attached to Kopfring (triangular section steel ring). Tail either steel sheet or drum-shaped. Suspension band. Originally painted green-grey/ buff (some later versions sky blue) with yellow stripe on tail. Filled with amatol, TNT or trialen.

Function Designed to maximise shock waves through air, water and earth and for general demolition. Used against railway property, large buildings, shipping and below-ground installations.
