**APPENDIX G - REPORT CONDITIONS****WHITE YOUNG GREEN ENVIRONMENTAL LTD***Southall Gas Works, Southall, London – Arboricultural Survey Report*

**West Southall**  
**Heritage Assessment**  
**For**  
**National Grid Property Ltd**

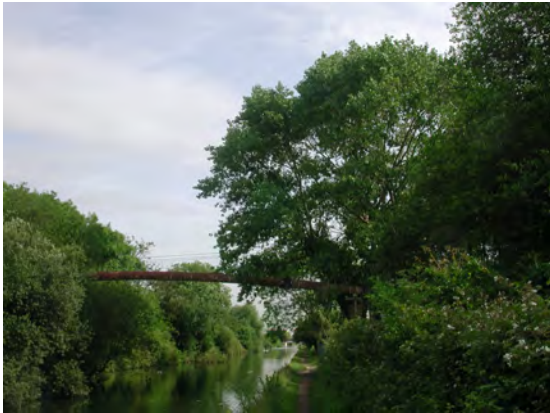
Fig. 1. Tree 01, a mature hybrid black poplar, viewed from the canal towpath to the south.

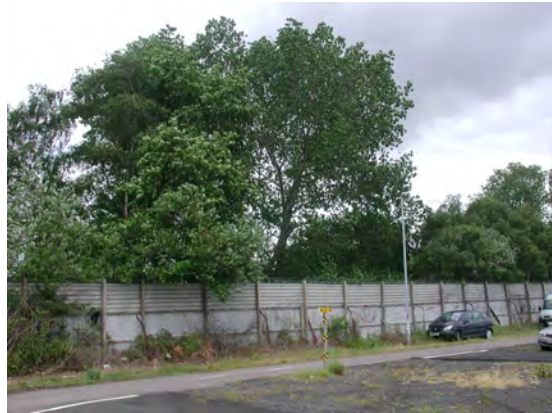
Fig. 2. Group G01, mature hybrid black poplar and goat willow with middle-age birch and sycamore, viewed from the south.

| Ref. no. | Species | Age class | Stem diameter @1.5m (mm) | Stem no. | Height (m) | Crown clearance height (m) | Crown spread radius (m) | Physiological condition | Structural condition | Comments | Preliminary work recommendations | Remaining contribution (yrs) | Category grade | RPA radius (m) | RPA area (m <sup>2</sup> ) |
|---|---|---|---|---|---|---|---|---|---|---|---|---|---|---|---|
| G1 | Hybrid black poplar†, sycamore, pedunculate oak, hawthorn | Mature/middle-age | 100-750 | 1/ Multi-stemmed | 6-22 | 0+ | 2-8 | Good | Fair/poor | Linear group of planted pollarded mature poplars and middle-age naturally regenerated trees. Assessed at distance as located behind sheet metal fence with no access. | Reinspect when access can be gained. Re-pollard topped trees on 5 year cycle if retained. | >40 | C2 | Crown spread | |

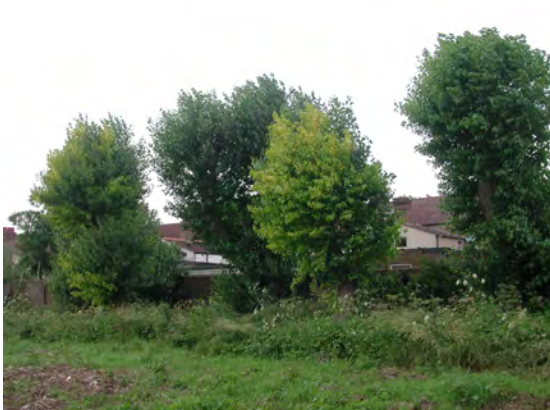
Fig. 5. Trees 29-33, pollarded mature hybrid black poplars close to the northern boundary, viewed from the south.

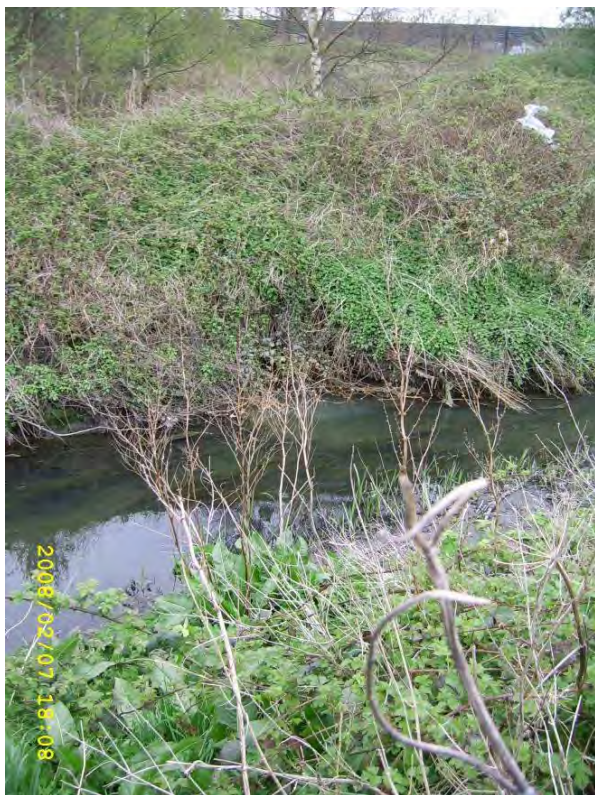
Photograph 1, Target Note 3. Minor outfall, creating discolouration of watercourse. Location partially hidden by dense vegetation.

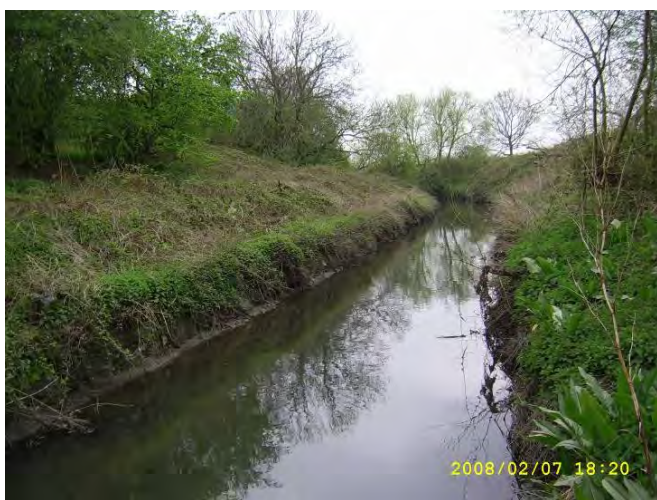
Photograph 3, showing resectioned bank: uniform steep sided bank, straight river channel.

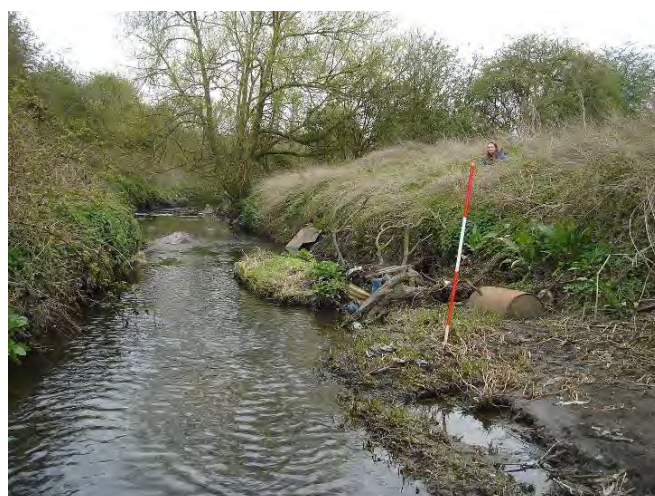
Photograph 5, Spot Check 3, facing downstream, viewed from mid-channel, showing unvegetated right side bar.

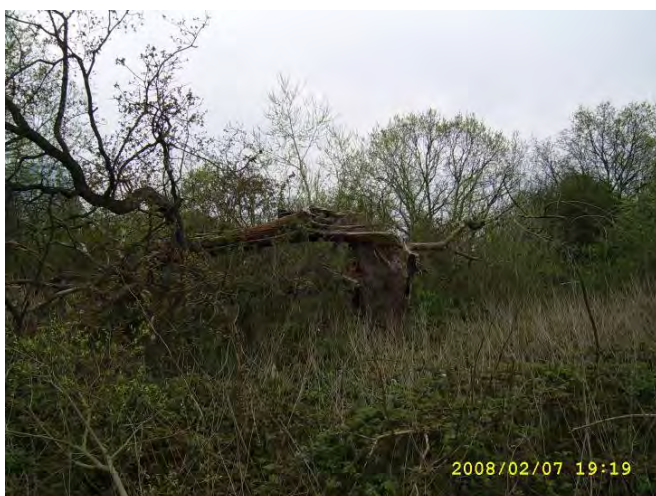
Photograph 6, Target Note 2. Fallen dead tree, within 50m of banktop, close to Spot Check 9.

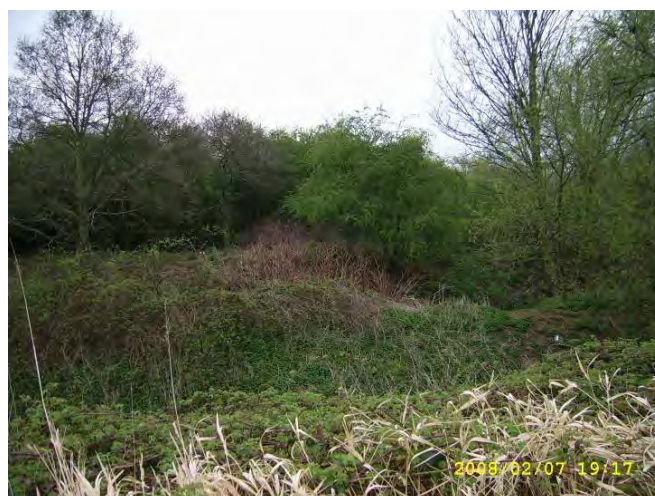
Photograph 7, Target Note 1. Clump of Japanese knotweed, centre of photograph.

The bank zone is however suffering in many places from infestation by a number of invasive, non-native plants including giant hogweed (*Heracleum mantegazzianum*), Himalayan balsam (*Impatiens glandulifera*) and Japanese knotweed (*Fallopia japonica*). All are notoriously difficult to control. They are very effective at spreading and out-competing other plants, causing a reduction in native riverine species diversity. In addition giant hogweed presents a potential human health risk as it contains a chemical in its sap that can cause photo-sensitive chemical burns to the skin.

The habitats of greatest value within Minet Country Park along the Yeading Brook are found along the bank tops and include scrub, woodland, ruderal vegetation and rank grassland. This provides a good variety of common plant species and complex structure that can support a range of common and notable fauna. These areas are relatively undisturbed, as the dense vegetation structure does not encourage intensive recreation. It is recommended that these areas are managed for their wildlife interest, according to the recent Management Plan produced by 'A Rocha Living Waterways' (Conroy 2004). The greatest existing threat to these areas is the extensive growth of invasive plant species such as giant hogweed and Japanese knotweed. These require urgent and on-going control.

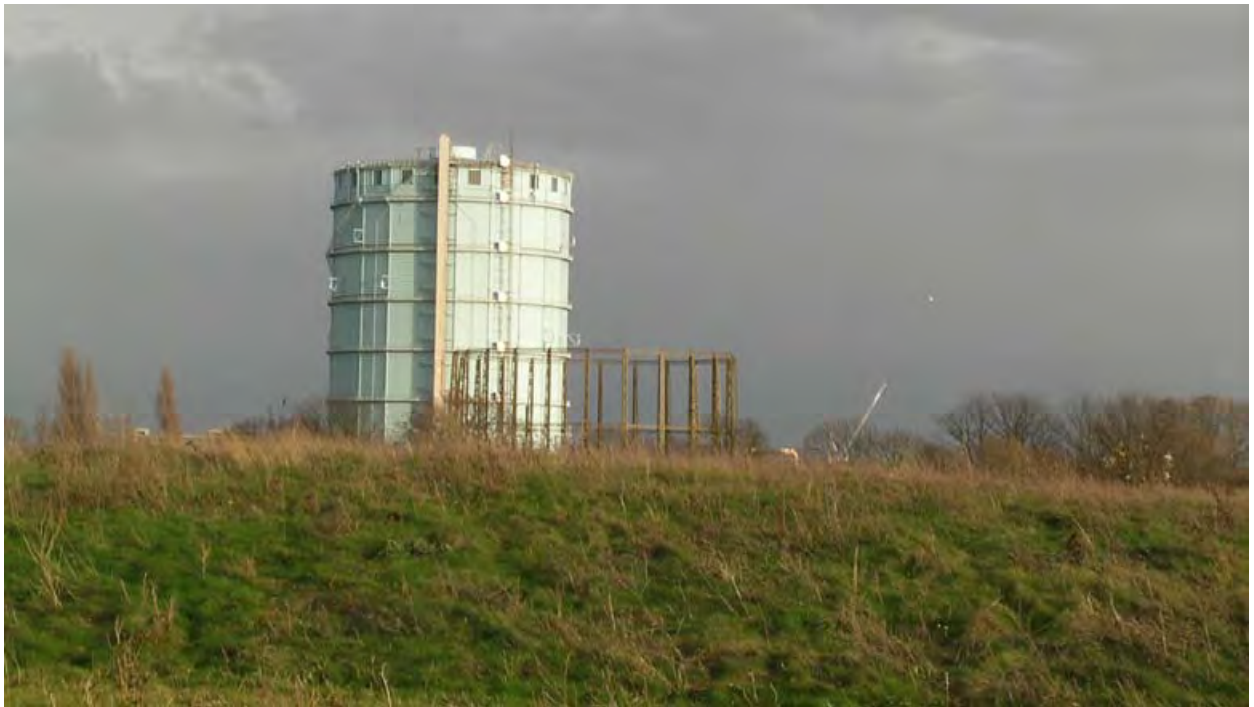
Figure 8. The gasworks site, viewed from the north-west: the box-lattice standards of No. 3 in front of the 'blue tower' fixed gasholder, which is to be retained
