Asbestos Survey Report and Register

Survey Type:	**Asbestos Demolition Survey**
Site:	Rainham Road North Garages, Romford, London, RM10 7EH
Surveyor:	Ben James
Contract:	C23061-C
Survey Date:	29th March 2021
Report Date:	11th April 2021
Re-inspection Due:	29th March 2022
Client:	**Arcadis** Part 2nd Floor, Charter House, Cambridge, CB2 1LA

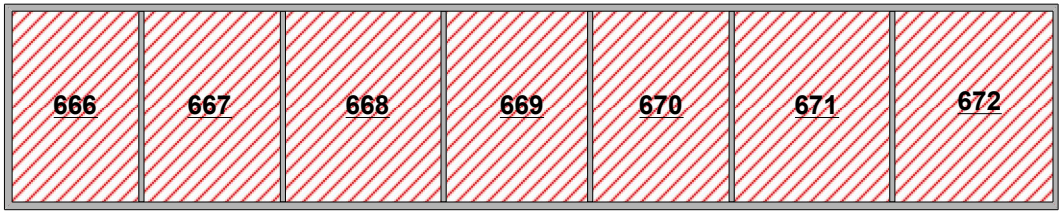
BJ001 S01 Cement	= To All Roofs For Garages 666-679
