**S I L V E R D E L L**

**Report For  
English Partnership**

**Type 2 Asbestos Survey  
Cane Hill Hospital  
Coulsden  
Surrey  
CU5**

| SILVERDELL PROJECT No: | Y3303 |

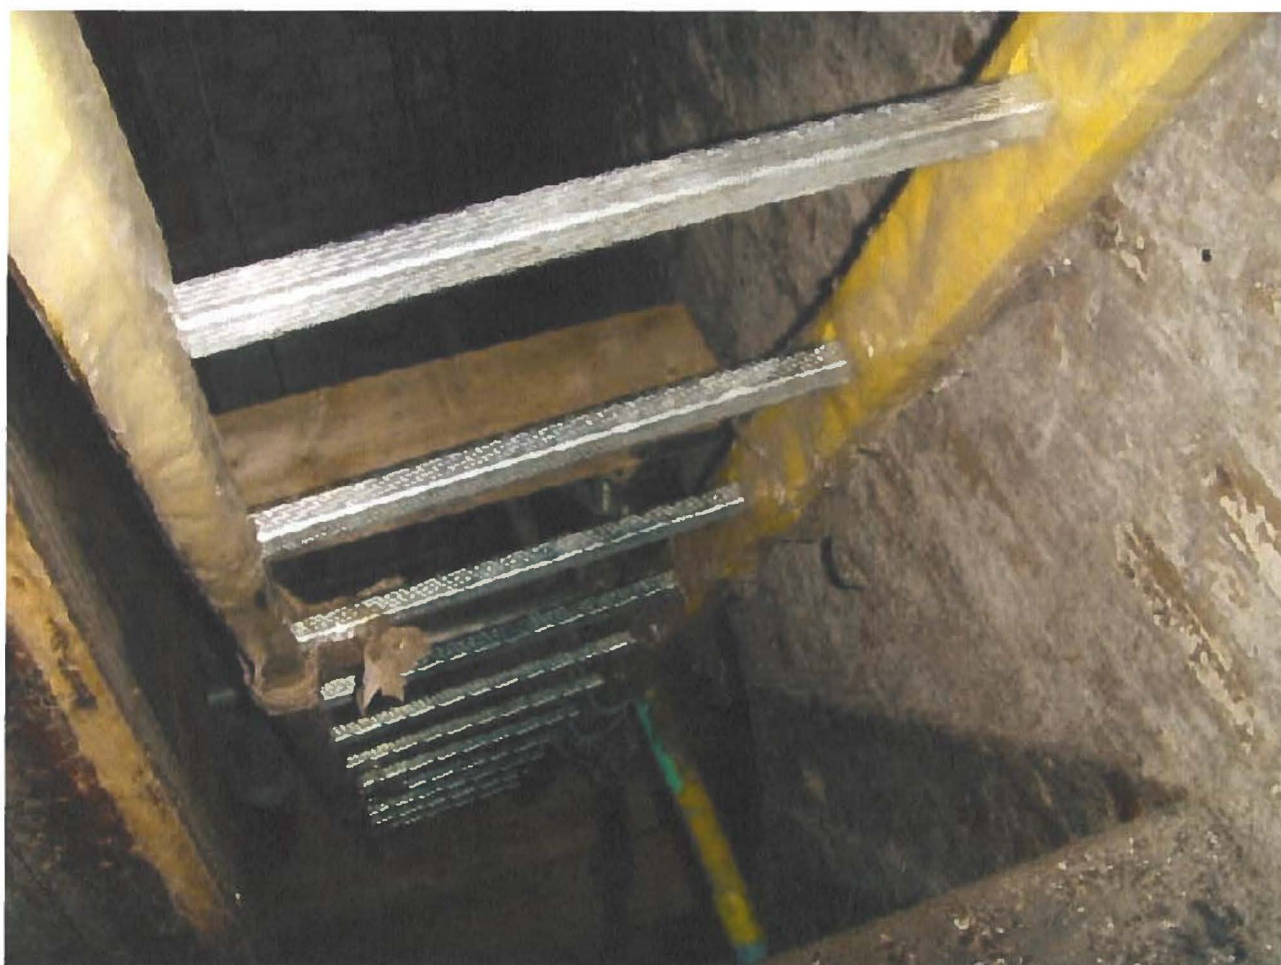
| Survey Type | - | Type 3 -<br>PreDemolition/Major<br>Refurbishment Survey | Photograph N°. | - | 040 |

| Asbestos Type | - | N/A | Damage Extent | - | N/A |
| Quantity | - | N/A | Hazard Rating | - | 0 |

| Comments: | - | N/A |

| Recommendations: | - | N/A |

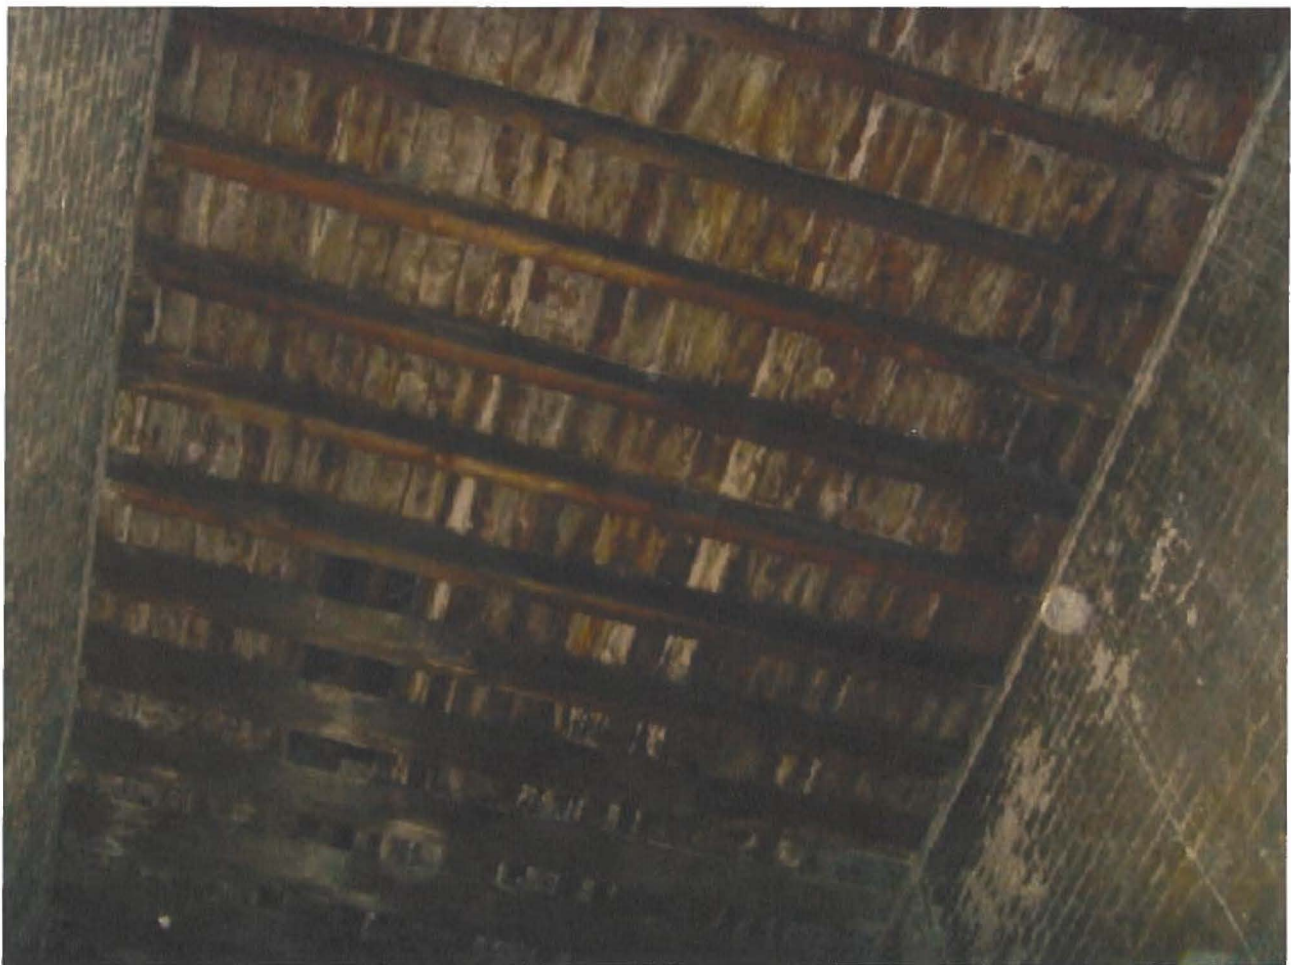
| Asbestos Type | - | N/A | Damage Extent | - | N/A |
| Quantity | - | N/A | Hazard Rating | - | 0 |

| Comments: | - | N/A |

| Recommendations: | - | N/A |

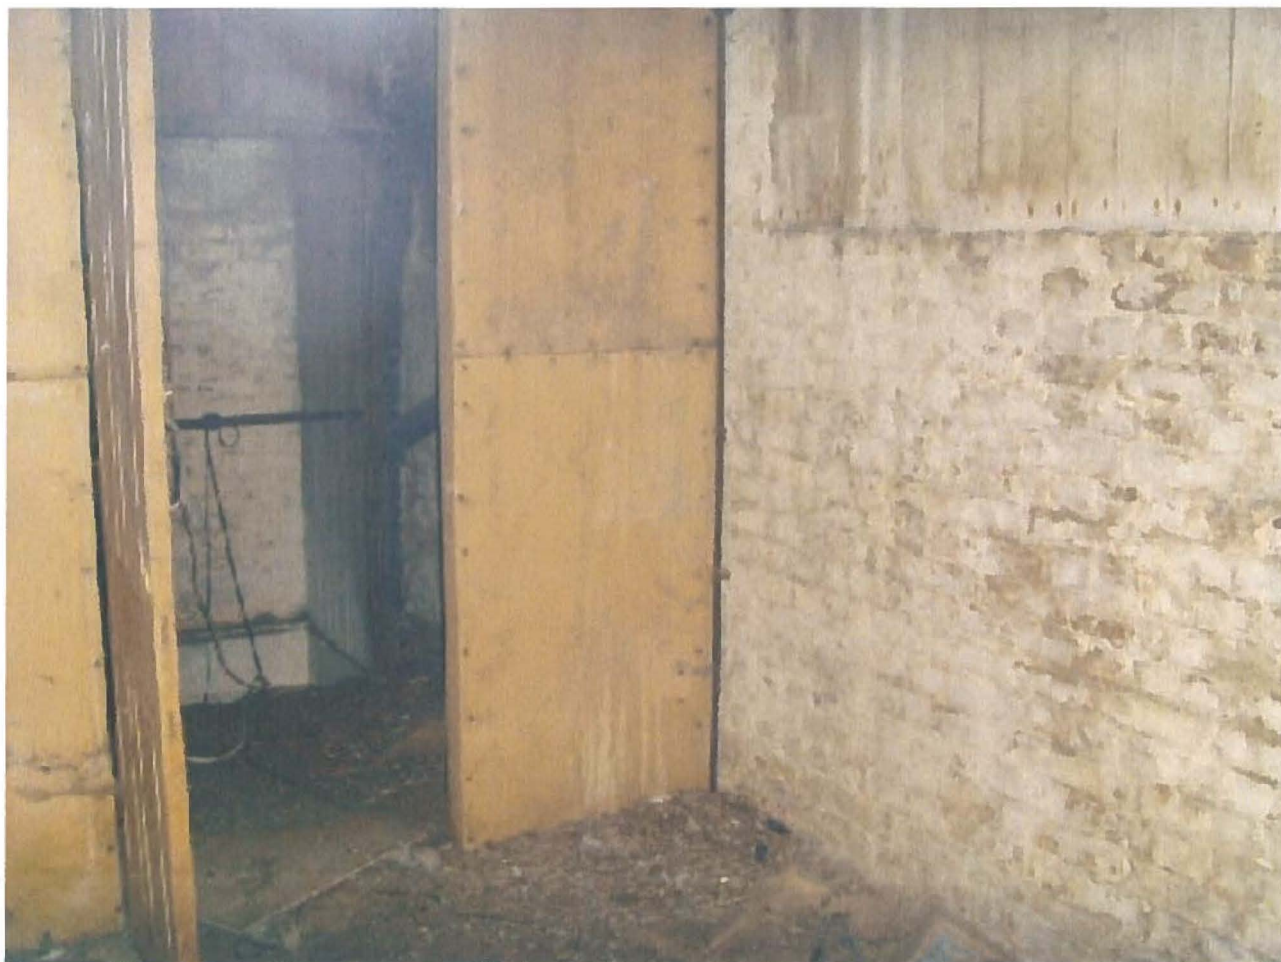
| Asbestos Type | - | N/A | Damage Extent | - | N/A |
| Quantity | - | N/A | Hazard Rating | - | 0 |

| Comments: | - | N/A |

| Recommendations: | - | N/A |
