**Report For  
English Partnership**

**Type 2 Asbestos Survey  
Cane Hill Hospital  
Coulsden  
Surrey  
CU5**

| SILVERDELL PROJECT No: | Y3303 |

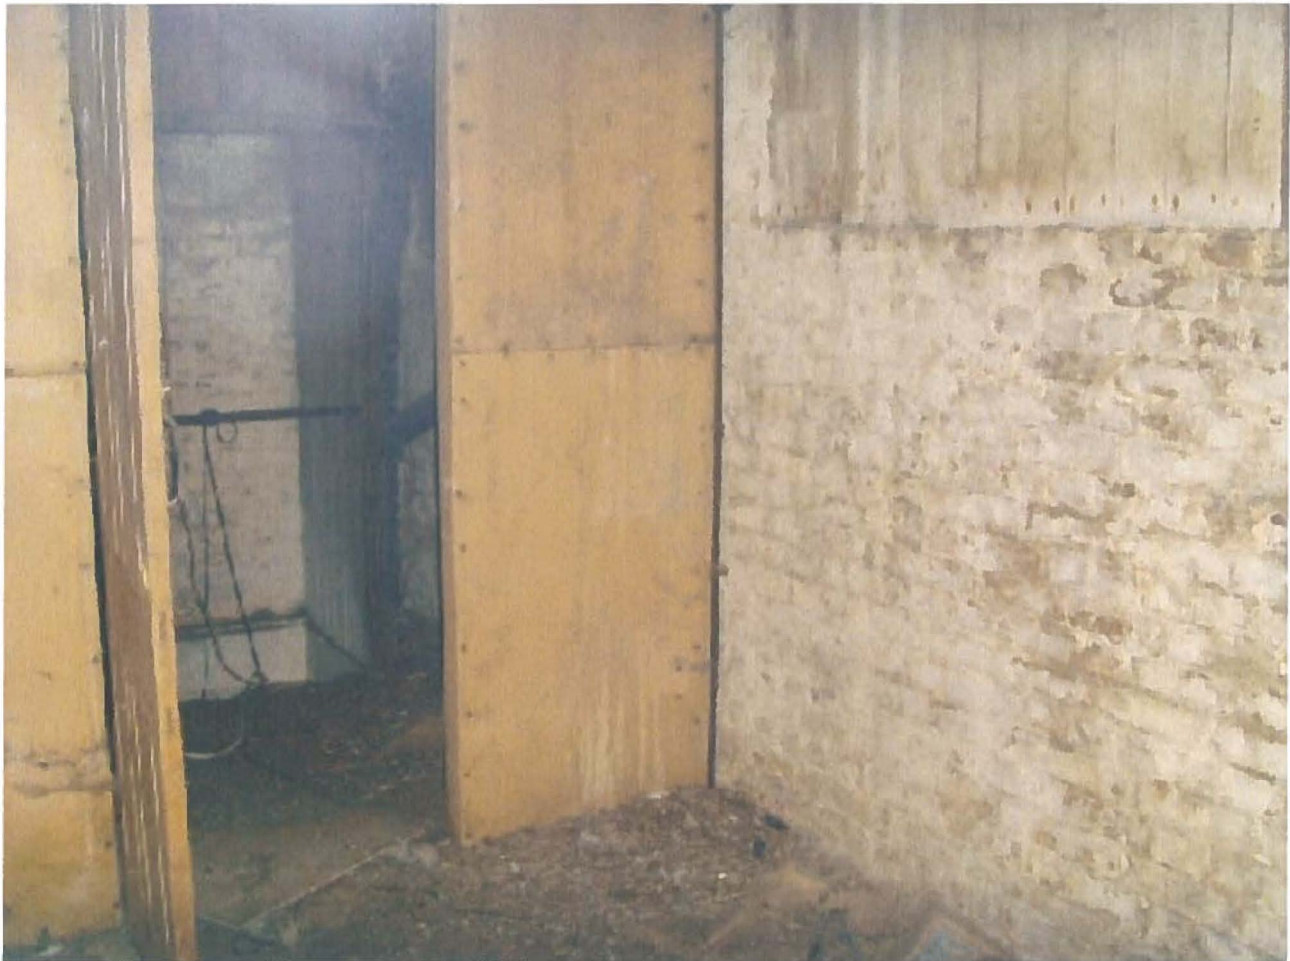
| Asbestos Type | - | N/A | Damage Extent | - | N/A |
| Quantity | - | N/A | Hazard Rating | - | 0 |

| Comments: | - | N/A |

| Recommendations: | - | N/A |
