# Outline Condition Survey Report

## CAPITA SYMONDS

### Cane Hill Hospital – Building 5

File No: CS/022329  
Date of Inspection: 2<sup>nd</sup> November 2006

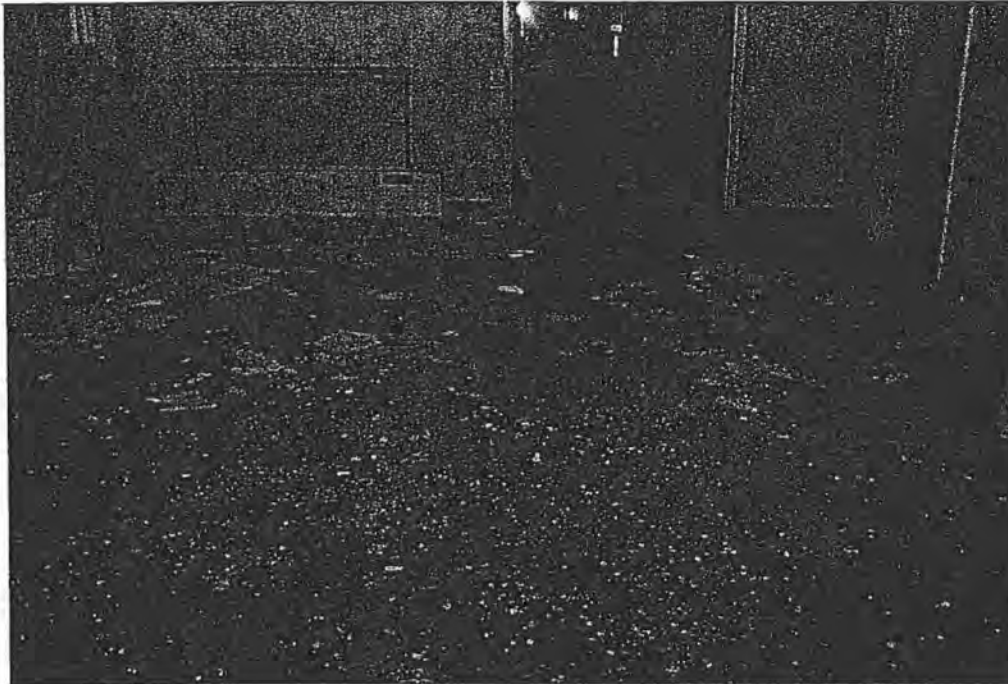
07 Second floor corridor- west end

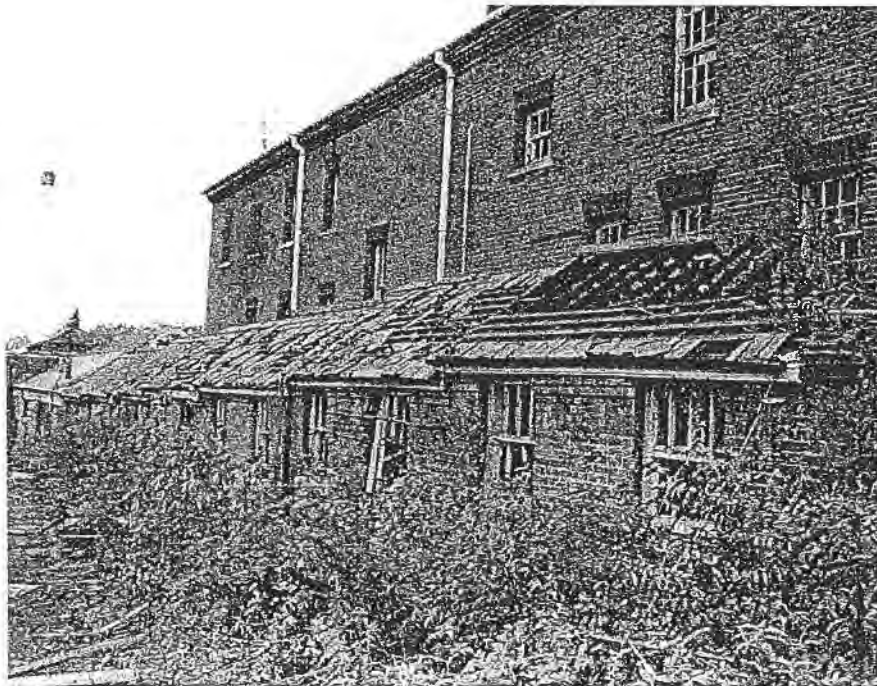
02 SW Elevation of 14A

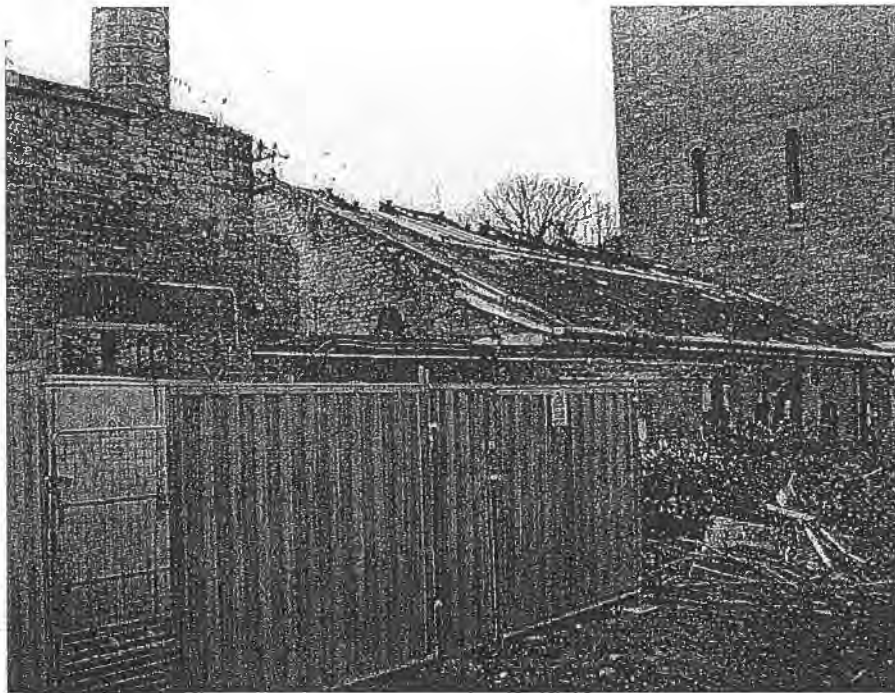
03 NE Elevation of 14B

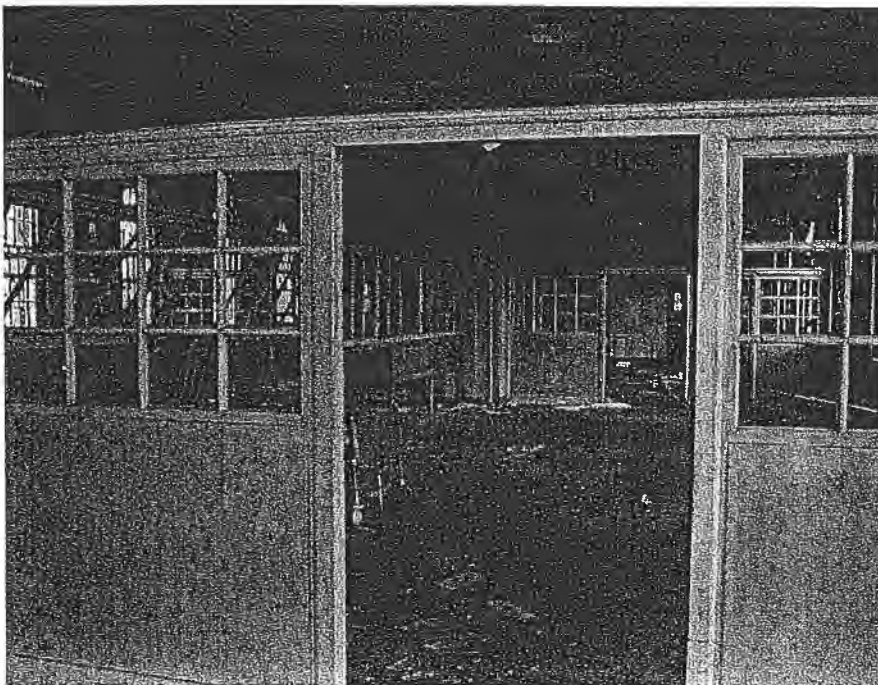
06 1st floor dormitory

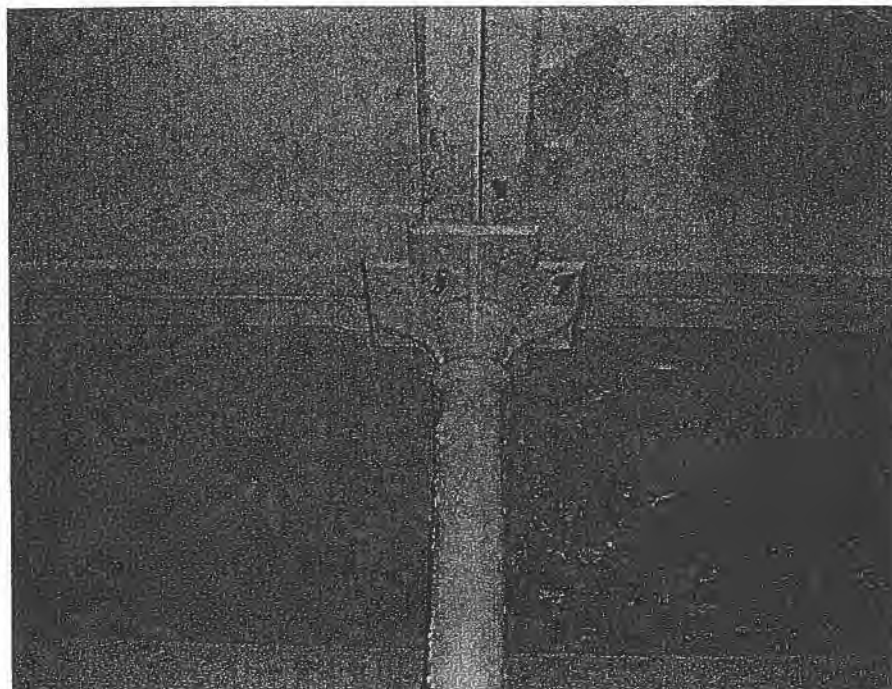
08 Head of structural steel column

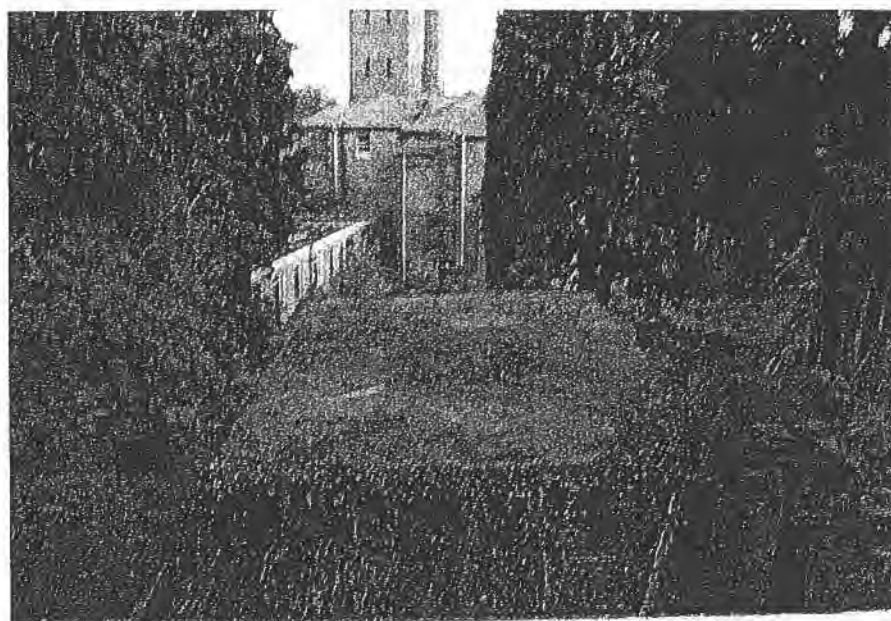
12 15B roof coverings

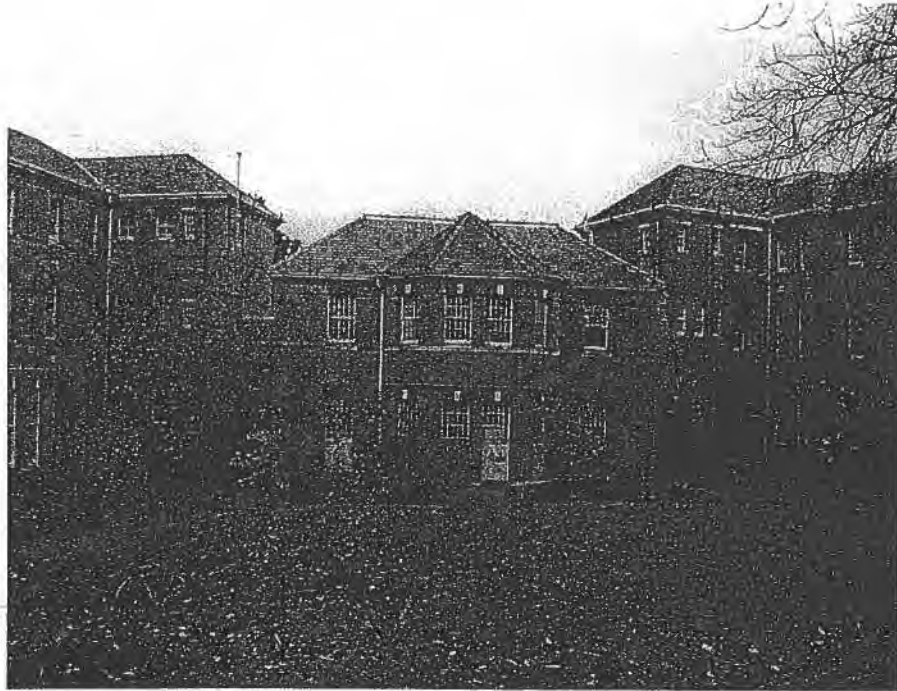
03 South elevation of 16B

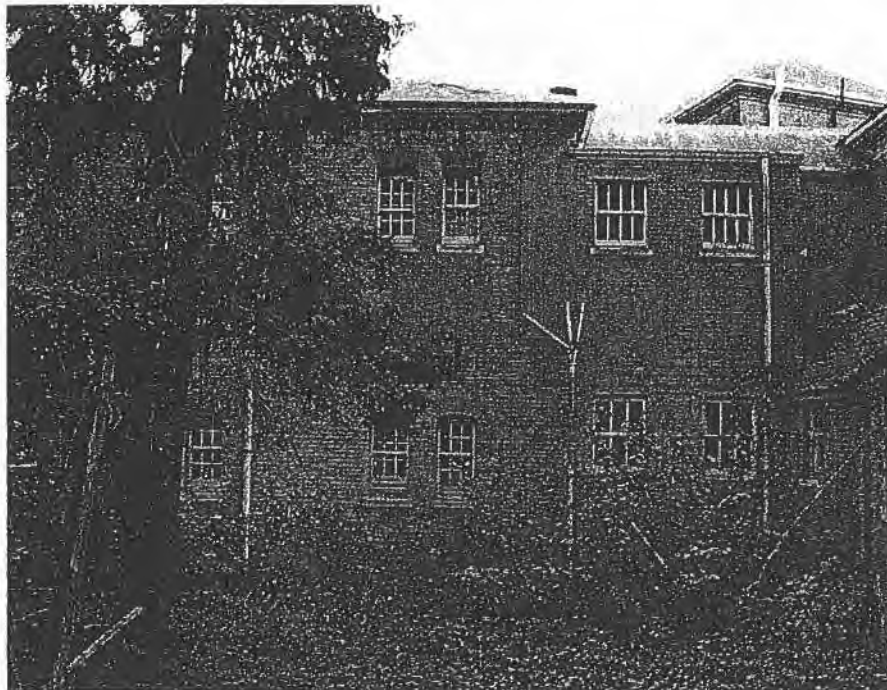
04 W. elevation of rear addition of 16B

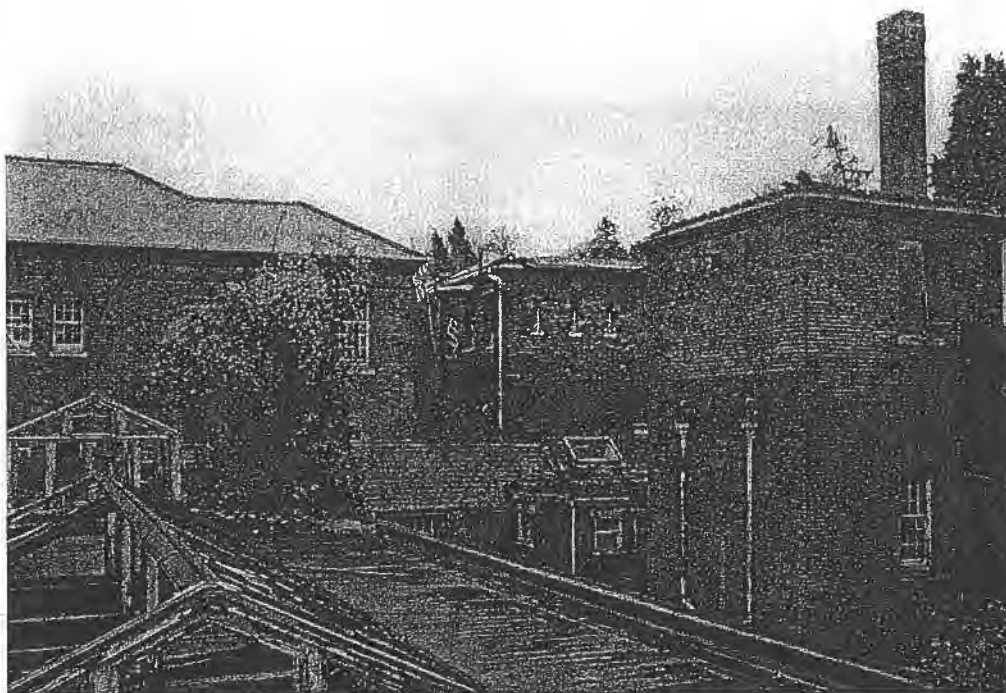
03 South elevation to west & east blocks

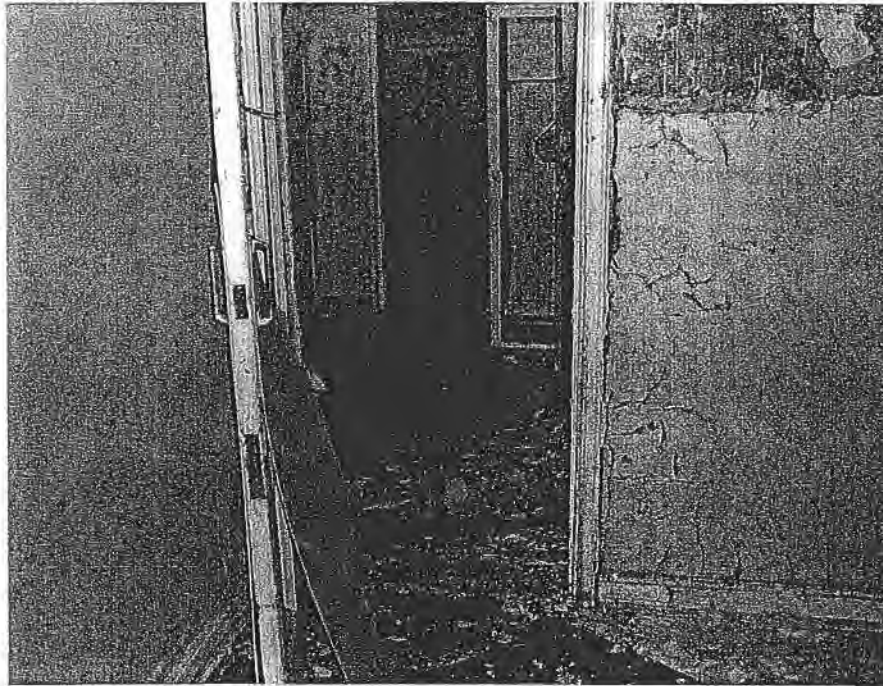
07. Collapsed timber floor

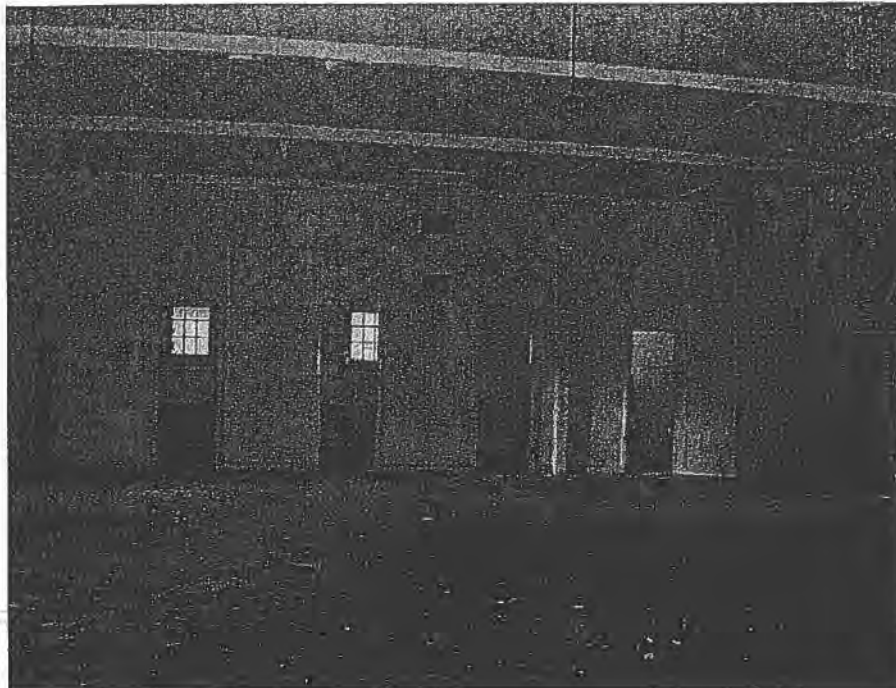
07 General condition of dormitories in 19A

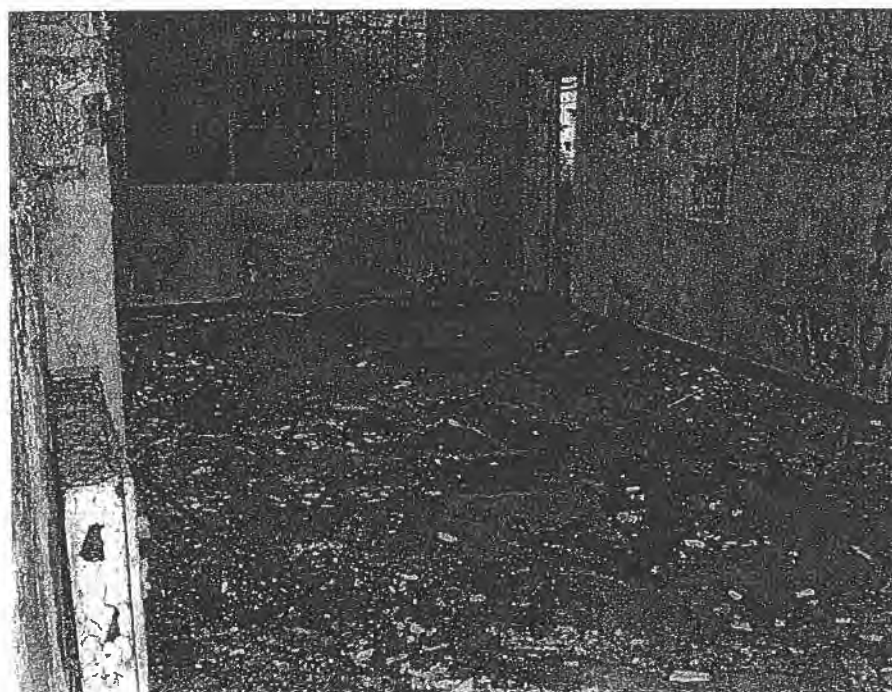
12 Condition of floor in parts of 19B
