17 November 2006

Outline Condition Survey Report  
Cane Hill Hospital – Building 24

## **Outline Condition Survey Report**

**English Partnerships**

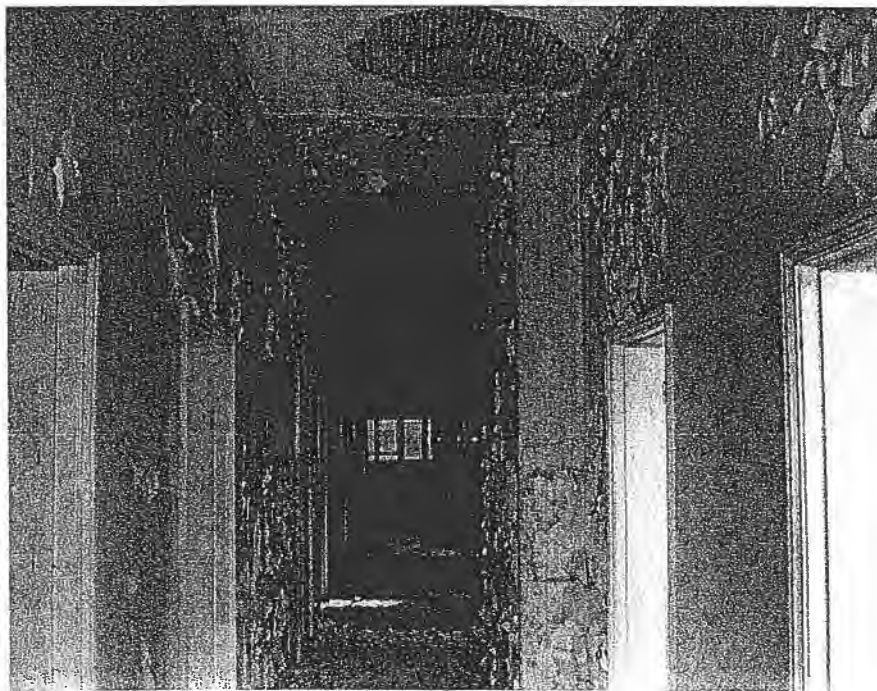
08 Second floor corridor - south end

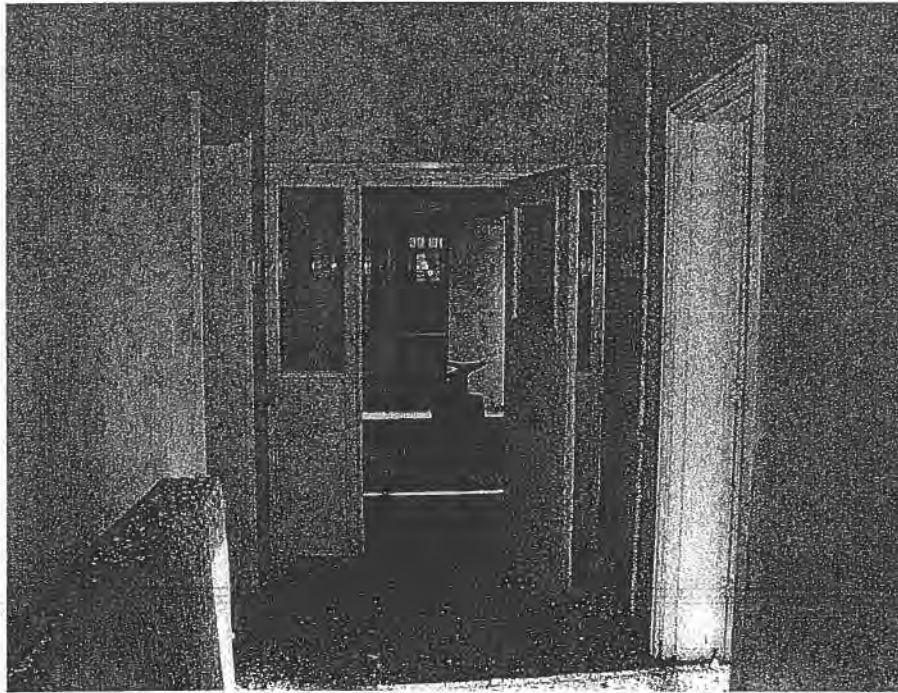
09 Second floor corridor - north end

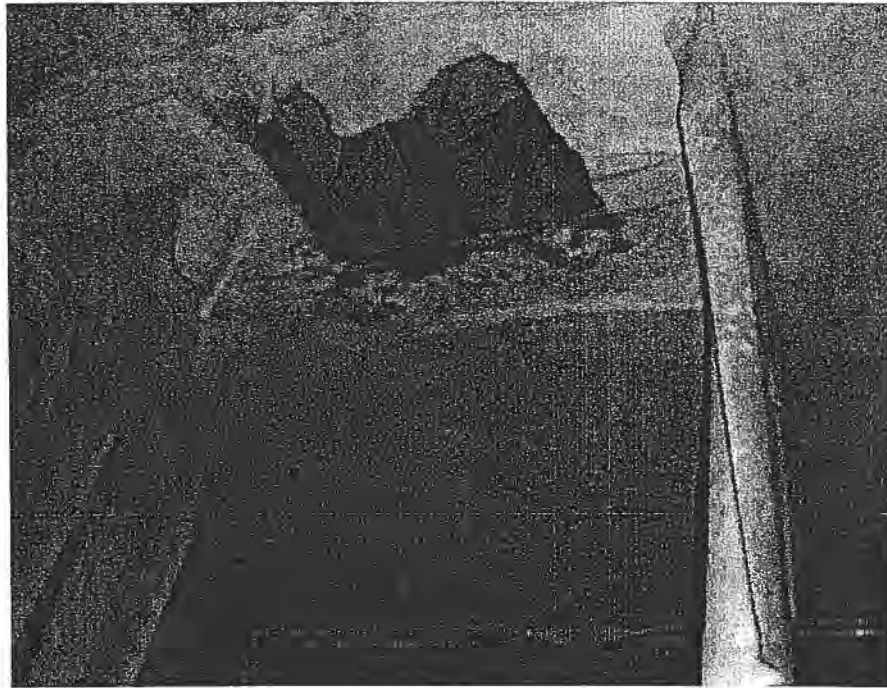
| | Element Description | Condition |
|--|---|---|
| | Internally<br>Ceilings to the habitable buildings of 6A & 6E and the link corridor are lath and plaster. | Generally, the ceilings to 6A & 6E are in poor condition. There are isolated areas of failure to the ceilings throughout these buildings caused by water ingress through the roof coverings. This has resulted in outbreaks of fungal decay to the ceiling structures and the |

05 Condition of ceiling of 6A

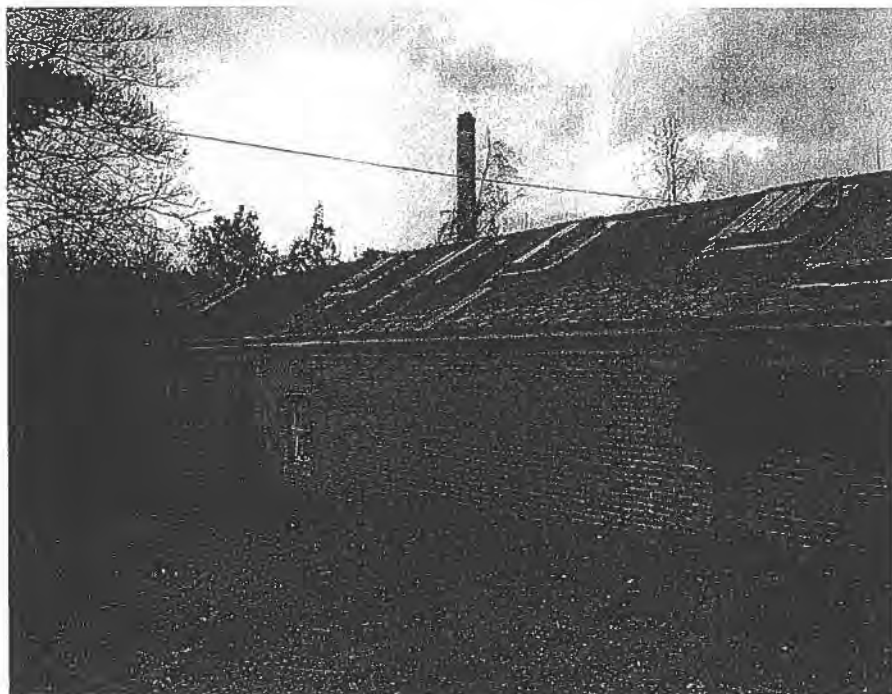
04 S elevation of 9C

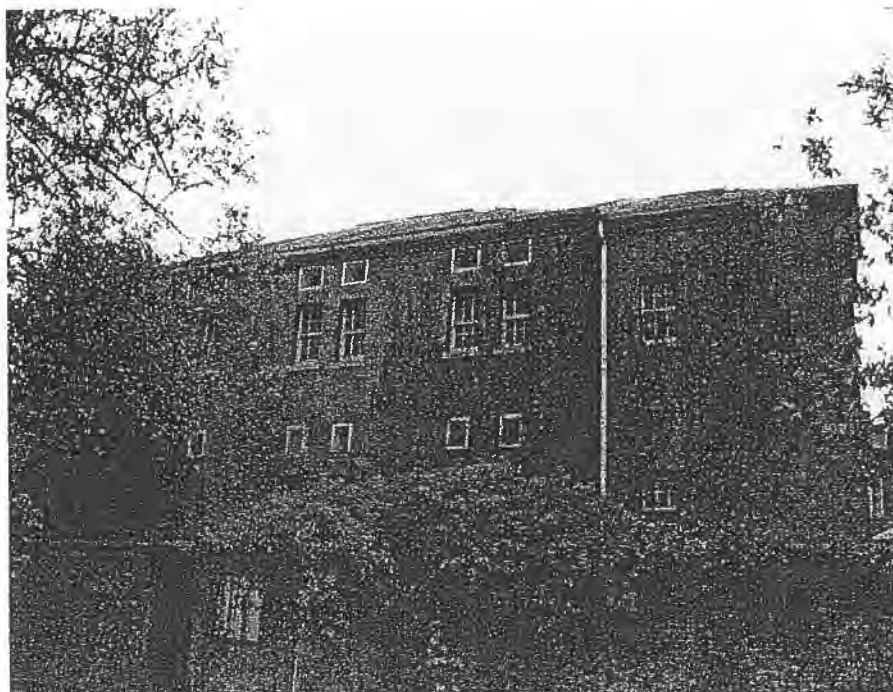
02 NW elevation and lean-to structure

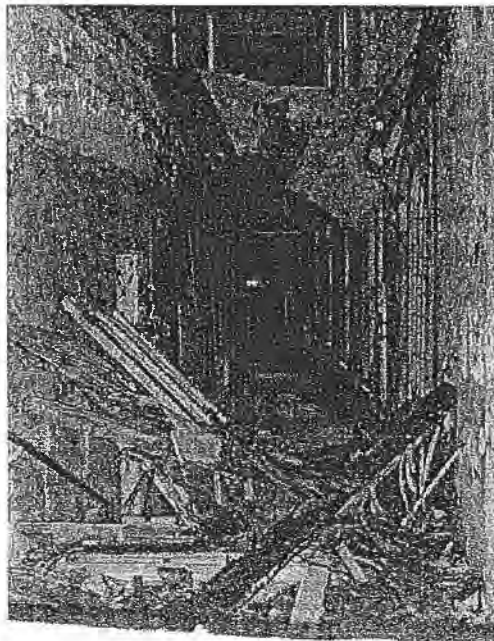
| BUILDING INSPECTION | |
|---|---|
| 4. | Collapse of upper floor due to water ingress |

04 Collapsed upper floor due to water ingress

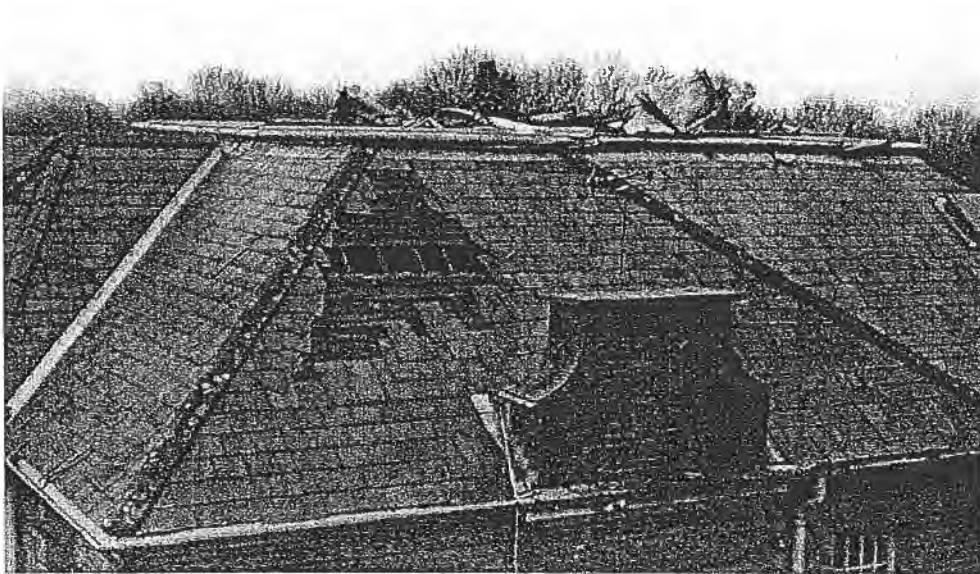
02. Vandalism to roof coverings
