TYPE 3  
SURVEY, ASSESSMENT AND REGISTER OF  
ASBESTOS CONTAINING MATERIALS  
AT  
CANE HILL, COULSDON  
SURREY, CR5 3ES

*Report No. 06/B/8026*

*September 2006*

**Strategic Risk Management  
P.O. Box 167, Sandbach  
Cheshire, CW11 3WG**

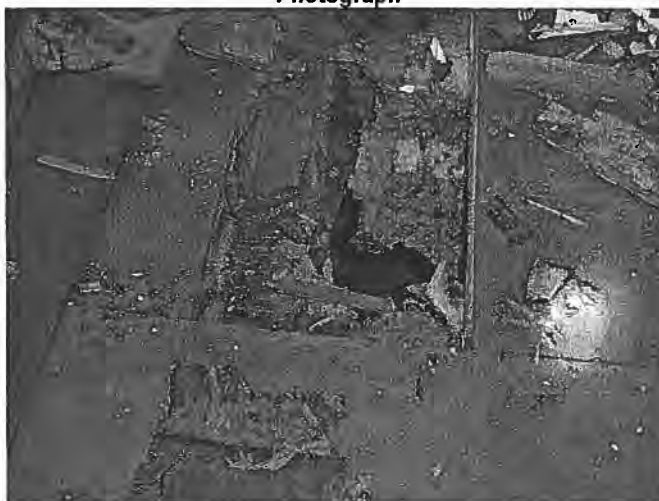
| <b>Location of Survey</b><br>Cane Hill Hospital,<br>Cane Hill,<br>Coulston, Surrey,<br>CR5 3ES | | <b>Position of Sample/Photo</b><br>Reception Block, 1 <sup>st</sup> Room,<br>Ground Floor, Male Side, Fire<br>Heating Element | <b>Asbestos</b><br><br><b>Type</b> | <b>No Asbestos<br/>Detected</b><br><br>N/A |
| <b>Material<br/>Type</b> | Board | <b>Quantity</b> | 0.5m <sup>2</sup> | <b>Sample No</b> 06/B/8026/3<br><br><b>Survey Date</b> 24.04 - 29.06.06<br><br><b>Date of Report</b> 18.08.06<br><br><b>Surveyor(s)</b> <span style="background-color: black; color: black;">[REDACTED]</span> |

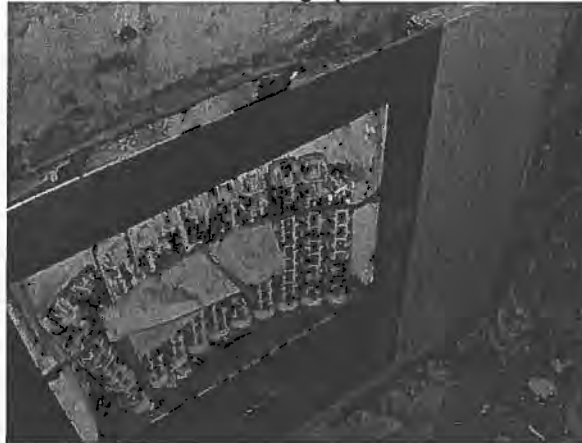
| <b>Location of Survey</b><br>Cane Hill Hospital,<br>Cane Hill,<br>Coulsdon, Surrey,<br>CR5 3ES | | <b>Position of Sample/Photo</b><br>1 <sup>st</sup> Room , Male Side, Through<br>To Reception Entrance, Panel<br>Above Door | <b>Asbestos</b><br><br><b>Type</b> | <b>No Asbestos<br/>Detected</b><br><br>N/A |

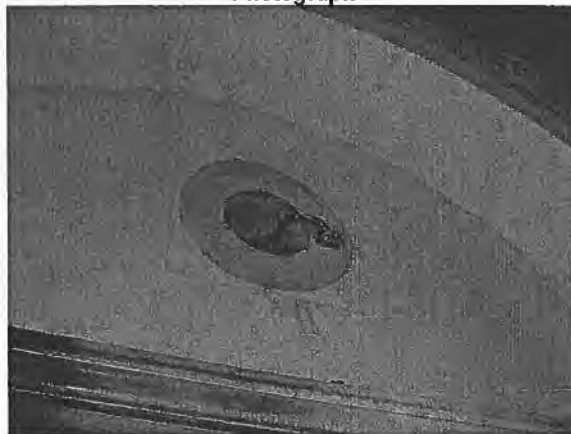
| <b>Location of Survey</b><br>Cane Hill Hospital,<br>Cane Hill,<br>Coulson, Surrey,<br>CR5 3ES | | <b>Position of Sample/Photo</b><br>Reception Block, Male side<br>W.C, Shires Lynx type Cistern<br>(x5) | <b>Asbestos</b> Yes<br><br><b>Type</b> Amosite (Brown) |
| <b>Material Type</b> Plastic | <b>Quantity</b> 1m <sup>2</sup><br>(x2 on Grd)<br>(x1 on<br>Basement, 1 <sup>st</sup><br>& 2 <sup>nd</sup> floors) | <b>Sample No</b> 06/B/8026/5<br><br><b>Survey Date</b> 24.04 - 29.06.06<br><br><b>Date of Report</b> 18.08.06<br><br><b>Surveyor(s)</b> [REDACTED] | |

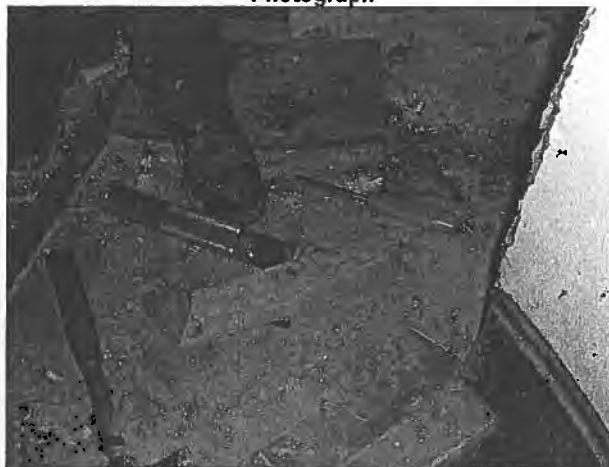
| <b>Location of Survey</b><br>Cane Hill Hospital,<br>Cane Hill,<br>Coulsdon, Surrey,<br>CR5 3ES | <b>Position of Sample/Photo</b><br>Reception Block, Stairs, Red<br>Stair Nosing (18 steps) | <b>Asbestos</b><br><br><b>No Asbestos Detected</b><br><br><b>Type</b> N/A |
| <b>Material Type</b> Vinyl | <b>Quantity</b> 2m <sup>2</sup> | <b>Sample No</b> 06/B/8026/8<br><br><b>Survey Date</b> 24.04 - 29.06.06<br><br><b>Date of Report</b> 18.08.06<br><br><b>Surveyor(s)</b> <span style="background-color: black; color: black;">[REDACTED]</span> |

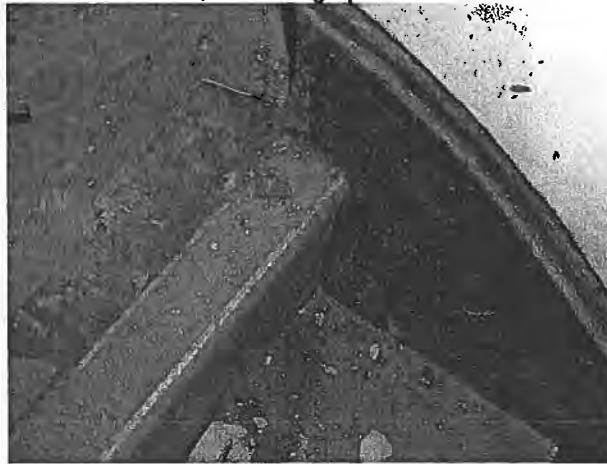
| <b>Location of Survey</b><br><br>Cane Hill Hospital,<br>Cane Hill,<br>Coulsdon, Surrey,<br>CR5 3ES | <b>Position of Sample/Photo</b><br><br>Reception Block, Male Side,<br>Basement, Flash Pad<br>(Strongly Presumed<br>throughout to all electrics) | <b>Asbestos</b> Yes<br><br><b>Type</b> Chrysotile (White) |
| <b>Material Type</b> Rope | <b>Quantity</b> <1m <sup>2</sup> | <b>Sample No</b> 06/B/8026/9<br><br><b>Survey Date</b> 24.04 - 29.06.06<br><br><b>Date of Report</b> 18.08.06<br><br><b>Surveyor(s)</b> <span style="background-color: black; color: black;">[REDACTED]</span> |

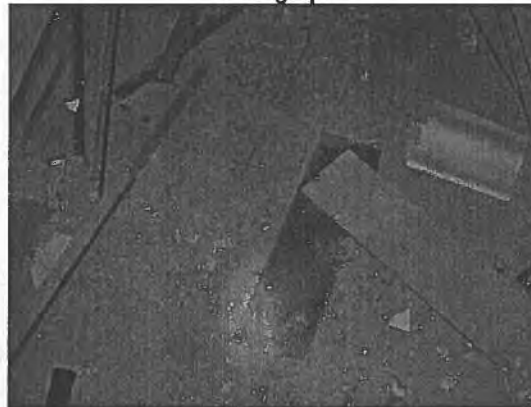
| <b>Location of Survey</b><br>Cane Hill Hospital,<br>Cane Hill,<br>Coulsdon, Surrey,<br>CR5 3ES | <b>Position of Sample/Photo</b><br>Reception Building<br>Second Floor<br>Front Office<br>Panel beneath heater | <b>Asbestos</b> Yes<br><br><b>Type</b> Amosite (Brown)<br>Chrysotile (White) |
| <b>Material Type</b> Board | <b>Quantity</b> 1m <sup>2</sup> | <b>Sample No</b> 06/B/8026/14<br><br><b>Survey Date</b> 24.04 - 29.06.06<br><br><b>Date of Report</b> 18.08.06<br><br><b>Surveyor(s)</b> <span style="background-color: black; color: black;">[REDACTED]</span> |

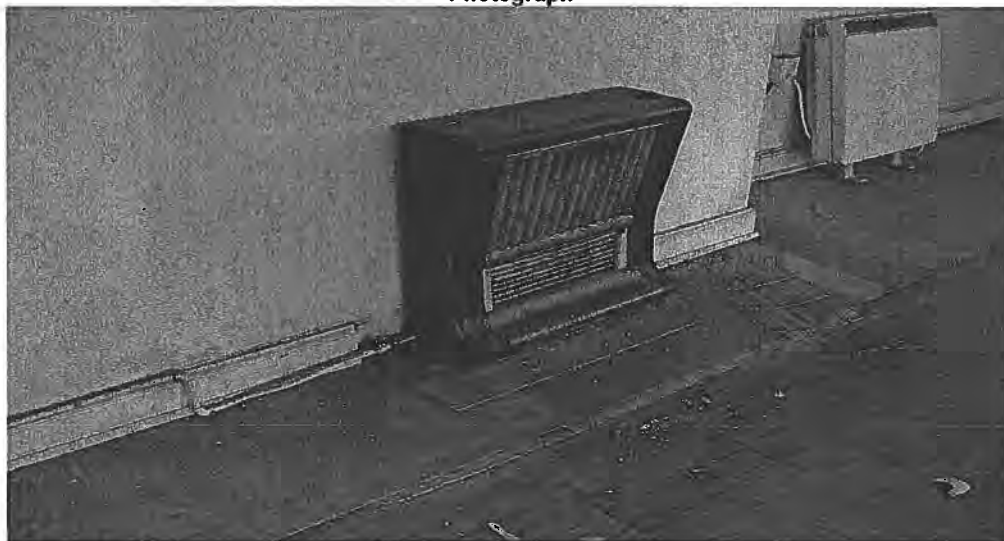
| <b>Location of Survey</b><br>Cane Hill Hospital,<br>Cane Hill,<br>Coulston, Surrey,<br>CR5 3ES | | <b>Position of Sample/Photo</b><br>Reception Building<br>Second Floor<br>Rear Office<br>Panel beneath heater | | <b>Asbestos</b><br><br><b>Type</b> | Yes, Strongly<br>Presumed<br><br>Amosite (Brown)<br>Chrysotile (White) |

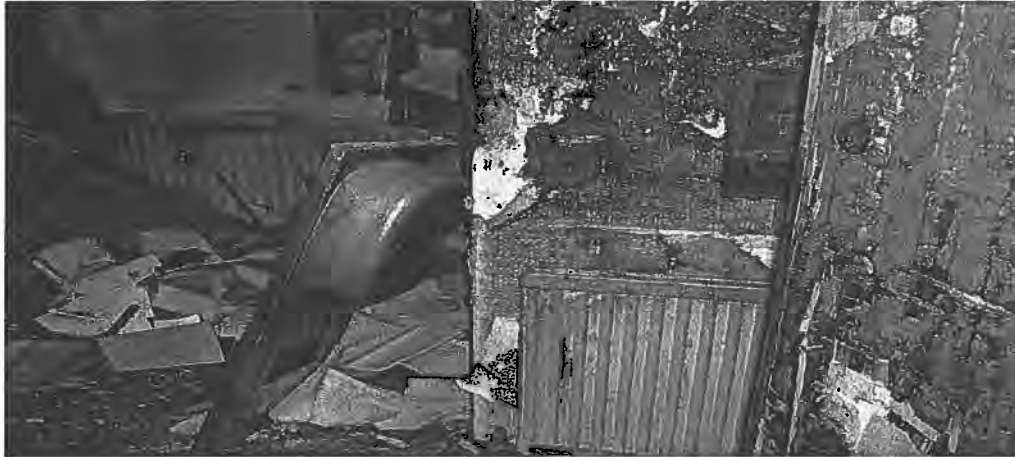
| <b>Location of Survey</b><br>Cane Hill Hospital,<br>Cane Hill,<br>Coulston, Surrey,<br>CR5 3ES | <b>Position of Sample/Photo</b><br>Reception Building<br>Ground Floor Office adjacent<br>stairs to basement<br>Panel behind radiator | <b>Asbestos</b> Yes<br><br><b>Type</b> Chrysotile (White) |
| <b>Material Type</b> Cement | <b>Quantity</b> 2m <sup>2</sup> | <b>Sample No</b> 06/B/8026/19<br><br><b>Survey Date</b> 24.04 - 29.06.06<br><br><b>Date of Report</b> 18.08.06<br><b>Surveyor(s)</b> <span style="background-color: black; color: black;">[REDACTED]</span> |

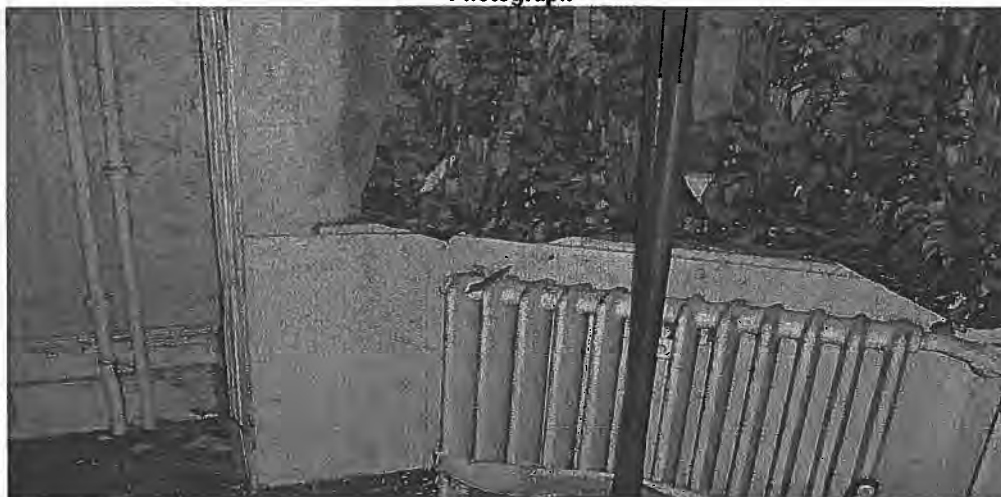
| <b>Location of Survey</b><br>Cane Hill Hospital,<br>Cane Hill,<br>Coulsdon, Surrey,<br>CR5 3ES | <b>Position of Sample/Photo</b><br>Reception Building,<br>Female side,<br>Basement<br>Fireplace panel | <b>Asbestos</b> Yes<br><br><b>Type</b> Chrysotile (White) |
| <b>Material Type</b> Cement | <b>Quantity</b> 2m <sup>2</sup> | <b>Sample No</b> 06/B/8026/20<br><br><b>Survey Date</b> 24.04 - 29.06.06<br><br><b>Date of Report</b> 18.08.06<br><br><b>Surveyor(s)</b> <span style="background-color: black; color: black;">[REDACTED]</span> |

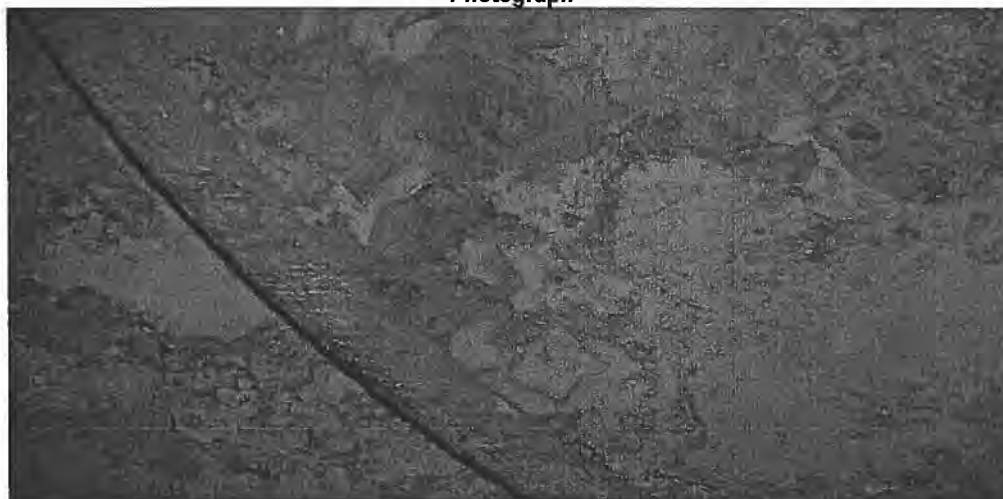
| <b>Location of Survey</b><br>Cane Hill Hospital,<br>Cane Hill,<br>Coulsdon, Surrey,<br>CR5 3ES | <b>Position of Sample/Photo</b><br>Reception Building,<br>Female side, Basement<br>Electrics<br>Rope Seal | <b>Asbestos</b> Yes<br><br><b>Type</b> Chrysotile (White) |
| <b>Material Type</b> Rope | <b>Quantity</b> 1m | <b>Sample No</b> 06/B/8026/22<br><br><b>Survey Date</b> 24.04 - 29.06.06<br><br><b>Date of Report</b> 18.08.06<br><br><b>Surveyor(s)</b> <span style="background-color: black; color: black;">[REDACTED]</span> |

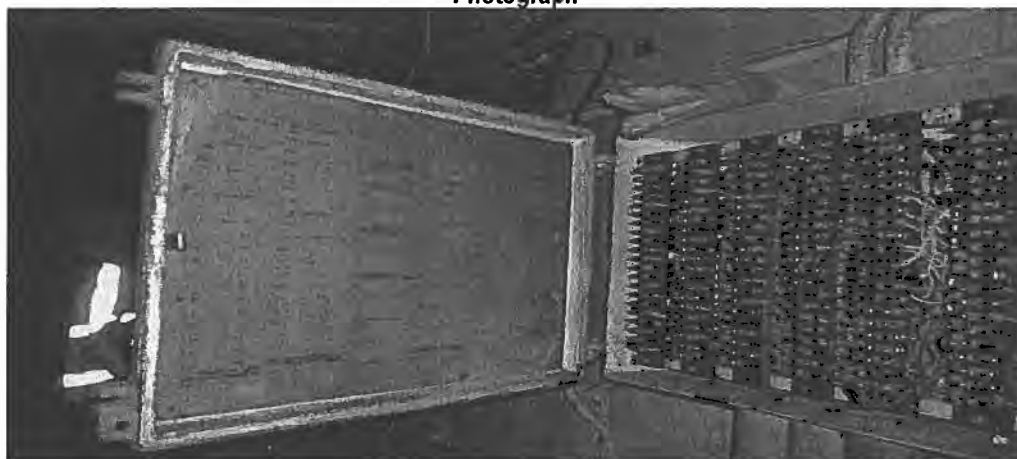
| <b>Location of Survey</b><br>Cane Hill Hospital,<br>Cane Hill,<br>Coulsdon, Surrey,<br>CR5 3ES | <b>Position of Sample/Photo</b><br>Reception Building<br>Female Side, First Floor<br>WC Boxing | <b>Asbestos</b><br><br><b>Type</b> | Yes, Strongly<br>Presumed<br><br>Chrysotile (White) |

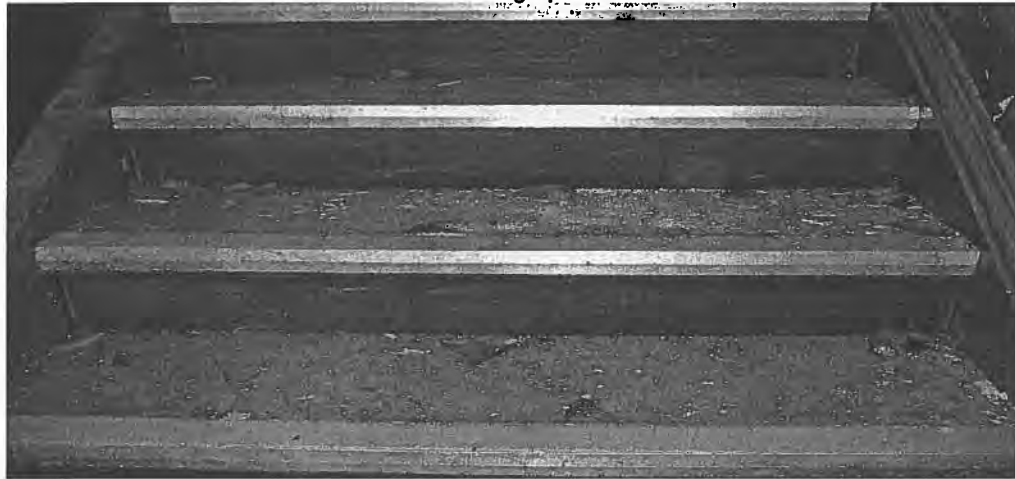
| <b>Location of Survey</b><br>Cane Hill Hospital,<br>Cane Hill,<br>Coulston, Surrey,<br>CR5 3ES | | <b>Position of Sample/Photo</b><br>Reception Building<br>Female Side,<br>White Stair Nosing | | <b>Asbestos</b> | <b>No Asbestos<br/>Detected</b> |

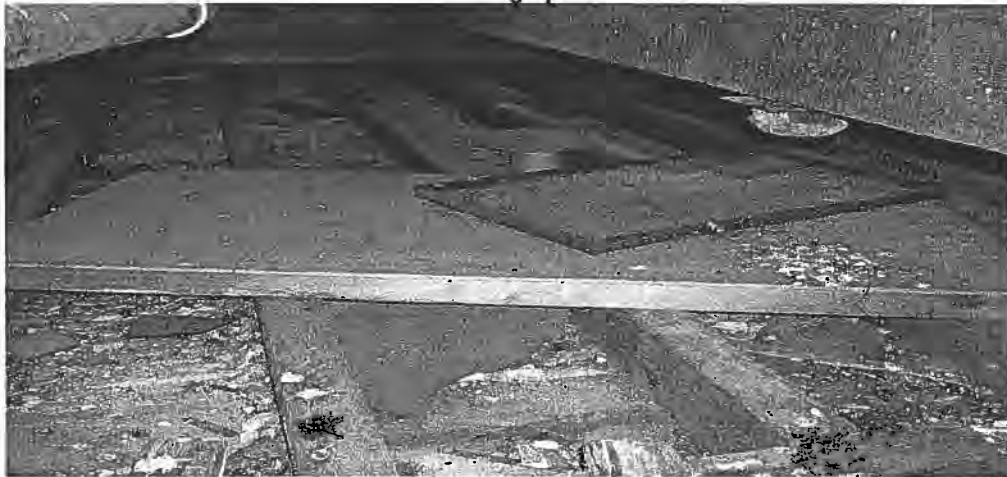
| <b>Location of Survey</b><br>Cane Hill Hospital,<br>Cane Hill,<br>Coulsdon, Surrey,<br>CR5 3ES | | <b>Position of Sample/Photo</b><br>Reception Building<br>Corridor adjacent Reception<br>Beige Floor Tile & Bitumen | | <b>Asbestos</b> Yes | |

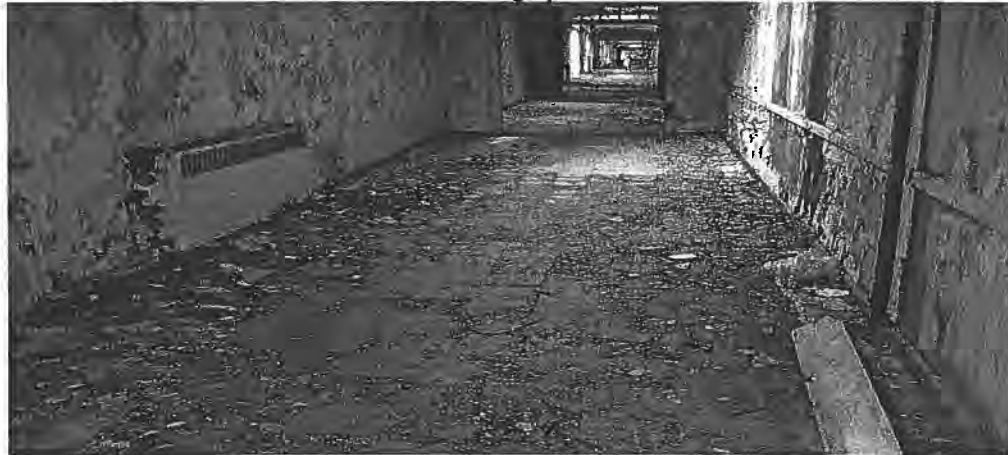
| <b>Location of Survey</b><br><br>Cane Hill Hospital,<br>Cane Hill,<br>Coulsdon, Surrey,<br>CR5 3ES | <b>Position of Sample/Photo</b><br><br>Reception Building<br>Corridor adjacent Reception<br>Red Floor Tile & Bitumen | <b>Asbestos</b> Yes<br><br><b>Type</b> Chrysotile (White) |
| <b>Material Type</b> Vinyl &<br>Bitumen | <b>Quantity</b> 60 <sup>2</sup> | <b>Sample No</b> 06/B/8026/30<br><br><b>Survey Date</b> 24.04 - 29.06.06<br><br><b>Date of Report</b> 18.08.06<br><br><b>Surveyor(s)</b> <span style="background-color: black; color: black;">[REDACTED]</span> |

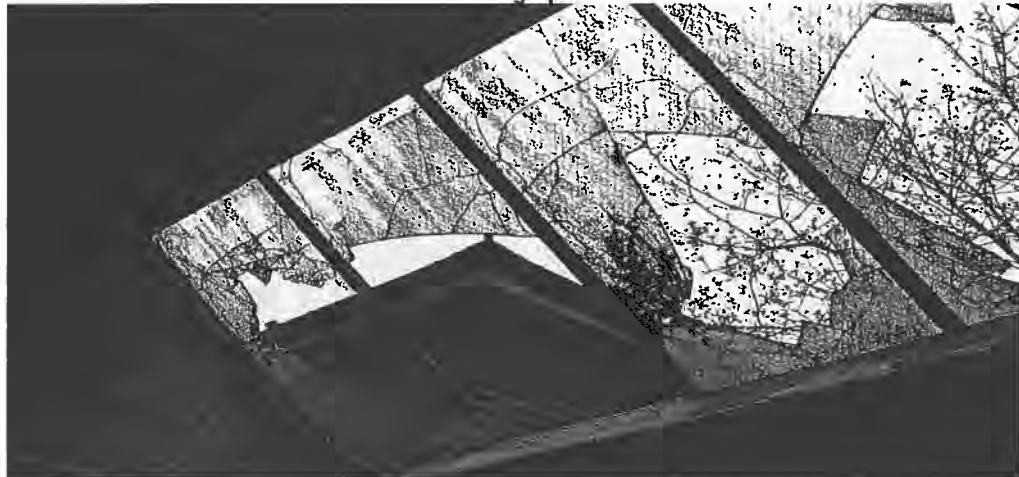
| <b>Location of Survey</b><br>Cane Hill Hospital,<br>Cane Hill,<br>Coulston, Surrey,<br>CR5 3ES | | <b>Position of Sample/Photo</b><br>Reception Building<br>Main Corridor skylight (X2)<br>Rope seals | | <b>Asbestos</b><br><br><b>Type</b> | Yes<br><br>Chrysotile (White) |

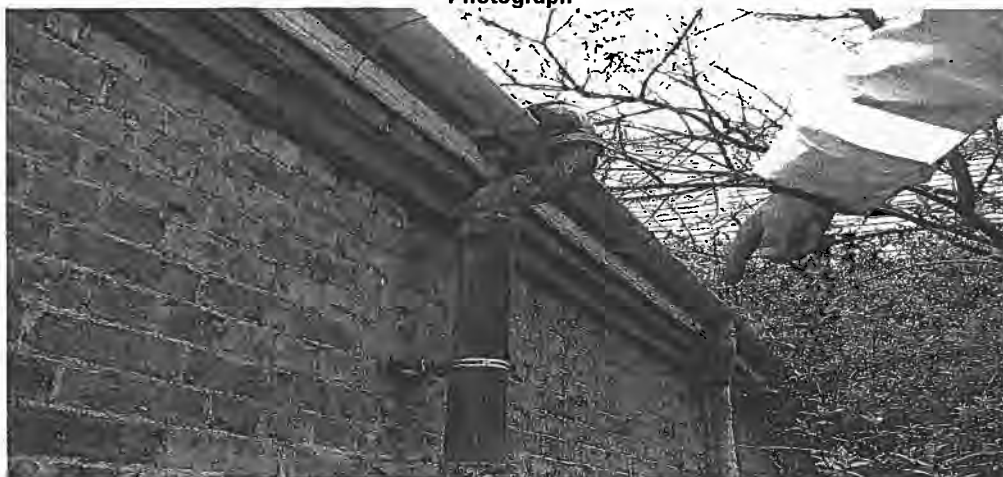
| <b>Location of Survey</b><br>Cane Hill Hospital,<br>Cane Hill,<br>Coulson, Surrey,<br>CR5 3ES | | <b>Position of Sample/Photo</b><br>Reception Building<br>W.C adjacent corridor<br>External Flue Pipe | | <b>Asbestos</b> | Yes, Strongly<br>Presumed |

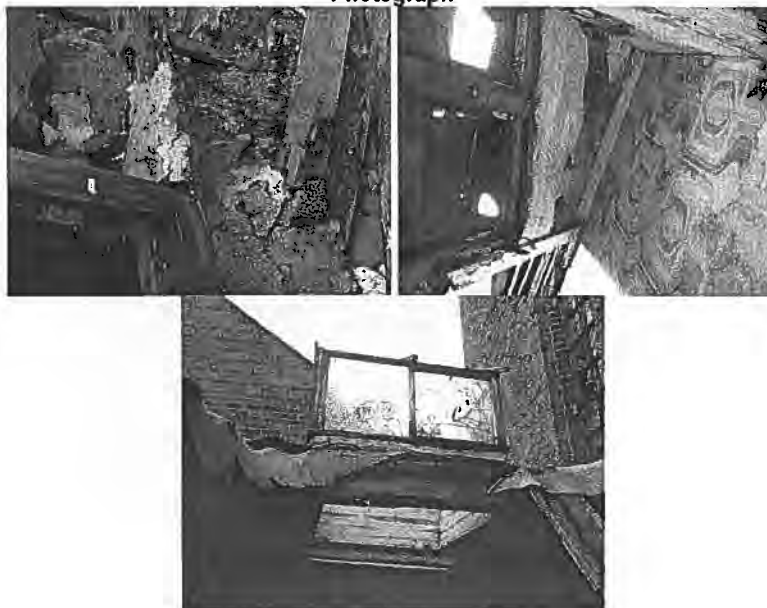
| <b>Location of Survey</b><br>Cane Hill Hospital,<br>Cane Hill,<br>Coulston, Surrey,<br>CR5 3ES | | <b>Position of Sample/Photo</b><br>Hall/Chapel Area<br>Fibre Board Paper Lining In<br>Small Room Between Chapel<br>And LHS Adj Corridor (debris<br>throughout on floor) | <b>Asbestos</b> Yes |

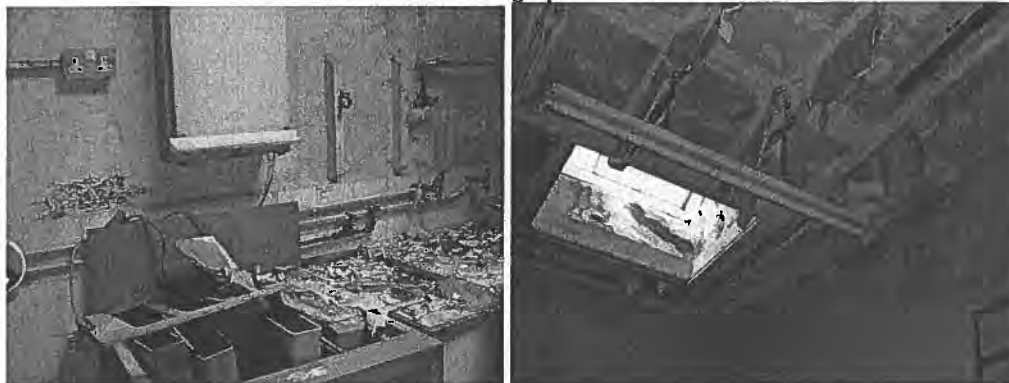
| <b>Location of Survey</b><br>Cane Hill Hospital,<br>Cane Hill,<br>Coulsdon, Surrey,<br>CR5 3ES | | <b>Position of Sample/Photo</b><br>Hall/Chapel Area, Fibre Board<br>Ceiling Paper Lining In<br>X-Ray room LHS Adj<br>Corridor and debris | | <b>Asbestos</b><br><br><b>Type</b> | Yes, Strongly<br>presumed<br><br>Chrysotile (White) |

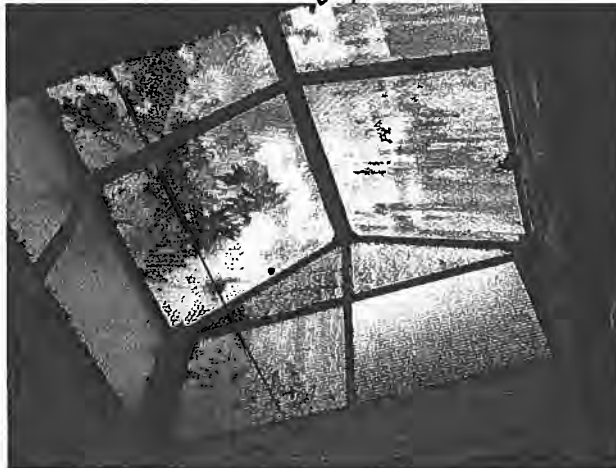
| <b>Location of Survey</b><br>Cane Hill Hospital,<br>Cane Hill,<br>Coulston, Surrey,<br>CR5 3ES | | <b>Position of Sample/Photo</b><br>Hall/Chapel Area<br>X-Ray LHS Adj Corridor –<br>Rope seals to skylights | | <b>Asbestos</b><br><br><b>Type</b> | Yes, Strongly<br>presumed<br><br>Chrysotile (White) |
| <b>Material Type</b><br>Rope | | <b>Quantity</b><br>Approx 48 l/m | | <b>Sample No</b><br><br><b>Survey Date</b><br><br><b>Date of Report</b><br><br><b>Surveyor(s)</b> | As 06/B/8026/31<br>24.04 - 29.06.06<br>18.08.06<br> |

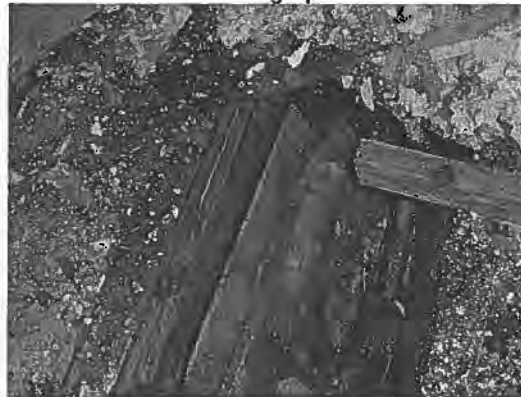
| <b>Location of Survey</b><br>Cane Hill Hospital,<br>Cane Hill,<br>Coulsdon, Surrey,<br>CR5 3ES | <b>Position of Sample/Photo</b><br>Hall/Chapel Area,<br>2 <sup>nd</sup> Room, Cement Sheet In<br>Floor Duct With Solid Floor Adj<br>Left Hand Side Of Corridor<br>(Lending Library) | <b>Asbestos</b> Yes<br><br><b>Type</b> Chrysotile (White) | |
| <b>Material Type</b> Cement | <b>Quantity</b> 15m <sup>2</sup> | <b>Sample No</b> 06/B/8026/34<br><br><b>Survey Date</b> 24.04 - 29.06.06<br><br><b>Date of Report</b> 18.08.06<br><br><b>Surveyor(s)</b> <span style="background-color: black; color: black;">[REDACTED]</span> | |

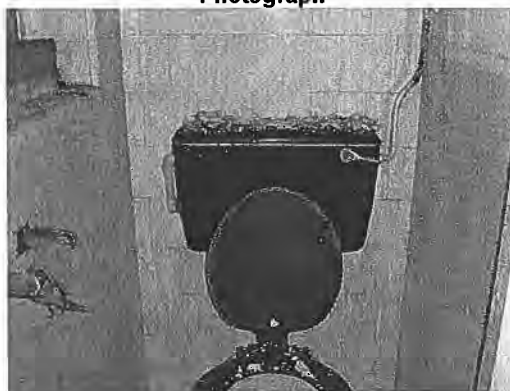
| <b>Location of Survey</b><br>Cane Hill Hospital,<br>Cane Hill,<br>Coulsdon, Surrey,<br>CR5 3ES | | <b>Position of Sample/Photo</b><br>Hall/Chapel Area,<br>2 <sup>nd</sup> Room next to Hall, Shires<br>lynx WC cistern (X1) Adj Left<br>Hand Side Of Corridor<br>(Lending Library) | <b>Asbestos</b><br><br><b>Type</b> | Yes, Strongly<br>presumed<br><br>Amosite (Brown) |
| <b>Material Type</b> | Plastic | <b>Quantity</b> 1m <sup>2</sup> | <b>Sample No</b><br><br><b>Survey Date</b><br><br><b>Date of Report</b><br><br><b>Surveyor(s)</b> | As 06/B/8026/5<br>24.04 - 29.06.06<br>18.08.06<br><div></div> |

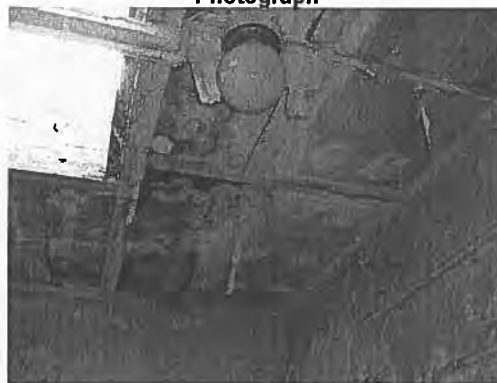
| <b>Location of Survey</b><br>Cane Hill Hospital,<br>Cane Hill,<br>Coulsdon, Surrey,<br>CR5 3ES | | <b>Position of Sample/Photo</b><br>Hall/Chapel Area,<br>2 <sup>nd</sup> room Lending library,<br>Fibre Board Ceiling | | <b>Asbestos</b><br><br><b>Type</b> | <b>Yes</b><br><br>Chrysotile (White) |

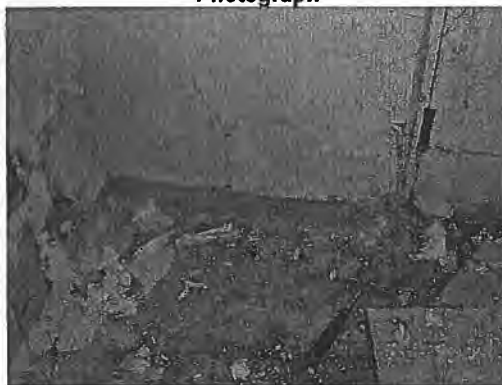
| <b>Location of Survey</b><br>Cane Hill Hospital,<br>Cane Hill,<br>Coulsdon, Surrey,<br>CR5 3ES | | <b>Position of Sample/Photo</b><br>Hall/Chapel Area,<br>Floor Coating, Lopped Up<br>Walls In Last Room Right<br>Hand Side Of Left Hand<br>Corridor | | <b>Asbestos</b> | No Asbestos<br>Detected |

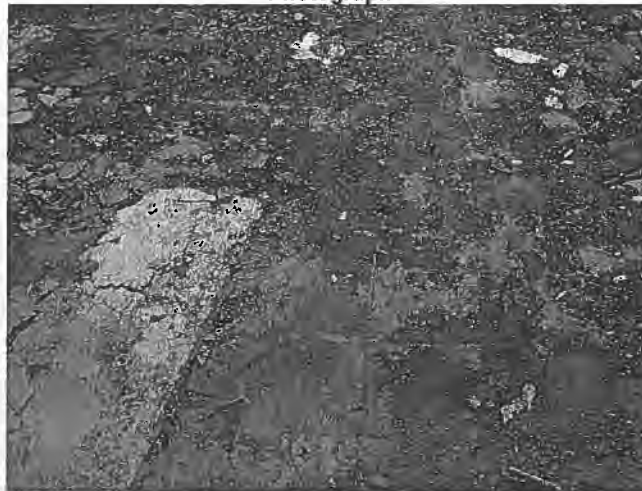
| <b>Location of Survey</b><br>Cane Hill Hospital,<br>Cane Hill,<br>Coulston, Surrey,<br>CR5 3ES | | <b>Position of Sample/Photo</b><br>Hall/Chapel Area<br>Corridor To The Back Of<br>Chapel, incl access links from<br>main corridors Grey Floor Tiles | <b>Asbestos</b><br><br><b>Type</b> | Yes,<br>Bitumen only<br><br>Chrysotile (White)<br>Bitumen only |
| <b>Material Type</b> | Vinyl &<br>Bitumen | <b>Quantity</b> | 200m <sup>2</sup> | <b>Sample No</b> 06/B/8026/37<br><br><b>Survey Date</b> 24.04 - 29.06.06<br><br><b>Date of Report</b> 18.08.06<br><br><b>Surveyor(s)</b> <span style="background-color: black; color: black;">[REDACTED]</span> |

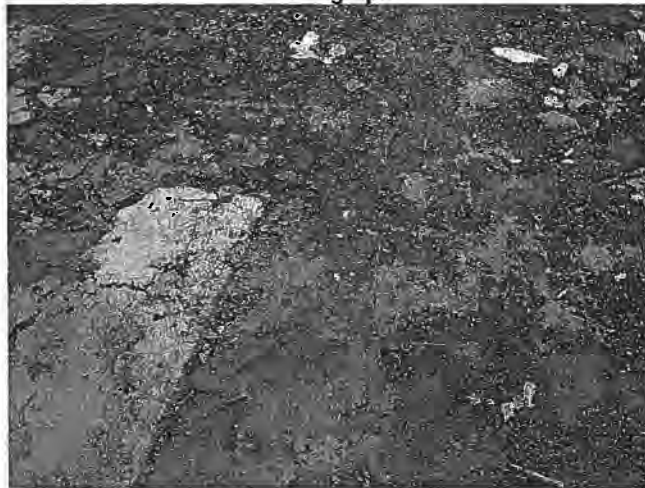
| <b>Location of Survey</b><br>Cane Hill Hospital,<br>Cane Hill,<br>Coulston, Surrey,<br>CR5 3ES | | <b>Position of Sample/Photo</b><br>Hall/Chapel Area,<br>Corridor To The Back Of<br>Chapel, incl access links from<br>main corridors Red Floor Tiles | | <b>Asbestos</b><br><br>Yes<br>Bitumen only |

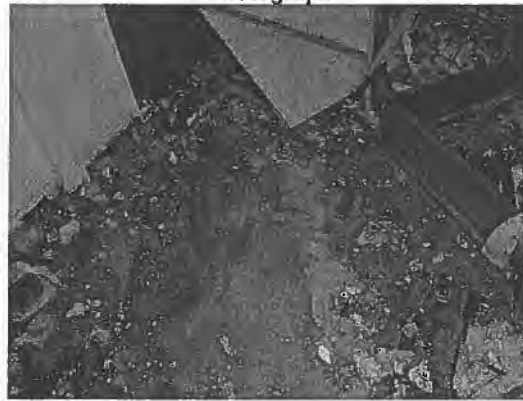
| <b>Location of Survey</b><br>Cane Hill Hospital,<br>Cane Hill,<br>Coulston, Surrey,<br>CR5 3ES | | <b>Position of Sample/Photo</b><br>Hall/Chapel Area<br>Corner Room, Left Hand And<br>Back Corridor, Floor Coating | | <b>Asbestos</b> | <b>No Asbestos<br/>Detected</b> |

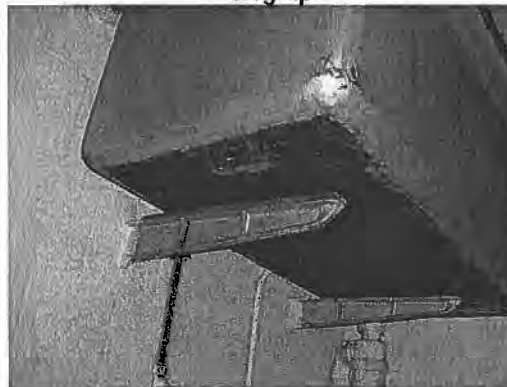
| <b>Location of Survey</b><br>Cane Hill Hospital,<br>Cane Hill,<br>Coulston, Surrey,<br>CR5 3ES | | <b>Position of Sample/Photo</b><br>Hall/Chapel Area<br>Back Room Of 2 <sup>nd</sup> Room, Back<br>Corridor To Chapel, Sink<br>Coating | | <b>Asbestos</b><br><br><b>Type</b> | <b>No Asbestos<br/>Detected</b><br><br>N/A |

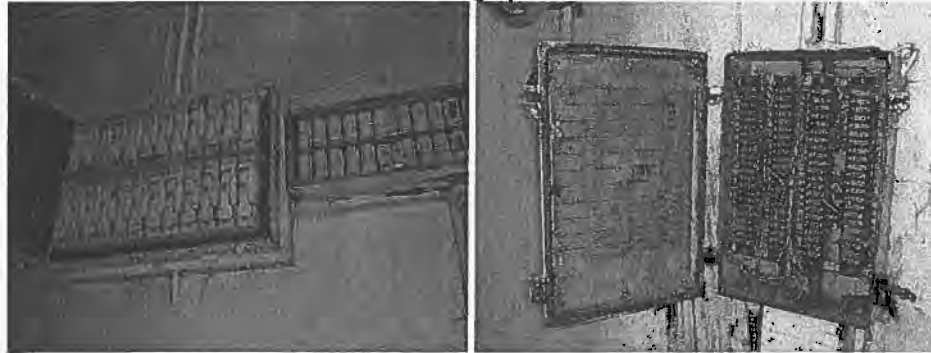
| <b>Location of Survey</b><br>Cane Hill Hospital,<br>Cane Hill,<br>Coulsdon, Surrey,<br>CR5 3ES | <b>Position of Sample/Photo</b><br>Hall/Chapel Area<br>Corridor To The Back Of<br>Chapel, Access link<br>Rope to switchboards | <b>Asbestos</b><br><br><b>Type</b> | Yes, Strongly<br>presumed<br><br>Chrysotile (White) |
| <b>Material Type</b> Rope | <b>Quantity</b> 2m <sup>2</sup> | <b>Sample No</b> As 06/B/8026/22<br><br><b>Survey Date</b> 24.04 - 29.06.06<br><br><b>Date of Report</b> 18.08.06<br><br><b>Surveyor(s)</b> <span style="background-color: black; color: black;">[REDACTED]</span> | |

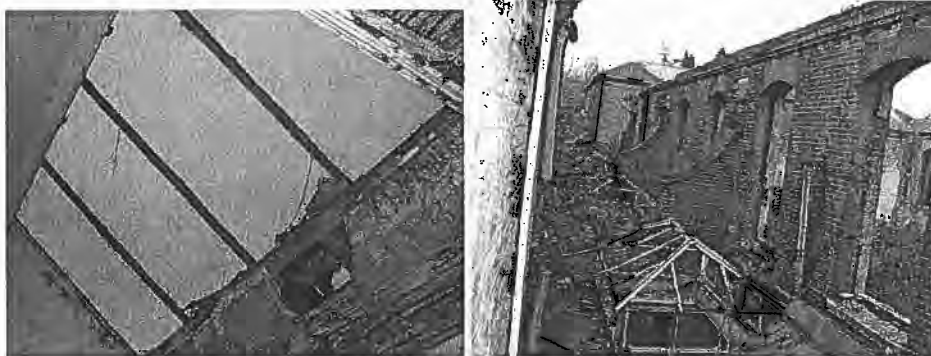
| <b>Location of Survey</b><br>Cane Hill Hospital,<br>Cane Hill,<br>Coulston, Surrey,<br>CR5 3ES | | <b>Position of Sample/Photo</b><br>Hall/Chapel Area,<br>Corridors adj Chapel<br>Rope seals to skylights | | <b>Asbestos</b><br><br><b>Type</b> | Yes, Strongly<br>Presumed<br><br>Chrysotile (White) |
| <b>Material Type</b><br>Rope | | <b>Quantity</b><br>28 l/m each<br>set of 4 | | <b>Sample No</b><br><br><b>Survey Date</b><br><br><b>Date of Report</b><br><br><b>Surveyor(s)</b> | As 06/B/8026/31<br>24.04 - 29.06.06<br>18.08.06<br> |

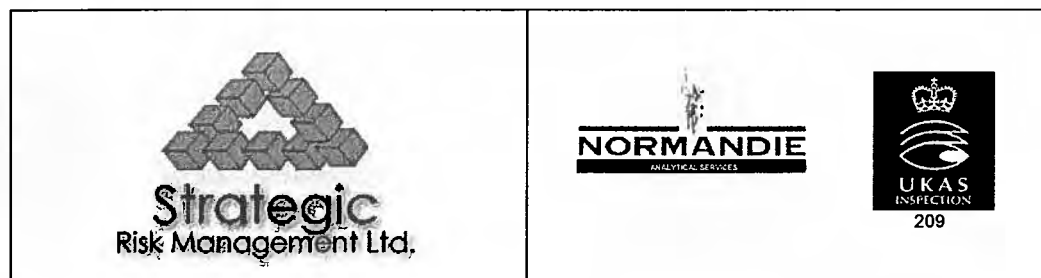
| <b>Location of Survey</b><br><br>Cane Hill Hospital,<br>Cane Hill,<br>Coulsdon, Surrey,<br>CR5 3ES | <b>Position of Sample/Photo</b><br><br>Hall/Chapel Area<br>Lightwell adj chapel RH rear,<br>Corrugated cement sheets | <b>Asbestos</b><br><br>Yes, Strongly<br>presumed | <b>Type</b><br><br>Chrysotile (White) |
| <b>Material Type</b><br><br>Cement | <b>Quantity</b><br><br>4m <sup>2</sup> | <b>Sample No</b><br>As 06/B/8026/126<br><br><b>Survey Date</b><br>24.04 - 29.06.06<br><br><b>Date of Report</b><br>18.08.06<br><br><b>Surveyor(s)</b><br><div style="background-color: black; width: 100px; height: 30px; margin-top: 5px;"></div> | |

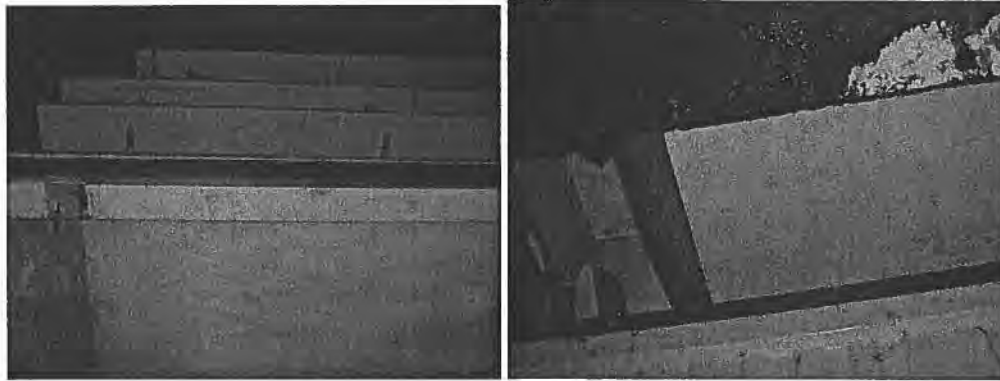
| <b>Location of Survey</b><br>Cane Hill Hospital,<br>Cane Hill,<br>Coulsdon, Surrey,<br>CR5 3ES | <b>Position of Sample/Photo</b><br>Hall/Chapel Area,<br>Dispensary,<br>Radiator panels (X2) | <b>Asbestos</b><br><br><b>Type</b> | Yes, Strongly<br>presumed<br><br>Chrysotile (White) |
| <b>Material</b> Board<br><b>Type</b> | <b>Quantity</b> 1m <sup>2</sup><br>(X2) | <b>Sample No</b> As 06/B/8026/24<br><br><b>Survey Date</b> 24.04 - 29.06.06<br><br><b>Date of Report</b> 18.08.06<br><br><b>Surveyor(s)</b> <span style="background-color: black; color: black;">[REDACTED]</span> | |

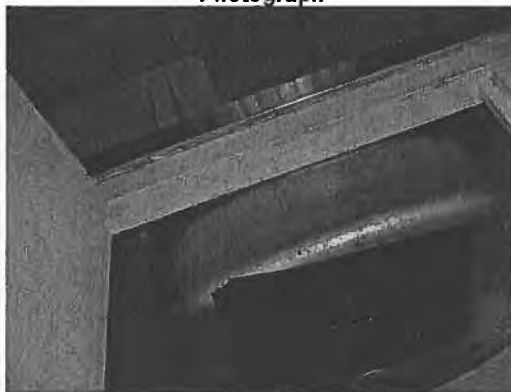
| <b>Location of Survey</b><br>Cane Hill Hospital,<br>Cane Hill,<br>Coulsdon, Surrey,<br>CR5 3ES | | <b>Position of Sample/Photo</b><br>Hall/Chapel Area<br>Dispensary Room,<br>Sink Pad (x3) (2 are to<br>drainers) | | <b>Asbestos</b> Yes |
| <b>Material Type</b> Bitumen | | <b>Quantity</b> 0.5m <sup>2</sup><br>Each Unit | | <b>Type</b> Chrysotile (White)<br><br><b>Sample No</b> 06/B/8026/41<br><br><b>Survey Date</b> 24.04 - 29.06.06<br><br><b>Date of Report</b> 18.08.06<br><br><b>Surveyor(s)</b> <span style="background-color: black; color: black;">[REDACTED]</span> |

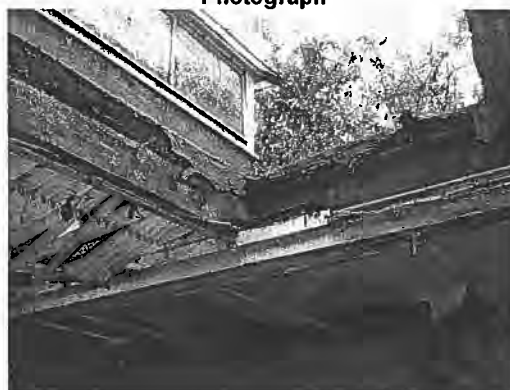
| <b>Location of Survey</b><br>Cane Hill Hospital,<br>Cane Hill,<br>Coulsdon, Surrey,<br>CR5 3ES | | <b>Position of Sample/Photo</b><br>Hall/Chapel Area<br>Admin Office, Cementaceous<br>Roof Coating<br>Also noted throughout site | | <b>Asbestos</b><br><br><b>Type</b> | <b>No Asbestos<br/>Detected</b><br><br>N/A |
| <b>Material Type</b><br>Bitumen<br>/ Cement | | <b>Quantity</b><br>40m <sup>2</sup> | | <b>Sample No</b><br><br><b>Survey Date</b><br><br><b>Date of Report</b><br><br><b>Surveyor(s)</b> | 06/B/8026/42<br>24.04 - 29.06.06<br>18.08.06<br> |

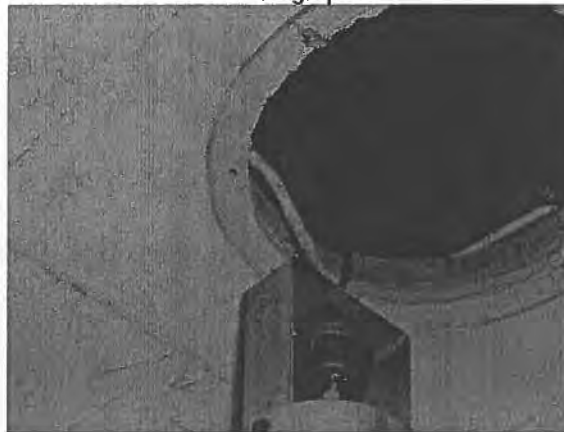
| <b>Location of Survey</b><br>Cane Hill Hospital,<br>Cane Hill,<br>Coulsdon, Surrey,<br>CR5 3ES | | <b>Position of Sample/Photo</b><br>Hall/Chapel Area,<br>Vestry,<br>Rope Cable To Ceiling Lights | | <b>Asbestos</b> Yes |

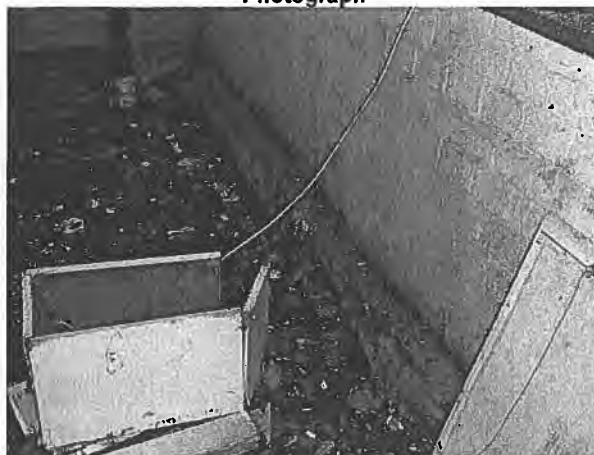
| <b>Location of Survey</b><br>Cane Hill Hospital,<br>Cane Hill,<br>Coulston, Surrey,<br>CR5 3ES | | <b>Position of Sample/Photo</b><br>Hall/Chapel Area,<br>Pipe Lagging, Covered Light<br>Well, Next To Vestry (note<br>damaged) | | <b>Asbestos</b> | Yes |

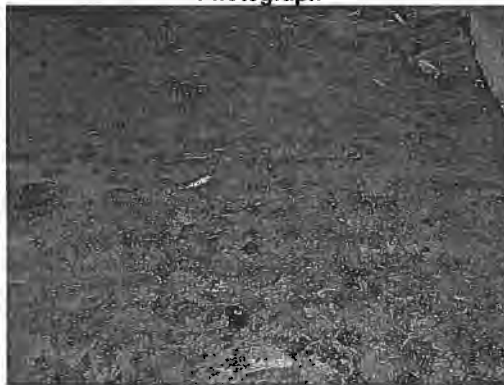
| <b>Location of Survey</b><br>Cane Hill Hospital,<br>Cane Hill,<br>Coulston, Surrey,<br>CR5 3ES | | <b>Position of Sample/Photo</b><br>Hall/Chapel Area<br>Chapel, Small Red Floor Tiles | <b>Asbestos</b> Yes |

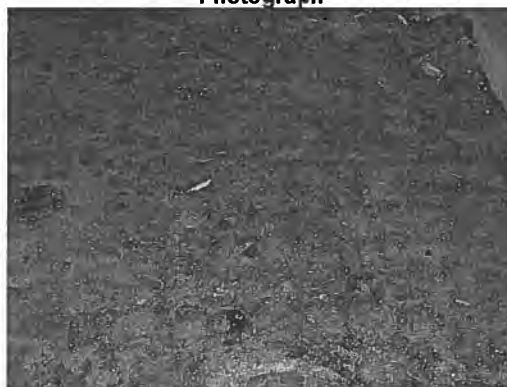
| <b>Location of Survey</b><br>Cane Hill Hospital,<br>Cane Hill,<br>Coulston, Surrey,<br>CR5 3ES | | <b>Position of Sample/Photo</b><br>Hall/Chapel Area<br>Chapel, Small Black Floor<br>Tiles | | <b>Asbestos</b> | Yes |

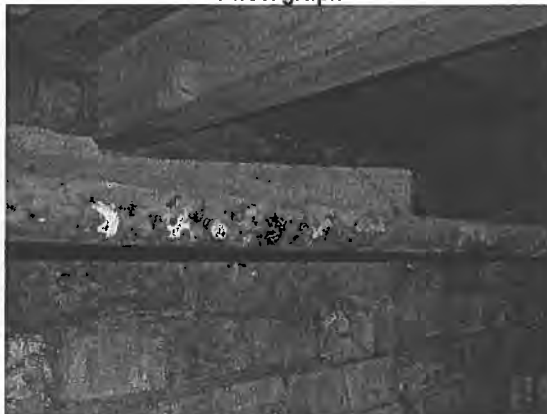
| <b>Material Type</b> Lagging | <b>Quantity</b> 1m <sup>2</sup> | <b>Sample No</b> 06/B/8026/48<br><br><b>Survey Date</b> 24.04 - 29.06.06<br><br><b>Date of Report</b> 18.08.06<br><br><b>Surveyor(s)</b> | |

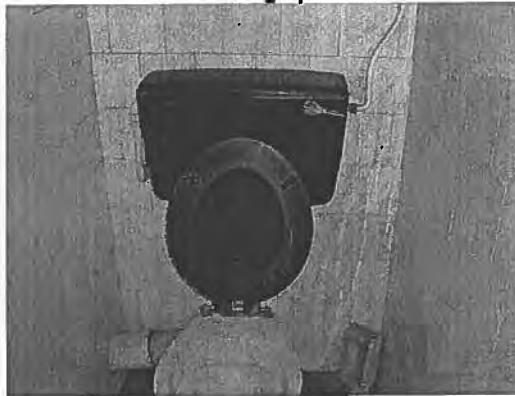
| <b>Location of Survey</b><br>Cane Hill Hospital,<br>Cane Hill,<br>Coulston, Surrey,<br>CR5 3ES | | <b>Position of Sample/Photo</b><br>Olave Queens Ward<br>Ground floor Toilet off 1 <sup>st</sup><br>ward – Shires Lynx WC<br>cistern (X1) | | <b>Asbestos</b><br><br><b>Type</b> | Yes<br>Strongly<br>presumed<br><br>Amosite (Brown) |

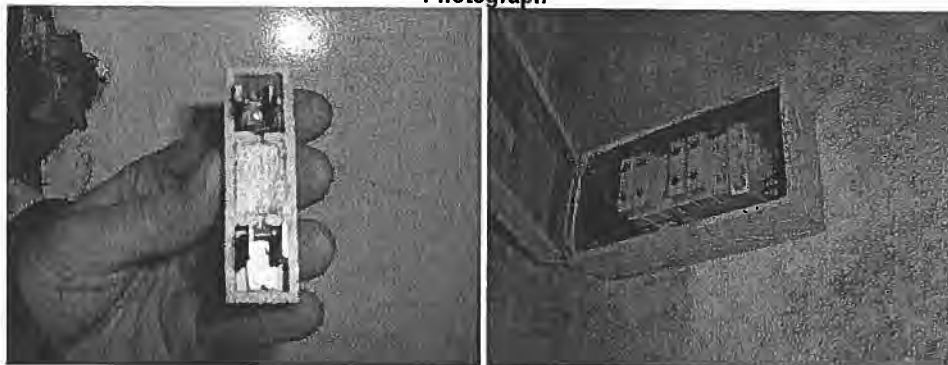
| <b>Location of Survey</b><br>Cane Hill Hospital,<br>Cane Hill,<br>Coulsdon, Surrey,<br>CR5 3ES | <b>Position of Sample/Photo</b><br>Olive Queens Ward,<br>Ground floor 1 <sup>st</sup> ward,<br>Flashpads in electrical box | <b>Asbestos</b> Yes, Strongly Presumed<br><br><b>Type</b> Chrysotile (White) |
| <b>Material Type</b> Lagging | <b>Quantity</b> 70 l/m | <b>Sample No</b> As 06/B/8026/9<br><br><b>Survey Date</b> 24.04 - 29.06.06<br><br><b>Date of Report</b> 18.08.06<br><b>Surveyor(s)</b> <span style="background-color: black; color: black;">[REDACTED]</span> |

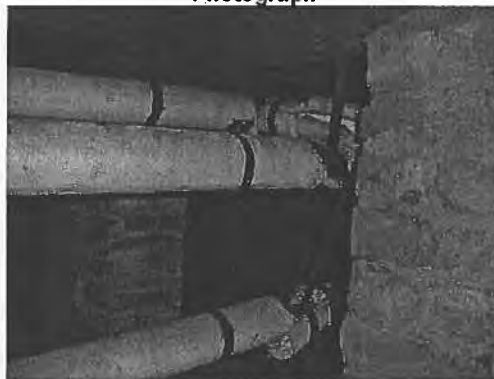
| <b>Location of Survey</b><br>Cane Hill Hospital,<br>Cane Hill,<br>Coulston, Surrey,<br>CR5 3ES | | <b>Position of Sample/Photo</b><br>Olave Queens Ward<br>Undercroft<br>Lagging | | <b>Asbestos</b> | None Detected |

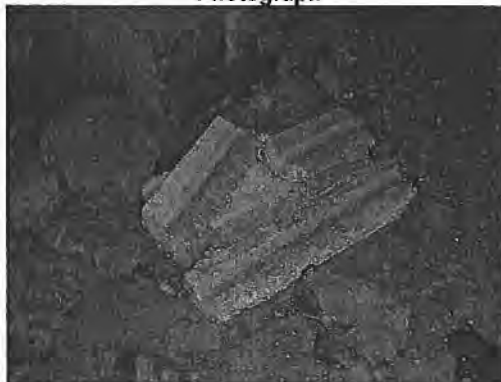
| <b>Location of Survey</b><br>Cane Hill Hospital,<br>Cane Hill,<br>Coulston, Surrey,<br>CR5 3ES | | <b>Position of Sample/Photo</b><br>Olave Queens Ward<br>Sectional Lagging to<br>undercroft pipework debris | | <b>Asbestos</b> Yes |

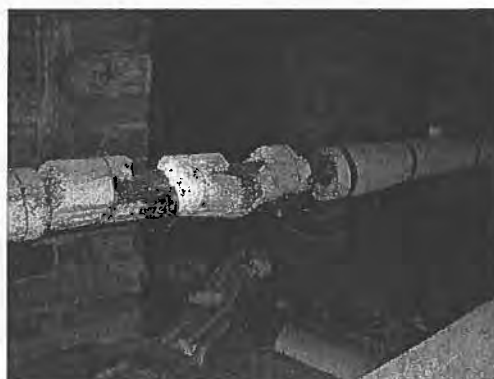
| <b>Location of Survey</b><br>Cane Hill Hospital,<br>Cane Hill,<br>Coulston, Surrey,<br>CR5 3ES | | <b>Position of Sample/Photo</b><br>Olave Queens Ward –<br>Undercroft – Sectional Pipe<br>Lagging | | <b>Asbestos</b><br><br><b>Type</b> | Yes<br><br>Amosite (Brown)<br>Chrysotile (White) |

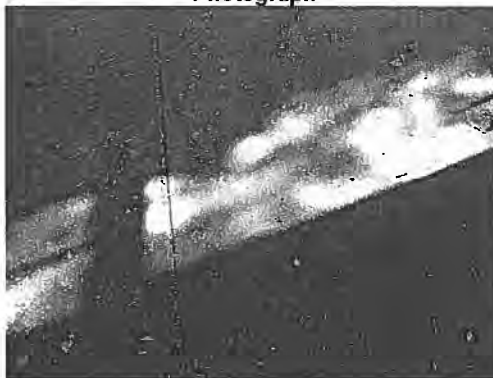
| <b>Location of Survey</b><br>Cane Hill Hospital,<br>Cane Hill,<br>Coulsdon, Surrey,<br>CR5 3ES | | <b>Position of Sample/Photo</b><br>Olave Queens Ward<br>Green Floor Tile In Second<br>Room | <b>Asbestos</b> | Yes,<br>Backing only |

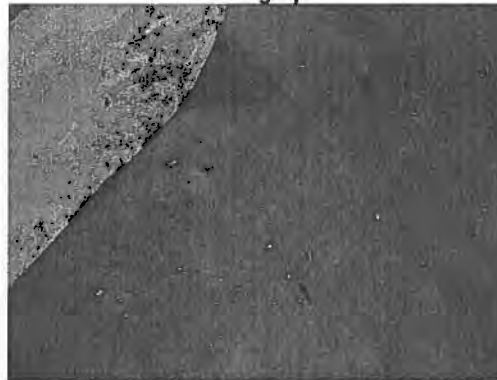
| <b>Location of Survey</b><br>Cane Hill Hospital,<br>Cane Hill,<br>Coulston, Surrey,<br>CR5 3ES | | <b>Position of Sample/Photo</b><br>Olave Queens Ward<br>Crimson Floor Tile | | <b>Asbestos</b> | No Asbestos<br>Detected |

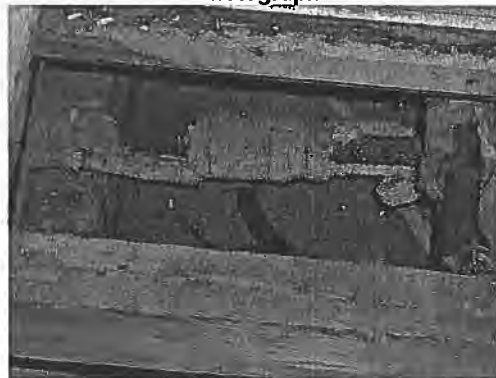
| <b>Location of Survey</b><br><br>Cane Hill Hospital,<br>Cane Hill,<br>Coulsdon, Surrey,<br>CR5 3ES | <b>Position of Sample/Photo</b><br><br>Olave / Queens Ward central<br>ward open area floor hatch to<br>undercroft debris / pipes<br>underneath<br>-Strongly presumed throughout<br>under footprint | <b>Asbestos</b> Yes, Strongly<br>presumed<br><br><b>Type</b> Amosite (Brown)<br>Chrysotile (White) |
| <b>Material Type</b> Lagging | <b>Quantity</b> 90l/m | <b>Sample No</b> As 06/B/8026/52<br><br><b>Survey Date</b> 24.04 - 29.06.06<br><br><b>Date of Report</b> 18.08.06<br><b>Surveyor(s)</b> <span style="background-color: black; color: black;">[REDACTED]</span> |

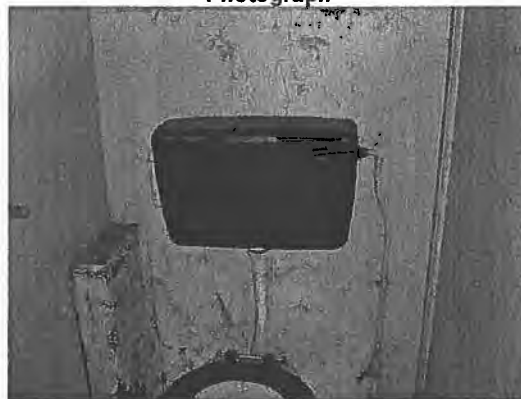
| <b>Location of Survey</b><br>Cane Hill Hospital,<br>Cane Hill,<br>Coulson, Surrey,<br>CR5 3ES | | <b>Position of Sample/Photo</b><br>Olave Queens Ward,<br>Ground Floor<br>Shires Toilet Cistern | | <b>Asbestos</b> | No Asbestos<br>Detected |

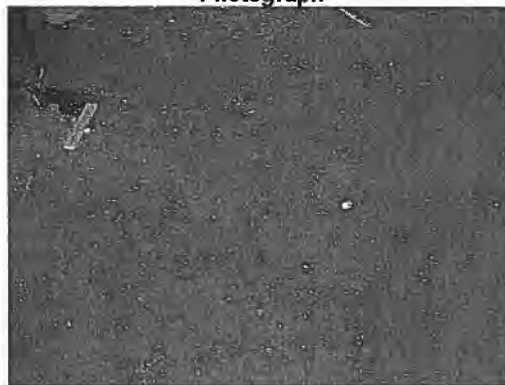
| <b>Location of Survey</b><br>Cane Hill Hospital,<br>Cane Hill,<br>Coulston, Surrey,<br>CR5 3ES | | <b>Position of Sample/Photo</b><br>Olave Queens Ward,<br>Main Ward Room<br>Light Brown Floor Tile | | <b>Asbestos</b> | <b>No Asbestos<br/>Detected</b> |

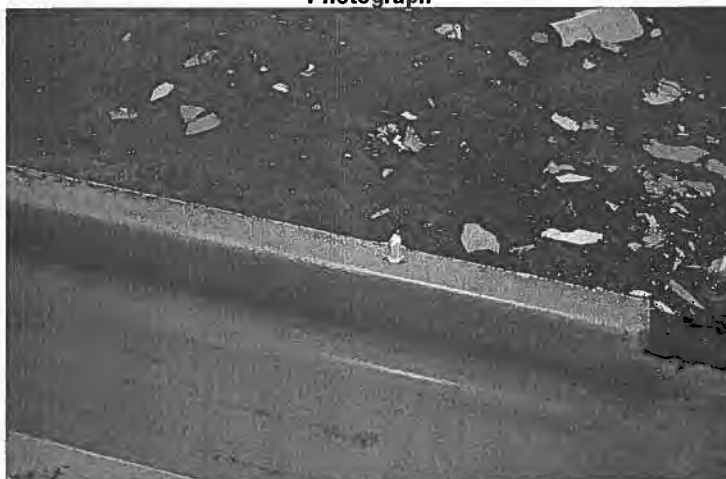
| <b>Location of Survey</b><br><br>Cane Hill Hospital,<br>Cane Hill,<br>Coulsdon, Surrey,<br>CR5 3ES | <b>Position of Sample/Photo</b><br><br>Olave/Queens Ward<br>Throughout Ward and<br>presumed throughout site –<br>Rawl plugs to metal rising pipe<br>sheaths and metal grid heater<br>covers in segregation rooms | <b>Asbestos</b><br><br><b>Type</b> | Yes, Strongly<br>presumed<br><br>Chrysotile (White) |
| <b>Material Type</b> Rope | <b>Quantity</b> 2cm <sup>2</sup><br>Each sheath<br>approx 8<br>plugs | <b>Sample No</b> As 06/B/8026/85<br><br><b>Survey Date</b> 24.04 - 29.06.06<br><br><b>Date of Report</b> 18.08.06<br><br><b>Surveyor(s)</b> <span style="background-color: black; color: black;">[REDACTED]</span> | |

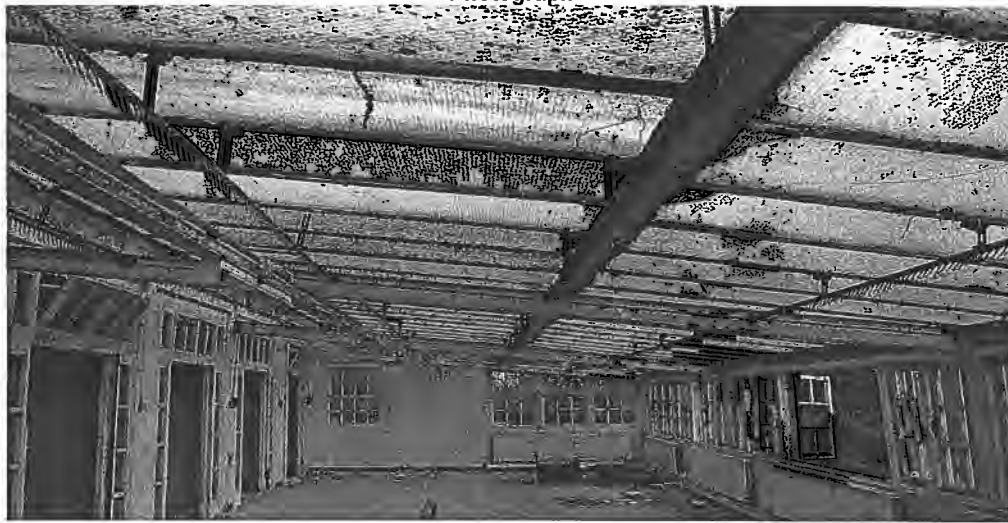
| <b>Location of Survey</b><br>Cane Hill Hospital,<br>Cane Hill,<br>Coulsdon, Surrey,<br>CR5 3ES | | <b>Position of Sample/Photo</b><br>Olave Queens Ward<br>Sun Room/Verandah<br>Rope to skylight | | <b>Asbestos</b><br><br><b>Type</b> | Yes, Strongly<br>Presumed<br><br>Chrysotile (White) |

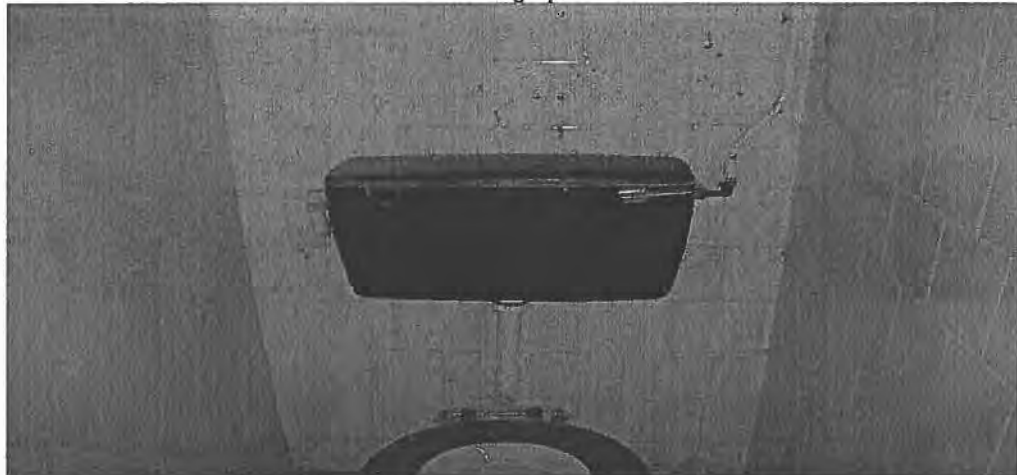
| <b>Location of Survey</b><br>Cane Hill Hospital,<br>Cane Hill,<br>Coulston, Surrey,<br>CR5 3ES | | <b>Position of Sample/Photo</b><br>Olave Queens Ward<br>W.C Cistern (X12) | <b>Asbestos</b><br><br><b>Type</b> | <b>Yes, Strongly Presumed</b><br><br>Amosite (Brown) |
| <b>Material Type</b> | Plastic | <b>Quantity</b> | <1m <sup>2</sup> | <b>Sample No</b> As 06/B/8026/5<br><br><b>Survey Date</b> 24.04 - 29.06.06<br><br><b>Date of Report</b> 18.08.06<br><br><b>Surveyor(s)</b> <span style="background-color: black; color: black;">[REDACTED]</span> |

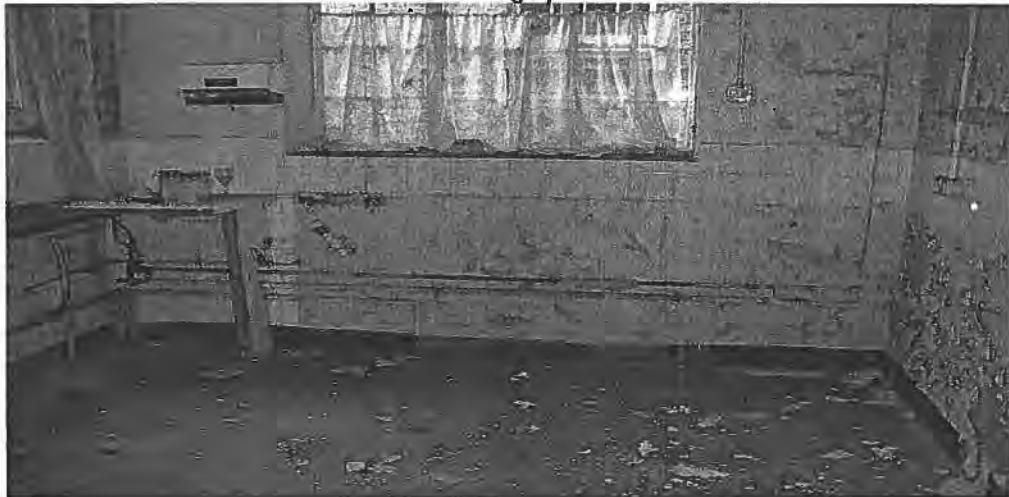
| <b>Location of Survey</b><br>Cane Hill Hospital,<br>Cane Hill,<br>Coulston, Surrey,<br>CR5 3ES | | <b>Position of Sample/Photo</b><br>Olave Queens Ward<br>Ground Floor<br>Kitchen adjacent corridor<br>Rope to lower pipe | | <b>Asbestos</b> Yes |
