TYPE 3  
SURVEY, ASSESSMENT AND REGISTER OF  
ASBESTOS CONTAINING MATERIALS  
AT  
CANE HILL, COULSDON  
SURREY, CR5 3ES

*Report No. 06/B/8026*

*September 2006*

**Strategic Risk Management  
P.O. Box 167, Sandbach  
Cheshire, CW11 3WG**

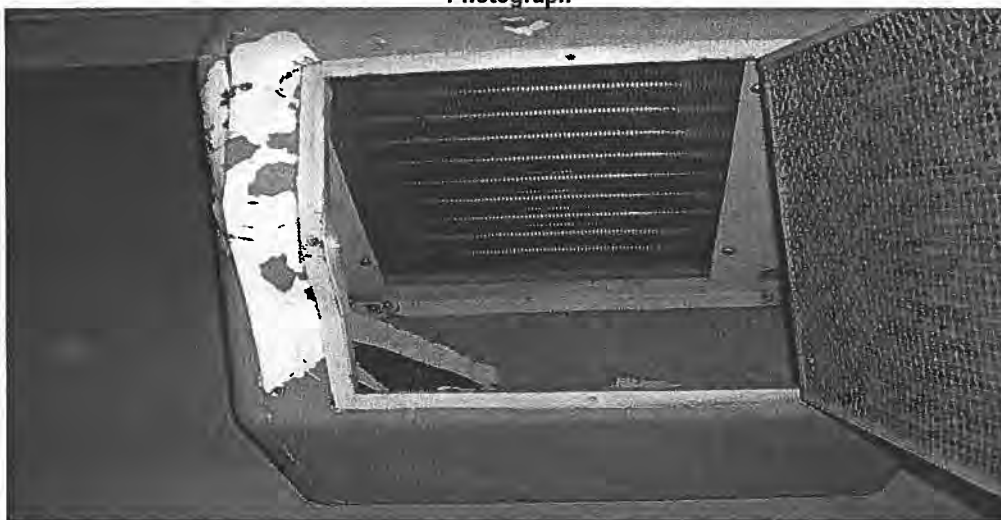
| <b>Location of Survey</b><br>Cane Hill Hospital,<br>Cane Hill,<br>Coulson, Surrey,<br>CR5 3ES | | <b>Position of Sample/Photo</b><br>Olave Queens Ward<br>Heater bitumen pad | | <b>Asbestos</b> | <b>No Asbestos<br/>Detected</b> |

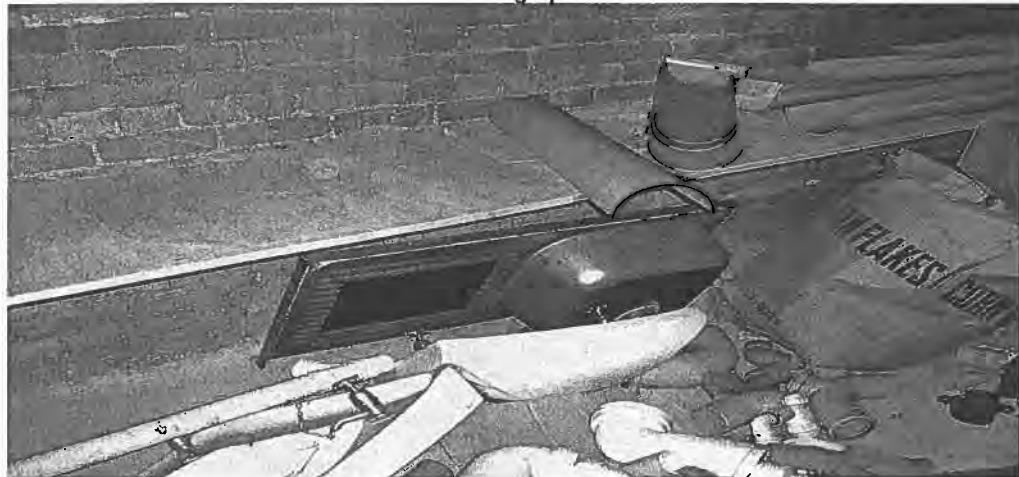
| <b>Location of Survey</b><br>Cane Hill Hospital,<br>Cane Hill,<br>Coulston, Surrey,<br>CR5 3ES | | <b>Position of Sample/Photo</b><br>Olave Queens Ward<br>Undercroft Stores<br>Sink pads | | <b>Asbestos</b><br><br><b>Type</b> | <b>Yes, Strongly Presumed</b><br><br>Chrysotile (White) |

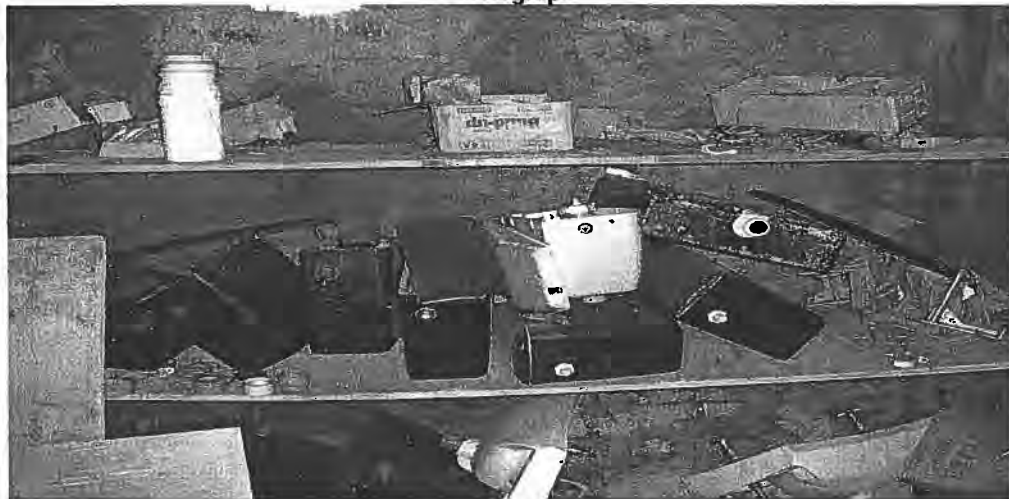
| <b>Location of Survey</b><br>Cane Hill Hospital,<br>Cane Hill,<br>Coulston, Surrey,<br>CR5 3ES | | <b>Position of Sample/Photo</b><br>Olave Queens Ward<br>Undercroft Stores<br>Cisterns (X18) | <b>Asbestos</b><br><br><b>Type</b> | Yes, Strongly<br>Presumed<br><br>Amosite (Brown) |

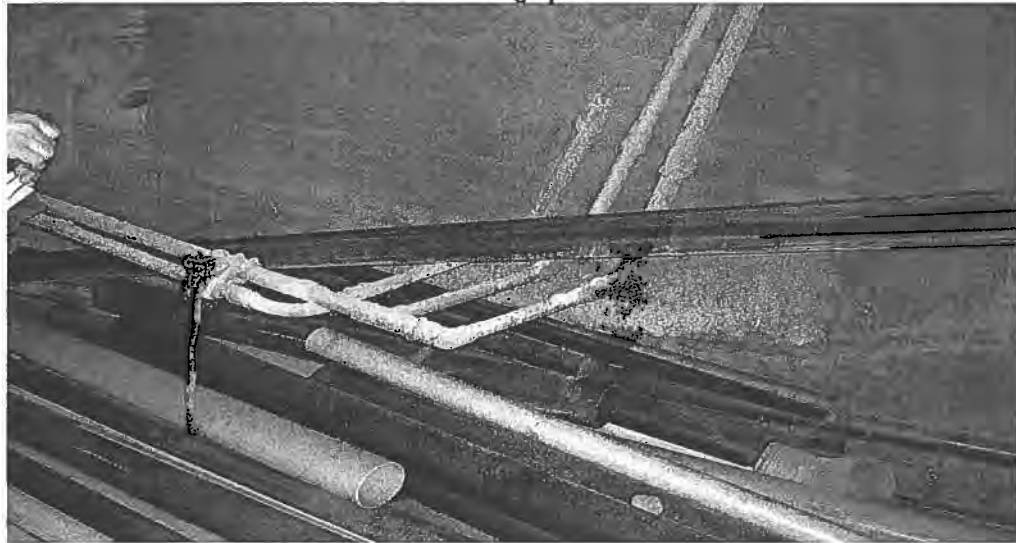
| <b>Location of Survey</b><br>Cane Hill Hospital,<br>Cane Hill,<br>Coulston, Surrey,<br>CR5 3ES | | <b>Position of Sample/Photo</b><br>Olave Queens Ward<br>Undercroft Stores<br>Rope | | <b>Asbestos</b> | <b>No Asbestos<br/>Detected</b> |

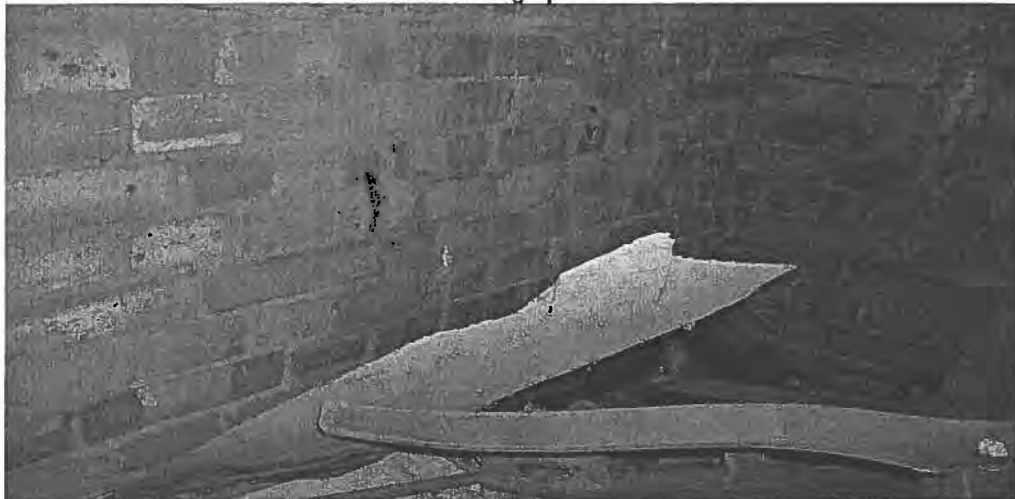
| <b>Location of Survey</b><br>Cane Hill Hospital,<br>Cane Hill,<br>Coulsdon, Surrey,<br>CR5 3ES | <b>Position of Sample/Photo</b><br>Olive Queens Ward<br>Undercroft Stores<br>Redundant panels | <b>Asbestos</b><br>Yes, Strongly Presumed<br><br><b>Type</b><br>Chrysotile (White)<br>Amosite (Brown) | |
| <b>Material Type</b> Board | <b>Quantity</b> 1m <sup>2</sup> | <b>Sample No</b> As 06/B/8026/24<br><br><b>Survey Date</b> 24.04 - 29.06.06<br><br><b>Date of Report</b> 18.08.06<br><br><b>Surveyor(s)</b> <span style="background-color: black; color: black;">[REDACTED]</span> | |

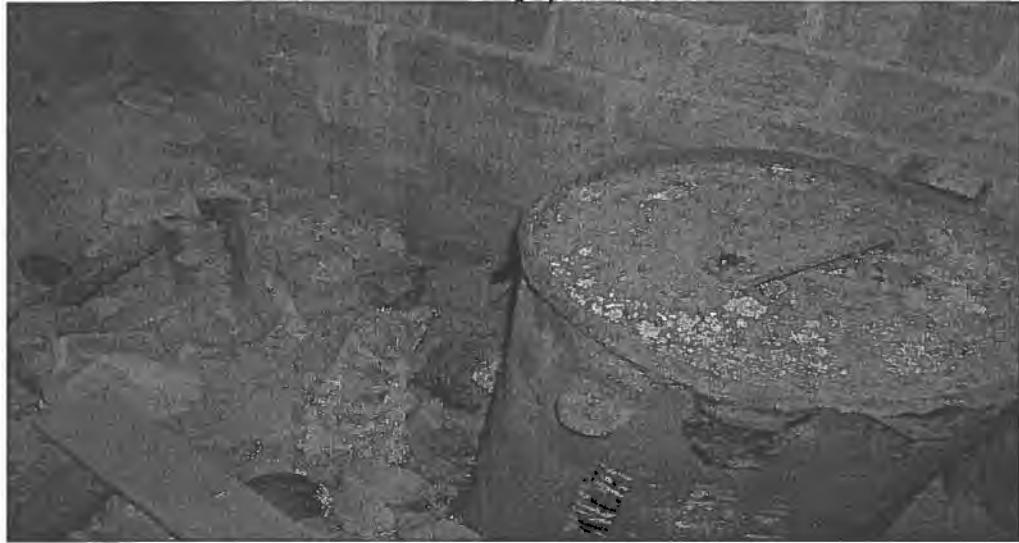
| <b>Location of Survey</b><br>Cane Hill Hospital,<br>Cane Hill,<br>Coulston, Surrey,<br>CR5 3ES | | <b>Position of Sample/Photo</b><br>Olave Queens Ward<br>Undercroft Stores<br>Lagging debris<br>(presumed throughout) | | <b>Asbestos</b> | Yes, Strongly<br>Presumed |

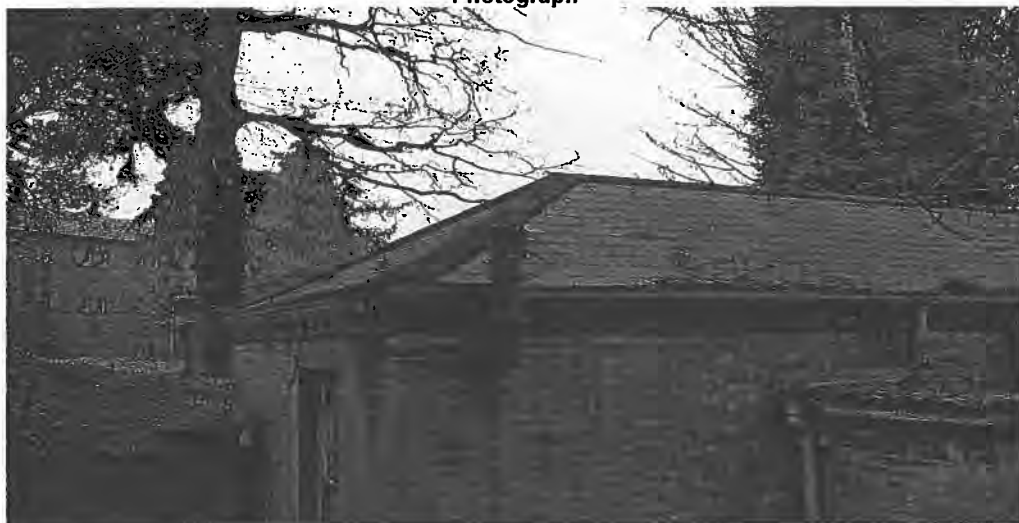
| <b>Location of Survey</b><br>Cane Hill Hospital,<br>Cane Hill,<br>Coulston, Surrey,<br>CR5 3ES | | <b>Position of Sample/Photo</b><br>Olave Queens Ward<br>External flue pipe | | <b>Asbestos</b><br><br><b>Type</b> | Yes, Strongly<br>Presumed<br><br>Chrysotile (White) |

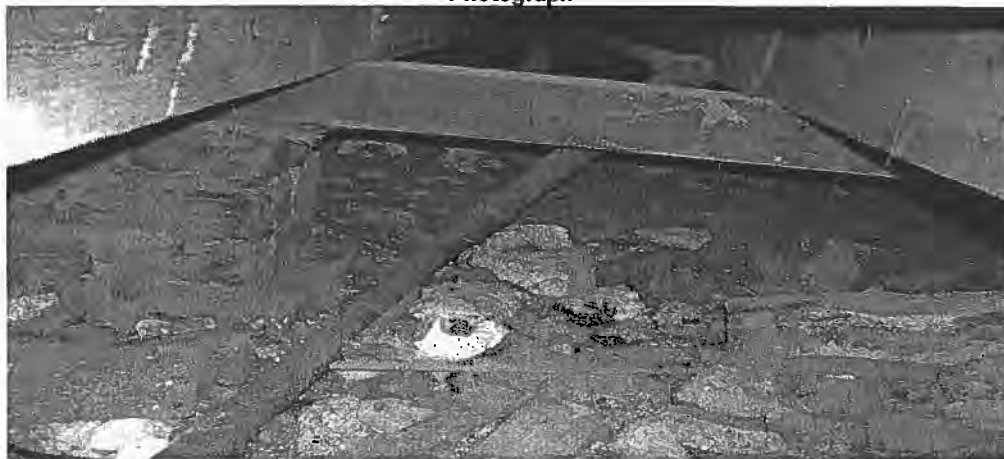
| <b>Location of Survey</b><br>Cane Hill Hospital,<br>Cane Hill,<br>Coulson, Surrey,<br>CR5 3ES | | <b>Position of Sample/Photo</b><br>Browning Blake Ward<br>Female Ward Undercroft<br>Pipe Lagging Debris<br>(presumed throughout) | | <b>Asbestos</b><br><br><b>Type</b> | Yes, Strongly<br>Presumed<br><br>Chrysotile (White)<br>Amosite (Brown) |

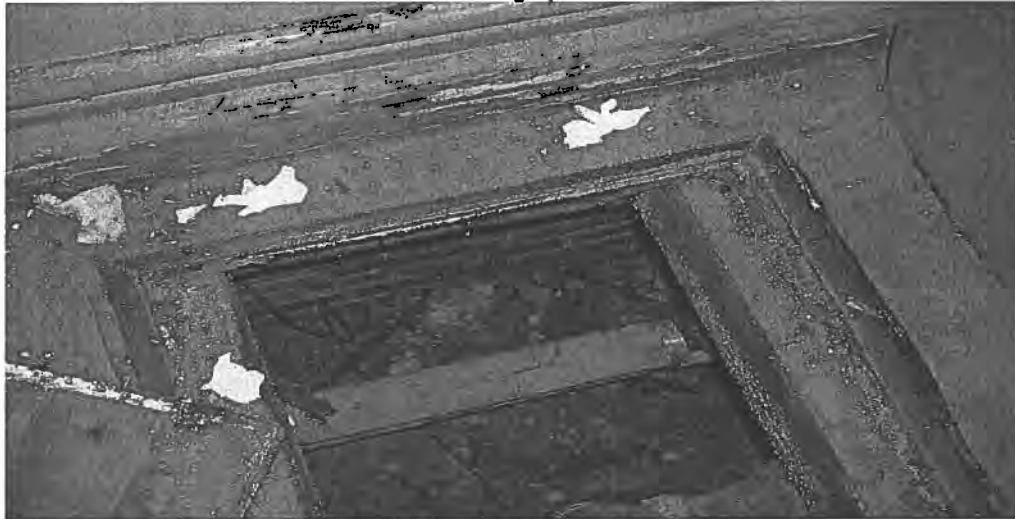
| <b>Location of Survey</b><br>Cane Hill Hospital,<br>Cane Hill,<br>Coulston, Surrey,<br>CR5 3ES | | <b>Position of Sample/Photo</b><br>Browning Blake Ward<br>End Ward Undercroft<br>Pipe Lagging Debris<br>(presumed throughout) | | <b>Asbestos</b> | Yes, Strongly<br>Presumed |

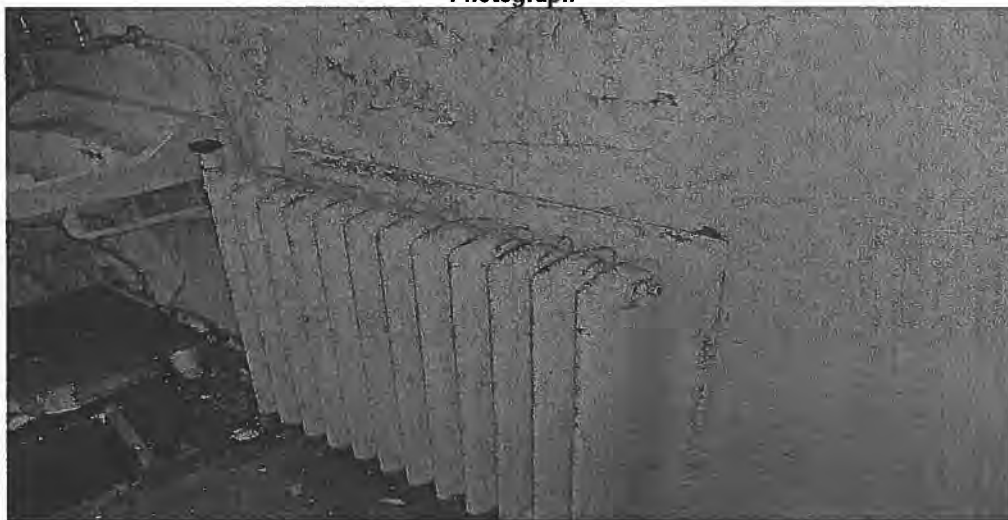
| <b>Location of Survey</b><br>Cane Hill Hospital,<br>Cane Hill,<br>Coulsdon, Surrey,<br>CR5 3ES | | <b>Position of Sample/Photo</b><br>Browning Blake Ward<br>Room adjacent end ward<br>Panel behind radiator (X2) | | <b>Asbestos</b> Yes |

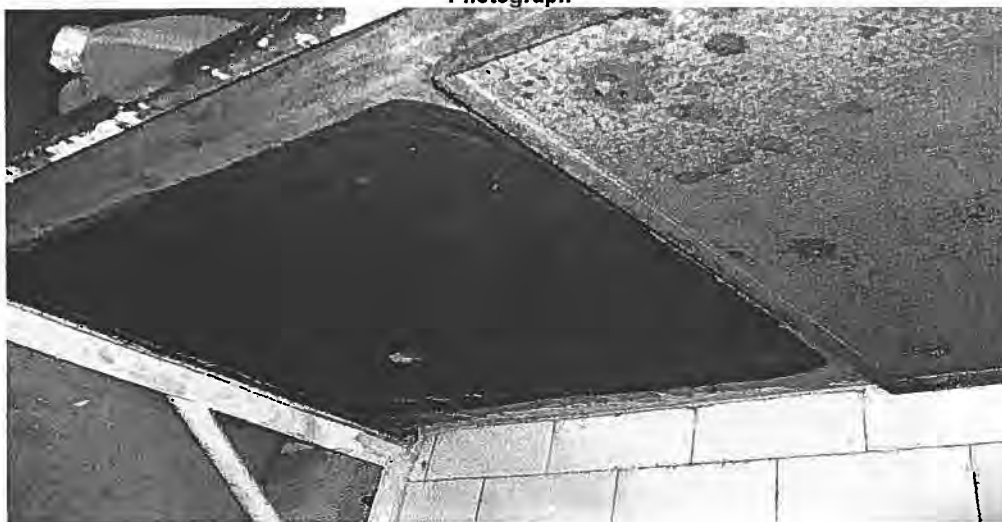
| <b>Location of Survey</b><br>Cane Hill Hospital,<br>Cane Hill,<br>Coulsdon, Surrey,<br>CR5 3ES | | <b>Position of Sample/Photo</b><br>Browning Blake Ward<br>Office adjacent ward<br>Ironing Board Pad | | <b>Asbestos</b><br><br><b>Type</b> | <b>Yes, Strongly Presumed</b><br><br>Chrysotile (White) |

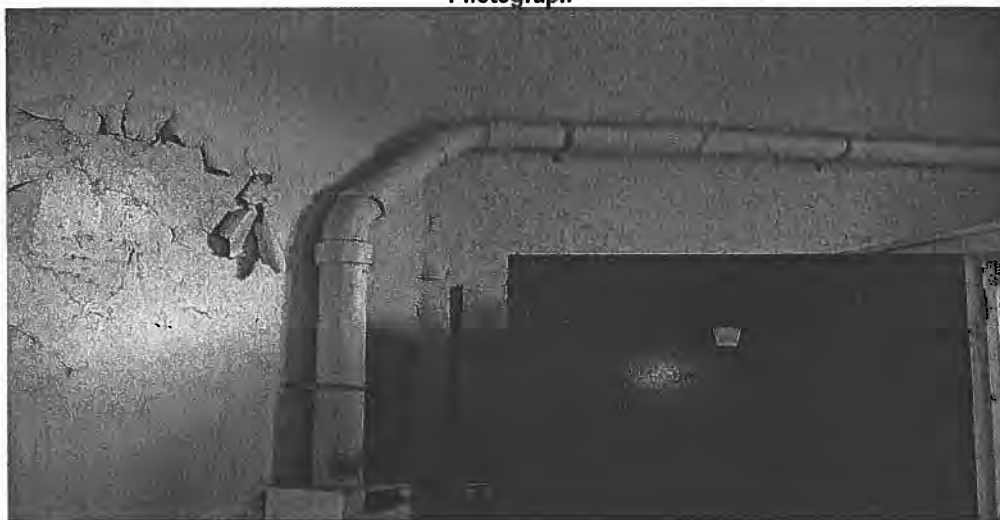
| <b>Location of Survey</b><br>Cane Hill Hospital,<br>Cane Hill,<br>Coulson, Surrey,<br>CR5 3ES | | <b>Position of Sample/Photo</b><br>Browning Blake Ward<br>First floor WC adjacent<br>corridor from stairs<br>Flue pipe | | <b>Asbestos</b><br><br><b>Type</b> | Yes, Strongly<br>Presumed<br><br>Chrysotile (White) |

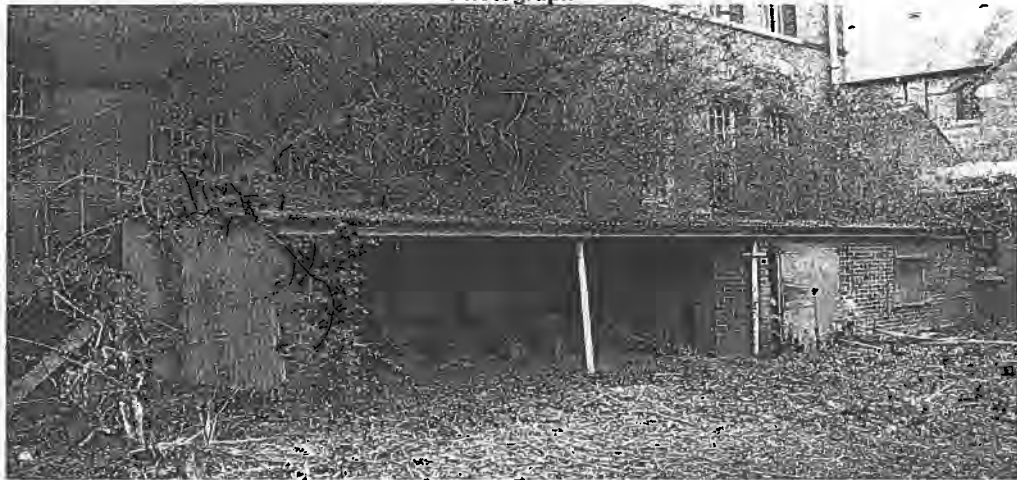
| <b>Location of Survey</b><br>Cane Hill Hospital,<br>Cane Hill,<br>Coulston, Surrey,<br>CR5 3ES | | <b>Position of Sample/Photo</b><br>Browning Blake Ward<br>External Store<br>Corrugated Roof sheet<br>& Side Panels | | <b>Asbestos</b><br><br><b>Type</b> | Yes, Strongly<br>Presumed<br><br>Chrysotile (White) |

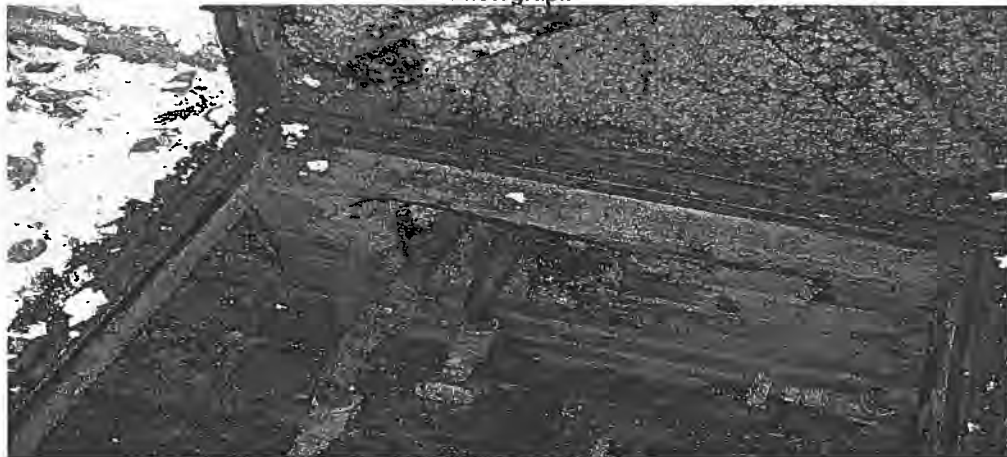
| <b>Location of Survey</b><br>Cane Hill Hospital,<br>Cane Hill,<br>Coulston, Surrey,<br>CR5 3ES | | <b>Position of Sample/Photo</b><br>Browning/Blake Ward<br>Undercroft debris | <b>Asbestos</b><br><br><b>Type</b> | <b>No Asbestos<br/>Detected</b><br><br>N/A |
| <b>Material<br/>Type</b> | Debris | <b>Quantity</b> | 1m <sup>2</sup> | <b>Sample No</b> 06/B/8026/79<br><br><b>Survey Date</b> 24.04 - 29.06.06<br><br><b>Date of Report</b> 18.08.06<br><br><b>Surveyor(s)</b> <span style="background-color: black; color: black;">[REDACTED]</span> |

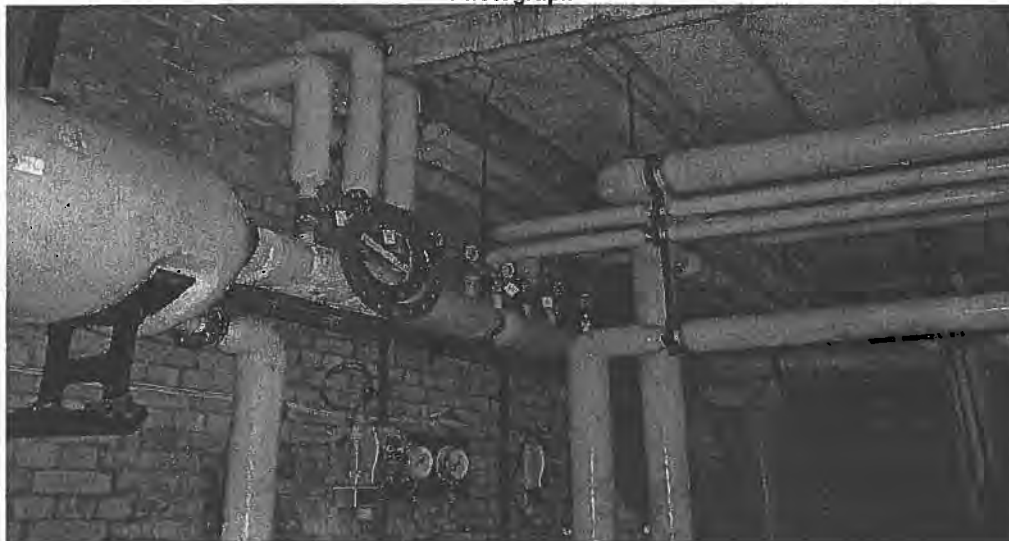
### Plant Room adjacent Reception Building

| <b>Material Type</b> Lagging | <b>Quantity</b> 140m | <b>Sample No</b> 06/B/8026/69<br><br><b>Survey Date</b> 24.04 - 29.06.06<br><br><b>Date of Report</b> 18.08.06<br><br><b>Surveyor(s)</b> <span style="background-color: black; color: black;">[REDACTED]</span> |

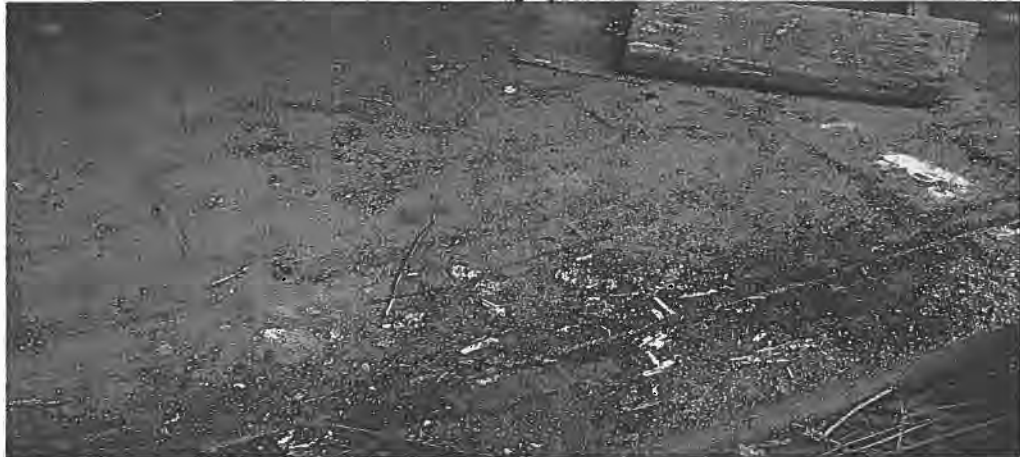
| <b>Location of Survey</b><br>Cane Hill Hospital,<br>Cane Hill,<br>Coulston, Surrey,<br>CR5 3ES | | <b>Position of Sample/Photo</b><br>Calorifier Room adjacent<br>Reception Building<br>Floor Debris<br>(presumed throughout) | <b>Asbestos</b> Yes |

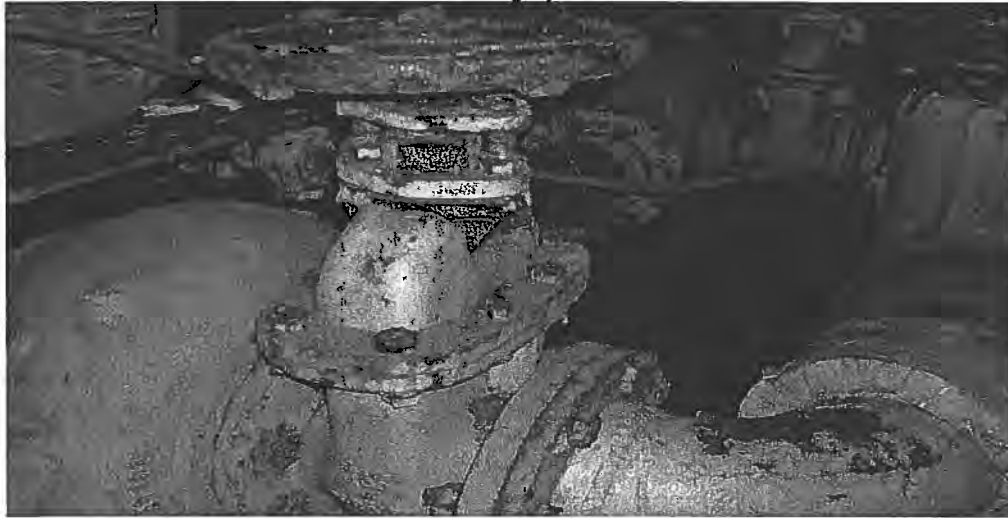
| <b>Location of Survey</b><br>Cane Hill Hospital,<br>Cane Hill,<br>Coulson, Surrey,<br>CR5 3ES | | <b>Position of Sample/Photo</b><br>Calorifier Room adjacent<br>Reception Building<br>Gaskets & Crane Valves<br>(presumed throughout site) | <b>Asbestos</b> Yes |

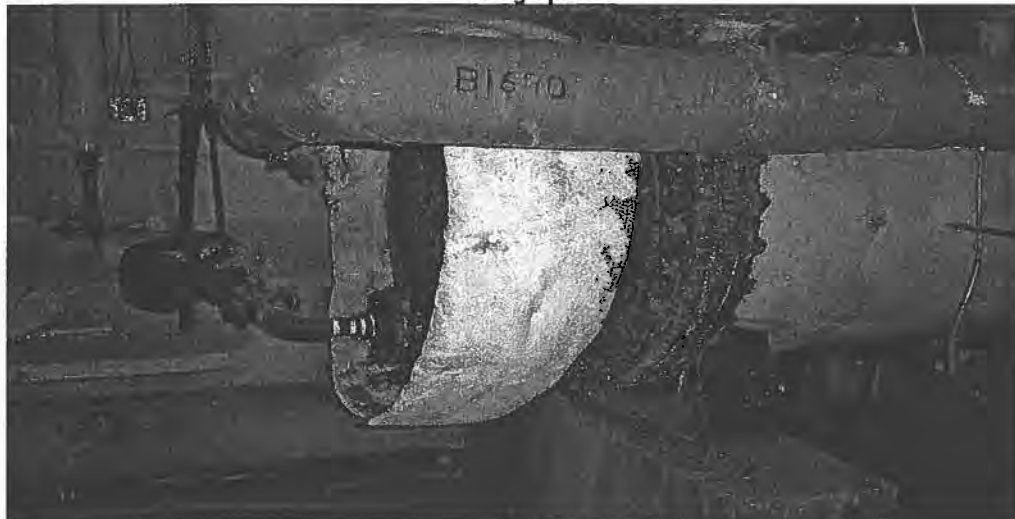
| <b>Location of Survey</b><br>Cane Hill Hospital,<br>Cane Hill,<br>Coulston, Surrey,<br>CR5 3ES | | <b>Position of Sample/Photo</b><br>Calorifier Room adjacent<br>Reception Building<br>Gaiter (X2) | | <b>Asbestos</b> Yes |

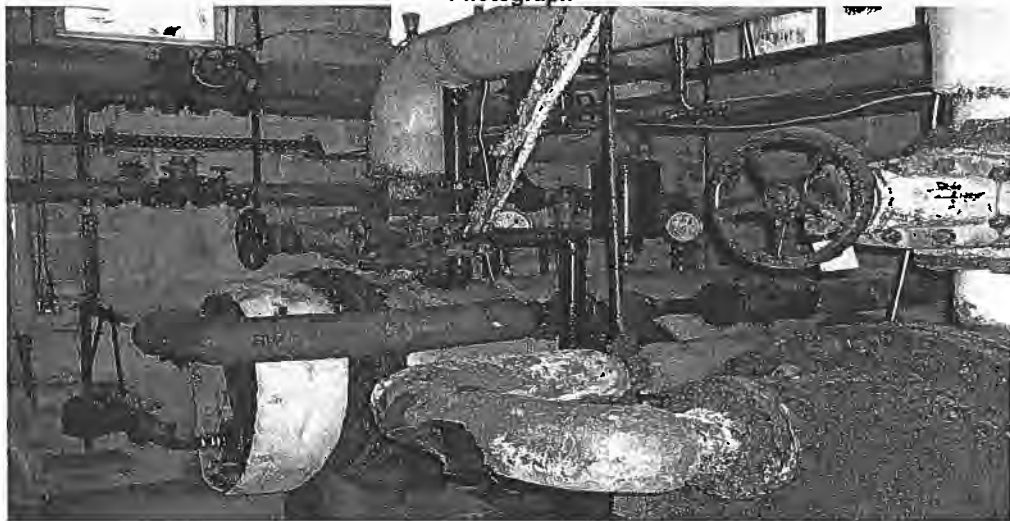
| <b>Location of Survey</b><br>Cane Hill Hospital,<br>Cane Hill,<br>Coulston, Surrey,<br>CR5 3ES | | <b>Position of Sample/Photo</b><br>Calorifier Room adjacent<br>Reception Building<br>Red Pipe Lagging | <b>Asbestos</b> Yes |

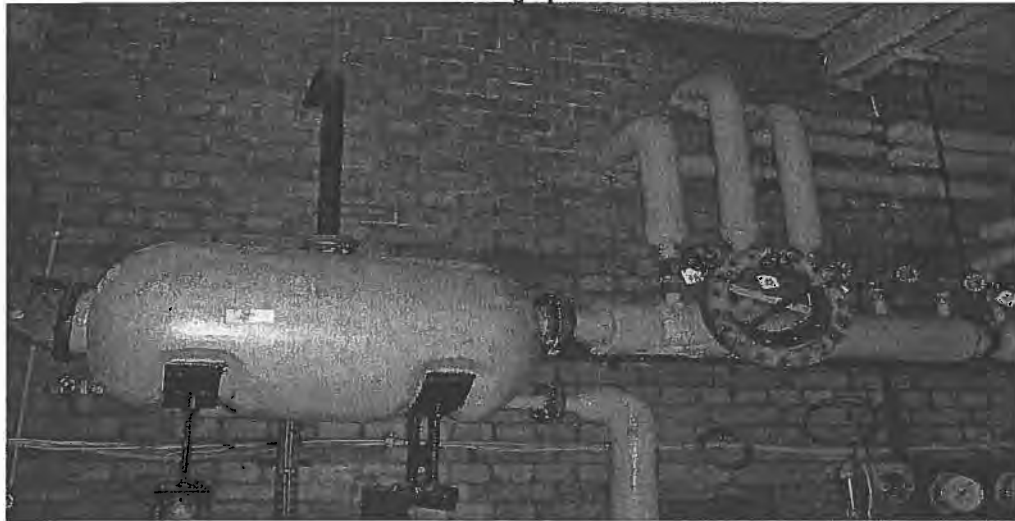
| <b>Location of Survey</b><br><br>Cane Hill Hospital,<br>Cane Hill,<br>Coulsdon, Surrey,<br>CR5 3ES | <b>Position of Sample/Photo</b><br><br>Calorifier Room adjacent<br>Reception Building<br>Small Blue Tank Lagging | <table style="width: 100%;"> <tr> <td style="width: 30%;"><b>Asbestos</b></td> <td>Yes</td> </tr> <tr> <td><b>Type</b></td> <td>Amosite (Brown)<br/>Chrysotile (White)</td> </tr> </table> | <b>Asbestos</b> | Yes | <b>Type</b> | Amosite (Brown)<br>Chrysotile (White) | | | | |

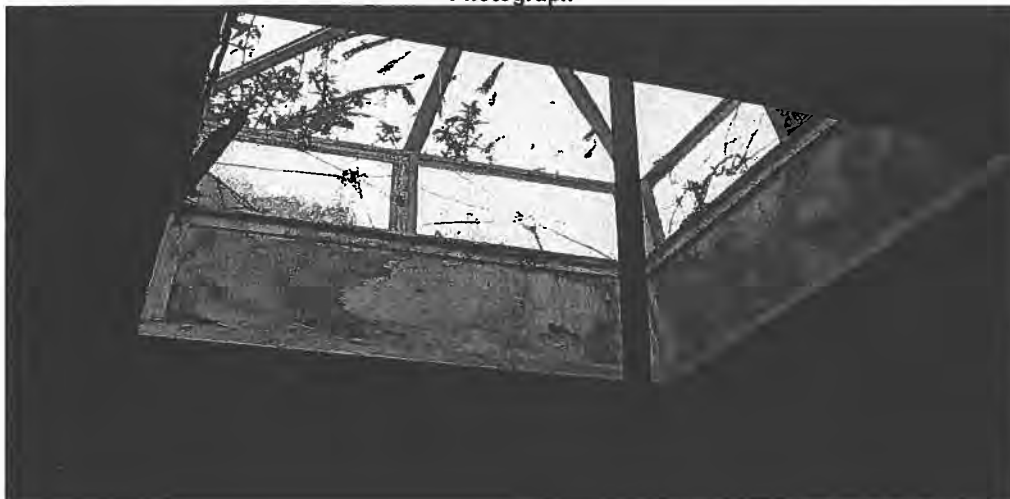
| <b>Location of Survey</b><br><br>Cane Hill Hospital,<br>Cane Hill,<br>Coulsdon, Surrey,<br>CR5 3ES | <b>Position of Sample/Photo</b><br><br>Corridor adjacent Olave<br>Queens Ward running parallel<br>to Chapel<br>Skylight Rope Seals | <b>Asbestos</b><br><br>Yes, Strongly<br>Presumed | <b>Type</b><br><br>Chrysotile (White) |
| <b>Material Type</b><br><br>Rope | <b>Quantity</b><br><br>10m | <b>Sample No</b><br>As 06/B/8026/31<br><br><b>Survey Date</b><br>24.04 - 29.06.06<br><br><b>Date of Report</b><br>18.08.06<br><br><b>Surveyor(s)</b><br><div style="background-color: black; width: 100px; height: 30px;"></div> | |

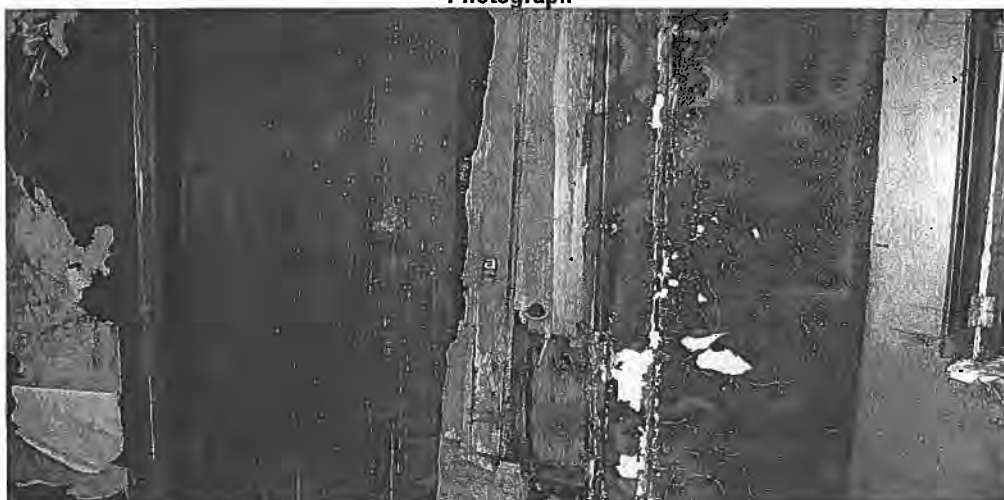
| <b>Location of Survey</b><br>Cane Hill Hospital,<br>Cane Hill,<br>Coulston, Surrey,<br>CR5 3ES | | <b>Position of Sample/Photo</b><br>Hall/Chapel Corridor<br>Door adjacent corridor to<br>Olave Queens Ward<br>Internal Panel | <b>Asbestos</b> Yes<br><br><b>Type</b> Chrysotile (White) |
| <b>Material Type</b> Cement | <b>Quantity</b> 2m <sup>2</sup> | <b>Sample No</b> 06/B/8026/75<br><br><b>Survey Date</b> 24.04 - 29.06.06<br><br><b>Date of Report</b> 18.08.06<br><br><b>Surveyor(s)</b> <span style="background-color: black; color: black;">[REDACTED]</span> | |

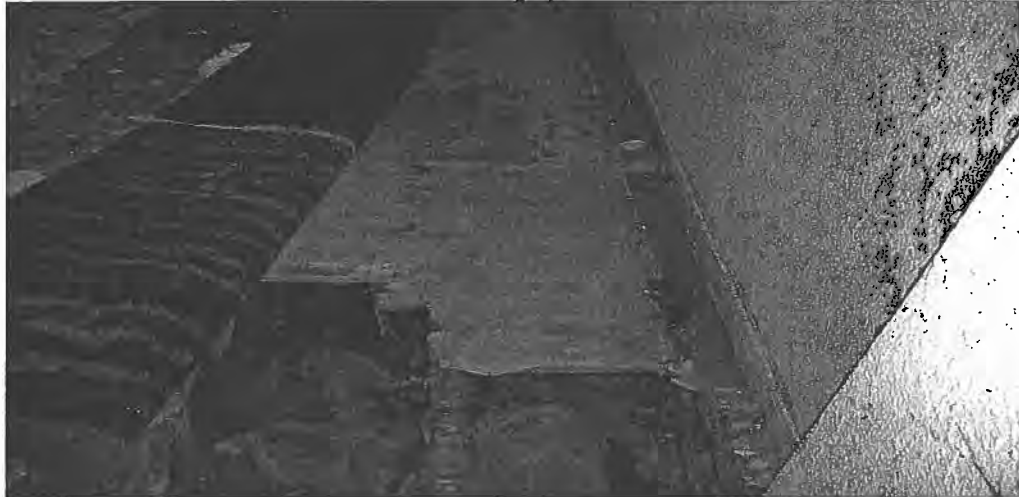
| <b>Location of Survey</b><br>Cane Hill Hospital,<br>Cane Hill,<br>Coulsdon, Surrey,<br>CR5 3ES | <b>Position of Sample/Photo</b><br>Hall/Chapel Corridor<br>Offices adjacent corridor to<br>Olive Queens Ward | <b>Asbestos</b><br><br><b>Type</b> | <b>No Asbestos Detected</b><br><br>N/A |
| <b>Material Type</b> Lagging | <b>Quantity</b> 10m | <b>Sample No</b> 06/B/8026/76<br><br><b>Survey Date</b> 24.04 - 29.06.06<br><br><b>Date of Report</b> 18.08.06<br><br><b>Surveyor(s)</b> <span style="background-color: black; color: black;">[REDACTED]</span> | |

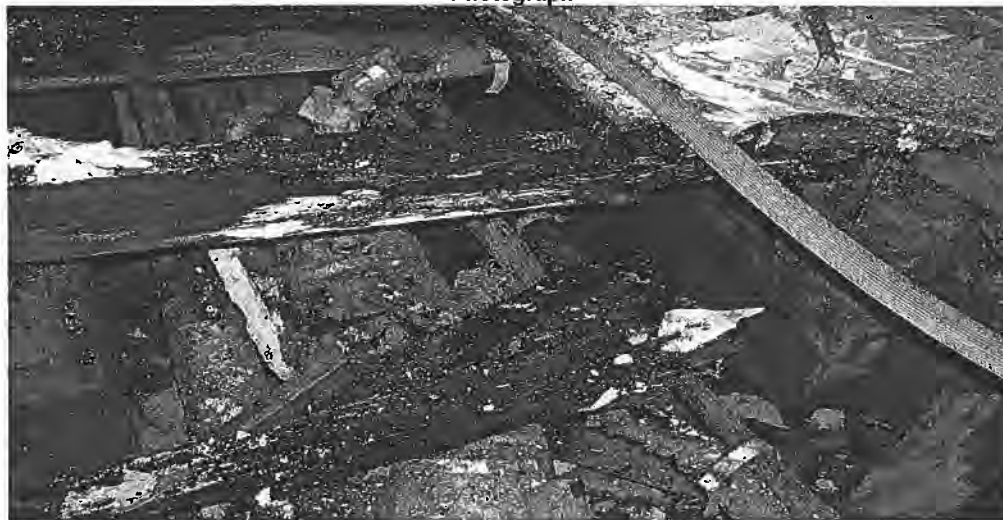
| <b>Location of Survey</b><br>Cane Hill Hospital,<br>Cane Hill,<br>Coulson, Surrey,<br>CR5 3ES | | <b>Position of Sample/Photo</b><br>Hall/Chapel Corridor<br>Lobby to corridor to Olave<br>Queens Ward<br>Undercroft Pipe lagging | <b>Asbestos</b> Yes |

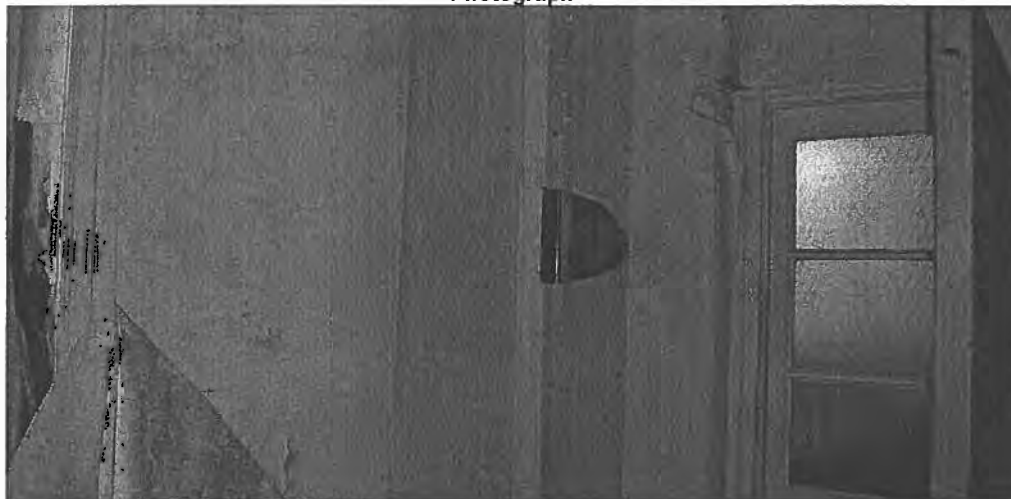
| <b>Location of Survey</b><br>Cane Hill Hospital,<br>Cane Hill,<br>Coulsdon, Surrey,<br>CR5 3ES | <b>Position of Sample/Photo</b><br>Hall/Chapel Corridor<br>End Office adj Pugin Paxton<br>Office Riser Panel | <b>Asbestos</b> Yes      /<br><br><b>Type</b> Amosite (Brown) |
| <b>Material</b> Board<br><b>Type</b> | <b>Quantity</b> 1m <sup>2</sup> | <b>Sample No</b> 06/B/8026/78<br><br><b>Survey Date</b> 24.04 - 29.06.06<br><br><b>Date of Report</b> 18.08.06<br><br><b>Surveyor(s)</b> <span style="background-color: black; color: black;">[REDACTED]</span> |

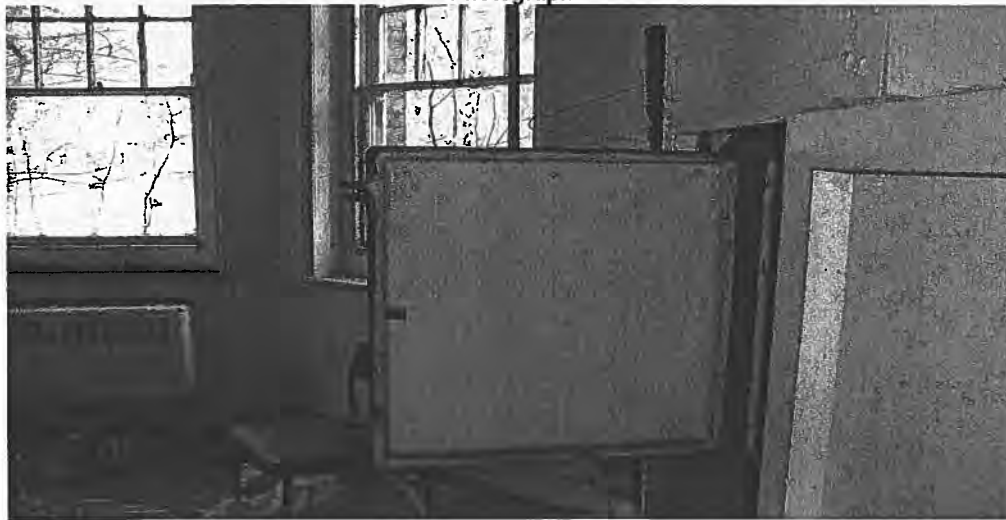
| <b>Location of Survey</b><br>Cane Hill Hospital,<br>Cane Hill,<br>Coulsdon, Surrey,<br>CR5 3ES | | <b>Position of Sample/Photo</b><br>Hall/Chapel Corridor<br>End Office adj Pugin Paxton<br>Electrics<br>Rope Seal | | <b>Asbestos</b> | Yes, Strongly<br>Presumed |

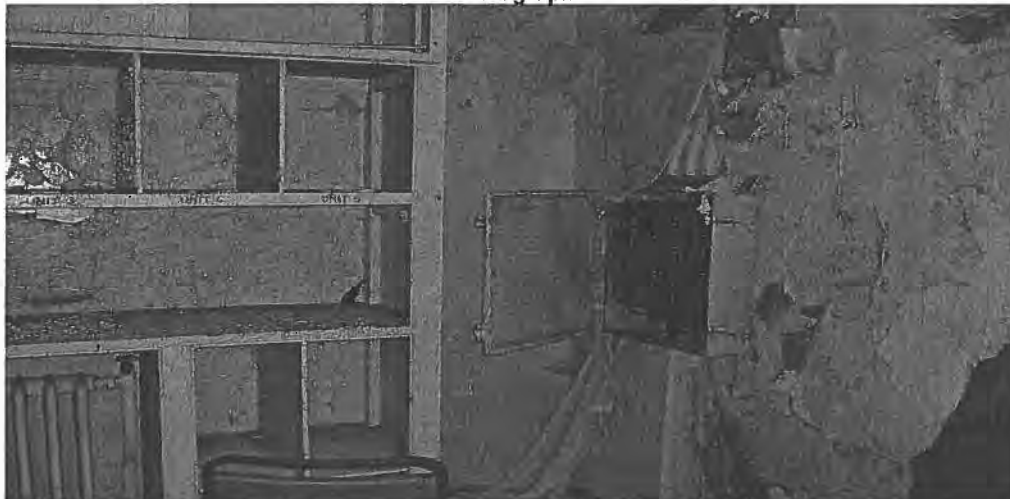
| <b>Location of Survey</b><br>Cane Hill Hospital,<br>Cane Hill,<br>Coulsdon, Surrey,<br>CR5 3ES | <b>Position of Sample/Photo</b><br>Hall/Chapel Corridor<br>Office Electrics<br>Rope seal | <b>Asbestos</b><br><br><b>Type</b> | Yes, Strongly<br>Presumed<br><br>Chrysotile (White) |
| <b>Material Type</b> Rope | <b>Quantity</b> 1m | <b>Sample No</b> As 06/B/8026/22<br><br><b>Survey Date</b> 24.04 - 29.06.06<br><br><b>Date of Report</b> 18.08.06<br><br><b>Surveyor(s)</b> <span style="background-color: black; color: black;">[REDACTED]</span> | |

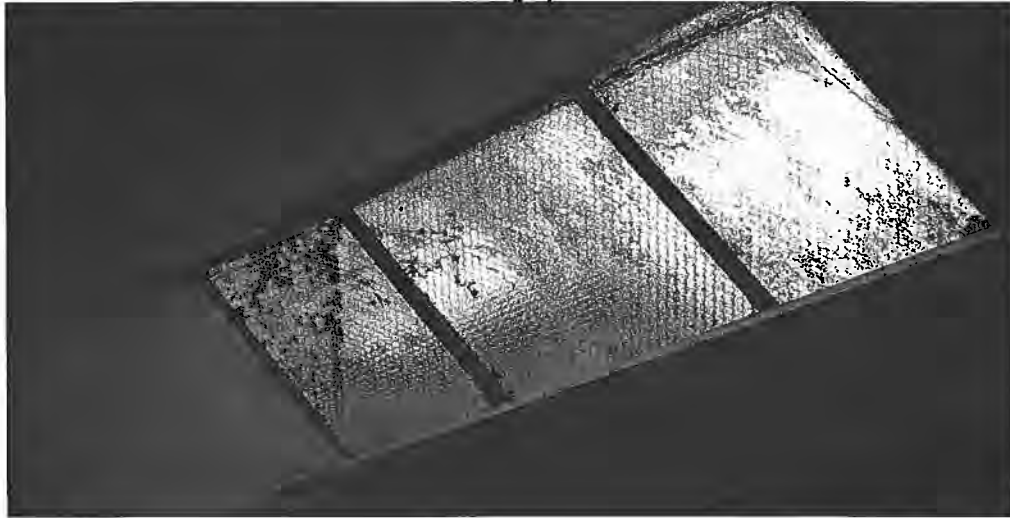
| <b>Location of Survey</b><br>Cane Hill Hospital,<br>Cane Hill,<br>Coulsdon, Surrey,<br>CR5 3ES | <b>Position of Sample/Photo</b><br>Hall/Chapel Corridor<br>Offices adjacent corridor to<br>Olave Queens skylight | <b>Asbestos</b> Yes, Strongly Presumed<br><br><b>Type</b> Chrysotile (White) |
| <b>Material Type</b> Rope | <b>Quantity</b> 10m | <b>Sample No</b> As 06/B8026/31<br><br><b>Survey Date</b> 24.04 - 29.06.06<br><br><b>Date of Report</b> 18.08.06<br><br><b>Surveyor(s)</b> <span style="background-color: black; color: black;">[REDACTED]</span> |

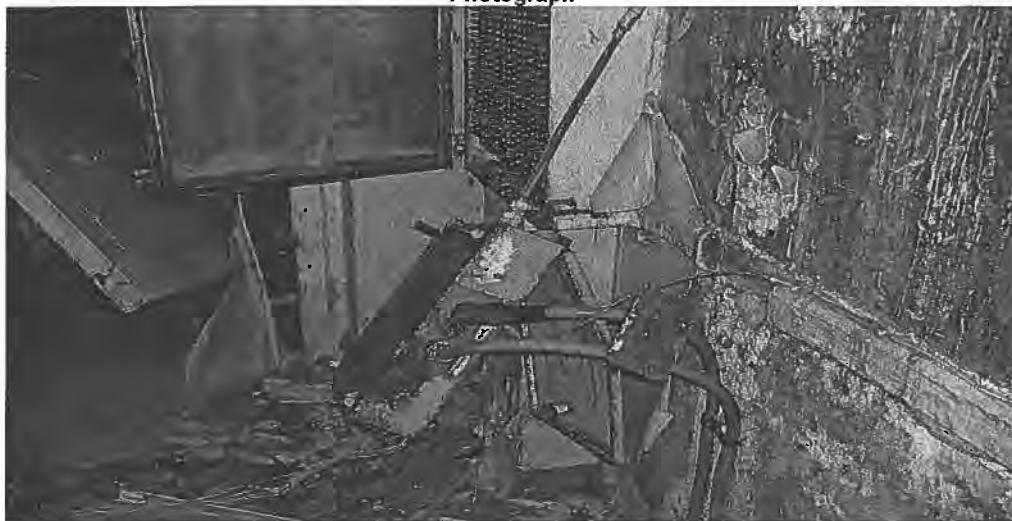
| <b>Location of Survey</b><br>Cane Hill Hospital,<br>Cane Hill,<br>Coulsdon, Surrey,<br>CR5 3ES | <b>Position of Sample/Photo</b><br>Hall/Chapel Corridor<br>Lobby Electrics to corridor to<br>Browning Blake Ward<br>Rope seal | <b>Asbestos</b><br><br><b>Type</b> | Yes, Strongly<br>Presumed<br><br>Chrysotile (White) |
| <b>Material Type</b> Rope | <b>Quantity</b> 1m | <b>Sample No</b><br><br><b>Survey Date</b><br><br><b>Date of Report</b><br><br><b>Surveyor(s)</b> | As 06/B/8026/22<br><br>24.04 - 29.06.06<br><br>18.08.06<br><br><div style="background-color: black; width: 100px; height: 30px;"></div> |

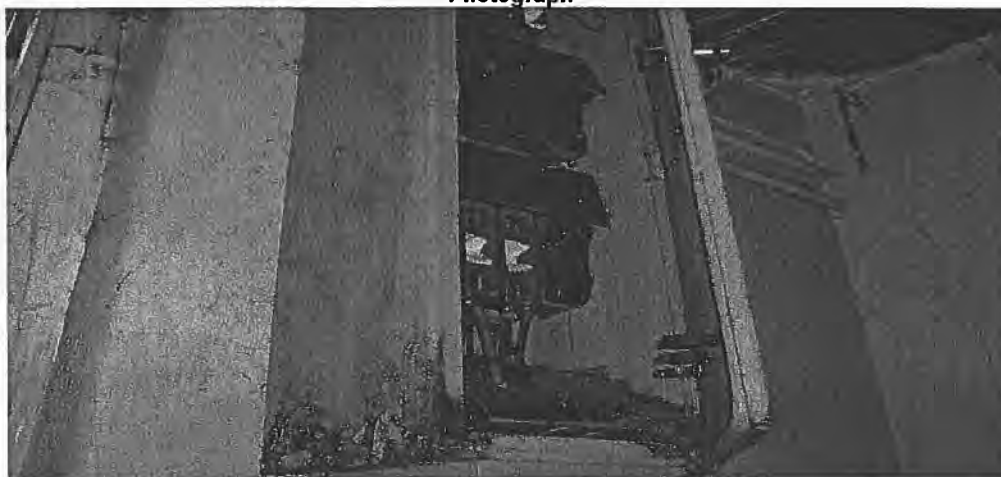
| <b>Location of Survey</b><br>Cane Hill Hospital,<br>Cane Hill,<br>Coulston, Surrey,<br>CR5 3ES | <b>Position of Sample/Photo</b><br>Hall/Chapel Corridor<br>Lobby Electrics to corridor to<br>Browning Blake Ward<br>Flashguards | <b>Asbestos</b> Yes, Strongly Presumed<br><br><b>Type</b> Chrysotile (White) |
| <b>Material Type</b> Rope | <b>Quantity</b> 1m | <b>Sample No</b> As 06/B/8026/9<br><br><b>Survey Date</b> 24.04 - 29.06.06<br><br><b>Date of Report</b> 18.08.06<br><br><b>Surveyor(s)</b> <span style="background-color: black; color: black;">[REDACTED]</span> |

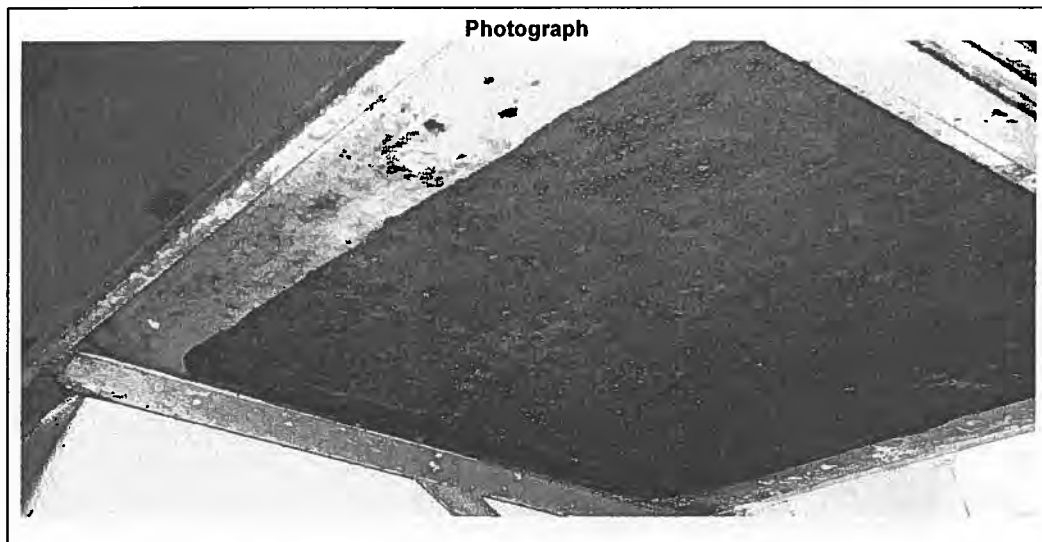
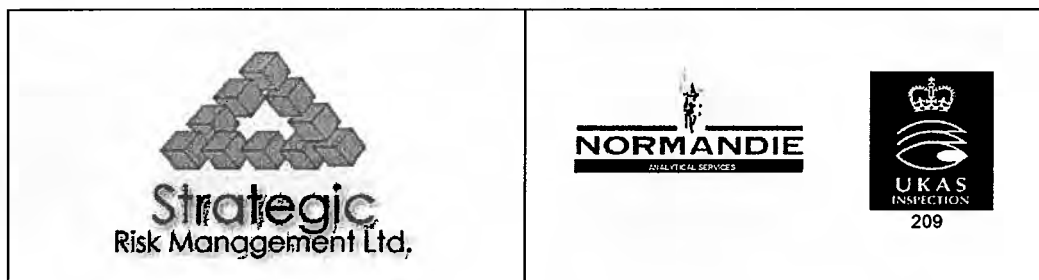
| <b>Location of Survey</b><br>Cane Hill Hospital,<br>Cane Hill,<br>Coulson, Surrey,<br>CR5 3ES | | <b>Position of Sample/Photo</b><br>Hall/Chapel Corridor<br>Kitchen adjacent Andrewes<br>Alley Ward, Sink Paint | | <b>Asbestos</b> | Strongly<br>Presumed |

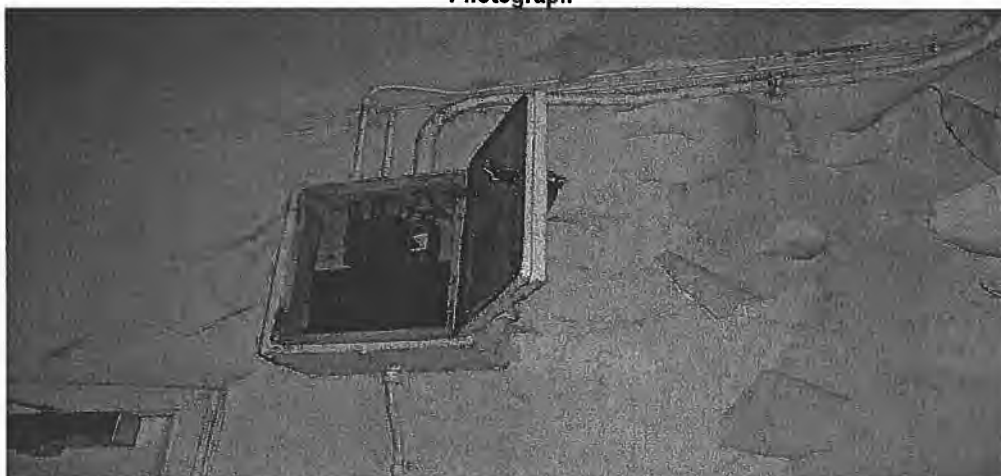
| <b>Location of Survey</b><br>Cane Hill Hospital,<br>Cane Hill,<br>Coulsdon, Surrey,<br>CR5 3ES | | <b>Position of Sample/Photo</b><br>Hall/Chapel Corridor<br>Lobby adjacent Andrewes<br>Alleyn Ward<br>Wall electrics | | <b>Asbestos</b><br><br><b>Type</b> | Yes, Strongly<br>Presumed<br><br>Chrysotile (White) |

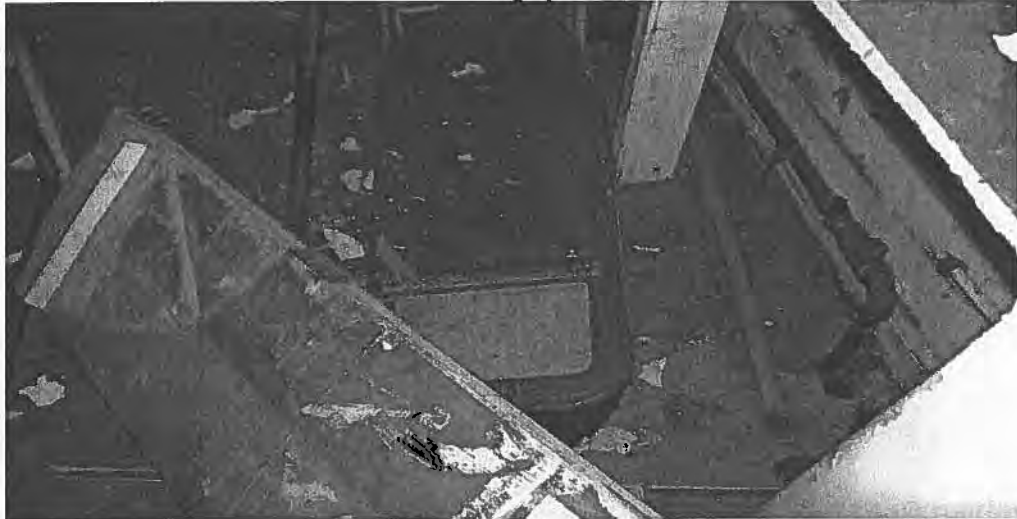
### Andrewes/Alleyn Ward

| <b>Material</b> Cement<br><b>Type</b> | <b>Quantity</b> <1m <sup>2</sup> | <b>Sample No</b> As 06/B/8026/20<br><br><b>Survey Date</b> 24.04 - 29.06.06<br><br><b>Date of Report</b> 18.08.06<br><b>Surveyor(s)</b> [REDACTED] |

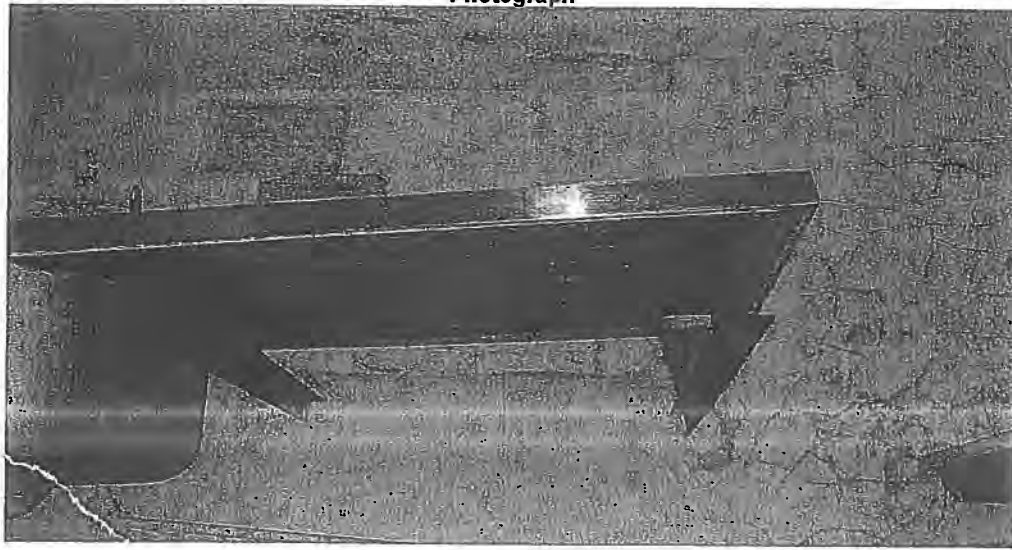
| <b>Location of Survey</b><br>Cane Hill Hospital,<br>Cane Hill,<br>Coulson, Surrey,<br>CR5 3ES | | <b>Position of Sample/Photo</b><br>Andrewes Alleyn Ward<br>Medication room<br>Sink Paint | | <b>Asbestos</b><br><br><b>Type</b> | <b>Yes, Strongly Presumed</b><br><br>Chrysotile (White) |

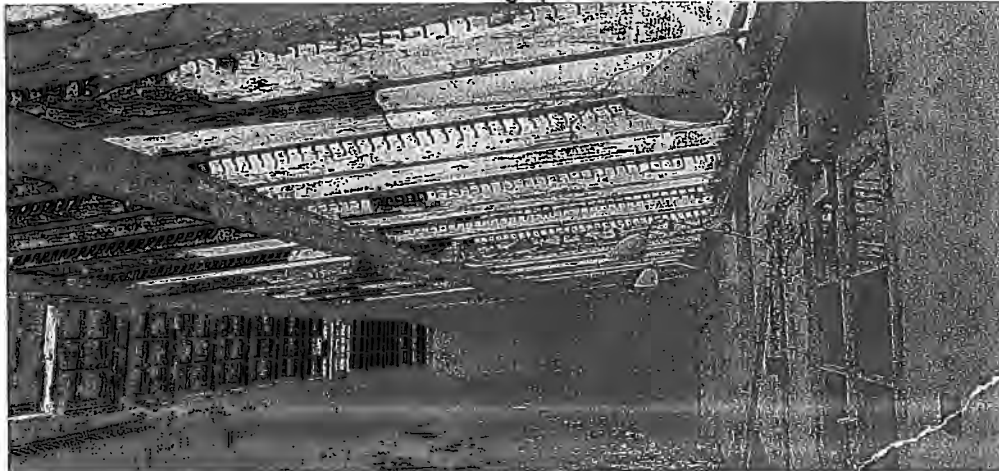
| <b>Location of Survey</b><br>Cane Hill Hospital,<br>Cane Hill,<br>Coulston, Surrey,<br>CR5 3ES | | <b>Position of Sample/Photo</b><br>Andrewes Alleyn Ward<br>Sun Room<br>Rope to skylight | | <b>Asbestos</b><br><br><b>Type</b> | <b>Yes, Strongly Presumed</b><br><br>Chrysotile (White) |

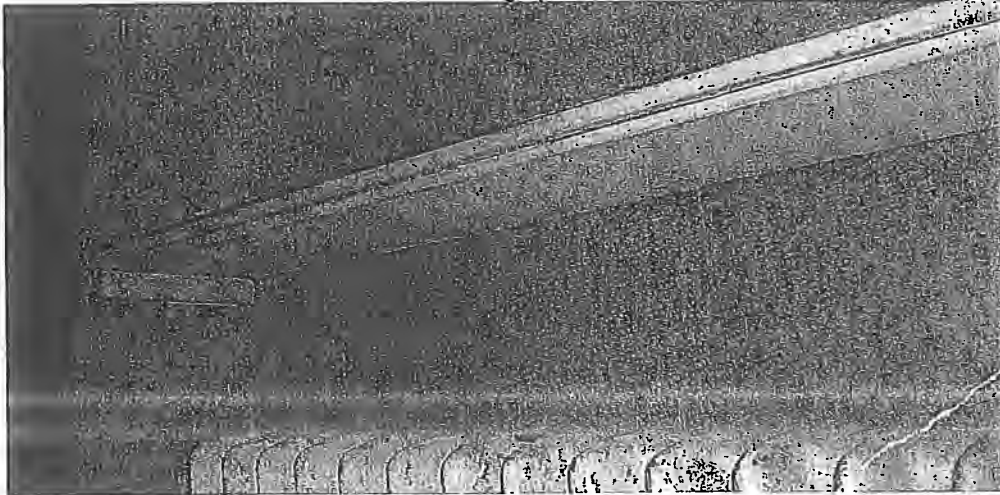
| <b>Location of Survey</b><br>Cane Hill Hospital,<br>Cane Hill,<br>Coulsdon, Surrey,<br>CR5 3ES | | <b>Position of Sample/Photo</b><br>Rear corridor adjacent<br>Andrewes Alleyn Ward<br>Room adjacent locker room<br>Radiator shelf panel | <b>Asbestos</b><br><br><b>Type</b> | Yes, Strongly<br>Presumed<br><br>Amosite (Brown) |
| <b>Material Type</b> | Board | <b>Quantity</b> | 1m <sup>2</sup> | <b>Sample No</b> As 06/B/8026/24<br><br><b>Survey Date</b> 24.04 - 29.06.06<br><br><b>Date of Report</b> 18.08.06<br><br><b>Surveyor(s)</b> <span style="background-color: black; color: black;">[REDACTED]</span> |
