TYPE 3  
SURVEY, ASSESSMENT AND REGISTER OF  
ASBESTOS CONTAINING MATERIALS  
AT  
CANE HILL, COULSDON  
SURREY, CR5 3ES

*Report No. 06/B/8026*

*September 2006*

**Strategic Risk Management  
P.O. Box 167, Sandbach  
Cheshire, CW11 3WG**

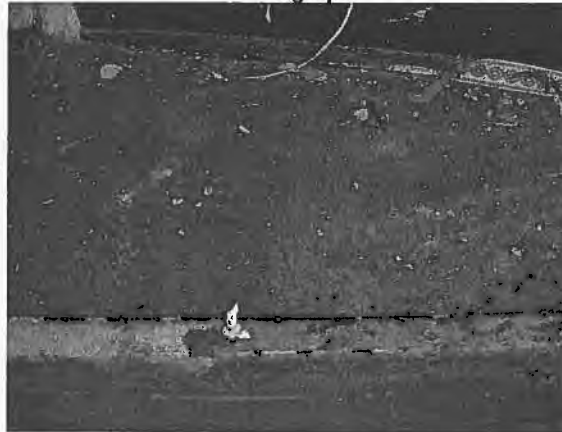
| <b>Location of Survey</b><br><br>Cane Hill Hospital,<br>Cane Hill,<br>Coulsdon, Surrey,<br>CR5 3ES | <b>Position of Sample/Photo</b><br><br>Pugin/Paxton Ward,<br>Throughout ward and<br>presumed throughout site –<br>Rawl plugs to metal rising pipe<br>sheaths and metal grid heater<br>covers in segregation rooms | <b>Asbestos</b><br><br>Yes | <b>Type</b><br><br>Chrysotile (White) |
| <b>Material Type</b><br><br>Rope | <b>Quantity</b><br><br>2cm <sup>2</sup> Each<br>Each sheath<br>approx 8<br>plugs | <b>Sample No</b> 06/B/8026/85<br><br><b>Survey Date</b> 24.04 - 29.06.06<br><br><b>Date of Report</b> 18.08.06<br><br><b>Surveyor(s)</b> <span style="background-color: black; color: black;">[REDACTED]</span> | |

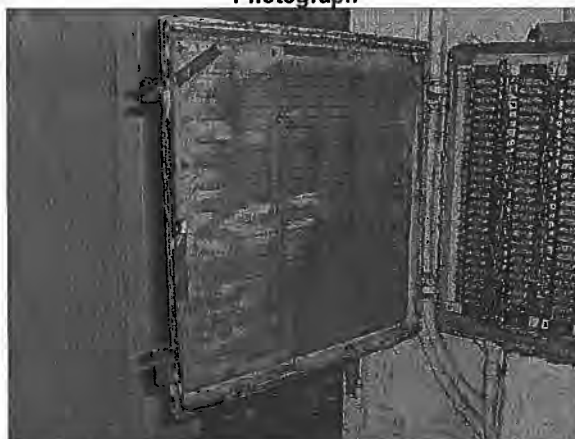
| <b>Location of Survey</b><br>Cane Hill Hospital,<br>Cane Hill,<br>Coulsdon, Surrey,<br>CR5 3ES | | <b>Position of Sample/Photo</b><br>Pugin/Paxton Ward,<br>Rope to switchboards | | <b>Asbestos</b><br><br><b>Type</b> | Yes<br>Strongly<br>presumed<br><br>Chrysotile (White) |

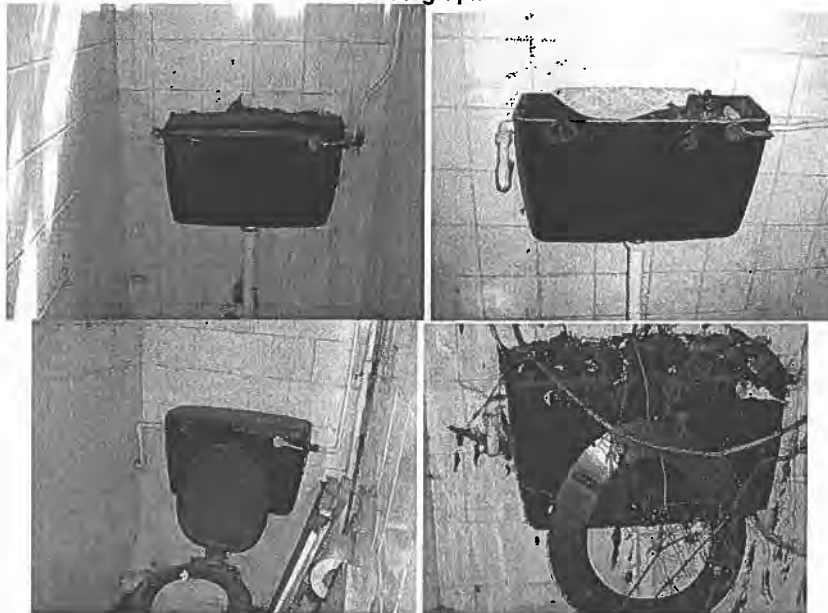
| <b>Location of Survey</b><br>Cane Hill Hospital,<br>Cane Hill,<br>Coulston, Surrey,<br>CR5 3ES | | <b>Position of Sample/Photo</b><br>Pugin/Paxton Ward,<br>Shires Lynx WC's cisterns<br>throughout | | <b>Asbestos</b> | Yes<br>Strongly<br>presumed |

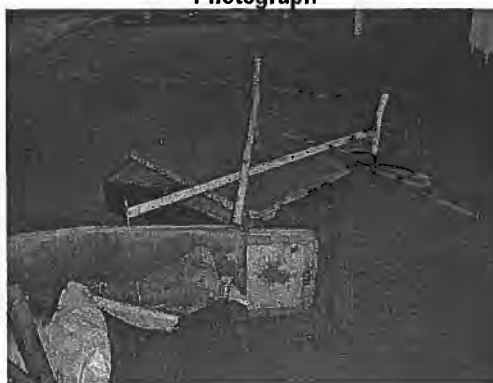
| <b>Location of Survey</b><br>Cane Hill Hospital,<br>Cane Hill,<br>Coulsdon, Surrey,<br>CR5 3ES | | <b>Position of Sample/Photo</b><br>Pugin/Paxton Ward,<br>Redundant ironing board pad | <b>Asbestos</b><br><br><b>Type</b> | Yes<br>Strongly<br>presumed<br><br>Chrysotile (White) |
| <b>Material Type</b> | Cement | <b>Quantity</b> | 0.25m <sup>2</sup> | <b>Sample No</b> As 06/B/8026/20<br><br><b>Survey Date</b> 24.04 - 29.06.06<br><br><b>Date of Report</b> 18.08.06<br><br><b>Surveyor(s)</b> <span style="background-color: black; color: black;">[REDACTED]</span> |

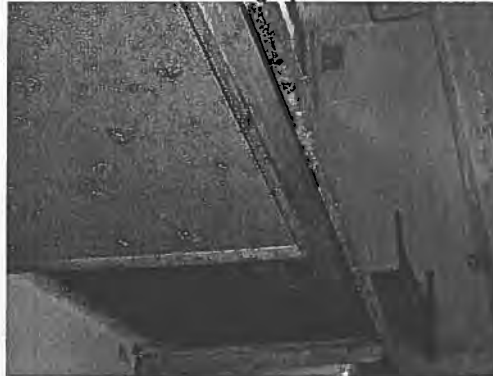
| <b>Location of Survey</b><br>Cane Hill Hospital,<br>Cane Hill,<br>Coulsdon, Surrey,<br>CR5 3ES | | <b>Position of Sample/Photo</b><br>Pugin / Paxton Ward,<br>1 <sup>st</sup> & 2 <sup>nd</sup> floor kitchen sinks and<br>drainers<br>Sink paint | | <b>Asbestos</b><br><br><b>Type</b> | Strongly<br>Presumed<br><br>Chrysotile (White) |

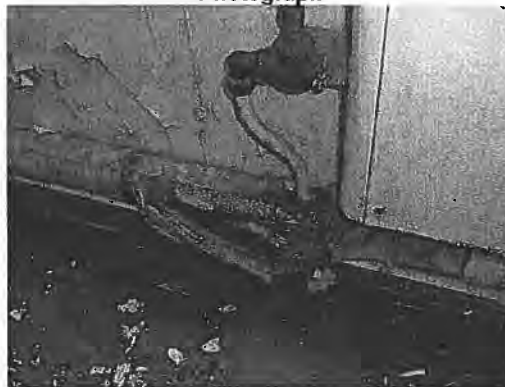
| <b>Location of Survey</b><br>Cane Hill Hospital,<br>Cane Hill,<br>Coulston, Surrey,<br>CR5 3ES | | <b>Position of Sample/Photo</b><br>Pugin/Paxton Ward<br>First Floor Kitchen, Pipe Cloth<br>Wrap | | <b>Asbestos</b><br><br><b>Type</b> | Yes<br><br>Chrysotile (White) |
| <b>Material Type</b><br>Cloth | | <b>Quantity</b><br>3m <sup>2</sup> | | <b>Sample No</b><br><br><b>Survey Date</b><br><br><b>Date of Report</b><br><b>Surveyor(s)</b> | 06/B/8026/88<br>24.04 - 29.06.06<br>18.08.06<br> |

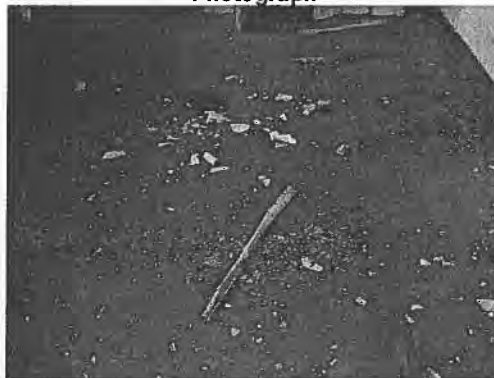
| <b>Location of Survey</b><br>Cane Hill Hospital,<br>Cane Hill,<br>Coulsdon, Surrey,<br>CR5 3ES | | <b>Position of Sample/Photo</b><br>Pugin/Paxton Ward,<br>First Floor Kitchen, Pipe Cloth<br>Wrap debris on floor | | <b>Asbestos</b><br><br><b>Type</b> | Yes<br>Strongly<br>presumed<br><br>Chrysotile (White) |

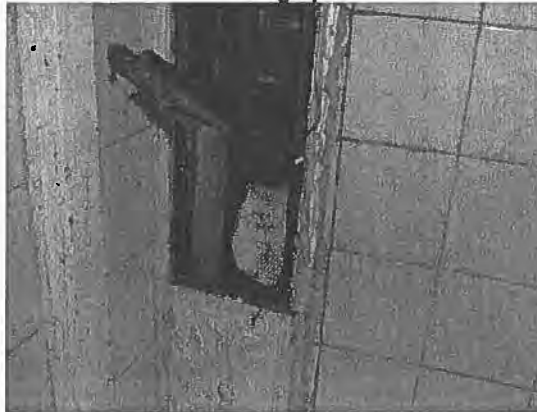
| <b>Location of Survey</b><br><br>Cane Hill Hospital,<br>Cane Hill,<br>Coulsdon, Surrey,<br>CR5 3ES | <b>Position of Sample/Photo</b><br><br>Pugin/Paxton Ward, 2nd Floor<br>Kitchen, Pipe Cloth Wrap<br>(strongly presumed within riser<br>between floors to each kitchen<br>and pipe work in each kitchen<br>Under MMMF lagging) | <b>Asbestos</b><br><br><b>Type</b> | Yes<br>Strongly<br>Presumed<br><br>Chrysotile (White) |
| <b>Material Type</b> Cloth | <b>Quantity</b> 4m <sup>2</sup> | <b>Sample No</b><br><br><b>Survey Date</b><br><br><b>Date of Report</b><br><b>Surveyor(s)</b> | As 06/B/8026/88<br><br>24.04 - 29.06.06<br><br>18.08.06<br><div style="background-color: black; width: 100px; height: 40px; margin-top: 5px;"></div> |

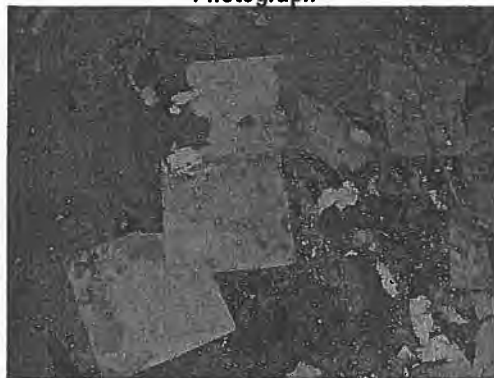
| <b>Location of Survey</b><br>Cane Hill Hospital,<br>Cane Hill,<br>Coulson, Surrey,<br>CR5 3ES | | <b>Position of Sample/Photo</b><br>Corridor Adjacent /Rear<br>Pugin/Paxton Ward<br>Light grey Floor Tile | | <b>Asbestos</b> | Yes |

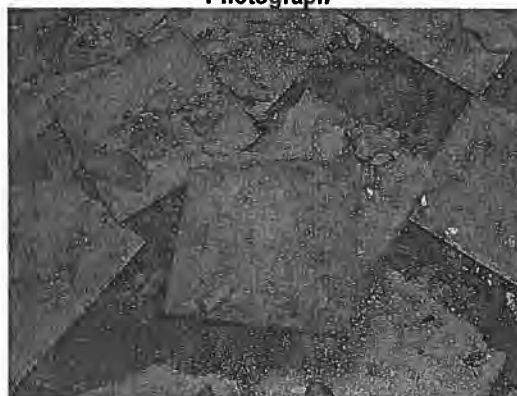
| <b>Location of Survey</b><br>Cane Hill Hospital,<br>Cane Hill,<br>Coulston, Surrey,<br>CR5 3ES | | <b>Position of Sample/Photo</b><br>Corridor Adjacent /Rear<br>Pugin/Paxton Ward<br>Dark grey Floor Tile | <b>Asbestos</b> Yes |

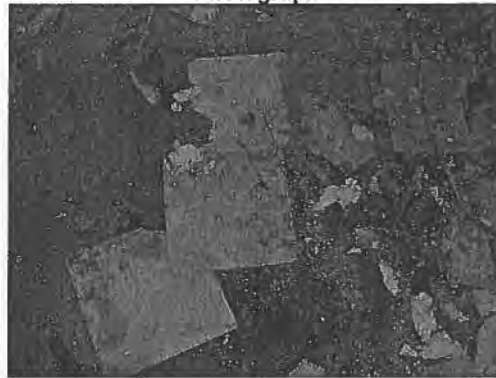
| <b>Location of Survey</b><br>Cane Hill Hospital,<br>Cane Hill,<br>Coulston, Surrey,<br>CR5 3ES | | <b>Position of Sample/Photo</b><br>Corridor Adjacent / Rear<br>Pugin/Paxton Ward,<br>Red Floor Tile | | <b>Asbestos</b><br><br><b>Type</b> | <b>Yes</b><br><br>Chrysotile (White) |

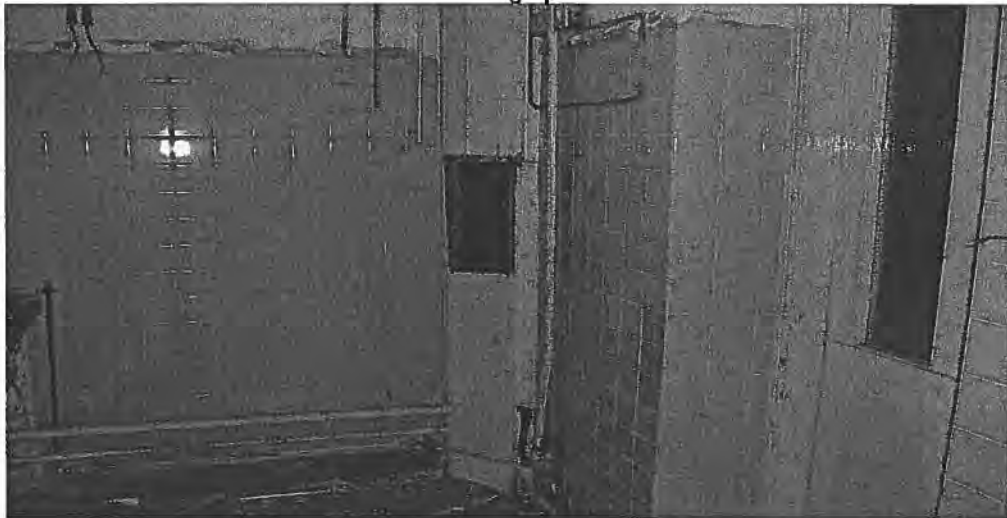
| <b>Location of Survey</b><br>Cane Hill Hospital,<br>Cane Hill,<br>Coulsdon, Surrey,<br>CR5 3ES | | <b>Position of Sample/Photo</b><br>Ruskin/Rosseti Ward<br>Kitchen<br>Riser panel | <b>Asbestos</b> Yes |

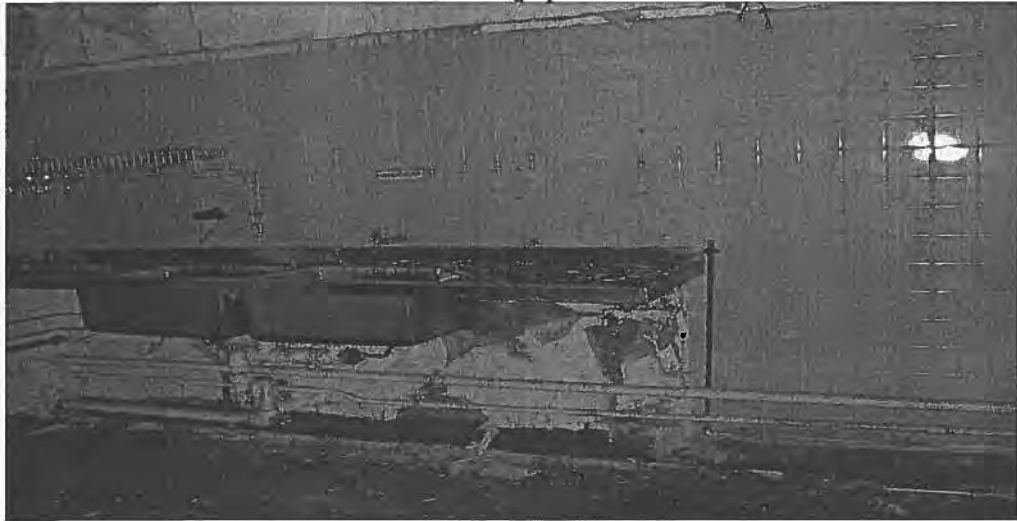
| <b>Location of Survey</b><br>Cane Hill Hospital,<br>Cane Hill,<br>Coulston, Surrey,<br>CR5 3ES | | <b>Position of Sample/Photo</b><br>Ruskin/Rossetti Ward<br>Ground Floor Kitchen<br>Sink Paint | | <b>Asbestos</b><br><br><b>Type</b> | <b>Yes, Strongly Presumed</b><br><br>Chrysotile (White) |

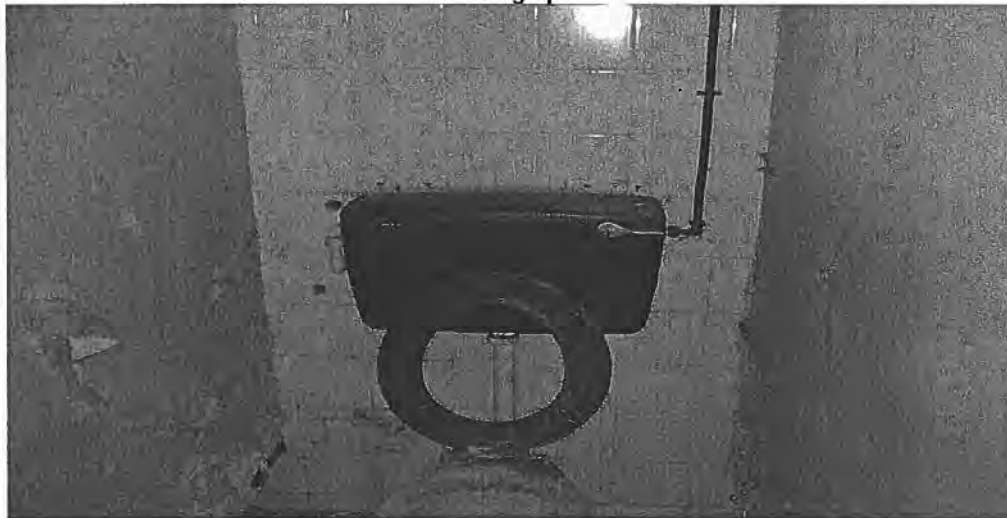
| <b>Location of Survey</b><br>Cane Hill Hospital,<br>Cane Hill,<br>Coulston, Surrey,<br>CR5 3ES | | <b>Position of Sample/Photo</b><br>Ruskin/Rosseti Ward<br>WC, Cistern (X8) | | <b>Asbestos</b><br><br><b>Type</b> | Yes, Strongly<br>Presumed<br><br>Amosite (Brown) |

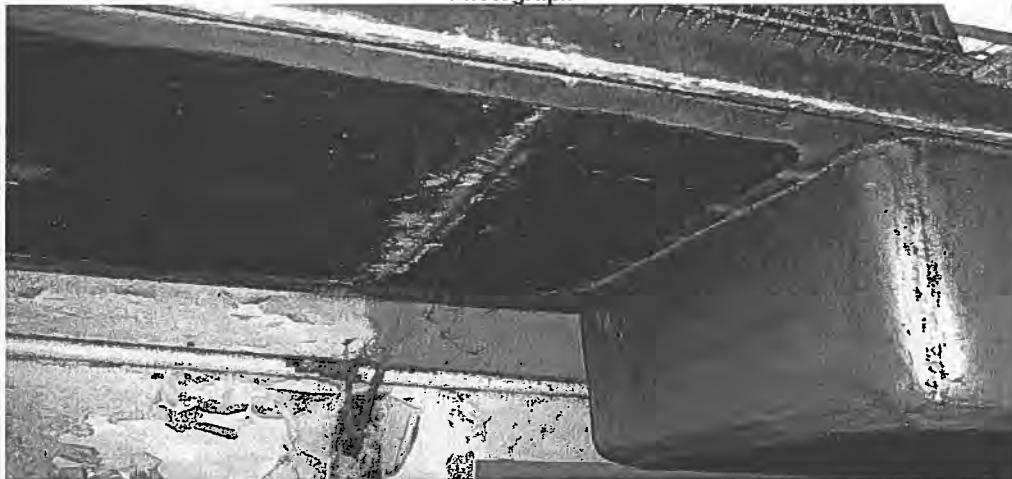
| <b>Location of Survey</b><br>Cane Hill Hospital,<br>Cane Hill,<br>Coulsdon, Surrey,<br>CR5 3ES | | <b>Position of Sample/Photo</b><br>Ruskin/Rossetti Ward<br>First floor kitchen<br>Sink Paint | | <b>Asbestos</b><br><br><b>Type</b> | <b>Yes, Strongly Presumed</b><br><br>Chrysotile (White) |

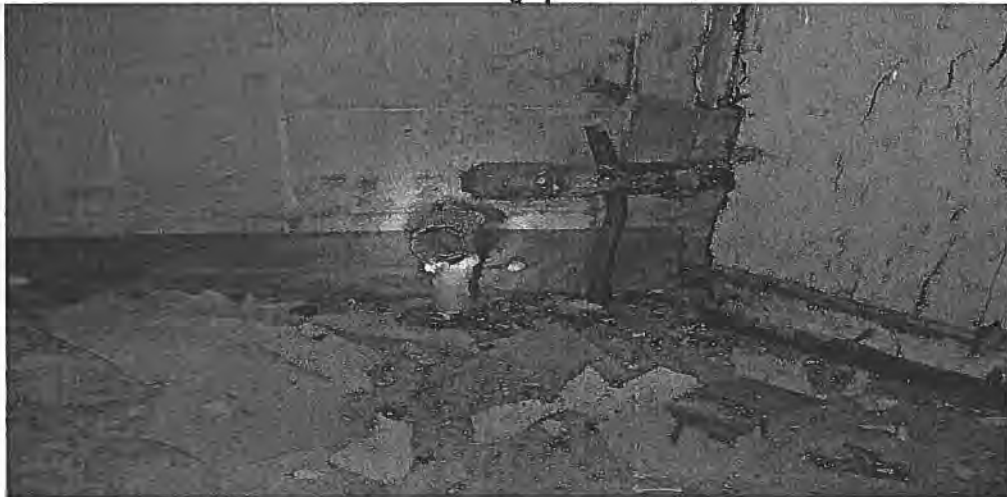
| <b>Location of Survey</b><br>Cane Hill Hospital,<br>Cane Hill,<br>Coulsdon, Surrey,<br>CR5 3ES | | <b>Position of Sample/Photo</b><br>Ruskin/Rosseti Ward<br>First floor kitchen<br>Rope to Pipe | | <b>Asbestos</b><br><br><b>Type</b> | Yes, Strongly<br>Presumed<br><br>Chrysotile (White) |

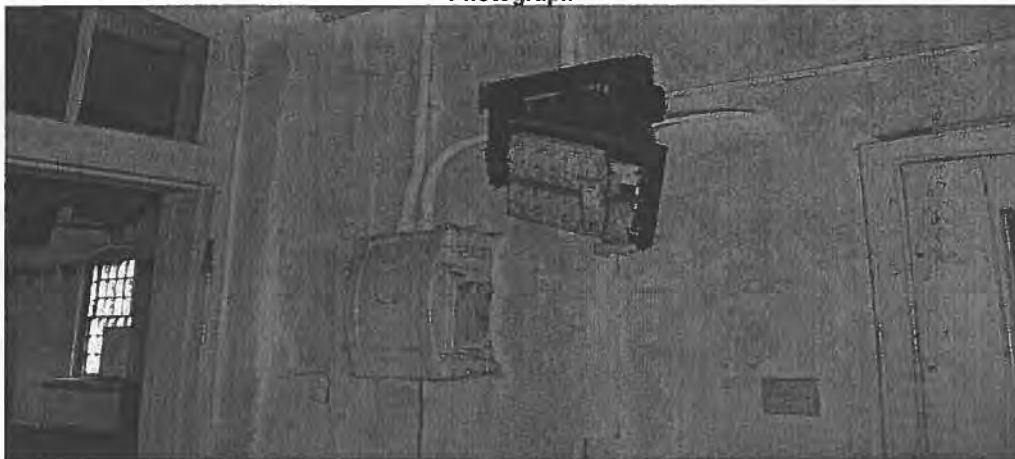
| <b>Location of Survey</b><br>Cane Hill Hospital,<br>Cane Hill,<br>Coulston, Surrey,<br>CR5 3ES | | <b>Position of Sample/Photo</b><br>Ruskin/Rosseti Ward<br>First floor corridor wall electrics<br>(rope, fuse carrier & shelf) | <b>Asbestos</b><br><br><b>Type</b> | Yes, Strongly<br>Presumed<br><br>Chrysotile (White) |
| <b>Material Type</b> | Rope<br>& Cement | <b>Quantity</b> | 1m <sup>2</sup> | <b>Sample No</b><br>As 06/B/8026/9<br>& 28<br><br><b>Survey Date</b><br>24.04 – 29.06.06<br><br><b>Date of Report</b><br>18.08.06<br><br><b>Surveyor(s)</b> |

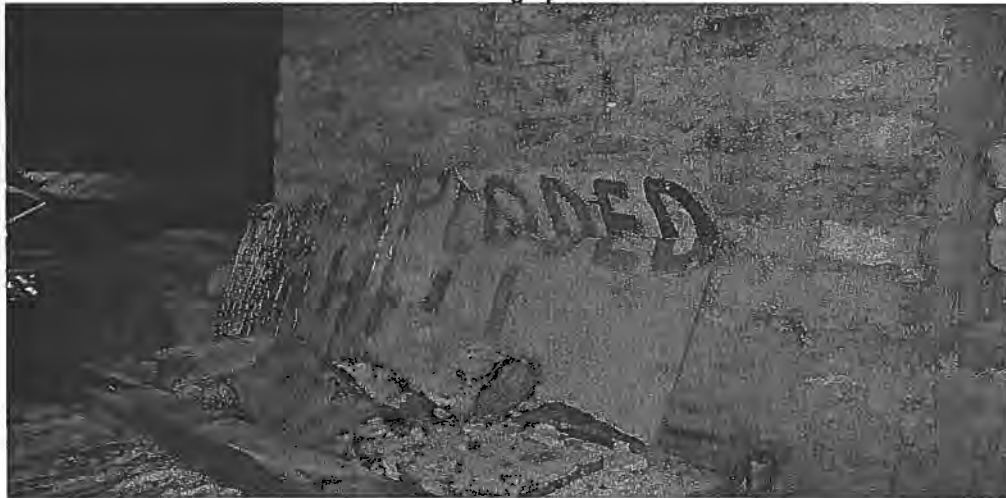
| <b>Location of Survey</b><br>Cane Hill Hospital,<br>Cane Hill,<br>Coulsdon, Surrey,<br>CR5 3ES | <b>Position of Sample/Photo</b><br>Ruskin/Rossetti Ward<br>Loft, AIB debris | <b>Asbestos</b> Yes<br><br><b>Type</b> Amosite (Brown)<br>Chrysotile (White) |
| <b>Material</b> Board<br><b>Type</b> | <b>Quantity</b> 2m | <b>Sample No</b> 06/B/8026/225<br><br><b>Survey Date</b> 24.04 - 29.06.06<br><br><b>Date of Report</b> 18.08.06<br><br><b>Surveyor(s)</b> <span style="background-color: black; color: black;">[REDACTED]</span> |

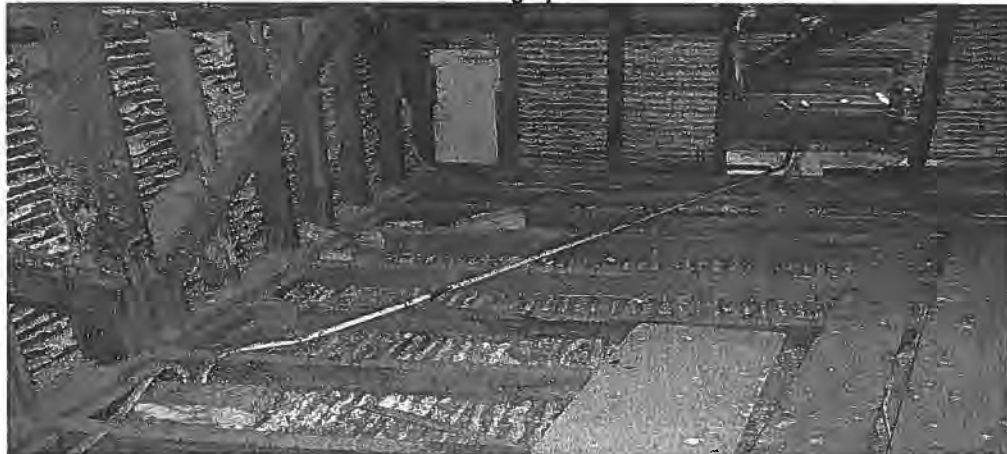
| <b>Location of Survey</b><br>Cane Hill Hospital,<br>Cane Hill,<br>Coulston, Surrey,<br>CR5 3ES | | <b>Position of Sample/Photo</b><br>Ruskin/Rossetti<br>Loft, AIB panel to eaves | <b>Asbestos</b><br><br><b>Type</b> | Yes, Strongly<br>Presumed<br><br>Chrysotile (White) |
| <b>Material Type</b> | Board | <b>Quantity</b> | 1m | <b>Sample No</b> As 06/B/8026/225<br><br><b>Survey Date</b> 24.04 - 29.06.06<br><br><b>Date of Report</b> 18.08.06<br><br><b>Surveyor(s)</b> <span style="background-color: black; color: black;">[REDACTED]</span> |

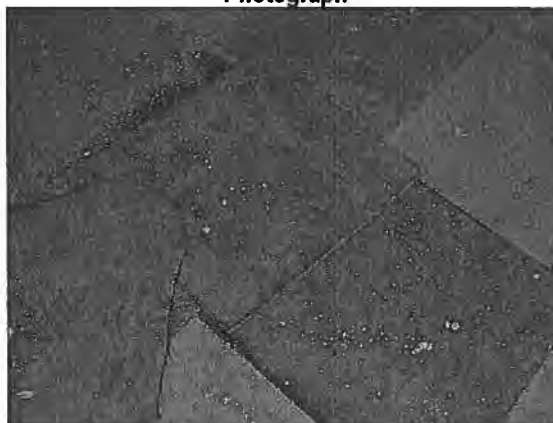
| <b>Location of Survey</b><br>Cane Hill Hospital,<br>Cane Hill,<br>Coulsdon, Surrey,<br>CR5 3ES | | <b>Position of Sample/Photo</b><br>Corridor Adjacent<br>Shaftesbury/Salter<br>Light grey Floor Tile | | <b>Asbestos</b> | Yes |

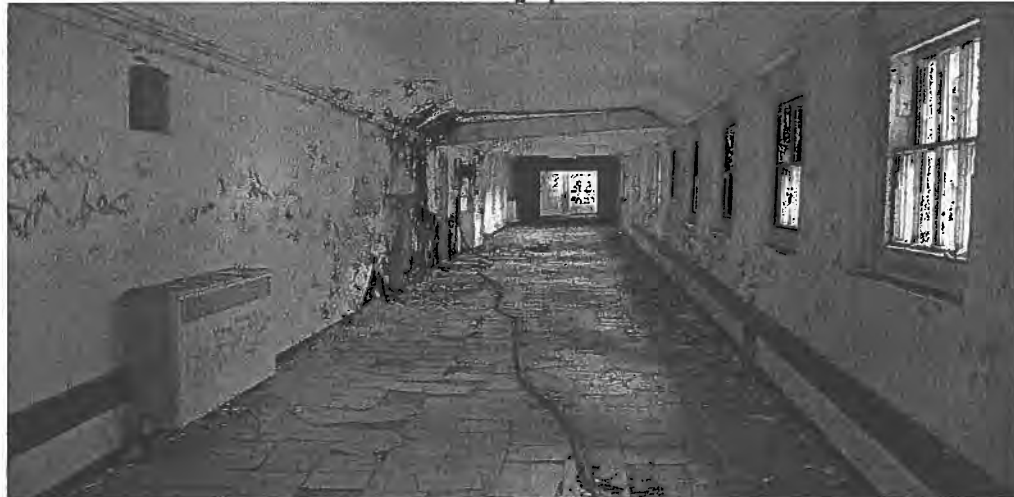
| <b>Location of Survey</b><br>Cane Hill Hospital,<br>Cane Hill,<br>Coulston, Surrey,<br>CR5 3ES | | <b>Position of Sample/Photo</b><br>Corridor Adjacent<br>Shaftesbury/Salter<br>Black Floor Tile | <b>Asbestos</b> Yes |

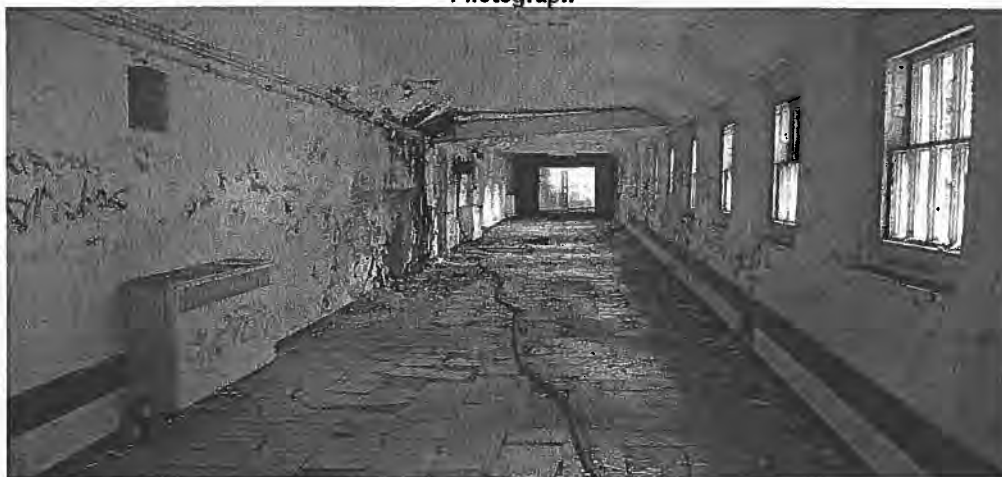
| <b>Location of Survey</b><br>Cane Hill Hospital,<br>Cane Hill,<br>Coulston, Surrey,<br>CR5 3ES | | <b>Position of Sample/Photo</b><br>Corridor Adjacent<br>Shaftesbury/Salter<br>Red Floor Tile | | <b>Asbestos</b> | <b>No Asbestos<br/>Detected</b> |

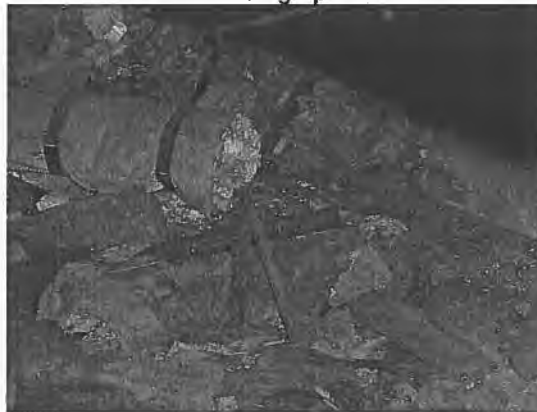
| <b>Location of Survey</b><br>Cane Hill Hospital,<br>Cane Hill,<br>Coulsdon, Surrey,<br>CR5 3ES | | <b>Position of Sample/Photo</b><br>Shaftesbury/Salter Ward,<br>Undercroft Sectional lagging<br>debris under Main Ward Room | | <b>Asbestos</b> | Yes |

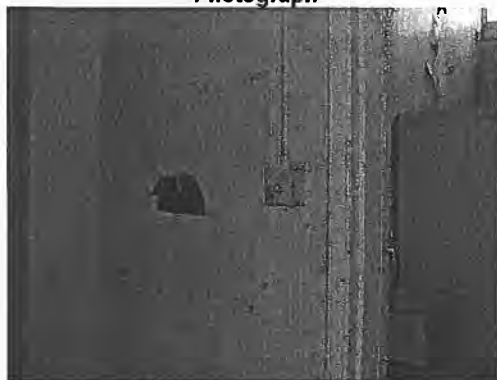
| <b>Location of Survey</b><br>Cane Hill Hospital,<br>Cane Hill,<br>Coulsdon, Surrey,<br>CR5 3ES | <b>Position of Sample/Photo</b><br>Shaftesbury/Salter Ward,<br>Ground W.C Lobby Wall Panel | <b>Asbestos</b><br><br><b>Type</b> | Yes<br><br>Chrysotile (White) |
| <b>Material Type</b><br>Cement | <b>Quantity</b><br>0.5m <sup>2</sup> | <b>Sample No</b><br>06/B/8026/103<br><br><b>Survey Date</b><br>24.04 - 29.06.06<br><br><b>Date of Report</b><br>18.08.06<br><br><b>Surveyor(s)</b> | <div style="background-color: black; width: 100px; height: 30px; margin-top: 10px;"></div> |

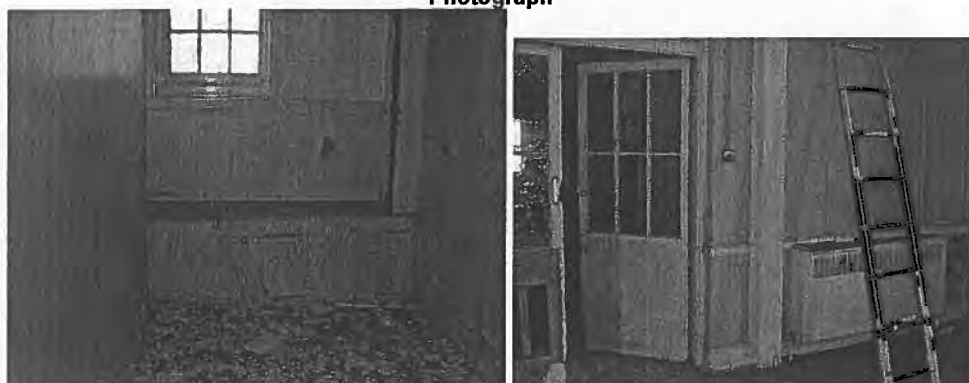
| <b>Location of Survey</b><br>Cane Hill Hospital,<br>Cane Hill,<br>Coulsdon, Surrey,<br>CR5 3ES | | <b>Position of Sample/Photo</b><br>Shaftesbury/Salter Ward<br>Throughout ward and<br>presumed throughout site –<br>Rawl plugs to metal rising pipe<br>sheaths and metal grid heater<br>covers in segregation rooms | | <b>Asbestos</b><br><br><b>Type</b> | Yes, Strongly<br>presumed<br><br>Chrysotile (White) |
| <b>Material Type</b> | Rope | <b>Quantity</b> | 2cm <sup>2</sup> Each<br>Each sheath<br>approx 8<br>plugs | <b>Sample No</b><br><br><b>Survey Date</b><br><br><b>Date of Report</b><br><br><b>Surveyor(s)</b> | As 06/B/8026/85<br>24.04 - 29.06.06<br>18.08.06<br>[REDACTED] |

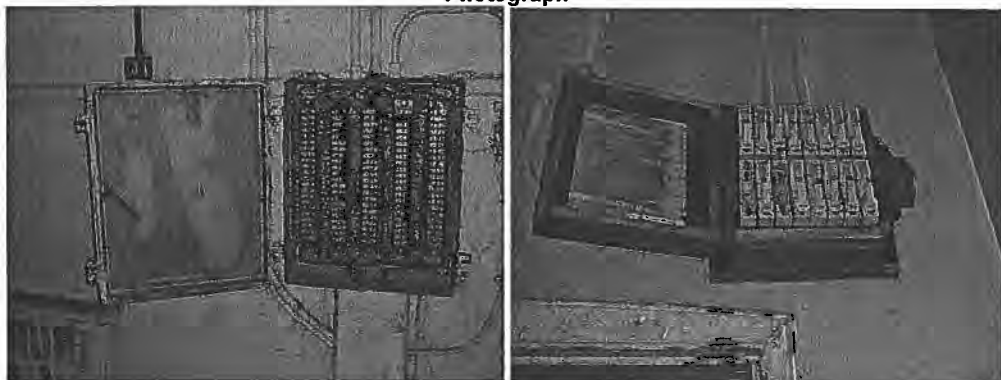
| <b>Location of Survey</b><br>Cane Hill Hospital,<br>Cane Hill,<br>Coulston, Surrey,<br>CR5 3ES | | <b>Position of Sample/Photo</b><br>Shaftesbury/Salter Ward<br>Rope to switchboards (all<br>floors) | | <b>Asbestos</b><br><br><b>Type</b> | <b>Strongly<br/>Presumed</b><br><br>Chrysotile (White) |

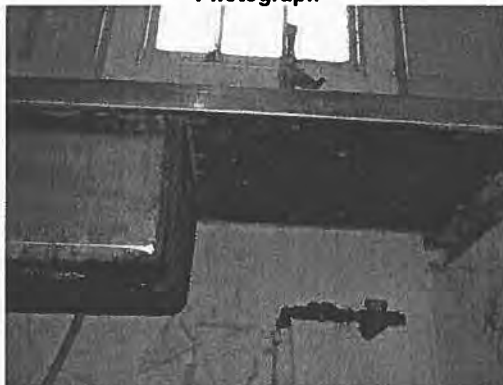
| <b>Location of Survey</b><br>Cane Hill Hospital,<br>Cane Hill,<br>Coulsdon, Surrey,<br>CR5 3ES | | <b>Position of Sample/Photo</b><br>Shaftesbury/Salter Ward,<br>Sink paint<br>(All kitchen sinks and dariners<br>on each floor.) | | <b>Asbestos</b><br><br><b>Type</b> | <b>Strongly<br/>Presumed</b><br><br>Chrysotile (White) |

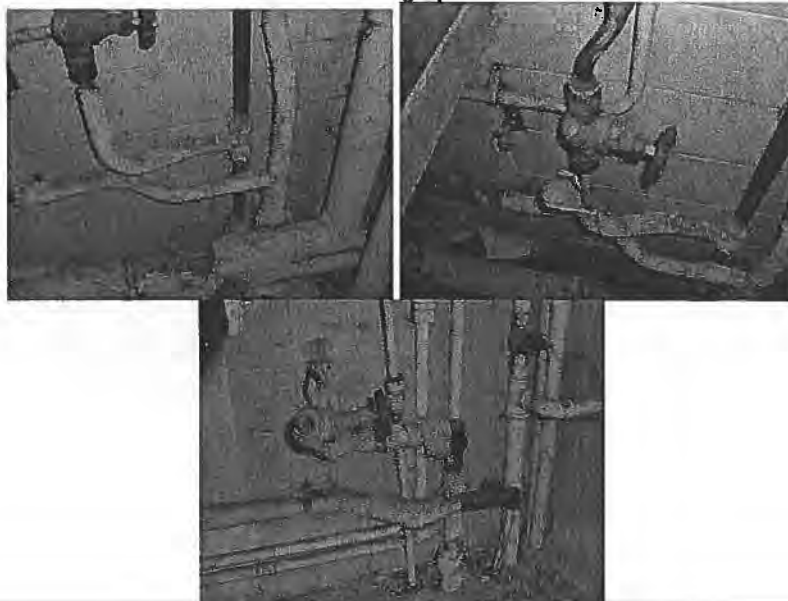
| <b>Location of Survey</b><br>Cane Hill Hospital,<br>Cane Hill,<br>Coulson, Surrey,<br>CR5 3ES | | <b>Position of Sample/Photo</b><br>Shaftesbury/Salter Ward,<br>Ground Floor Kitchen, Pipe<br>Cloth Wrap debris on floor<br>(also to 2 <sup>nd</sup> and 3 <sup>rd</sup> floors) | | <b>Asbestos</b><br><br><b>Type</b> | Yes, Strongly<br>Presumed<br><br>Chrysotile (White) |

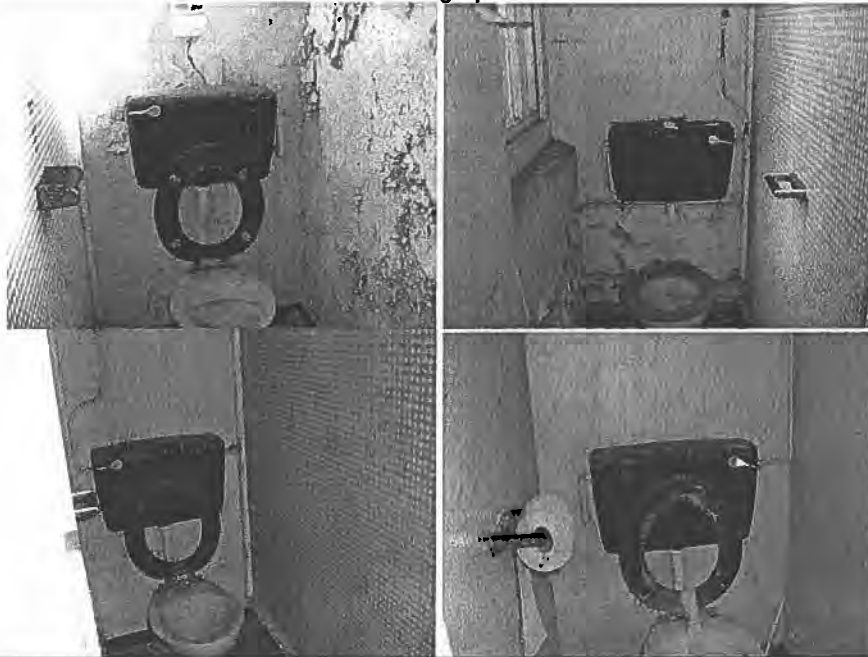
| <b>Location of Survey</b><br>Cane Hill Hospital,<br>Cane Hill,<br>Coulston, Surrey,<br>CR5 3ES | | <b>Position of Sample/Photo</b><br>Shaftesbury/Salter Ward,<br>Shires lynx WC cisterns<br>(approx 4 on all floors ) | | <b>Asbestos</b><br><br><b>Type</b> | Yes<br>Strongly<br>presumed<br><br>Amosite (Brown) |

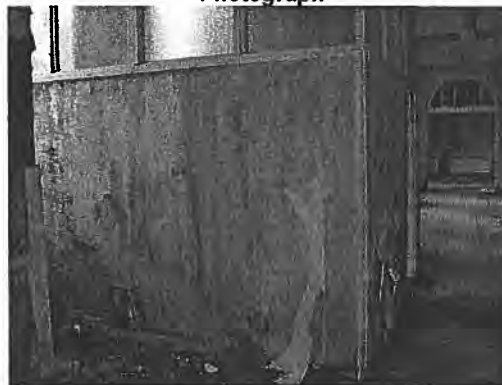
| <b>Location of Survey</b><br>Cane Hill Hospital,<br>Cane Hill,<br>Coulston, Surrey,<br>CR5 3ES | | <b>Position of Sample/Photo</b><br>Shaftesbury/Salter Ward,<br>Ground Floor Office Wall<br>Panel behind wood | | <b>Asbestos</b> Yes |

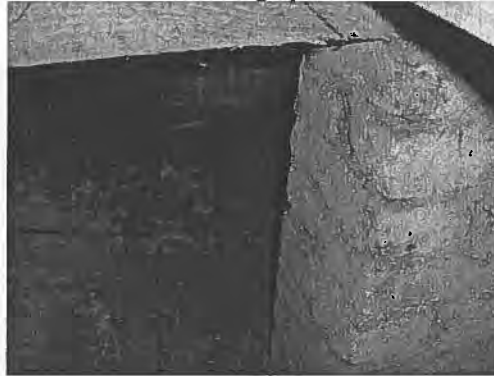
| <b>Location of Survey</b><br>Cane Hill Hospital,<br>Cane Hill,<br>Coulston, Surrey,<br>CR5 3ES | | <b>Position of Sample/Photo</b><br>Shaftesbury/Salter Ward<br>Undercroft,<br>Debris Floor void end room | | <b>Asbestos</b> | No Asbestos<br>Detected |

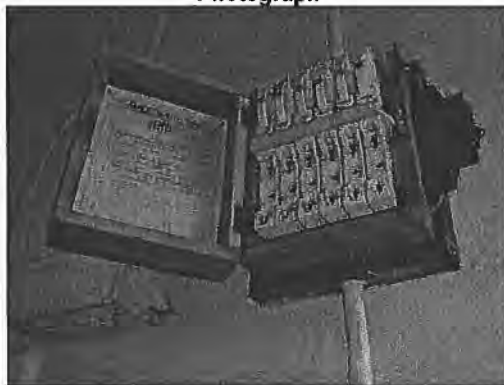
| <b>Location of Survey</b><br>Cane Hill Hospital,<br>Cane Hill,<br>Coulston, Surrey,<br>CR5 3ES | | <b>Position of Sample/Photo</b><br>Shaftesbury/Salter Ward,<br>Fuse Box Shelf<br>On 2 <sup>nd</sup> and 3 <sup>rd</sup> floors | | <b>Asbestos</b> Yes |

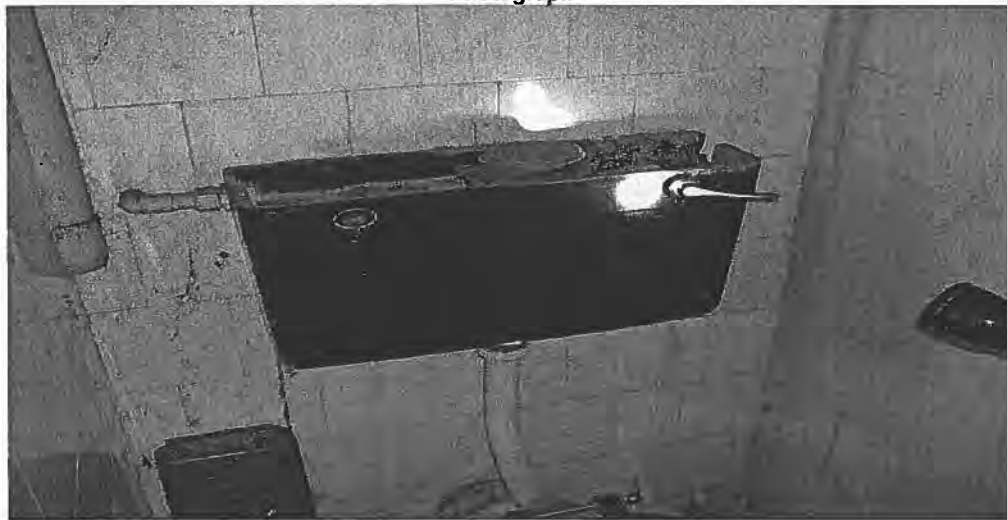
| <b>Location of Survey</b><br>Cane Hill Hospital,<br>Cane Hill,<br>Coulson, Surrey,<br>CR5 3ES | | <b>Position of Sample/Photo</b><br>Turner Ward<br>W.C. Cistern (X1) | | <b>Asbestos</b> | Yes, Strongly<br>Presumed |

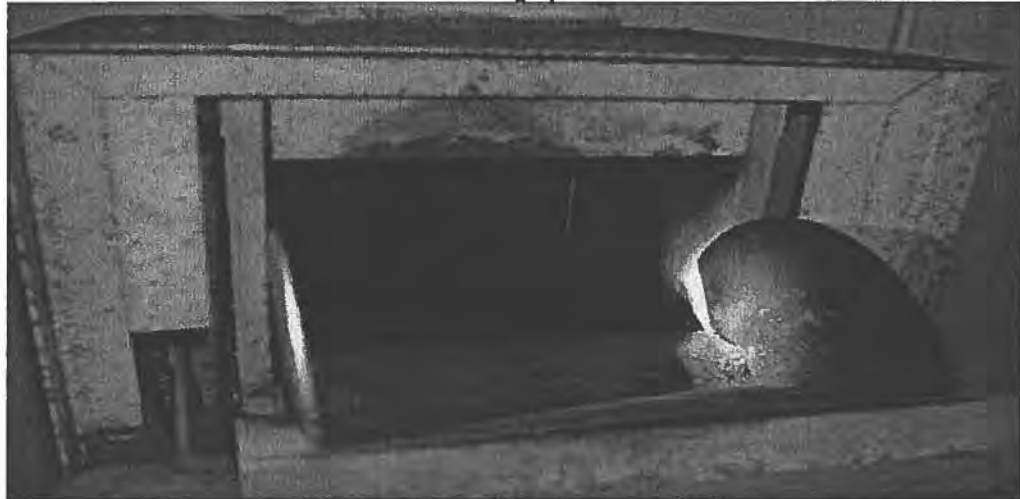
| <b>Location of Survey</b><br>Cane Hill Hospital,<br>Cane Hill,<br>Coulston, Surrey,<br>CR5 3ES | <b>Position of Sample/Photo</b><br>Turner Ward<br>First Floor Bunny Boiler<br>Internal Panel (presumed<br>within all bunny boilers) | <b>Asbestos</b><br><br><b>Type</b> | Yes<br><br>Chrysotile (White) |
| <b>Material Type</b><br>Cement | <b>Quantity</b><br>1m <sup>2</sup> | <b>Sample No</b><br><br><b>Survey Date</b><br><br><b>Date of Report</b><br><br><b>Surveyor(s)</b> | 06/B/8026/109<br><br>24.04 - 29.06.06<br><br>18.08.06<br><div style="background-color: black; width: 100px; height: 30px;"></div> |

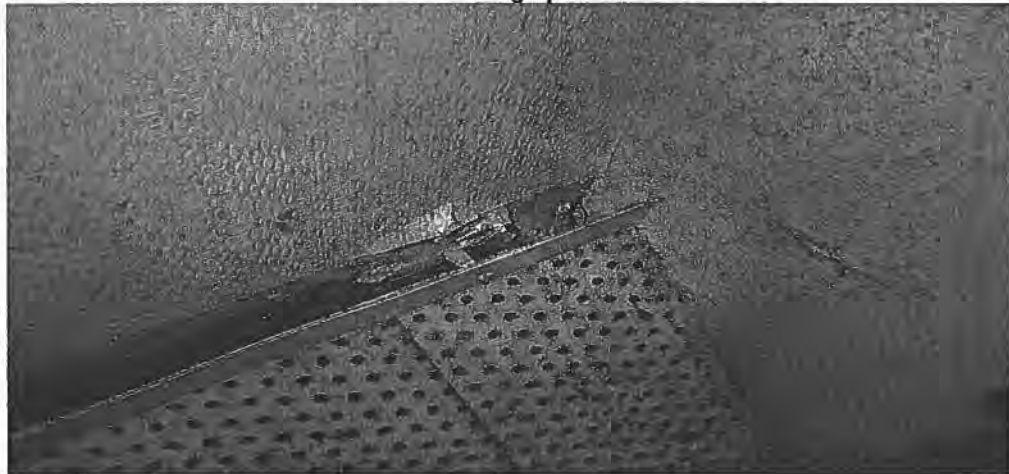
| <b>Location of Survey</b><br>Cane Hill Hospital,<br>Cane Hill,<br>Coulston, Surrey,<br>CR5 3ES | | <b>Position of Sample/Photo</b><br>Turner Ward<br>Rawl Plugs<br>(presumed throughout) | <b>Asbestos</b><br><br><b>Type</b> | Yes, Strongly<br>Presumed<br><br>Chrysotile (White) |
| <b>Material Type</b> | Board | <b>Quantity</b> | 1m <sup>2</sup> | <b>Sample No</b> As 06/B/8026/65<br><br><b>Survey Date</b> 24.04 - 29.06.06<br><br><b>Date of Report</b> 18.08.06<br><br><b>Surveyor(s)</b> <span style="background-color: black; color: black;">[REDACTED]</span> |

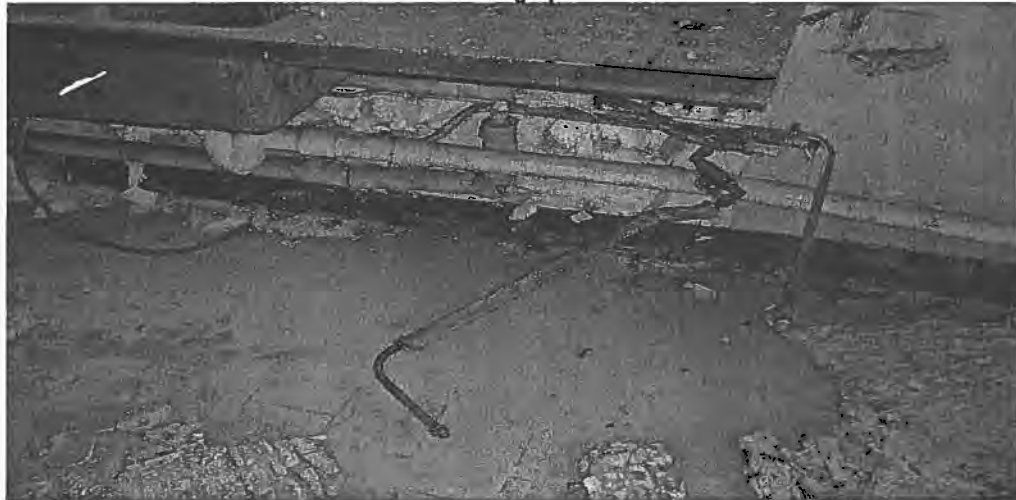
| <b>Location of Survey</b><br>Cane Hill Hospital,<br>Cane Hill,<br>Coulsdon, Surrey,<br>CR5 3ES | | <b>Position of Sample/Photo</b><br>Turner Ward<br>Kitchen<br>Rope to pipe | | <b>Asbestos</b><br><br><b>Type</b> | <b>Yes, Strongly Presumed</b><br><br>Chrysotile (White) |

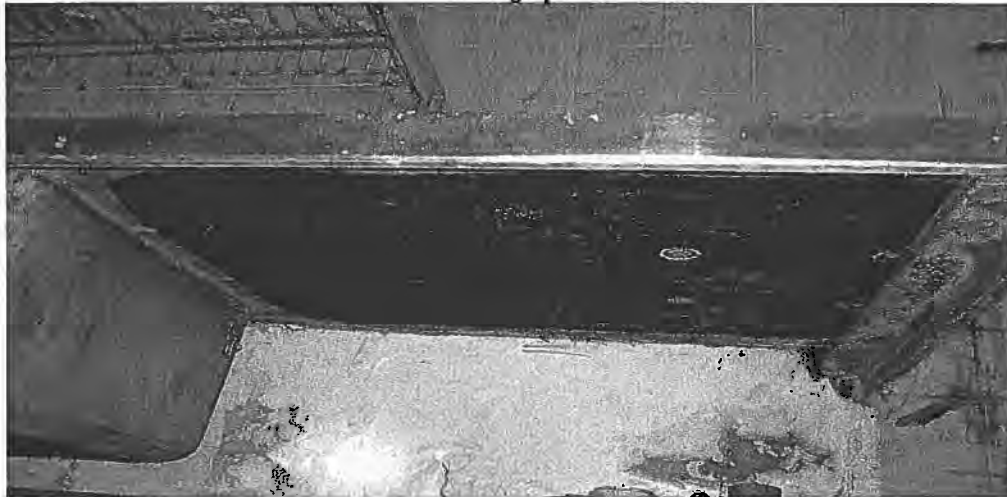
| <b>Location of Survey</b><br>Cane Hill Hospital,<br>Cane Hill,<br>Coulston, Surrey,<br>CR5 3ES | | <b>Position of Sample/Photo</b><br>Turner Ward<br>Kitchen<br>Sink Paint | | <b>Asbestos</b><br><br><b>Type</b> | Yes, Strongly<br>Presumed<br><br>Chrysotile (White) |

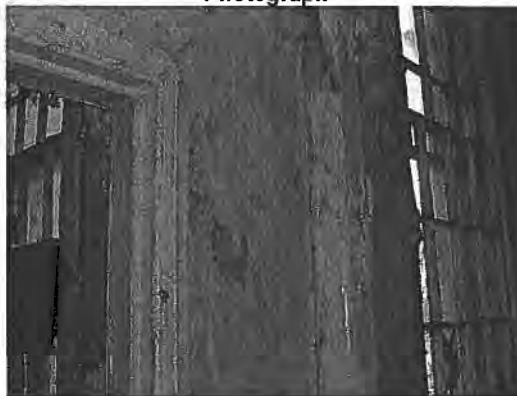
| <b>Location of Survey</b><br>Cane Hill Hospital,<br>Cane Hill,<br>Coulston, Surrey,<br>CR5 3ES | | <b>Position of Sample/Photo</b><br>Vanburgh/Vincent Ward<br>Corridor Wall | | <b>Asbestos</b> | <b>No Asbestos<br/>Detected</b> |

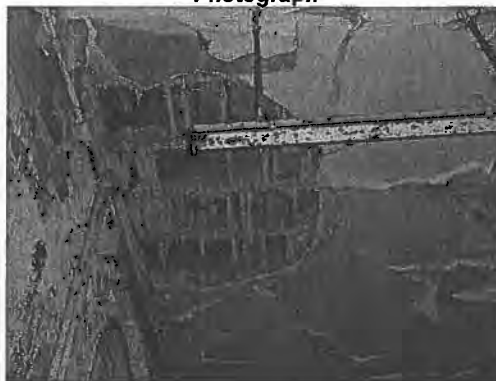
| <b>Location of Survey</b><br>Cane Hill Hospital,<br>Cane Hill,<br>Coulsdon, Surrey,<br>CR5 3ES | | <b>Position of Sample/Photo</b><br>Vanburgh/Vincent Link<br>Corridor Ceiling Lath Plaster | | <b>Asbestos</b> | <b>No Asbestos<br/>Detected</b> |

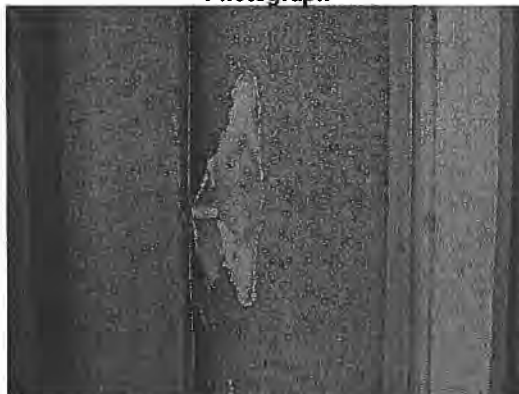
| <b>Location of Survey</b><br>Cane Hill Hospital,<br>Cane Hill,<br>Coulston, Surrey,<br>CR5 3ES | | <b>Position of Sample/Photo</b><br>Vanburgh/Vincent Ward<br>Kitchen Door Surround | | <b>Asbestos</b> | No Asbestos<br>Detected |

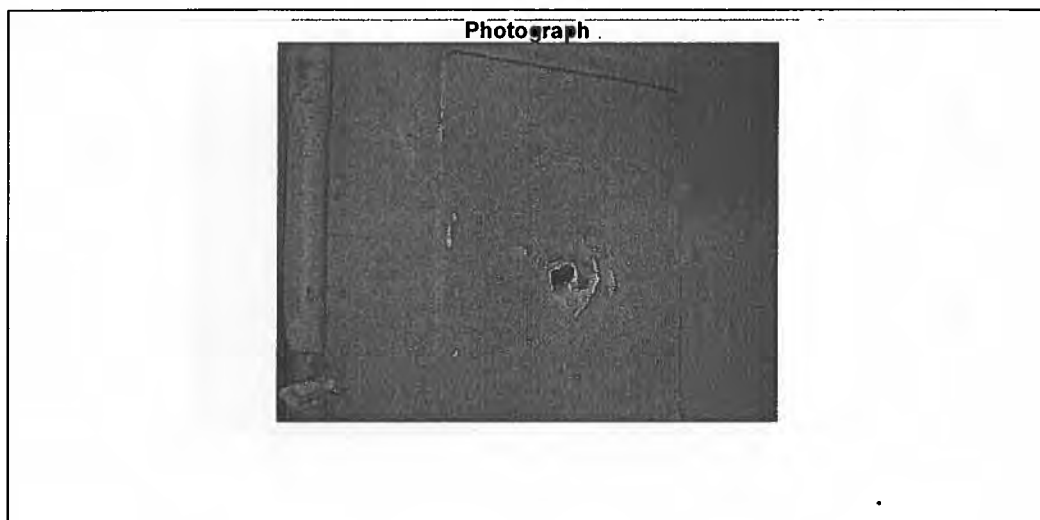
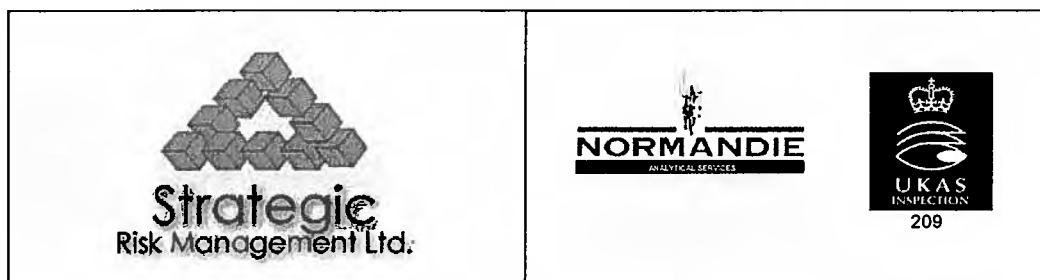
| <b>Location of Survey</b><br>Cane Hill Hospital,<br>Cane Hill,<br>Coulsdon, Surrey,<br>CR5 3ES | <b>Position of Sample/Photo</b><br>Vanburgh/ Vincent Ward<br>Ground W.C Link Wall Panel | <table style="width: 100%;"> <tr> <td style="width: 30%;"><b>Asbestos</b></td> <td>Yes</td> </tr> <tr> <td><b>Type</b></td> <td>Amosite (Brown)<br/>Chrysotile (White)</td> </tr> </table> | <b>Asbestos</b> | Yes | <b>Type</b> | Amosite (Brown)<br>Chrysotile (White) | | | | | | | | |

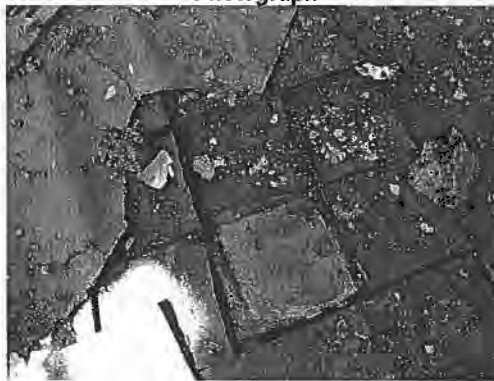
| <b>Location of Survey</b><br>Cane Hill Hospital,<br>Cane Hill,<br>Coulston, Surrey,<br>CR5 3ES | <b>Position of Sample/Photo</b><br>Vanburgh/Vincent Ward<br>Ground Floor Tile | <b>Asbestos</b><br><br><b>Type</b> | No Asbestos<br>Detected<br><br>N/A |
| Vinyl | 900m <sup>2</sup> | | |

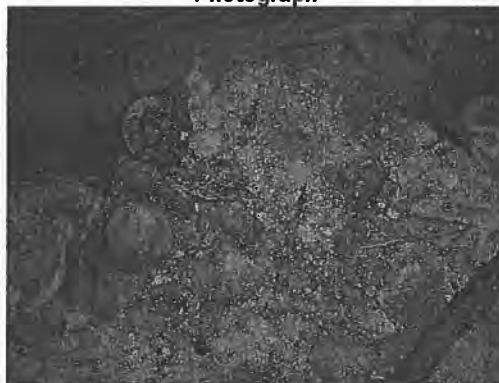
| <b>Location of Survey</b><br>Cane Hill Hospital,<br>Cane Hill,<br>Coulston, Surrey,<br>CR5 3ES | | <b>Position of Sample/Photo</b><br>Vanburgh/Vincent Ward<br>Undercroft | | <b>Asbestos</b> | <b>No Asbestos<br/>Detected</b> |

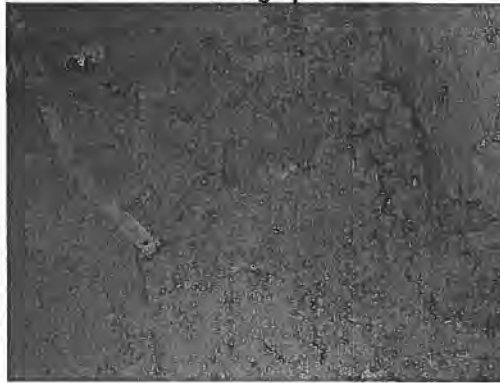
| <b>Location of Survey</b><br>Cane Hill Hospital,<br>Cane Hill,<br>Coulston, Surrey,<br>CR5 3ES | | <b>Position of Sample/Photo</b><br>Vanburgh/Vincent Undercroft<br>Debris | | <b>Asbestos</b> | <b>No Asbestos<br/>Detected</b> |

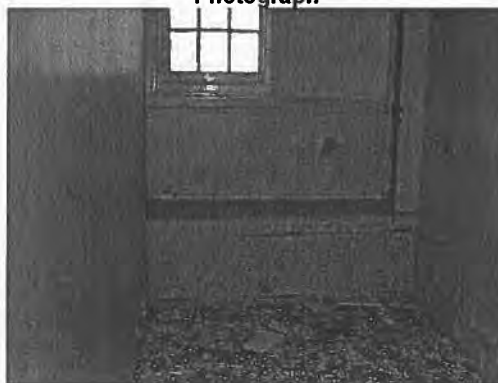
| <b>Location of Survey</b><br>Cane Hill Hospital,<br>Cane Hill,<br>Coulston, Surrey,<br>CR5 3ES | | <b>Position of Sample/Photo</b><br>Vanbrugh / Vincent Ward,<br>Rawl plugs to metal rising pipe<br>sheaths and metal grid heater<br>covers in segregation rooms<br>Throughout ward and<br>presumed throughout site – | | <b>Asbestos</b><br><br><b>Type</b> | Yes Strongly<br>presumed<br><br>Chrysotile (White) |
| <b>Material Type</b> | Rope | <b>Quantity</b> | 2cm <sup>2</sup> Each<br>Each sheath<br>approx 8<br>plugs | <b>Sample No</b><br><br><b>Survey Date</b><br><br><b>Date of Report</b><br><br><b>Surveyor(s)</b> | As 06/B/8026/85<br>24.04 - 29.06.06<br>18.08.06<br><div style="background-color: black; width: 100px; height: 20px;"></div> |

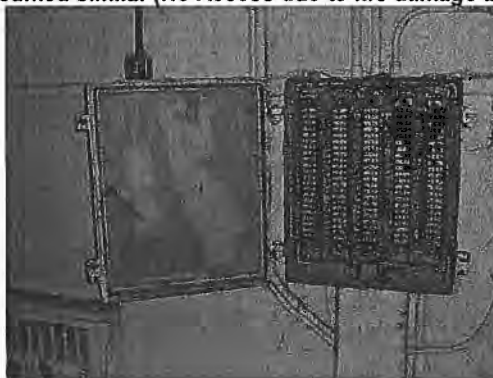
| <b>Material</b><br>Rope<br><b>Type</b> | | <b>Quantity</b><br>1m | | <b>Sample No</b><br><br><b>Survey Date</b><br><br><b>Date of Report</b><br><br><b>Surveyor(s)</b> | As 06/B/8026/22<br>24.04 - 29.06.06<br>18.08.06<br> |

**Photograph presumed similar (No Access due to fire damage and unsafe floors)**

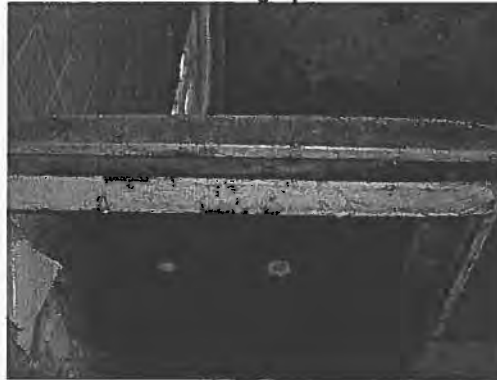
| <b>Location of Survey</b><br>Cane Hill Hospital,<br>Cane Hill,<br>Coulston, Surrey,<br>CR5 3ES | | <b>Position of Sample/Photo</b><br>Vanbrugh / Vincent Ward<br>Kitchens all floors<br>Undersink and drainer paint | | <b>Asbestos</b><br><br><b>Type</b> | <b>Yes, Strongly Presumed</b><br><br>Chrysotile (White) |

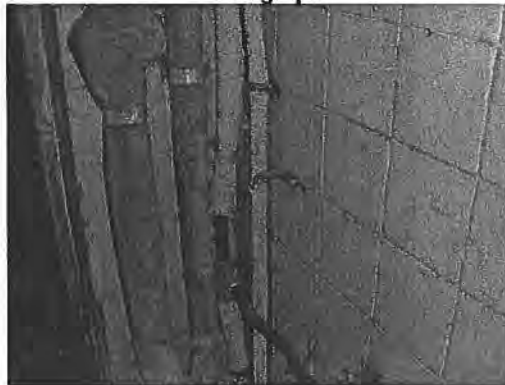
| <b>Location of Survey</b><br>Cane Hill Hospital,<br>Cane Hill,<br>Coulsdon, Surrey,<br>CR5 3ES | | <b>Position of Sample/Photo</b><br>Vanbrugh / Vincent Ward,<br>Ground Floor Kitchen,<br>Pipe Cloth Wrap debris on<br>floor (presume to 1 <sup>st</sup> , 2 <sup>nd</sup> and<br>3 <sup>rd</sup> floors) | | <b>Asbestos</b> | Yes, Strongly<br>Presumed |

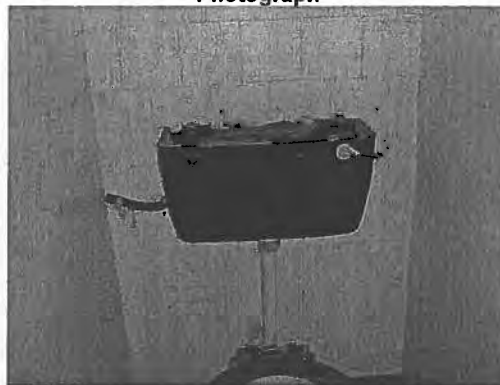
| <b>Location of Survey</b><br>Cane Hill Hospital,<br>Cane Hill,<br>Coulsdon, Surrey,<br>CR5 3ES | | <b>Position of Sample/Photo</b><br>Vanbrugh / Vincent Ward<br>Shires lynx WC cisterns<br>(Ground X5 and presume on<br>all floors ) | | <b>Asbestos</b><br><br><b>Type</b> | <b>Yes</b><br>Strongly<br>presumed<br><br>Amosite (Brown) |

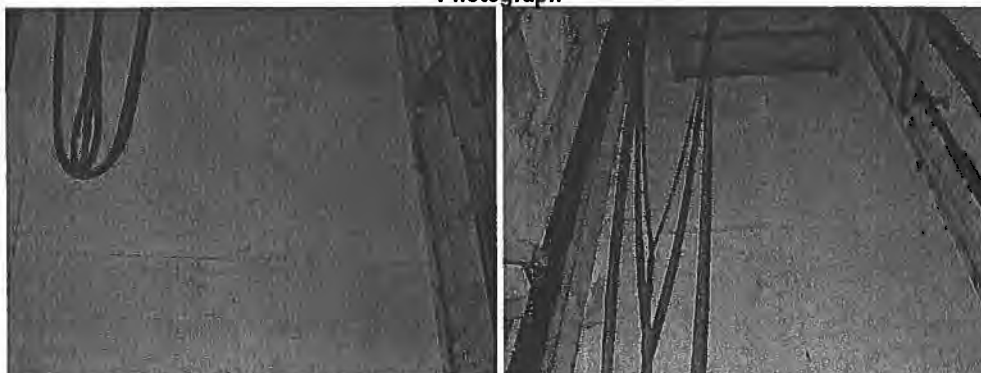
| <b>Location of Survey</b><br>Cane Hill Hospital,<br>Cane Hill,<br>Coulson, Surrey,<br>CR5 3ES | | <b>Position of Sample/Photo</b><br>Vanburgh/Vincent Ward,<br>Lift shaft lining Wall Panels (all<br>floors / whole shaft and ceiling)<br>(no access to lift room unsafe) | <b>Asbestos</b><br><br><b>Type</b><br>Yes<br>Strongly<br>presumed<br><br>Amosite (Brown)<br>Chrysotile (White) |
| <b>Material</b><br>Type | Board | <b>Quantity</b><br>200m <sup>2</sup> | <b>Sample No</b> As 06/B/8026/119<br><br><b>Survey Date</b> 24.04 - 29.06.06<br><br><b>Date of Report</b> 18.08.06<br><br><b>Surveyor(s)</b> |

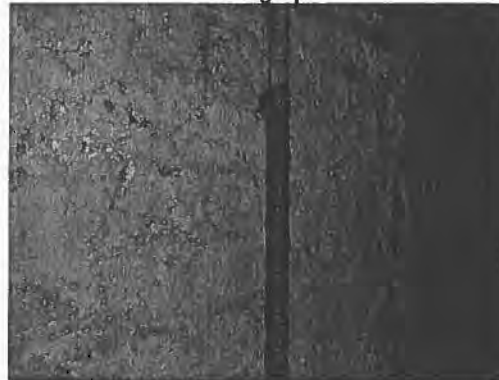
| <b>Material Type</b> | Bitumen<br>lagging | <b>Quantity</b> | 20l/m | <b>Sample No</b><br><br><b>Survey Date</b><br><br><b>Date of Report</b><br><br><b>Surveyor(s)</b> | 06/B/8026/110<br>24.04 - 29.06.06<br>18.08.06<br> |

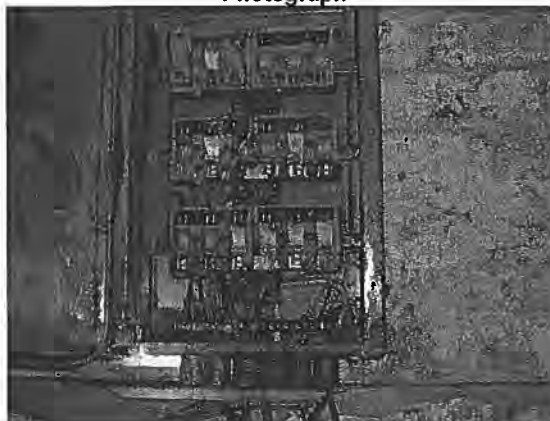
| <b>Location of Survey</b><br>Cane Hill Hospital,<br>Cane Hill,<br>Coulsdon, Surrey,<br>CR5 3ES | <b>Position of Sample/Photo</b><br>WWII Underground Bunker<br>Center Longitudinal Tunnel<br>Fuse Box Flashguard | <b>Asbestos</b> Yes<br><br><b>Type</b> Chrysotile (White) |
| <b>Material</b> Rope<br><b>Type</b> | <b>Quantity</b> <1m <sup>2</sup> | <b>Sample No</b> 06/B/8026/111<br><br><b>Survey Date</b> 24.04 - 29.06.06<br><br><b>Date of Report</b> 18.08.06<br><b>Surveyor(s)</b> |
