TYPE 3  
SURVEY, ASSESSMENT AND REGISTER OF  
ASBESTOS CONTAINING MATERIALS  
AT  
CANE HILL, COULSDON  
SURREY, CR5 3ES

*Report No. 06/B/8026*

*September 2006*

**Strategic Risk Management  
P.O. Box 167, Sandbach  
Cheshire, CW11 3WG**

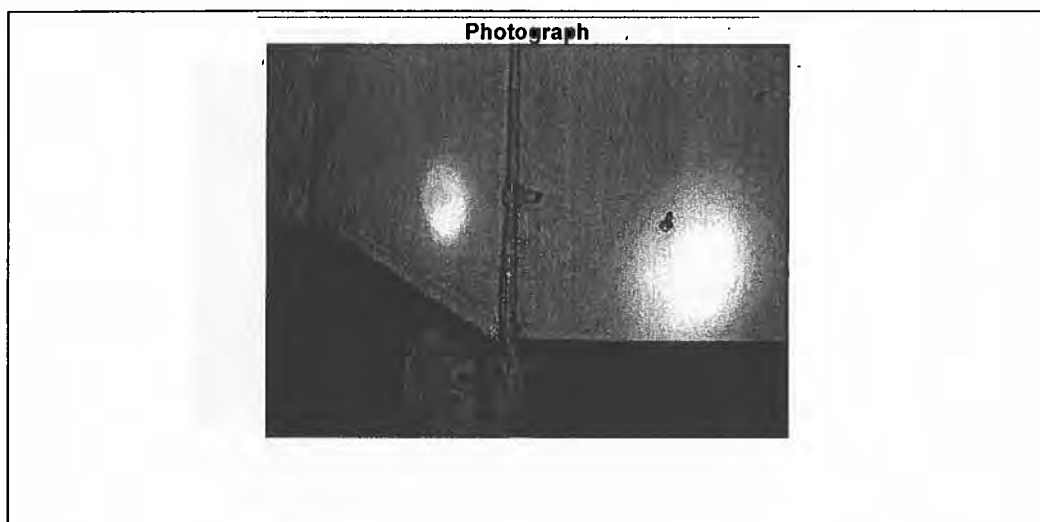
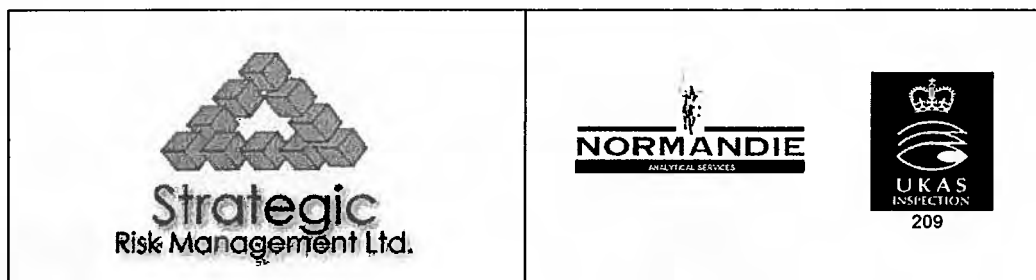
| <b>Location of Survey</b><br>Cane Hill Hospital,<br>Cane Hill,<br>Coulson, Surrey,<br>CR5 3ES | | <b>Position of Sample/Photo</b><br>WWII Underground Bunker<br>First Lateral Tunnel<br>Refrigeration Unit Seal | | <b>Asbestos</b> | No Asbestos<br>Detected |
| <b>Material Type</b><br>Sealant | | <b>Quantity</b><br>0.5m2 | <b>Type</b><br>N/A<br><br><b>Sample No</b><br>06/B/8026/112<br><br><b>Survey Date</b><br>24.04 - 29.06.06<br><br><b>Date of Report</b><br>18.08.06<br><br><b>Surveyor(s)</b><br><div style="background-color: black; width: 100px; height: 40px;"></div> | | |

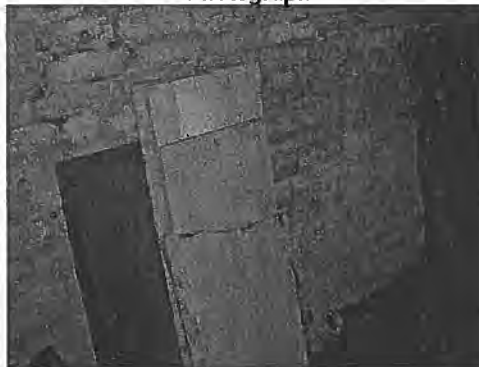
| <b>Location of Survey</b><br>Cane Hill Hospital,<br>Cane Hill,<br>Coulsdon, Surrey,<br>CR5 3ES | <b>Position of Sample/Photo</b><br>WWII Underground Bunker<br>Redundant AIB Sheet in South<br>Longitudinal Tunnel | <b>Asbestos</b> Yes<br><br><b>Type</b> Amosite (Brown) |
| <b>Material</b> Board<br><b>Type</b> | <b>Quantity</b> 3m <sup>2</sup> | <b>Sample No</b> 06/B/8026/113<br><br><b>Survey Date</b> 24.04 - 29.06.06<br><br><b>Date of Report</b> 18.08.06<br><br><b>Surveyor(s)</b> <span style="background-color: black; color: black;">[REDACTED]</span> |

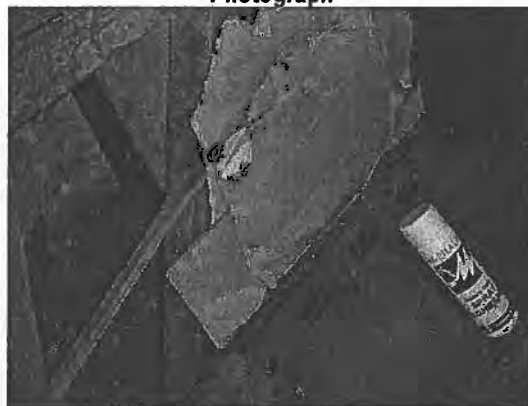
| <b>Location of Survey</b><br>Cane Hill Hospital,<br>Cane Hill,<br>Coulsdon, Surrey,<br>CR5 3ES | <b>Position of Sample/Photo</b><br>WWII Underground Bunker<br>South Longitudinal Tunnel<br>Redundant Sheets (millboard) | <b>Asbestos</b> Yes | <b>Type</b> Chrysotile (White) |
| <b>Material Type</b> Board | <b>Quantity</b> 2 l/m | <b>Sample No</b> 06/B/8026/114<br><br><b>Survey Date</b> 24.04 - 29.06.06<br><br><b>Date of Report</b> 18.08.06<br><br><b>Surveyor(s)</b> <span style="background-color: black; color: black;">[REDACTED]</span> | |

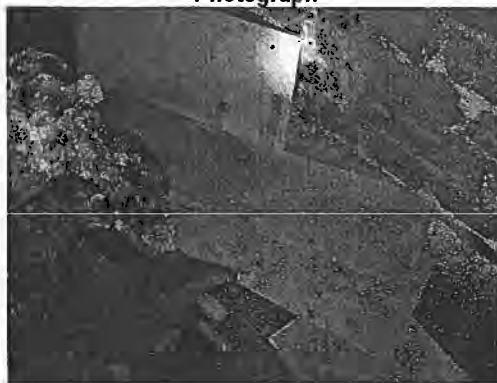
| <b>Location of Survey</b><br>Cane Hill Hospital,<br>Cane Hill,<br>Coulsdon, Surrey,<br>CR5 3ES | <b>Position of Sample/Photo</b><br>WWII Underground Bunker<br>South Longitudinal Tunnel<br>Redundant Sheets | <b>Asbestos</b> Yes<br><br><b>Type</b> Chrysotile (White) |
| <b>Material Type</b> Cement | <b>Quantity</b> 4m <sup>2</sup> | <b>Sample No</b> 06/B/8026/115<br><br><b>Survey Date</b> 24.04 - 29.06.06<br><br><b>Date of Report</b> 18.08.06<br><br><b>Surveyor(s)</b> <span style="background-color: black; color: black;">[REDACTED]</span> |

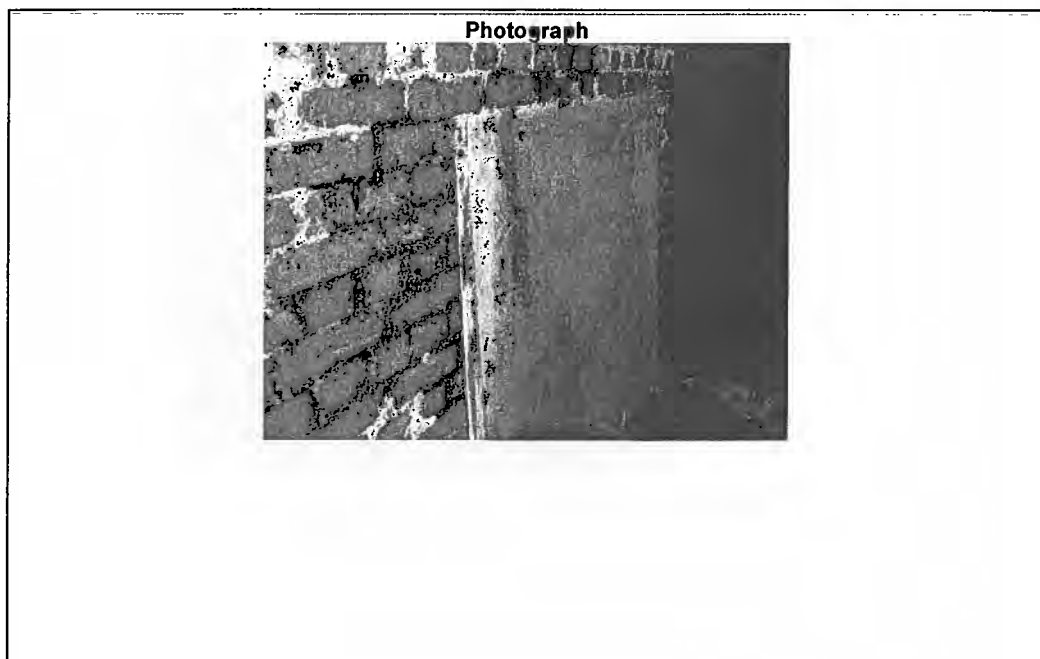
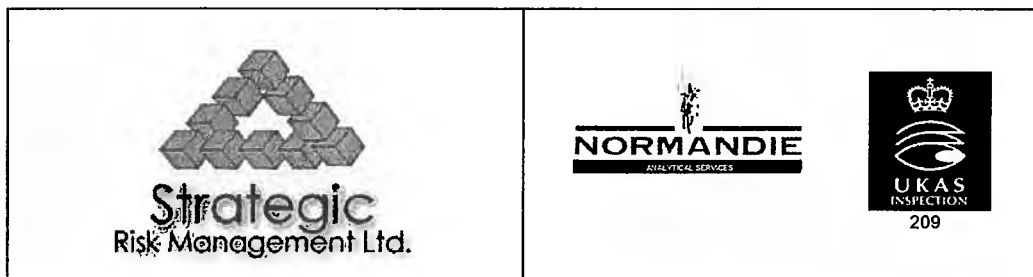
| <b>Location of Survey</b><br>Cane Hill Hospital,<br>Cane Hill,<br>Coulsdon, Surrey,<br>CR5 3ES | <b>Position of Sample/Photo</b><br>WWII Underground Bunker<br>South Longitudinal Tunnel thin<br>Sheets and floor debris<br>(spread through out this area) | <b>Asbestos</b><br><br><b>Type</b> | Yes<br>Strongly<br>presumed<br><br>Chrysotile (White) |
| <b>Material Type</b> Cement | <b>Quantity</b> 10m <sup>2</sup> | <b>Sample No</b> As 06/B/8026/116<br><br><b>Survey Date</b> 24.04 - 29.06.06<br><br><b>Date of Report</b> 18.08.06<br><b>Surveyor(s)</b> <span style="background-color: black; color: black;">[REDACTED]</span> | |

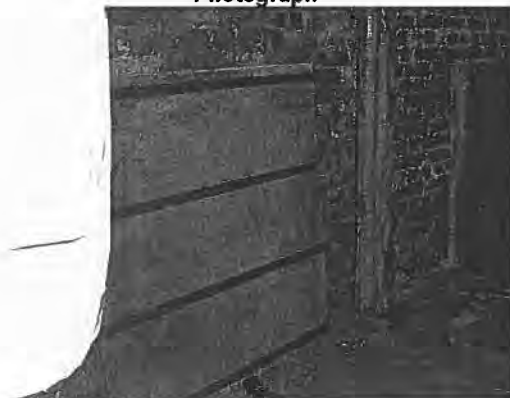
| <b>Location of Survey</b><br>Cane Hill Hospital,<br>Cane Hill,<br>Coulston, Surrey,<br>CR5 3ES | | <b>Position of Sample/Photo</b><br>WWII Underground Bunker<br>South Longitudinal Tunnel<br>Redundant Sheets leant<br>against wall and floor debris | | <b>Asbestos</b> Yes |

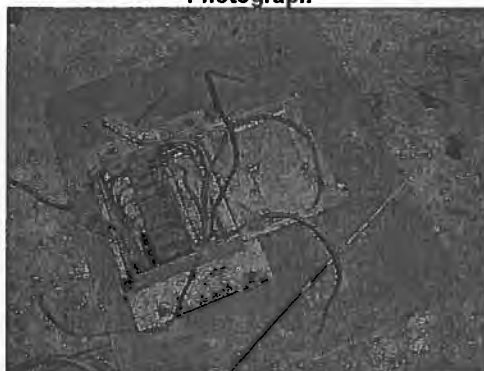
| <b>Location of Survey</b><br>Cane Hill Hospital,<br>Cane Hill,<br>Coulsdon, Surrey,<br>CR5 3ES | <b>Position of Sample/Photo</b><br>WWII Underground Bunker<br>Center Longitudinal Tunnel<br>Fuse Box rope seal on floor | <b>Asbestos</b><br><br><b>Type</b> | Yes<br>Strongly<br>Presumed<br><br>Chrysotile (White) |
| <b>Material Type</b> Rope | <b>Quantity</b> 1m <sup>2</sup> | <b>Sample No</b> As 06/B/8026/111<br><br><b>Survey Date</b> 24.04 - 29.06.06<br><br><b>Date of Report</b> 18.08.06<br><br><b>Surveyor(s)</b> <span style="background-color: black; color: black;">[REDACTED]</span> | |

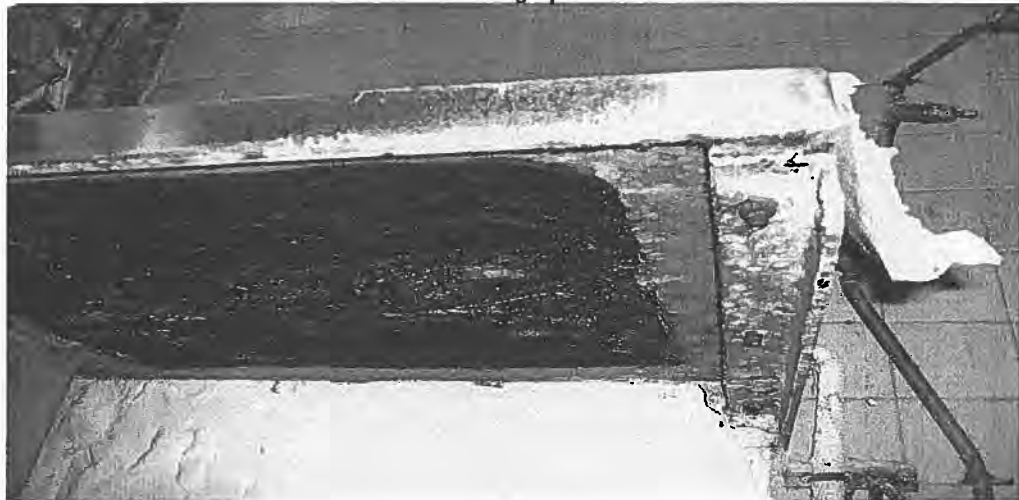
| <b>Location of Survey</b><br>Cane Hill Hospital,<br>Cane Hill,<br>Coulsdon, Surrey,<br>CR5 3ES | <b>Position of Sample/Photo</b><br>Wren/Wesley Ward<br>Sink paint | <b>Asbestos</b> Yes, Strongly Presumed<br><br><b>Type</b> Chrysotile (White) |
| <b>Material Type</b> Bitumen | <b>Quantity</b> 1m <sup>2</sup> | <b>Sample No</b> 06/B/8026/157<br><br><b>Survey Date</b> 24.04 - 29.06.06<br><br><b>Date of Report</b> 18.08.06<br><br><b>Surveyor(s)</b> <span style="background-color: black; color: black;">[REDACTED]</span> |

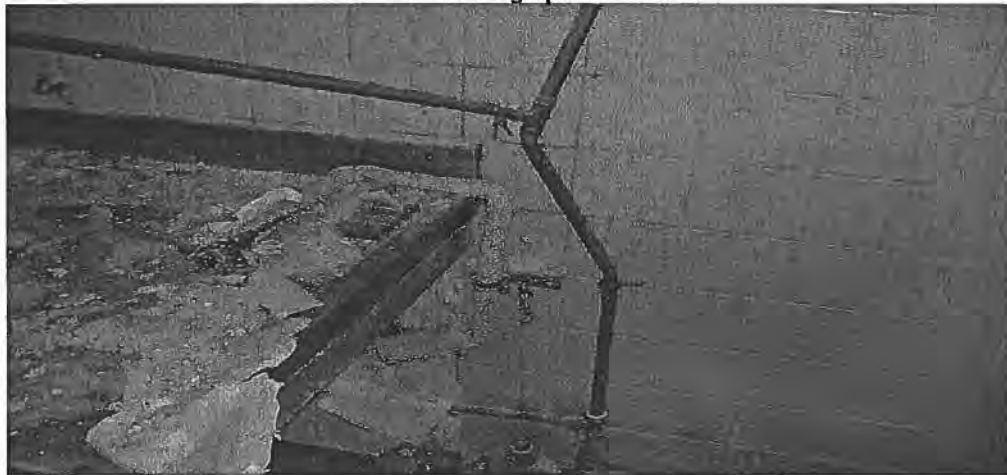
| <b>Location of Survey</b><br>Cane Hill Hospital,<br>Cane Hill,<br>Coulsdon, Surrey,<br>CR5 3ES | | <b>Position of Sample/Photo</b><br>Wren/Wesley Ward<br>Kitchen rope to pipe | | <b>Asbestos</b><br><br><b>Type</b> | Yes, Strongly<br>Presumed<br><br>Chrysotile (White) |

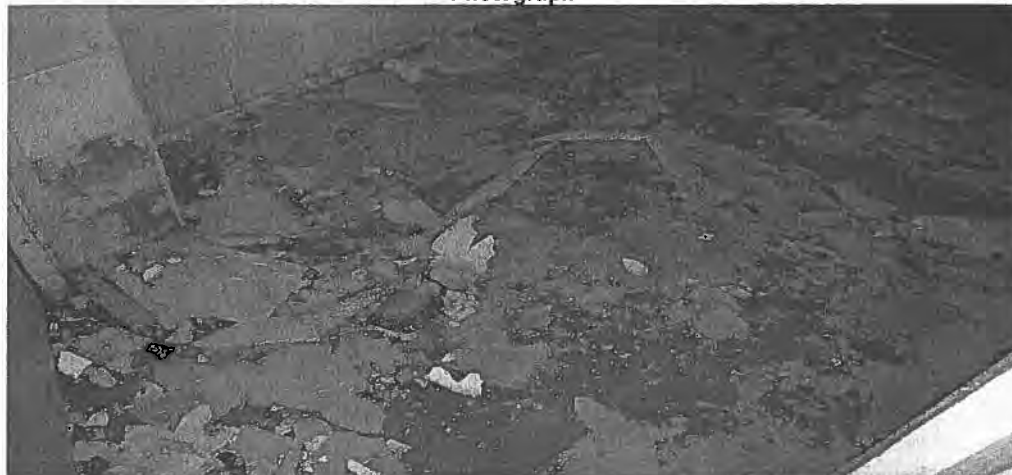
| <b>Location of Survey</b><br><br>Cane Hill Hospital,<br>Cane Hill,<br>Coulsdon, Surrey,<br>CR5 3ES | <b>Position of Sample/Photo</b><br><br>Wren/Wesley Ward<br>Rope debris in door to<br>bathroom adjacent cells | <b>Asbestos</b><br><br>Yes, Strongly<br>Presumed | <b>Type</b><br><br>Chrysotile (White) |
| <b>Material Type</b><br><br>Rope | <b>Quantity</b><br><br>1m <sup>2</sup> | <b>Sample No</b><br>As 06/B/8026/58<br><br><b>Survey Date</b><br>24.04 - 29.06.06<br><br><b>Date of Report</b><br>18.08.06<br><br><b>Surveyor(s)</b><br><div style="background-color: black; width: 100px; height: 20px;"></div> | |

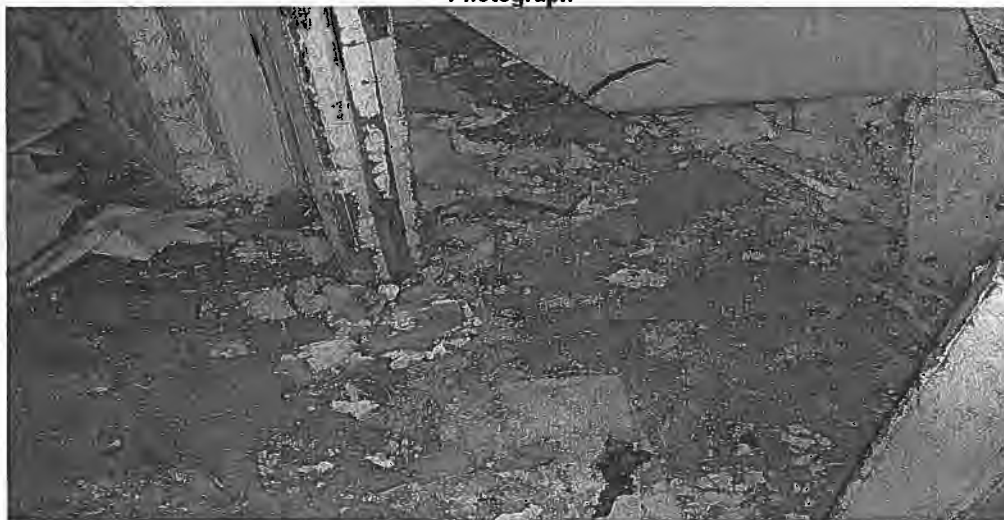
| <b>Location of Survey</b><br>Cane Hill Hospital,<br>Cane Hill,<br>Coulsdon, Surrey,<br>CR5 3ES | | <b>Position of Sample/Photo</b><br>Wren/Wesley Ward<br>Rope debris adjacent door to<br>middle ward | <b>Asbestos</b><br><br><b>Type</b> | Yes, Strongly<br>Presumed<br><br>Chrysotile (White) |
| <b>Material Type</b> | Rope | <b>Quantity</b> | 1m <sup>2</sup> | <b>Sample No</b> As 06/B/8026/58<br><b>Survey Date</b> 24.04 - 29.06.06<br><b>Date of Report</b> 18.08.06<br><b>Surveyor(s)</b> <span style="background-color: black; color: black;">[REDACTED]</span> |

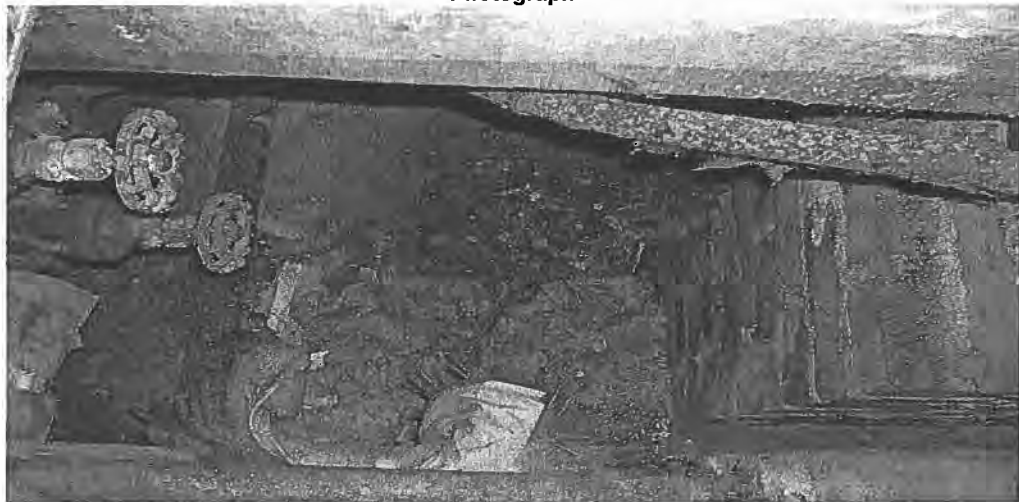
| <b>Location of Survey</b><br><br>Cane Hill Hospital,<br>Cane Hill,<br>Coulston, Surrey,<br>CR5 3ES | <b>Position of Sample/Photo</b><br><br>Wren/Wesley Ward<br>Undercroft Debris<br>(presumed throughout) | <b>Asbestos</b> Yes<br><br><b>Type</b> Crocidolite (Blue)<br>Amosite (Brown)<br>Chrysotile (White) | |
| <b>Material Type</b> Lagging | <b>Quantity</b> <1m <sup>2</sup> | <b>Sample No</b> 06/B/8026/123<br><br><b>Survey Date</b> 24.04 - 29.06.06<br><br><b>Date of Report</b> 18.08.06<br><br><b>Surveyor(s)</b> <span style="background-color: black; color: black;">[REDACTED]</span> | |

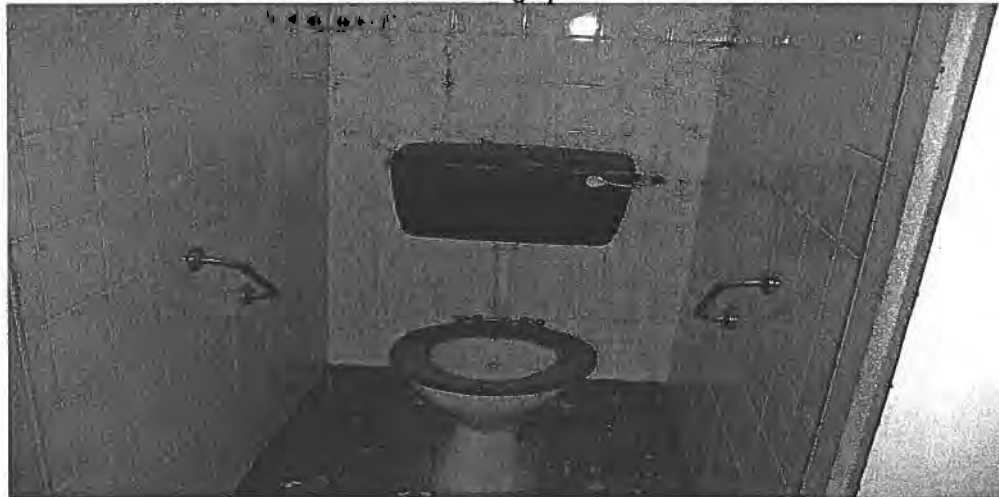
| <b>Location of Survey</b><br>Cane Hill Hospital,<br>Cane Hill,<br>Coulsdon, Surrey,<br>CR5 3ES | | <b>Position of Sample/Photo</b><br>Wren/Wesley Ward<br>W.C Cistern (X12) | <b>Asbestos</b><br><br><b>Type</b> | Yes, Strongly<br>Presumed<br><br>Amosite (Brown) |
| <b>Material Type</b> | Plastic | <b>Quantity</b> | 1m <sup>2</sup> | <b>Sample No</b><br>As 06/B/8026/5<br><br><b>Survey Date</b><br>24.04 – 29.06.06<br><br><b>Date of Report</b><br>18.08.06<br><b>Surveyor(s)</b> |

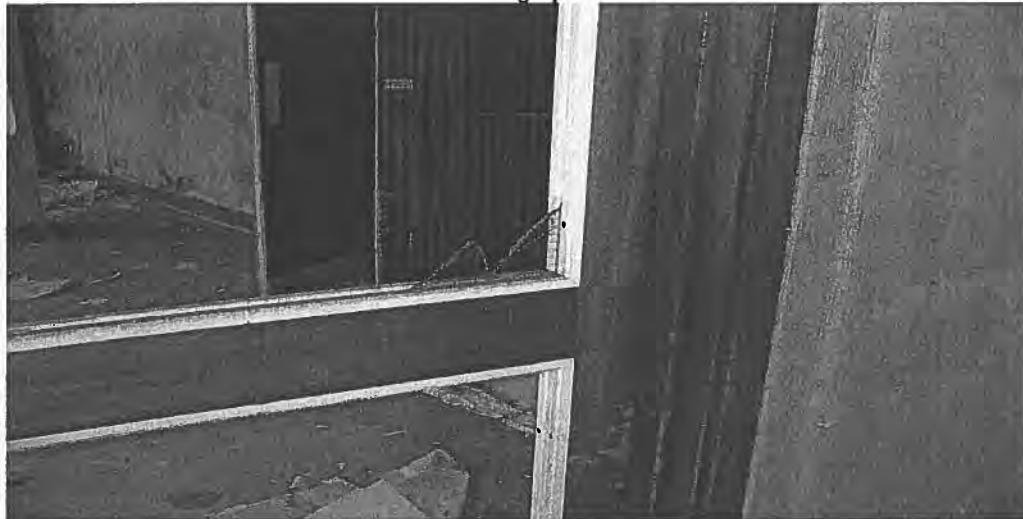
| <b>Location of Survey</b><br>Cane Hill Hospital,<br>Cane Hill,<br>Coulsdon, Surrey,<br>CR5 3ES | | <b>Position of Sample/Photo</b><br>Wren/Wesley Ward<br>Ward Door Beading | | <b>Asbestos</b> | <b>No Asbestos<br/>Detected</b> |

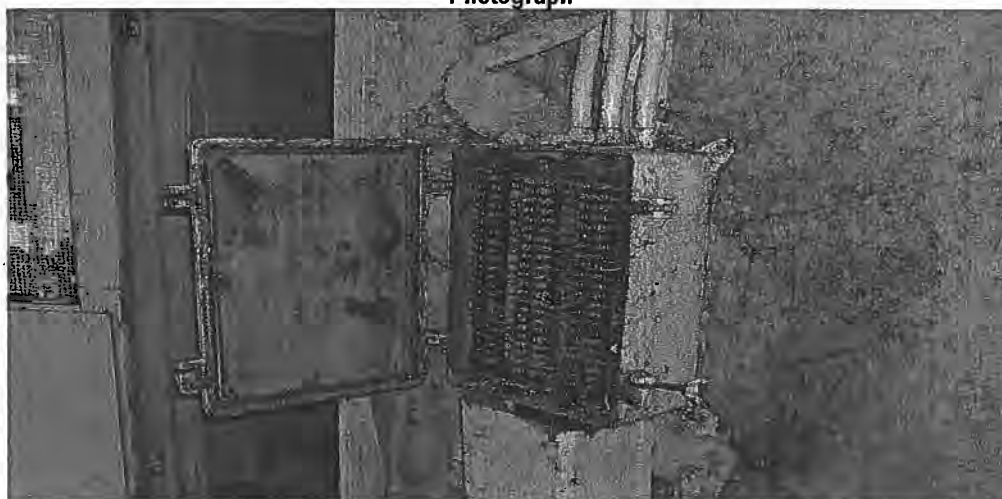
| <b>Location of Survey</b><br>Cane Hill Hospital,<br>Cane Hill,<br>Coulston, Surrey,<br>CR5 3ES | | <b>Position of Sample/Photo</b><br>Zachary Unwin Ward<br>Electrics<br>Rope seal | | <b>Asbestos</b><br><br><b>Type</b> | <b>Yes, Strongly Presumed</b><br><br>Chrysotile (White) |

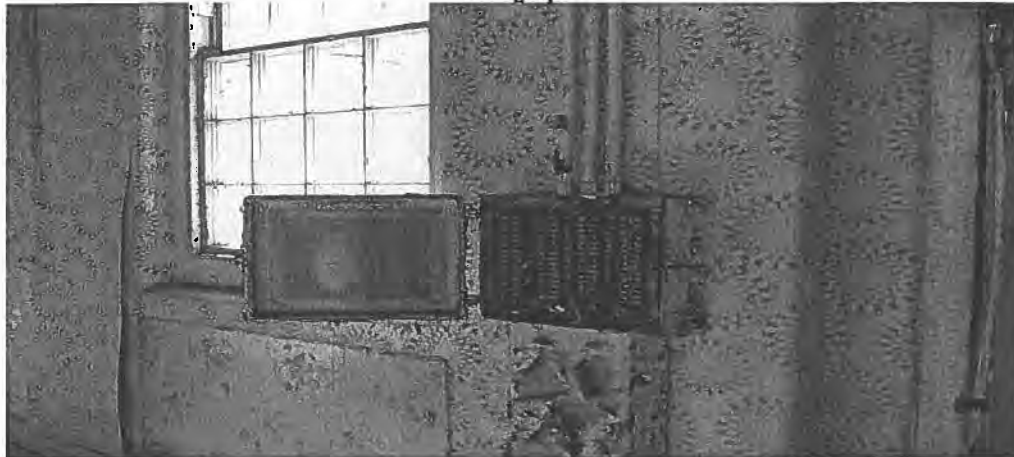
| <b>Location of Survey</b><br>Cane Hill Hospital,<br>Cane Hill,<br>Coulsdon, Surrey,<br>CR5 3ES | <b>Position of Sample/Photo</b><br>Zachary York Ward<br>Corridor electrics (X2)<br>Rope seal | <b>Asbestos</b><br><br><b>Type</b> | Yes, Strongly Presumed<br><br>Chrysotile (White) |
| <b>Material Type</b> Rope | <b>Quantity</b> 1m | <b>Sample No</b><br><br><b>Survey Date</b><br><br><b>Date of Report</b><br><br><b>Surveyor(s)</b> | As 06/B/8026/22<br><br>24.04 - 29.06.06<br><br>18.08.06<br><br><div style="background-color: black; width: 100px; height: 40px;"></div> |

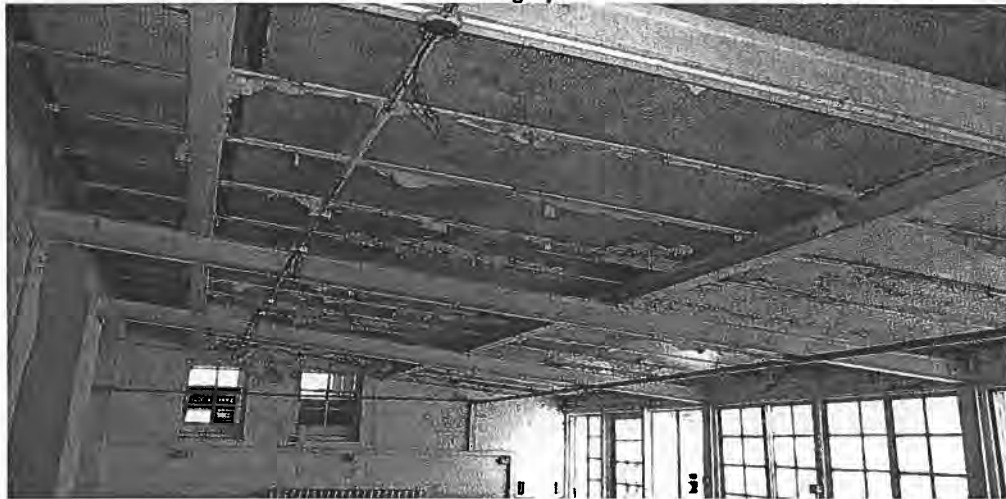
| <b>Location of Survey</b><br>Cane Hill Hospital,<br>Cane Hill,<br>Coulston, Surrey,<br>CR5 3ES | | <b>Position of Sample/Photo</b><br>Workhouse<br>Rope to skylights | <b>Asbestos</b><br><br><b>Type</b> | Yes, Strongly<br>Presumed<br><br>Chrysotile (White) |
| <b>Material Type</b> | Rope | <b>Quantity</b> | 260m | <b>Sample No</b> As 06/B/8026/31<br><b>Survey Date</b> 24.04 - 29.06.06<br><b>Date of Report</b> 18.08.06<br><b>Surveyor(s)</b> <span style="background-color: black; color: black;">[REDACTED]</span> |

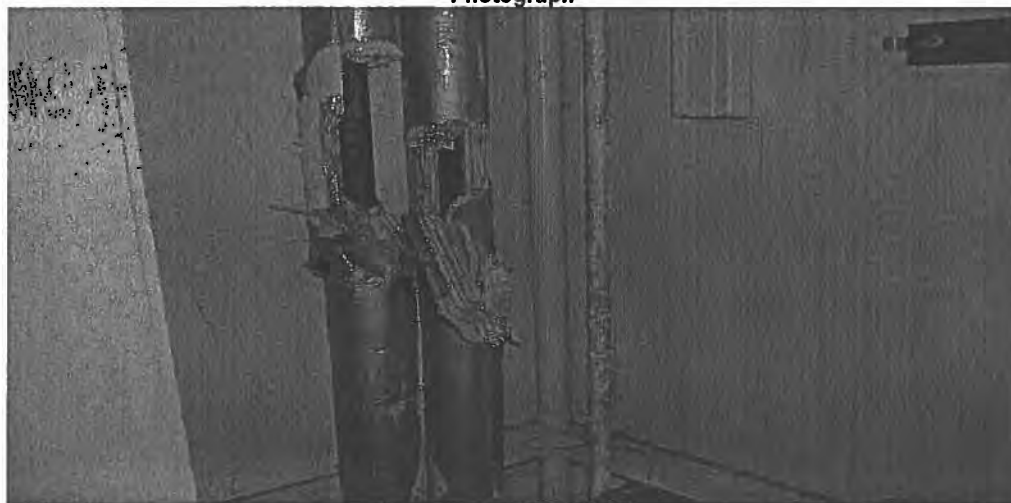
| <b>Material Type</b><br>Paper | <b>Quantity</b><br>4m | <b>Sample No</b><br>As 06/B/8026/77<br><br><b>Survey Date</b><br>24.04 - 29.06.06<br><br><b>Date of Report</b><br>18.08.06<br><br><b>Surveyor(s)</b><br><div style="background-color: black; width: 100px; height: 30px;"></div> | |

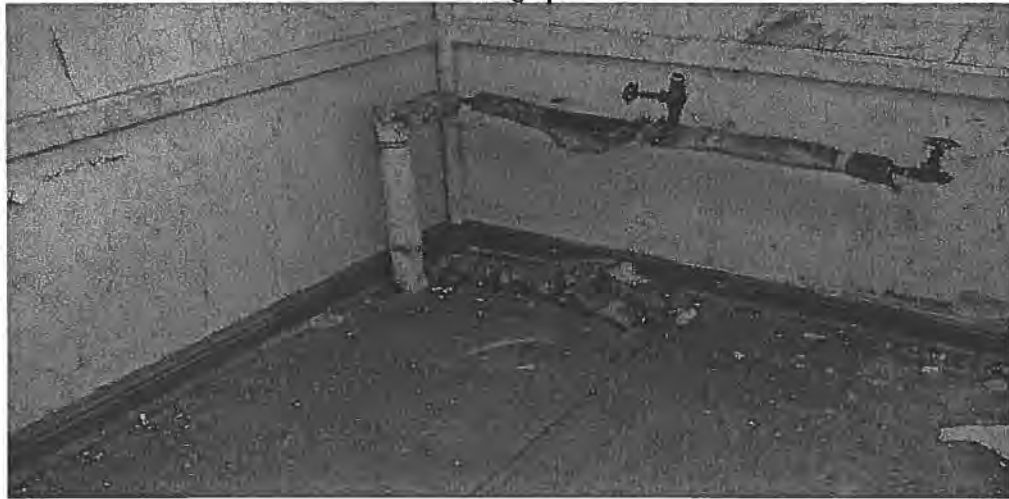
| <b>Location of Survey</b><br>Cane Hill Hospital,<br>Cane Hill,<br>Coulston, Surrey,<br>CR5 3ES | | <b>Position of Sample/Photo</b><br>Workhouse<br>First Floor<br>Workshop<br>Pipe Lagging | | <b>Asbestos</b><br><br><b>Type</b> | Yes, Strongly<br>Presumed<br><br>Chrysotile (White) |

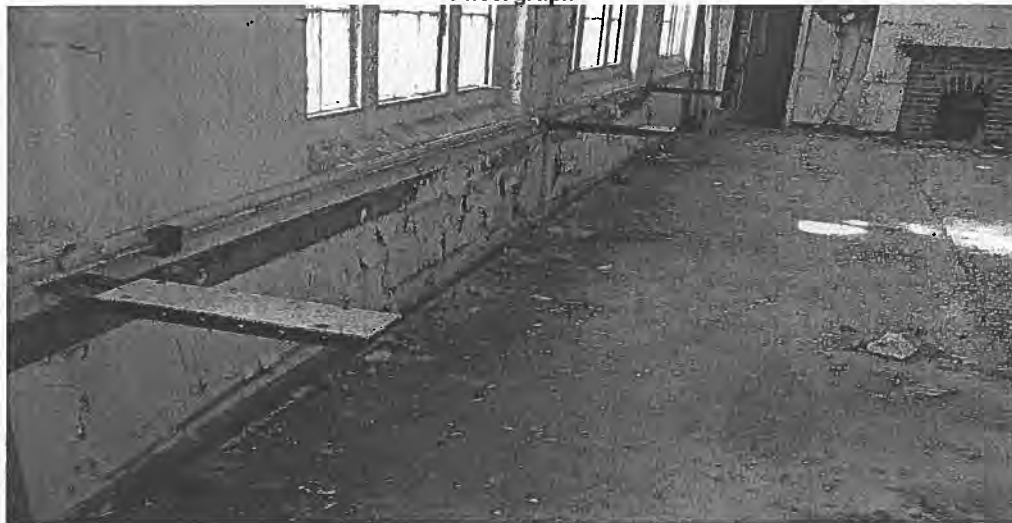
| <b>Location of Survey</b><br>Cane Hill Hospital,<br>Cane Hill,<br>Coulston, Surrey,<br>CR5 3ES | | <b>Position of Sample/Photo</b><br>Workhouse<br>First Floor<br>Bench Cement Pads to<br>brackets (X3) | | <b>Asbestos</b><br><br><b>Type</b> | <br>Yes, Strongly<br>Presumed<br><br>Chrysotile (White) |

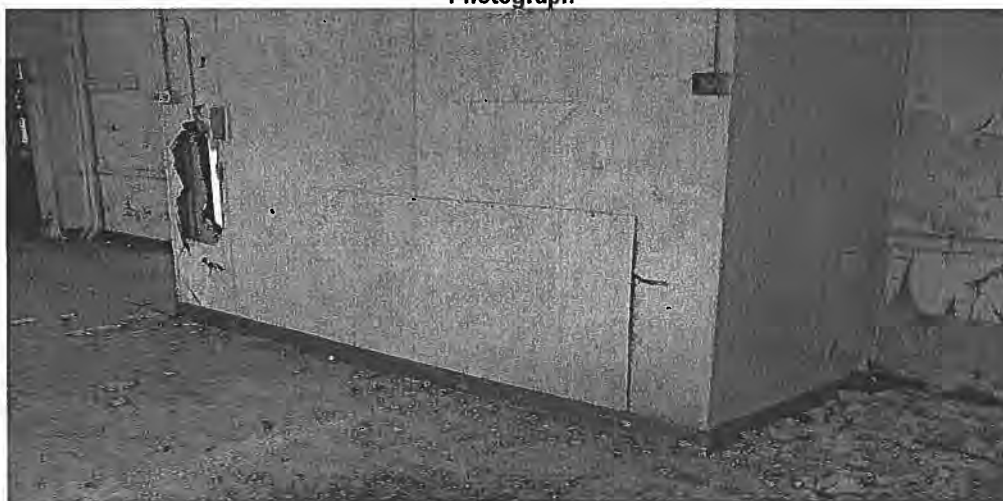
| <b>Location of Survey</b><br>Cane Hill Hospital,<br>Cane Hill,<br>Coulston, Surrey,<br>CR5 3ES | | <b>Position of Sample/Photo</b><br>Workhouse<br>First Floor<br>Workshop<br>Panel to stairs | | <b>Asbestos</b> | Yes, Strongly Presumed |

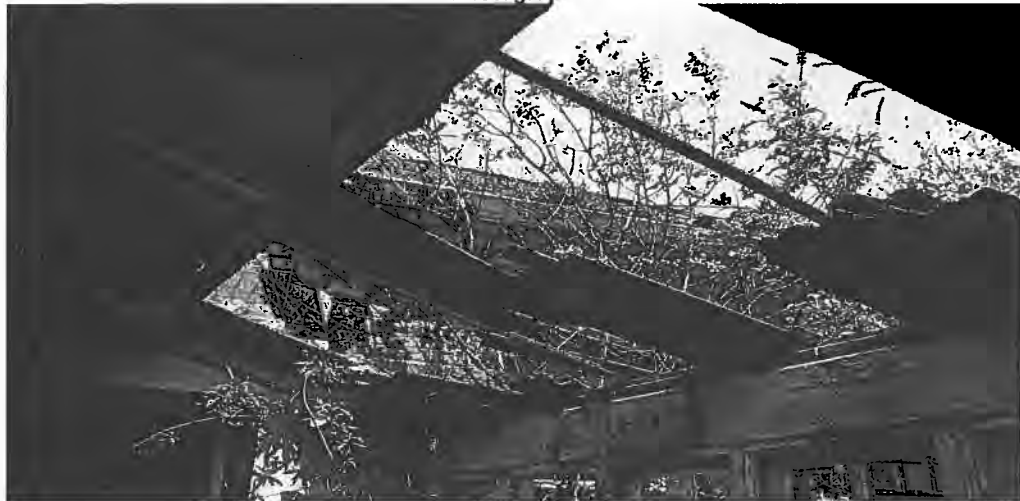
| <b>Location of Survey</b><br>Cane Hill Hospital,<br>Cane Hill,<br>Coulston, Surrey,<br>CR5 3ES | | <b>Position of Sample/Photo</b><br>Workhouse<br>First Floor<br>Roof sheet | | <b>Asbestos</b><br><br><b>Type</b> | Yes<br><br>Chrysotile (White) |

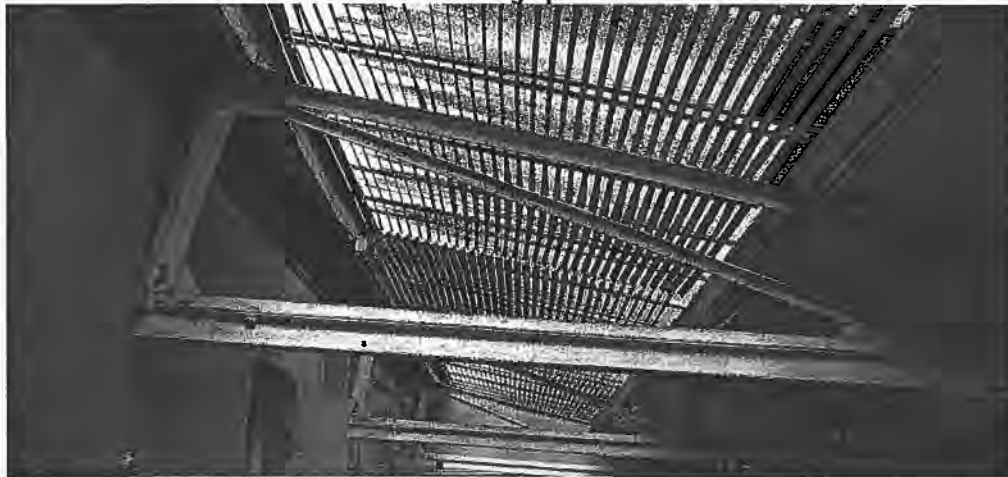
| <b>Location of Survey</b><br>Cane Hill Hospital,<br>Cane Hill,<br>Coulson, Surrey,<br>CR5 3ES | | <b>Position of Sample/Photo</b><br>Workhouse<br>First Floor<br>Rope to skylight | | <b>Asbestos</b><br><br><b>Type</b> | Yes, Strongly<br>Presumed<br><br>Chrysotile (White) |

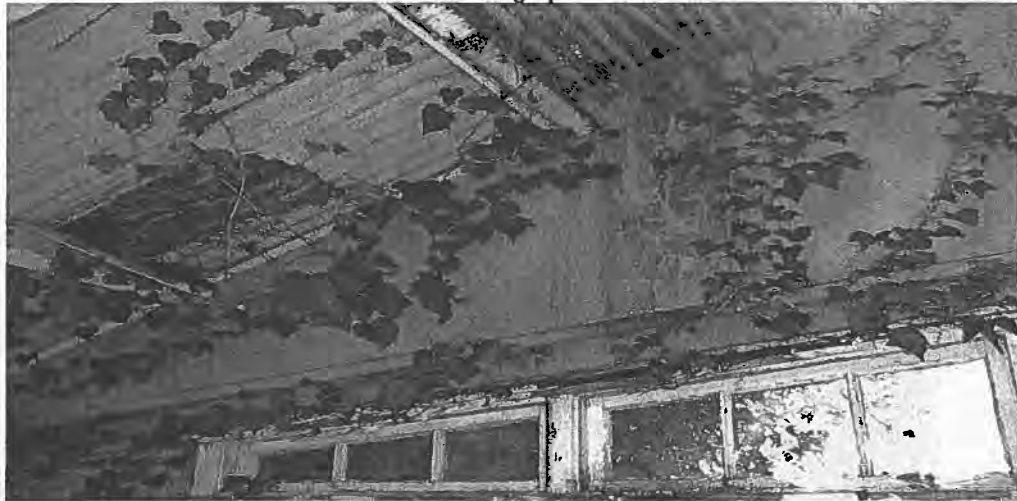
| <b>Location of Survey</b><br>Cane Hill Hospital,<br>Cane Hill,<br>Coulston, Surrey,<br>CR5 3ES | | <b>Position of Sample/Photo</b><br>Workhouse<br>First Floor<br>Roof Upstand panels | | <b>Asbestos</b><br><br><b>Type</b> | Yes, Strongly<br>Presumed<br><br>Chrysotile (White) |

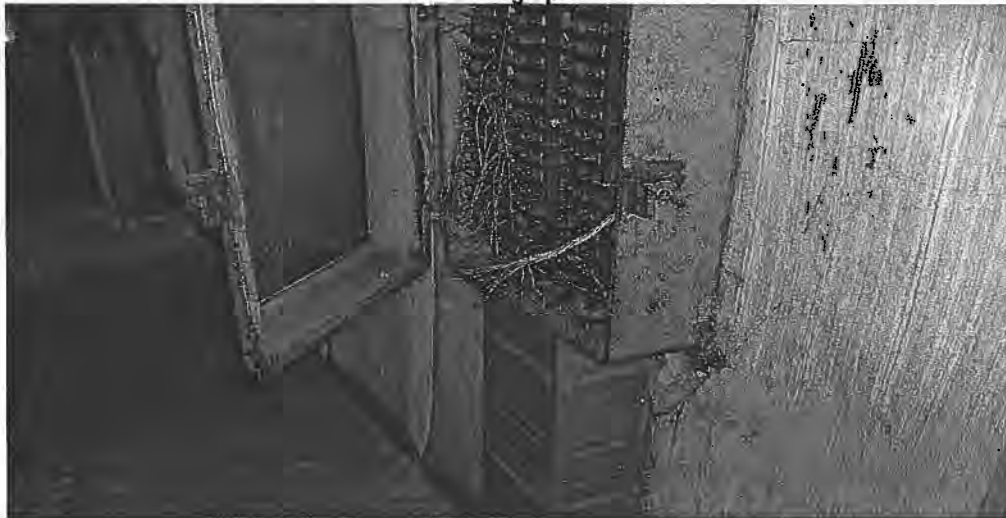
| <b>Location of Survey</b><br>Cane Hill Hospital,<br>Cane Hill,<br>Coulsdon, Surrey,<br>CR5 3ES | | <b>Position of Sample/Photo</b><br>Workhouse<br>Accommodation<br>Electrics rope seal | | <b>Asbestos</b><br><br><b>Type</b> | Yes, Strongly<br>Presumed<br><br>Chrysotile (White) |

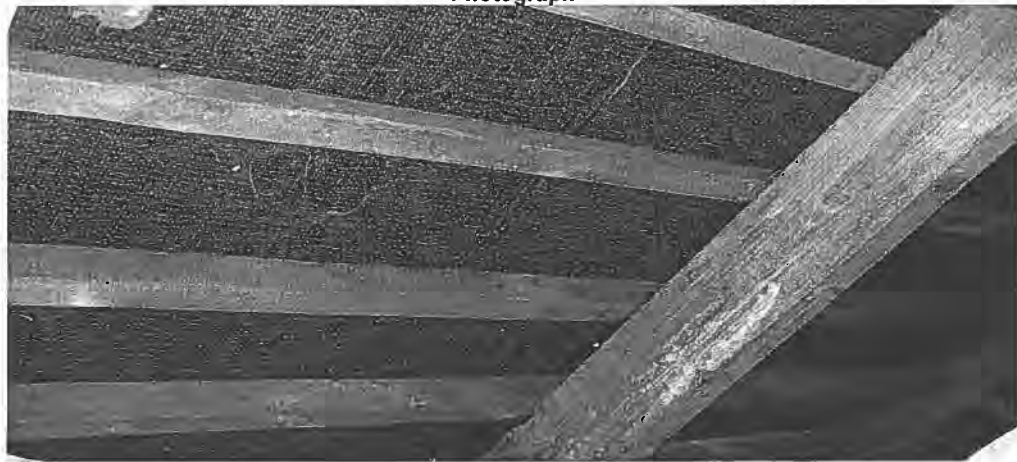
| <b>Location of Survey</b><br>Cane Hill Hospital,<br>Cane Hill,<br>Coulston, Surrey,<br>CR5 3ES | | <b>Position of Sample/Photo</b><br>Work House<br>Accommodation<br>Roof Felt | | <b>Asbestos</b><br><br><b>Type</b> | <b>No Asbestos<br/>Detected</b><br><br>N/A |

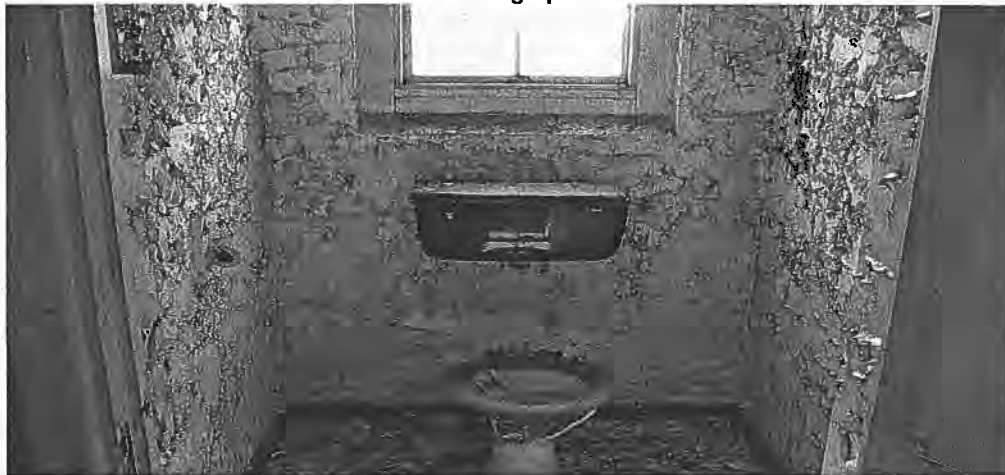
| <b>Location of Survey</b><br>Cane Hill Hospital,<br>Cane Hill,<br>Coulsdon, Surrey,<br>CR5 3ES | <b>Position of Sample/Photo</b><br>Workshop Accommodation<br>Dauntless Dolphin<br>W.C. Cistern | <b>Asbestos</b> Yes<br><br><b>Type</b> Amosite (Brown) |
| <b>Material Type</b> Plastic | <b>Quantity</b> 1m <sup>2</sup> | <b>Sample No</b> 06/B/8026/128<br><br><b>Survey Date</b> 24.04 - 29.06.06<br><br><b>Date of Report</b> 18.08.06<br><b>Surveyor(s)</b> <span style="background-color: black; color: black;">[REDACTED]</span> |
