# Public Realm, Walking and Cycling Strategy

**OOPR**  
OLD OAK & PARK ROYAL  
WALKING, CYCLING &  
PUBLIC REALM

*PERS Audit*

## Old Oak & Park Royal Walking, Cycling, Streets and Public Realm Strategy: PERS audit

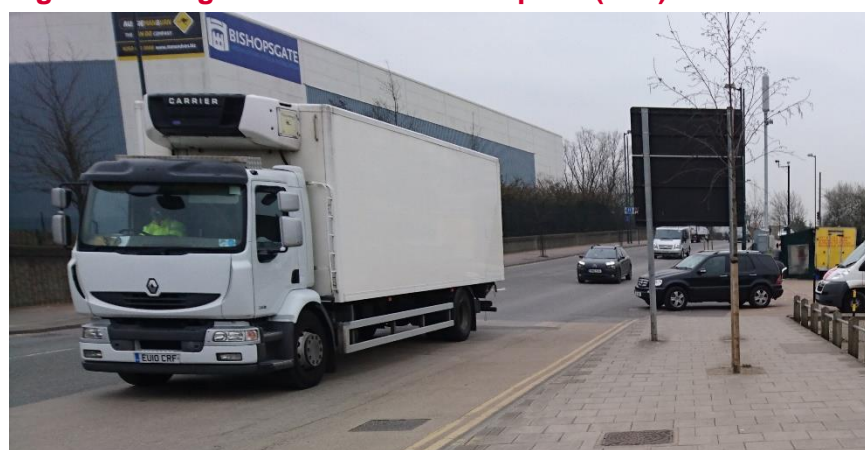
- 4.1.4 Several of the main routes into the study area are characterised by their high volume and speed of traffic. The provision of pedestrian crossing facilities is mixed. While there are some junctions where signalised pedestrian crossings are provided, there are also several examples of large roundabouts where pedestrians need to cross multiple lanes of traffic, often exiting the roundabout at speed. There are also key junctions where there is absolutely no provision

**Figure 4-2: High traffic volume and speed (R9a)**

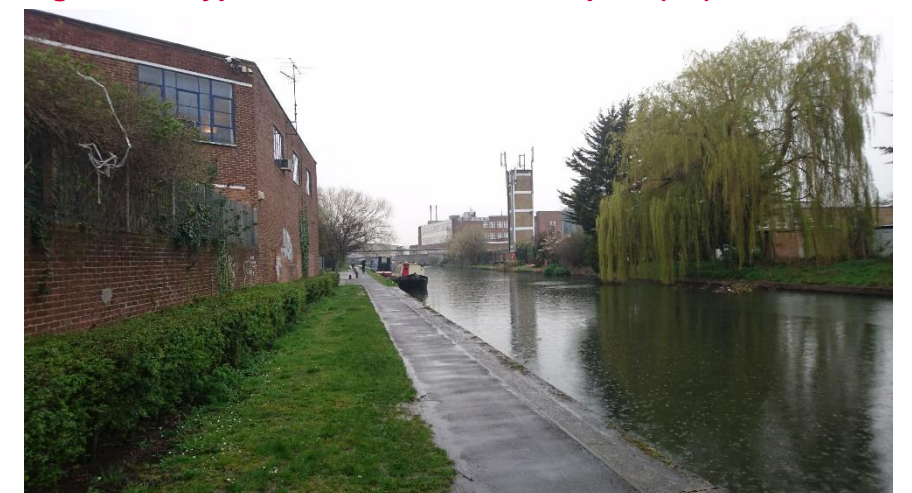
- 4.1.15 The canal towpath (R3) scores higher for quality of environment since it is a fascinating place combining nature, working industries, residential use of the canal boats and industrial heritage.

**Figure 4-6: Typical view of the canal towpath (R3)**

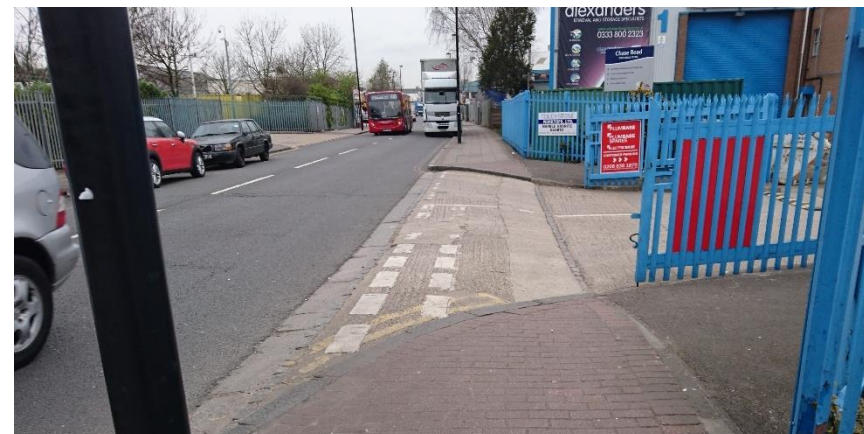
- 4.2.9 The study area also includes a number of links where the basic minimum of a continuous step-free footway along the main routes the area is not achieved. This is generally as a result of vehicle crossover arrangements to access industrial units. This is surprising in such an employment area not only because it excludes certain groups from accessing employment in Park Royal but because it also renders some types of servicing more difficult if goods are to be wheeled in by foot from vehicles parked in the street.

**Figure 4-11: Lack of step-free access at crossovers (L20)**

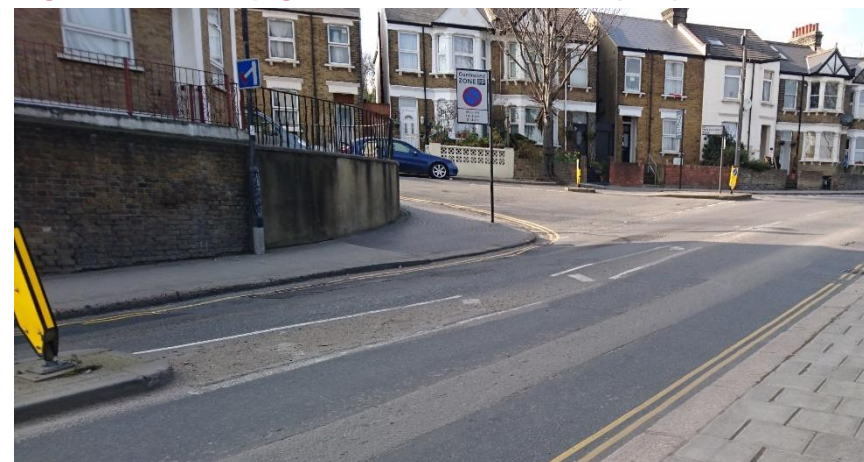
- 4.2.10 The topography of the study area means that a number of links contain some gradient. In most cases the street network follows continuous gradual gradients. Localised gradient issues in the detail of the pedestrian network can occur where steep dropped kerbs are provided on sections of slight gradient, or for example where the radius of a road junction leads to a tight pedestrian space with steep gradient and crossfall (L19).

**Figure 4-12: Steep gradients with crossfall (L19)**

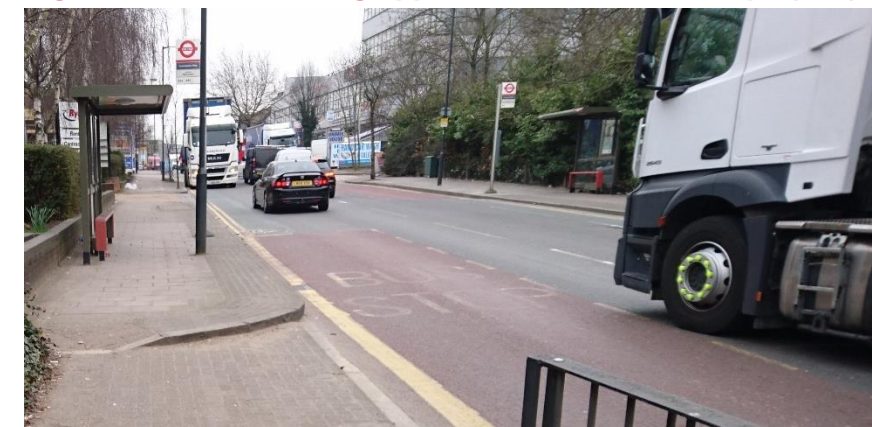
- 4.2.11 As described in the routes audit, the main routes into the site all carry high volumes of LGVs and HGVs. Yet some links score reasonably well if formal crossings are provided on all arms of the key junctions and additional pedestrian crossing assistance is provided on key desire lines.
- 4.2.12 A number of links score very poorly for permeability because there is no crossing provision at all at key points. This includes the lack of formal crossings or even informal refuges at key junctions in the walking network (L27, L28, L35 and L16). In these locations pedestrians are

**Figure 4-14: No crossing opportunities near bus stops (L35)**

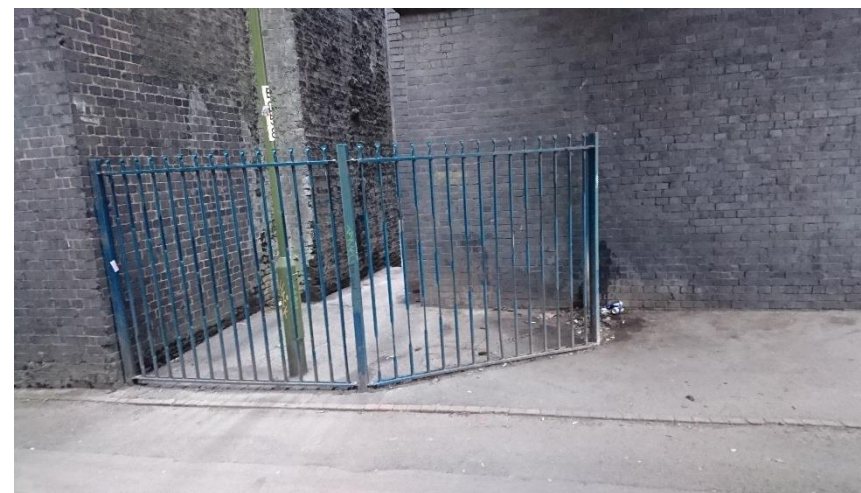
- 4.2.22 The routes into the study area from East Acton station (L17) and from Stonebridge Park station (L9) include successive railway tunnels. Even with dedicated lighting of the pedestrian space, these tunnels are dark and frequently damp spaces, which often have shadowy concealed spaces around the tunnel arch. In some cases measures have been taken to close off concealed spaces to give more confidence to pedestrians at night.

Figure 4-16: Closing off concealed spaces in tunnel (L9)

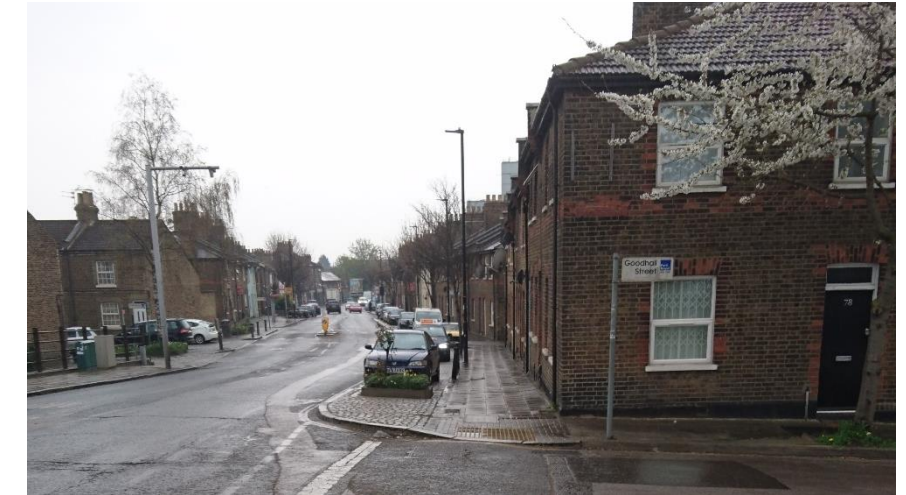
Figure 4-17: Overlooking residential frontages (L7)

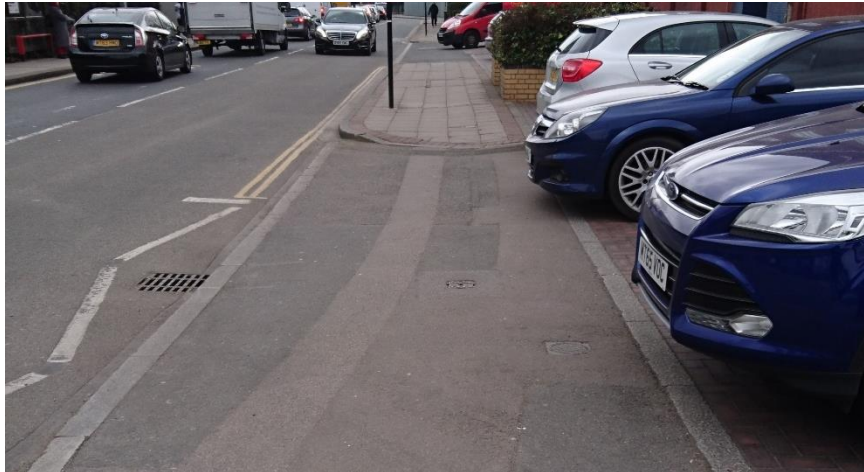
**Figure 4-19: Example of better surface at crossover(L25)**

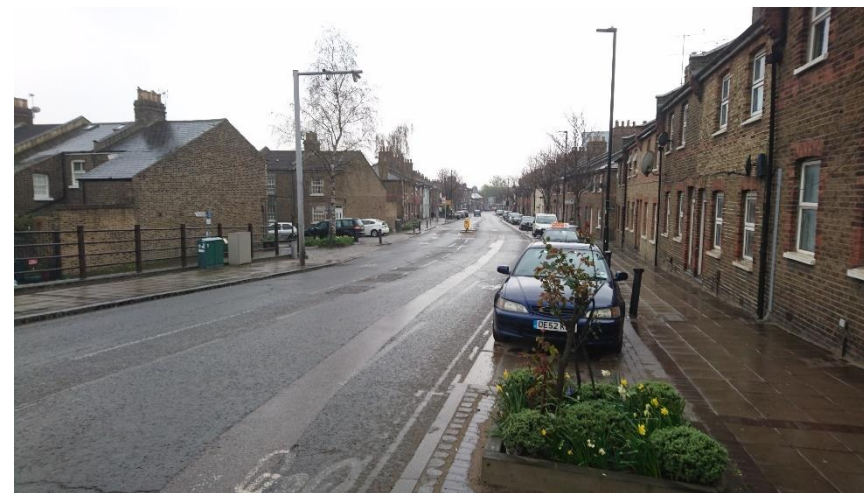
4.2.31 In the areas of residential frontage on Old Oak Common Lane (L7), the co-existence of on-street parking and a clear footway is well-managed.

**Figure 4-22: Management of on-street parking (L7)**

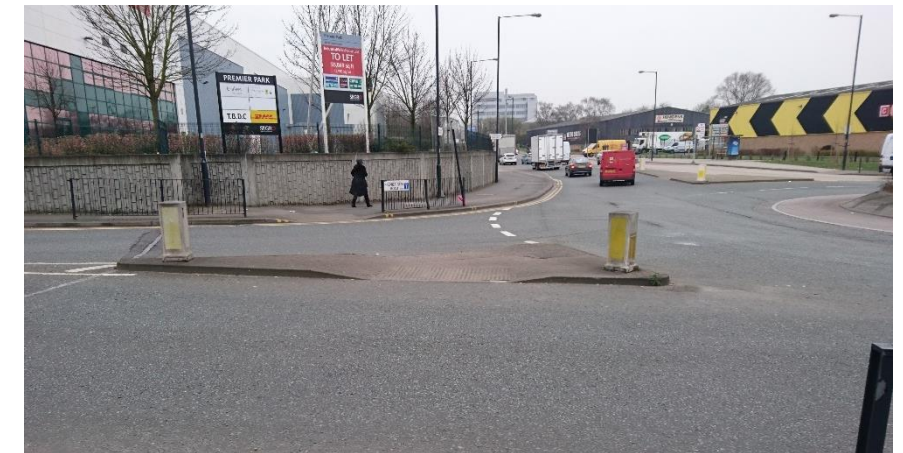
visual interest for pedestrians have the largest unit sizes, which turn their back on these routes (e.g. L36). The links with smaller units and more street-facing activities have a more human scale.

**Figure 4-23: Large unit sizes on Abbey Road (L36)**

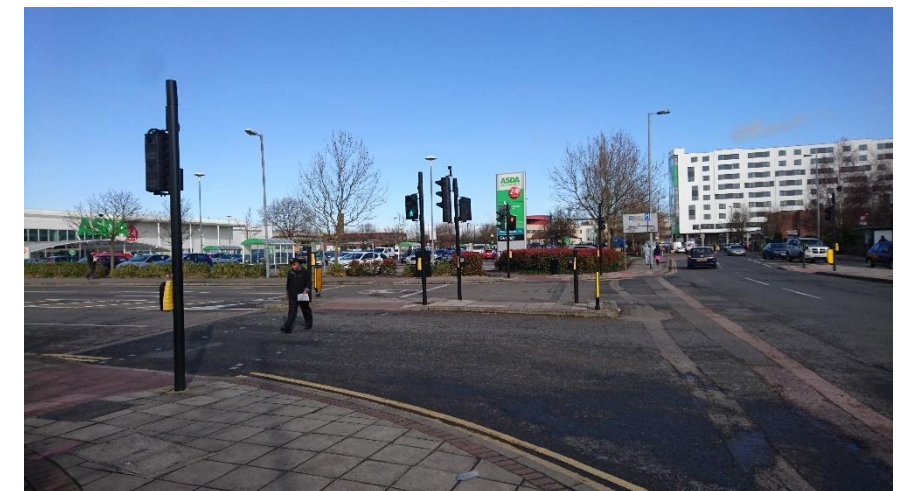
4.2.34 The main routes through Park Royal meet in what could be described as the 'town centre' of Park Royal around the hospital and ASDA supermarket. However, this area does not yet offer much of a sense of place. The supermarket is set back from the street by a large sea of parking. Current redevelopment of the corner site at the entrance to the hospital will provide a more urban frontage to the space on one side.

**Figure 4-24: Park Royal 'town centre' (L33)**

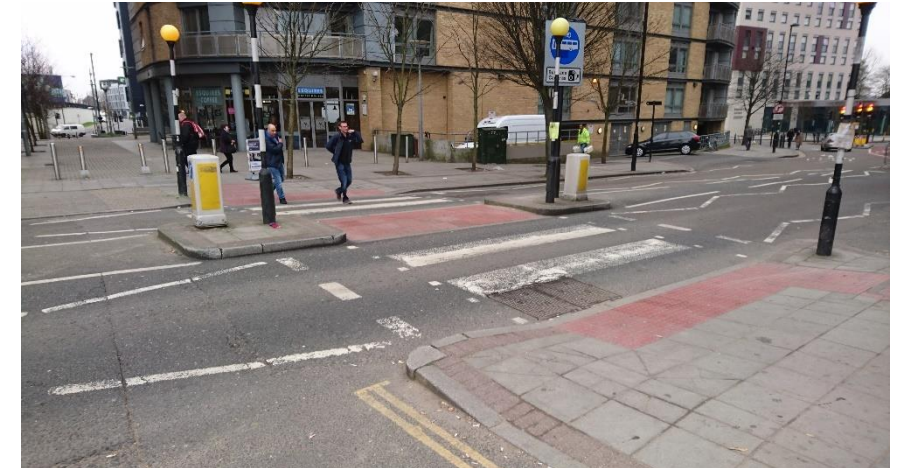
- 4.3.3 A number of the pedestrian crossing facilities are scored highly in terms of provision and performance. This includes the zebra crossing at the entry to North Acton station (C16), which has the capacity to cope well with the regular bursts of pedestrians exiting the Central Line. The signalised junctions on Abbey Road (C60, C61, C54, C55 and C56) also score well since they provide pedestrian-activated and protected crossings on what is a very busy road with high traffic flows.

**Figure 4-27: High capacity zebra crossing (C16)**

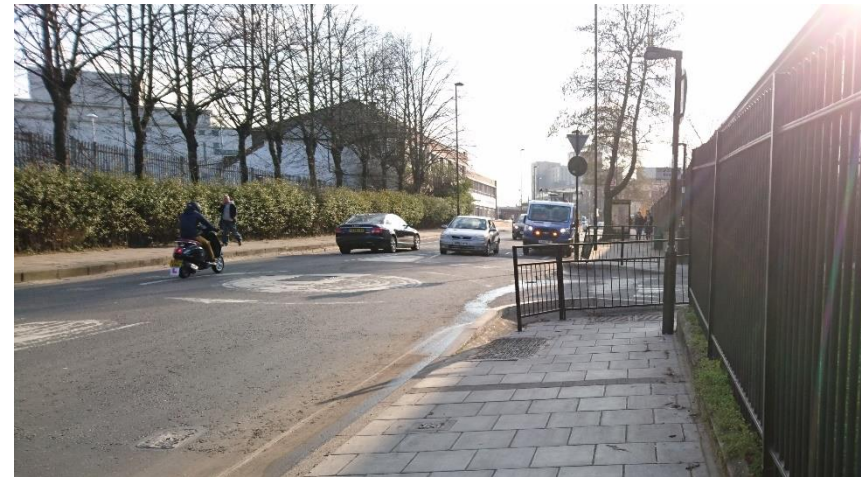
use of a mini-roundabout at this location is appropriate but the layout where pedestrians are forced into the drivers' blind spot to cross is unsatisfactory.

**Figure 4-30: Pedestrians forced to cross in blind spot (C25)**

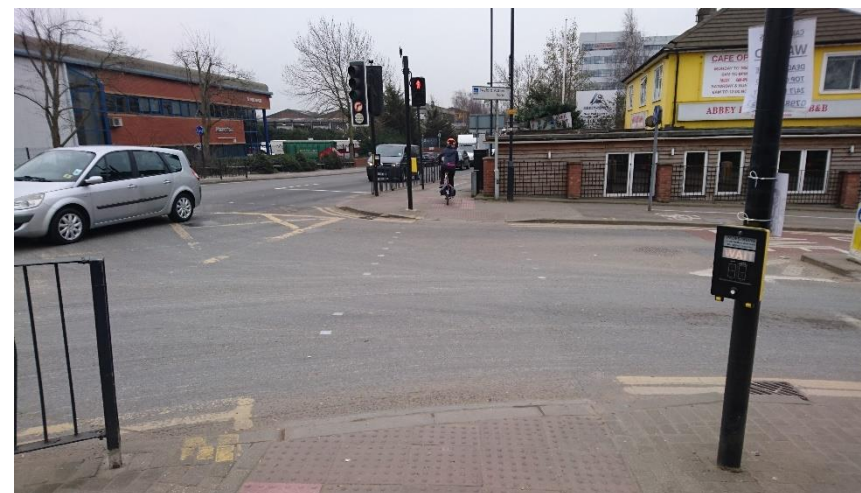
4.3.7 Many of the crossings in the study area are located on or reasonably close to the pedestrian desire lines. This is easier to achieve with crossings with a single stage.

**Figure 4-31: Single stage on the main desire line (C55)**

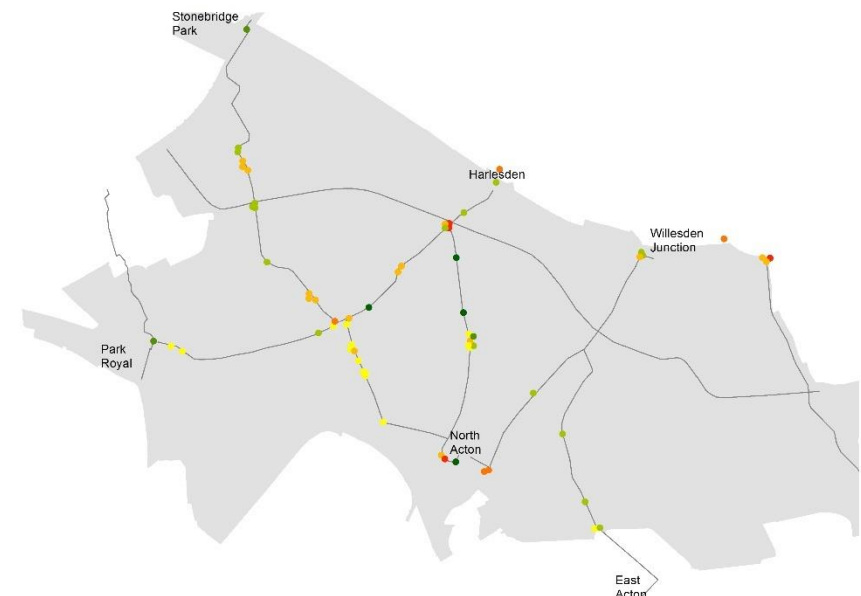
Delay

4.3.12 Pedestrian delay at the roundabouts and informal crossing refuges depends on the level of traffic observed at different

- 4.3.13 Where signalised crossings are provided at junctions, a variety of cycle times are observed. For example, at the junction of Harrow Road and Scrubs Lane (C5 and C7), the staggered crossings run in an approximately 100-second cycle. The junction of Acton Lane, Barretts Green Road and North Acton Road has a shorter cycle time of around 70-80 seconds but no dedicated pedestrian phases on three arms (C32, C33 and C34). As a result, pedestrians are observed to run across these arms in the brief intergreen phases.

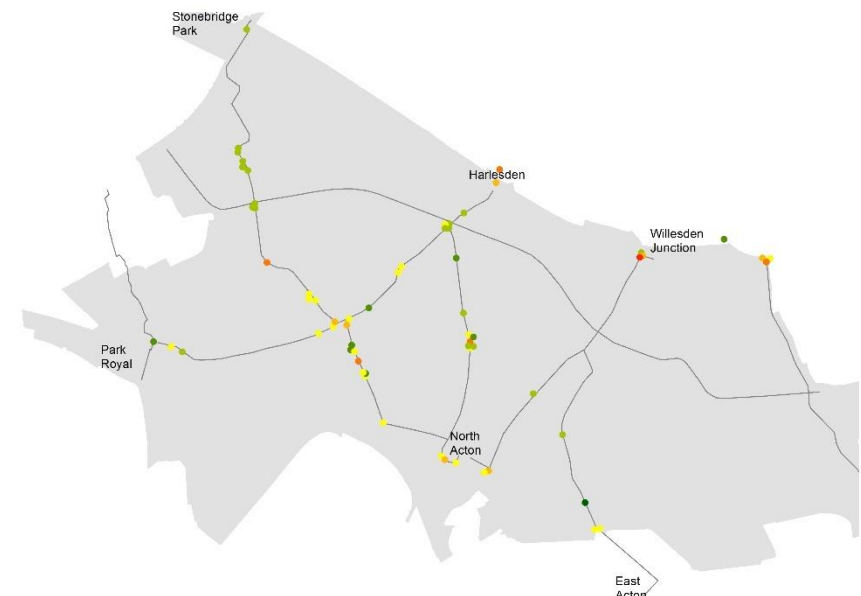
Capacity

4.3.9 The majority of the crossings in the study area are scored neutrally or positively for capacity. Given the low pedestrian flows observed in many locations, the need for particularly wide crossings is limited.

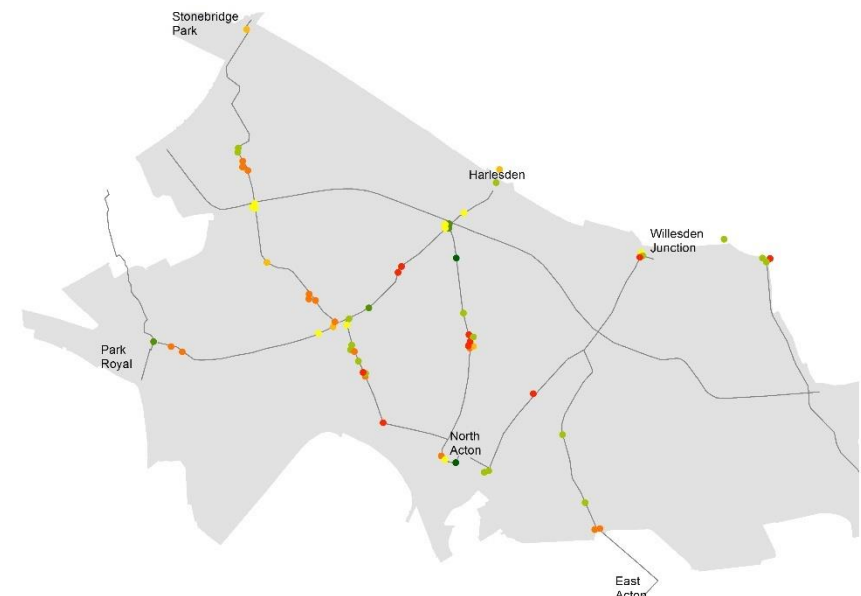
Legibility

- 4.3.14 The majority of the signalised and zebra crossings in the study area were assessed to have a reasonable delineation of the crossing space, clearly identifiable stop lines and generally good visibility for drivers and pedestrians.
- 4.3.15 The roundabouts do not perform as well in terms of the delineation of pedestrian crossing space and sightlines between drivers and pedestrians. In many cases there is simply very little sense of pedestrian ownership of the space. The double roundabout arrangement on Chase Road is one example of illegible crossings. Drivers are observed to approach at speed and negotiate between multiple vehicle movements while paying little attention to the presence of pedestrians.

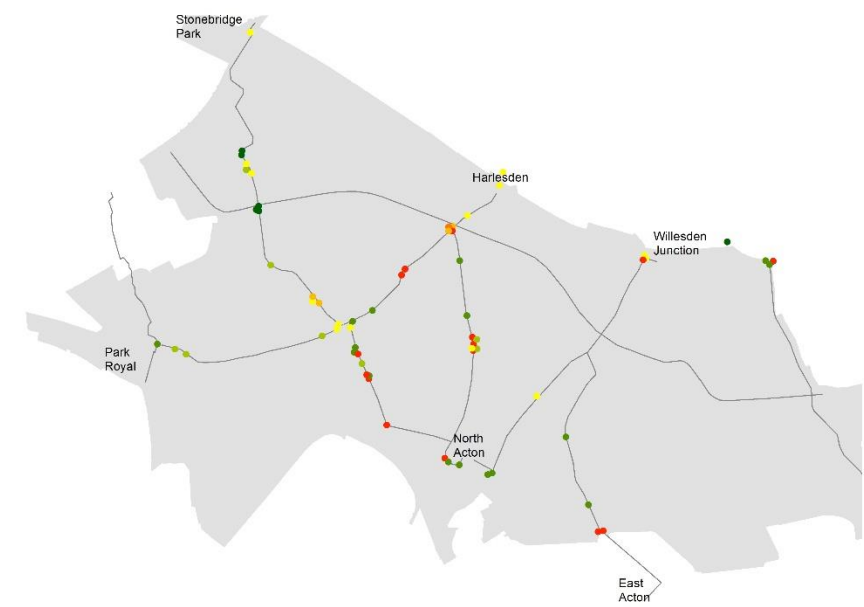
Legibility for sensory impaired people

- 4.3.16 All of the signalised crossings were observed to have some provision for sensory impaired persons in the form of tactile paving and rotating cones.
- 4.3.17 As described in the link audits, the use of coloured tactile paving at formal crossings is generally consistent. The greater challenge is the lack of any provision at all on the desire lines with no crossing assistance at all.

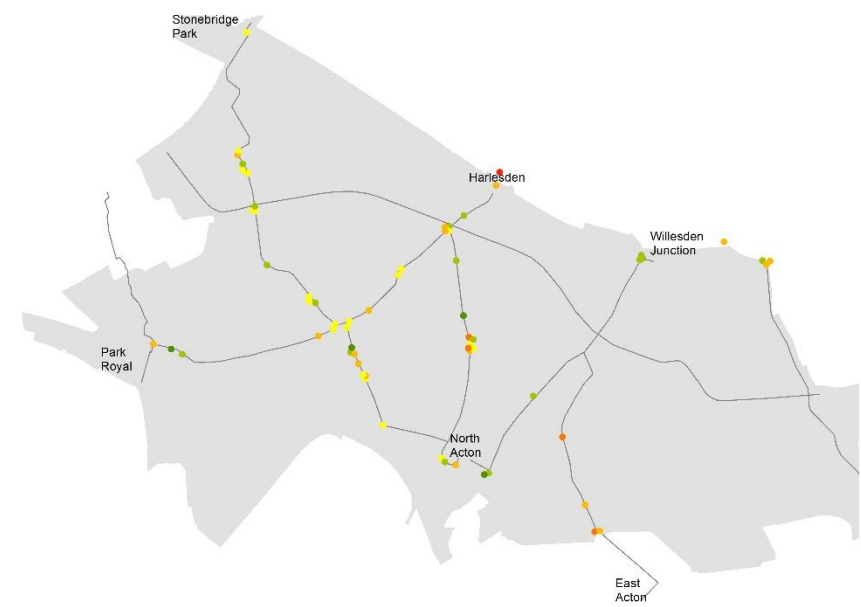
- 4.3.19 Surface quality issues occur at several points where the carriageway is uneven, rutted or broken up at the point where pedestrian cross the road (e.g. C20 and C22).

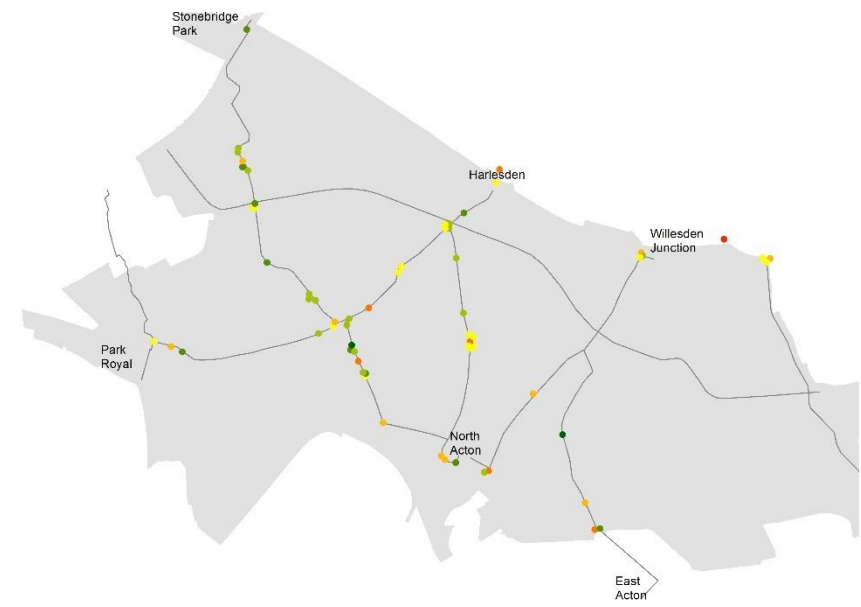
Obstructions

- 4.3.21 One specific issue noted in the study area is the frequent presence of guard rail and other street furniture that has been damaged by vehicles. This may be a consequence of the aggressive driving behaviour frequently observed in the area and it does reduce the effective pedestrian width available in several places (C13 and C58).
