### Asbestos Survey Report & Register

Survey Type:	Asbestos Demolition Survey
Site:	Garages - Beech Avenue, Adjacent to 48 Beech Avenue, Brentwood, TW8 8NH
Surveyor:	Liam Bates
Contract:	S-10564
Survey Date:	04 November 2019
Report Date:	13 November 2019
Client:	Arcadis LLP PO Box 307, Manchester, M60 3NT

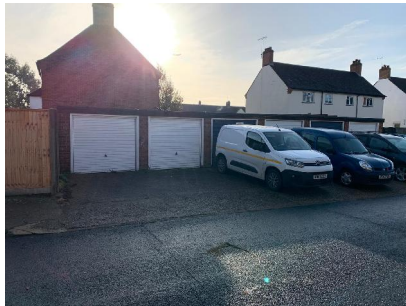
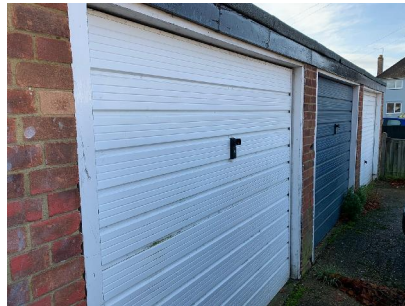
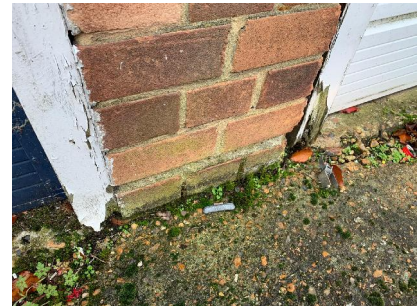
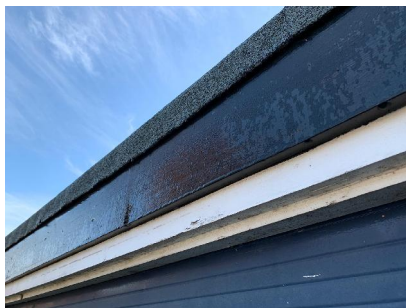
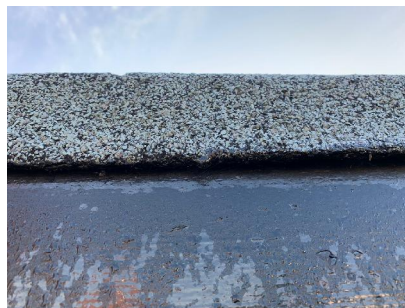
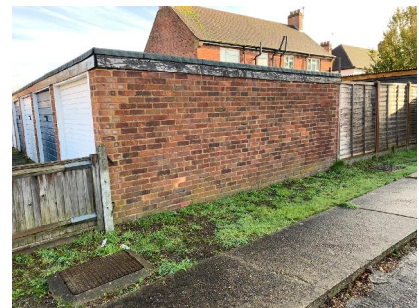
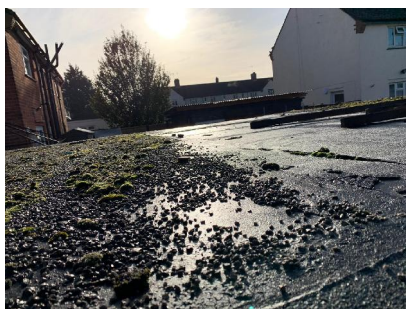
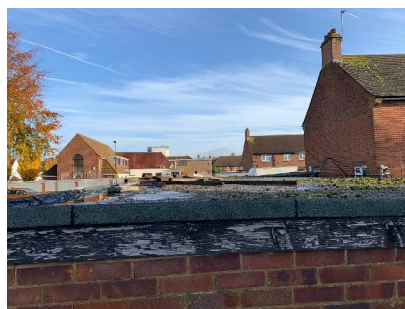
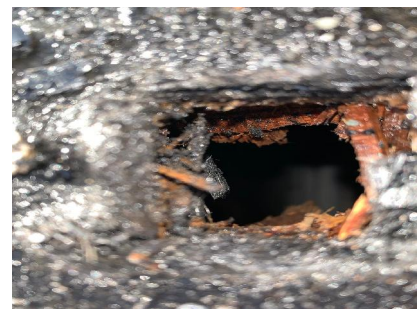
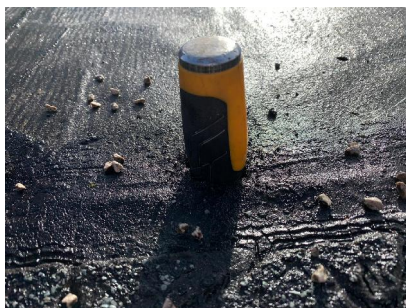
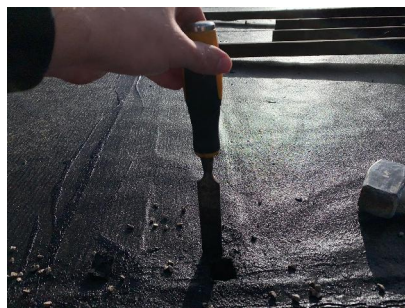
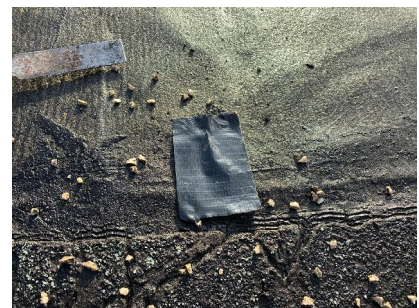
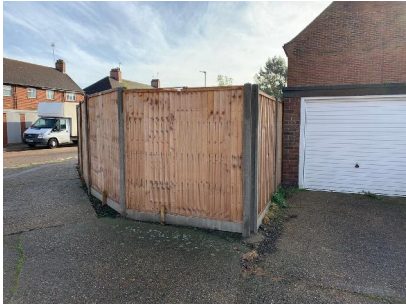
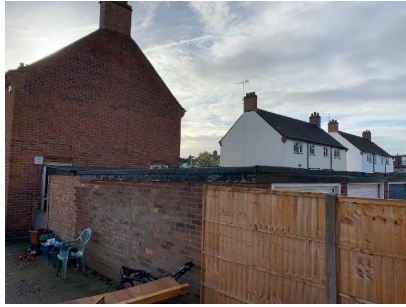
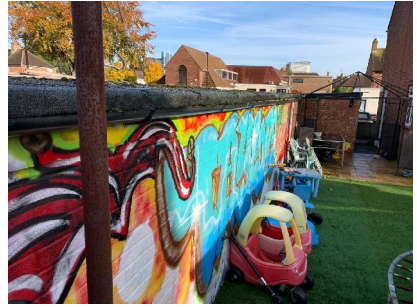
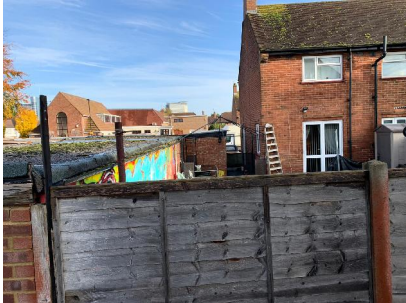
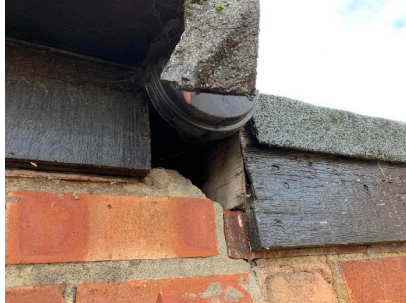
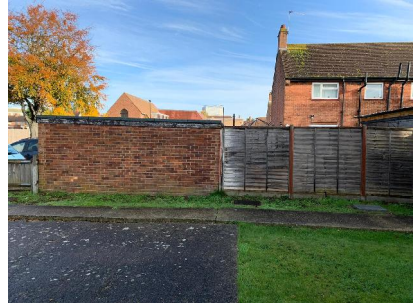
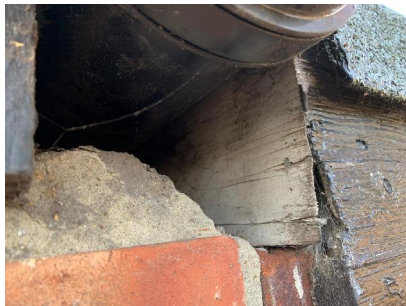
Photos:

Area:	x6 Garages - Beech Avenue
Floors:	The floors comprised of; no accessed within garages
Walls:	The walls comprised of brick
Ceilings:	The ceilings comprised of; roof felt (sampled) onto timber.
External:	The external areas comprised of; brick built, damp proof course (sampled), metal garage doors, putty to timber framework (sampled), timber fascia panels, plastic rainwater products to rear of garages, roofing felt (sampled).

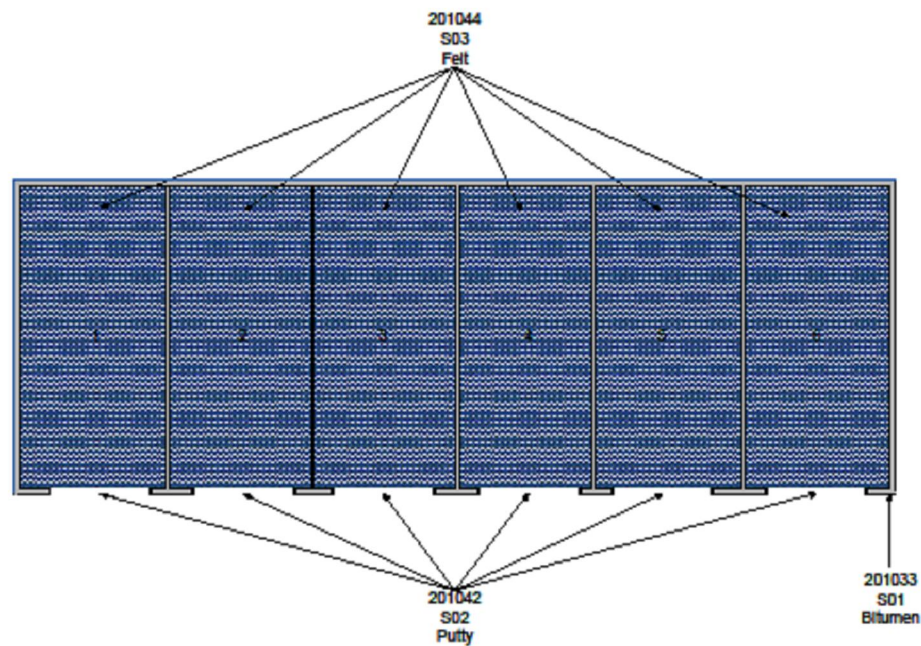
Not Accessed, presumed to contain asbestos	<b>Additional Information:</b>  No access areas: Only specific room areas will be highlighted within the plan. For more detailed information with regards to no access areas and restrictions please see the relevant section within the main body of the asbestos survey report.  Each sampling point has a unique identifier (e.g. OSL:001) which can be used to refer back to the individual asbestos register sheet for that location.
	<b>Site:</b> Garages at 48 Beech Avenue Brentwood TW8 8NH		
<b>Contract No:</b> S-10564	<b>Scale:</b> Not to Scale
