### Asbestos Survey Report & Register

Survey Type:	Asbestos Demolition Survey
Site:	Garages - Beaconsfield Close, Beaconsfield Close, Chiswick, W4 4EL
Surveyor:	Liam Bates
Contract:	S-10566
Survey Date:	04 November 2019
Report Date:	12 November 2019
Re-Inspection Due:	04 November 2020
Client:	Arcadis LLP PO Box 307, Manchester, M60 3NT

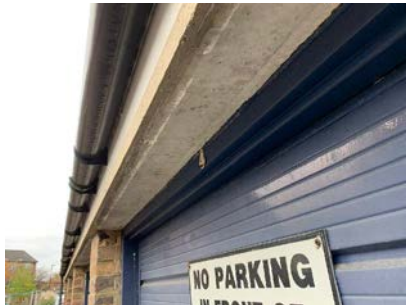
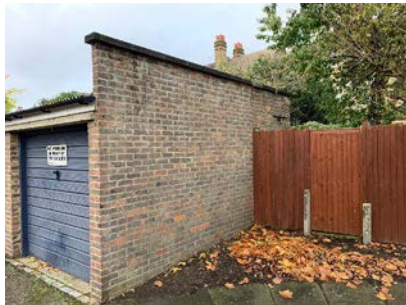
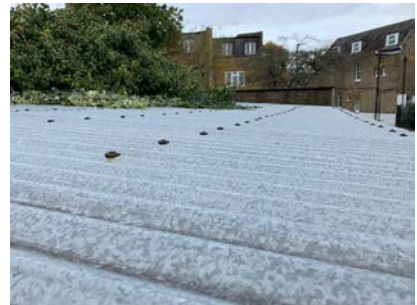
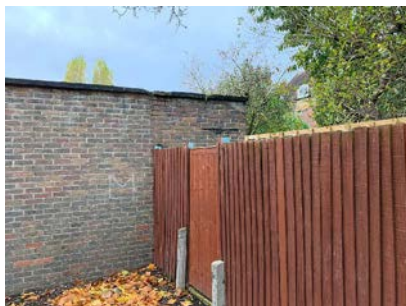
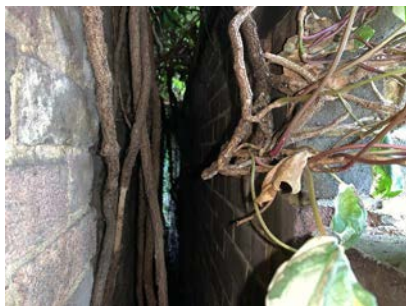
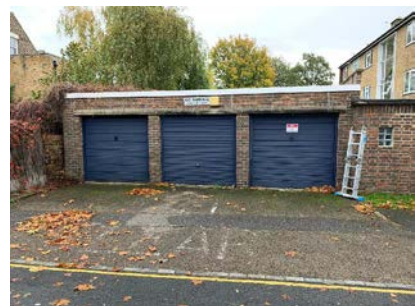
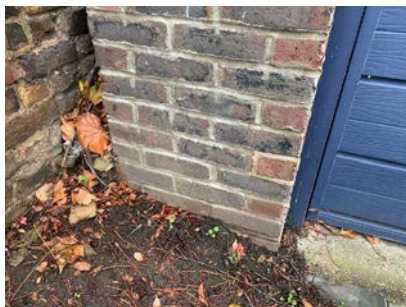
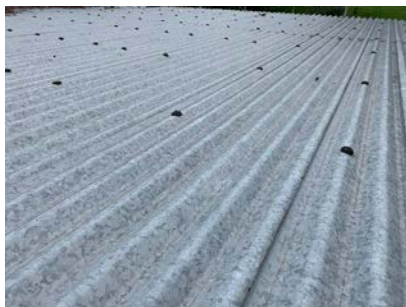
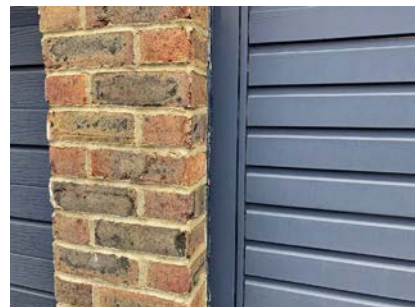
Photos:

Area:	x3 Garage Blocks - Beaconsfield Close
Floors:	Floors comprised of; no accessed within garages
Walls:	Walls comprised of brick
Ceilings:	Ceilings comprised of; 001 - corrugated metal sheet 002 - corrugated metal sheet 003 - corrugated metal sheet, cement sheet, and felt.
External:	External areas comprised of;  001 - brick built, no visible damp proof course, metal roof, metal and timber garage doors, putty to timber framework (sampled), UPVC fascia panels with modern mastic, plastic rainwater products, concrete soffits.  002 - brick built, damp proof course (sampled), metal garage doors, metal roof, putty to timber framework (sampled), UPVC fascia panels with modern mastic, plastic rainwater products to rear, concrete soffits.  003 - damp proof course (sampled), putty to timber framework (sampled), metal garage doors, concrete soffits, UPVC fascias, plastic rainwater products, bitumen packer layer, roofing was combination of metal, cement (sampled), and felt (sampled).
