### Asbestos Survey Report & Register

Survey Type:	Asbestos Demolition Survey
Site:	Garages - Florence Gardens, Florence Gardens, Chiswick, W4 3JX
Surveyor:	Liam Bates
Contract:	S-10567
Survey Date:	04 November 2019
Report Date:	12 November 2019
Client:	Arcadis LLP PO Box 307, Manchester, M60 3NT

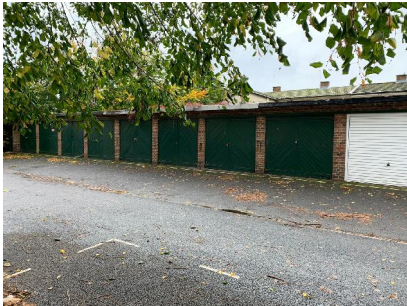
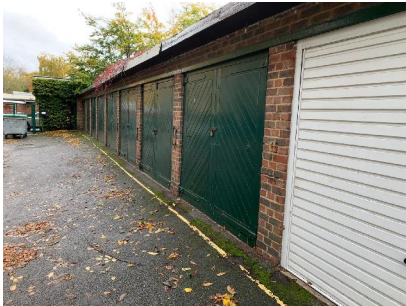
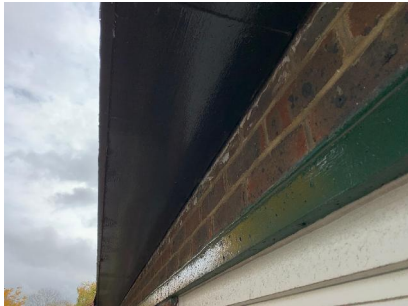
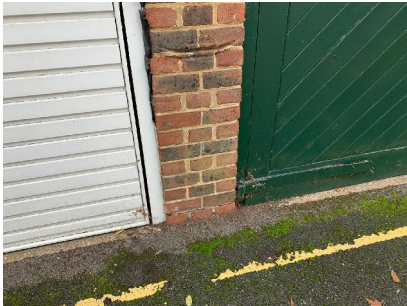
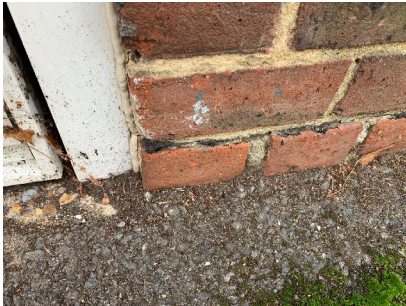
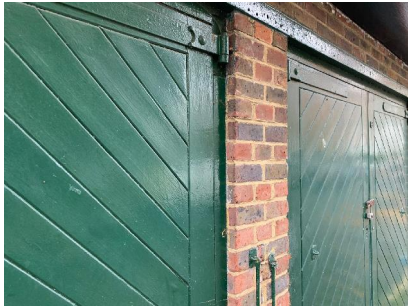
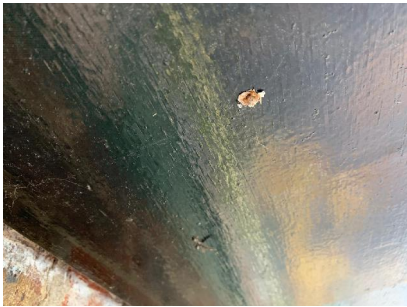
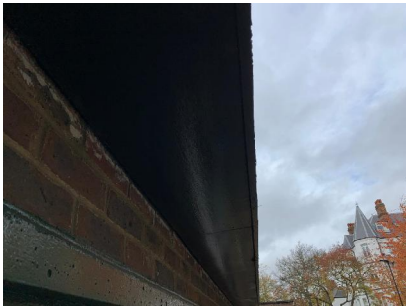
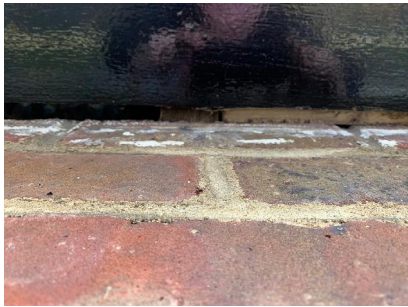
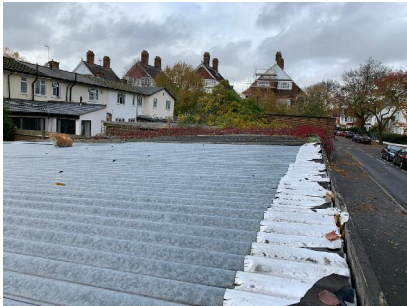
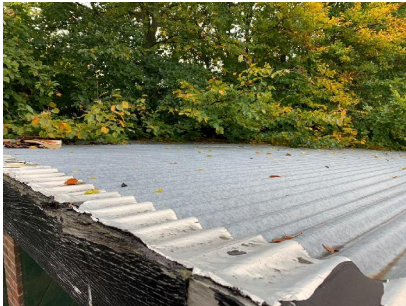
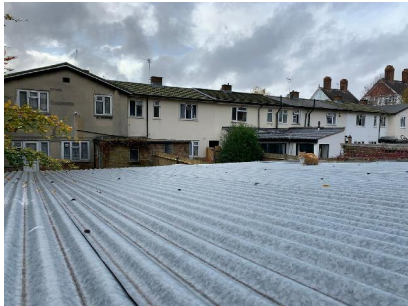
Photos:

Area:	x13 Garages in a Block - Florence Gardens
Floors:	Floors comprised of; no accessed within garages
Walls:	Walls comprised of brick
External:	External areas comprised of; brick built, damp proof course, roofing included metal, cement (sampled) and felt (sampled), metal and timber garage doors, putty to timber framework (sampled), timber soffits & fascia panels.
