Asbestos Survey Report & Register

Survey Type:	Asbestos Demolition Survey
Site:	Garage Site 9, Garage Blocks at Gunnersbury Close, Chiswick, W4 4EQ
Surveyor:	Jason Pack
Contract:	S-07995
Survey Date:	03 April 2019
Report Date:	12 April 2019
Client:	Arcadis LLP PO Box 307, Manchester, M60 3NT

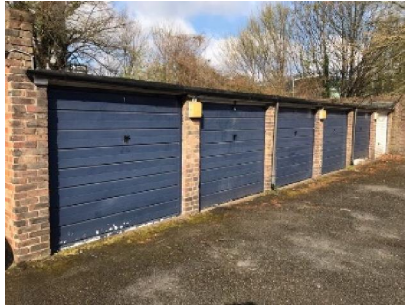
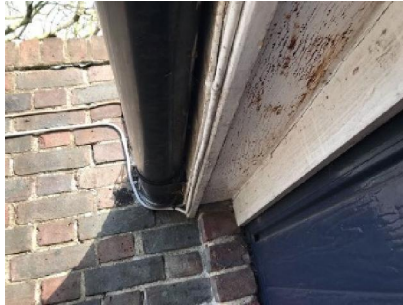
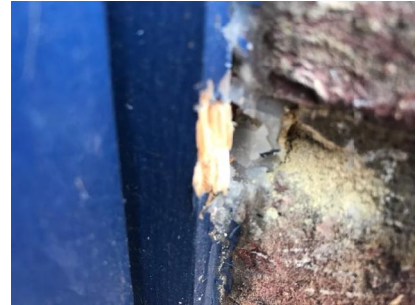
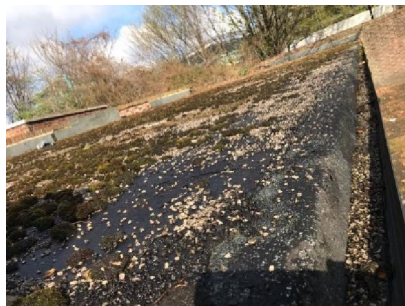
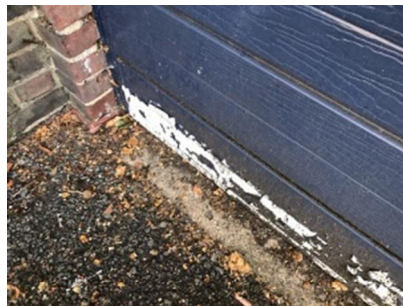
Area:	Externals to Garage Blocks 1-6 & 7-16
Floors:	No access was gained within garages
Walls:	The walls are of a traditional brick construction
Ceilings:	The ceilings could not be inspected as no access was gained internally as they were locked at the time of the survey.
Other:	Not applicable
External:	The garage blocks are comprised of brick walls with timber soffits and fascia's and plastic guttering and down pipes.
