TFL SITES
PHASE 2 SMALL SITES
NEWHAM WAY

PAS128 M4P
UNDERGROUND UTILITY MAPPING SURVEY

SURVEYED BY: PW / MM / JE / EE	DRAWN BY: VK	APPROVED BY: EE
SCALE: 1:200 @ A2	SURVEY DATE: 01 / 2019	
DRAWING NUMBER: 1670_P_Newham_Way		
SHEET NUMBER: 1 of 1 A2		REV:

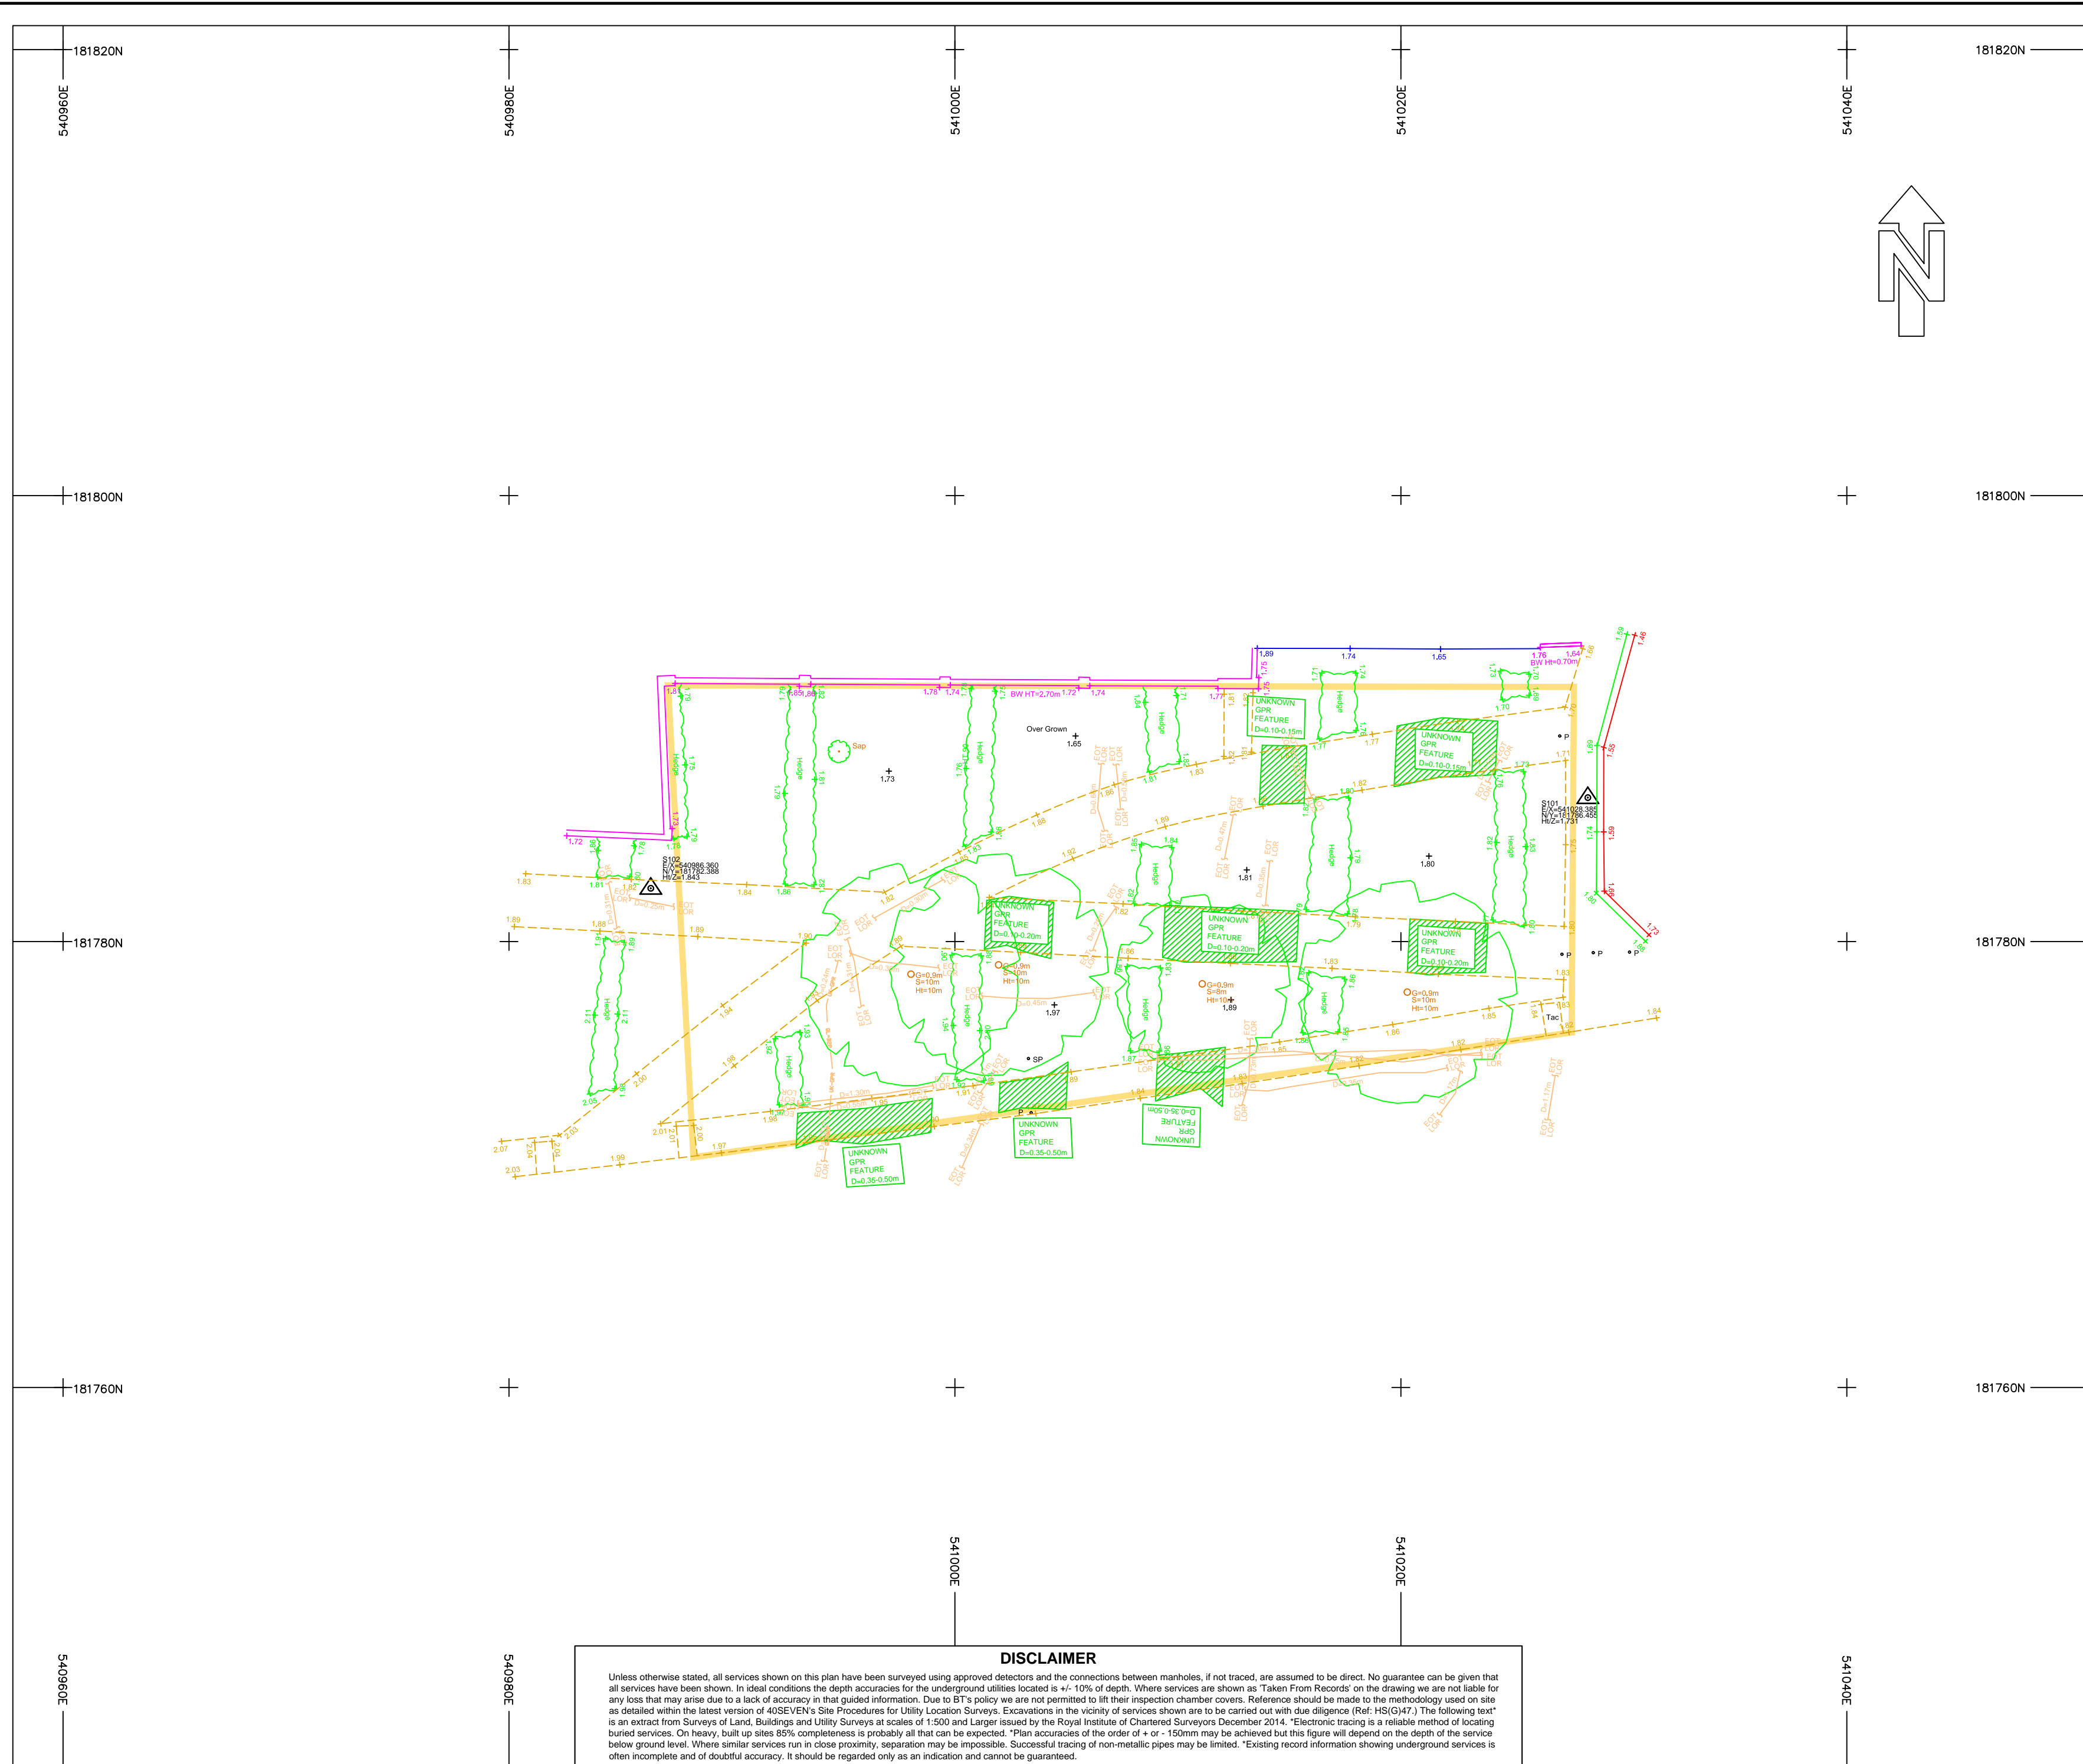
Read in conjunction with existing records.
Utility routes and text shown in dark grey are from existing records.
Drainage routes with a pipe diameter of 300mm or greater are shown as the pipe width along with continuous line style.
For additional copies please contact 40SEVEN.
Services plotted outside survey extents should not be considered to be exhaustive.
