LONDON BOROUGH OF HOUNSLOW SMALL SITES SMALL BUILDERS PROGRAMME

GARAGE BLOCK AT GARTH COURT, CHISWICK, W4 4QL

Preliminary BS5837:2012 Tree Survey Report

MAY 2019

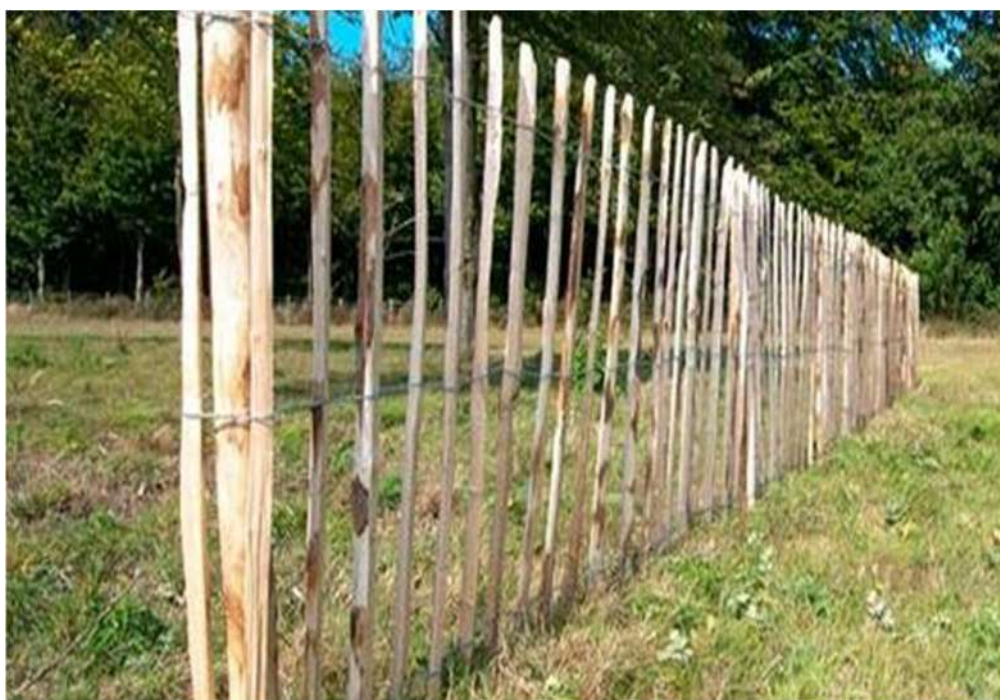
Figure C1 Tree Protection fencing example for low use areas

The system illustrated in Figure C1 is adequate to define areas of protected vegetation and exclude traffic, and comprises Cleft Chestnut Pale Fence in accordance with *BS 1722 Part 4: Specification for cleft chestnut pale fences (British Standards Institution, 1991)* supported by 150mm wooden stakes. Assembled with galvanized 14-gauge (2 mm) wire, four strands per row, peeled and pointed one end. Approximate spacing of pales 75 mm.

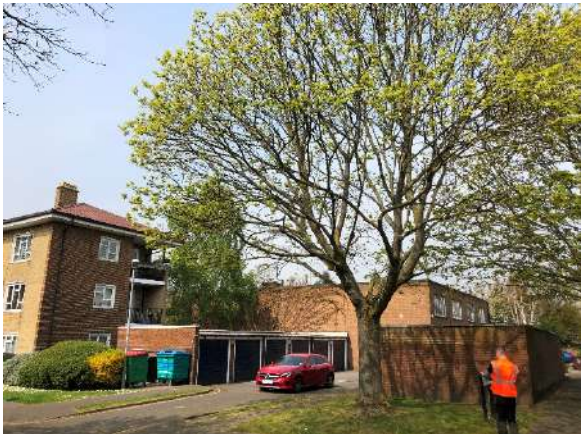
Tree No.	Description	Photograph
T1	Norway Maple (<i>Acer platanoides</i>)

A large, mature Norway Maple tree with a dense canopy of green leaves. It is situated in a residential area with a brick house and a red car visible in the background. A person in an orange high-visibility vest is standing near the base of the tree.
T2	Norway Maple (<i>Acer platanoides</i>)

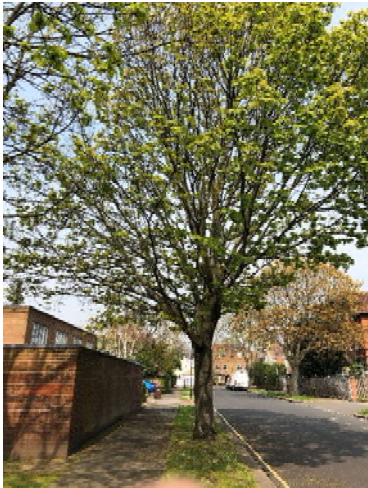
A Norway Maple tree with green leaves, growing on a street. A brick wall is visible on the left side of the frame.
T3	Silver Birch (<i>Betula pendula</i>)

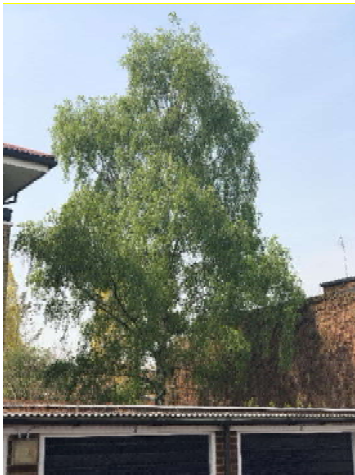
A Silver Birch tree with characteristic weeping branches and green leaves. It is located behind a brick wall and a building.
