# Outline Condition Survey Report

## CAPITA SYMONDS

### Cane Hill Hospital – Building 5

File No: CS/022329  
Date of Inspection: 2<sup>nd</sup> November 2006

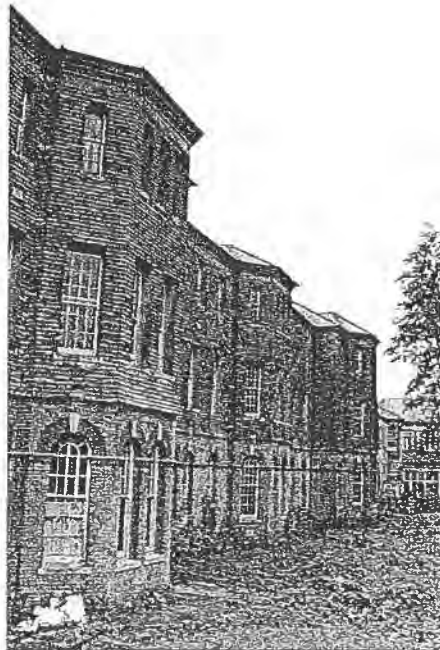
02 South Elevation

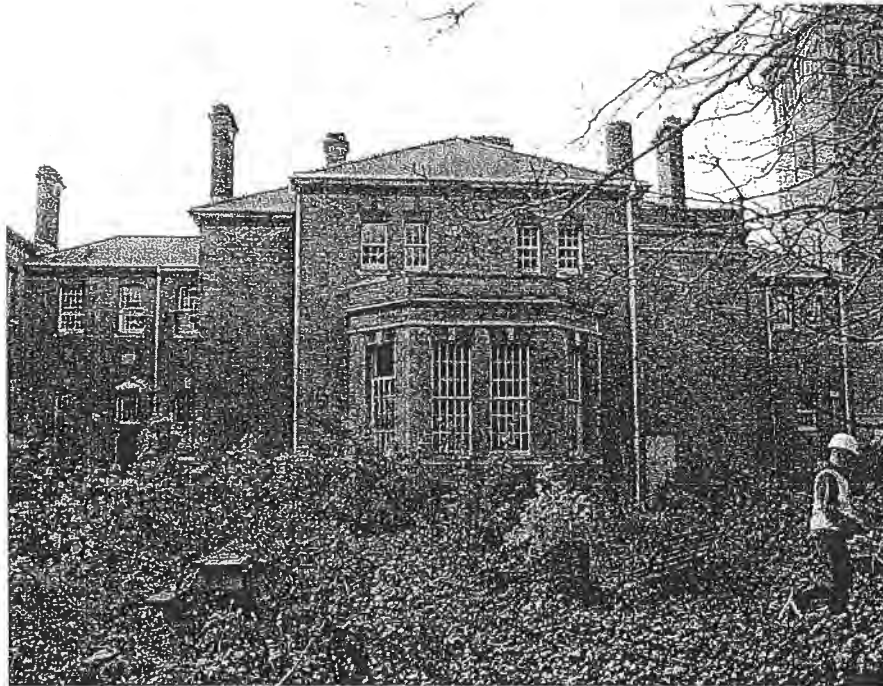
01 NE elevation of 14A

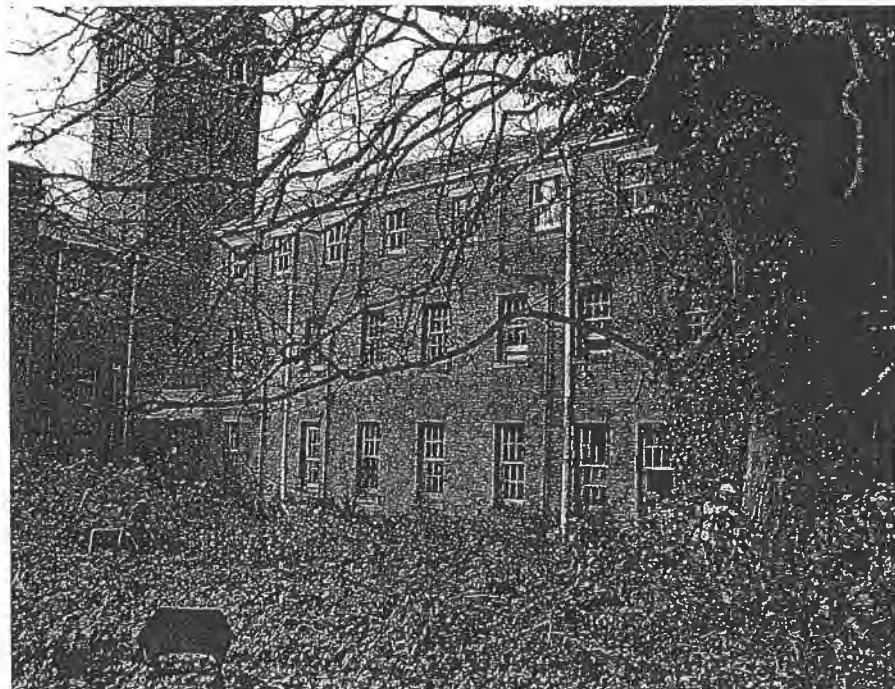
04 S Elevation of 14C

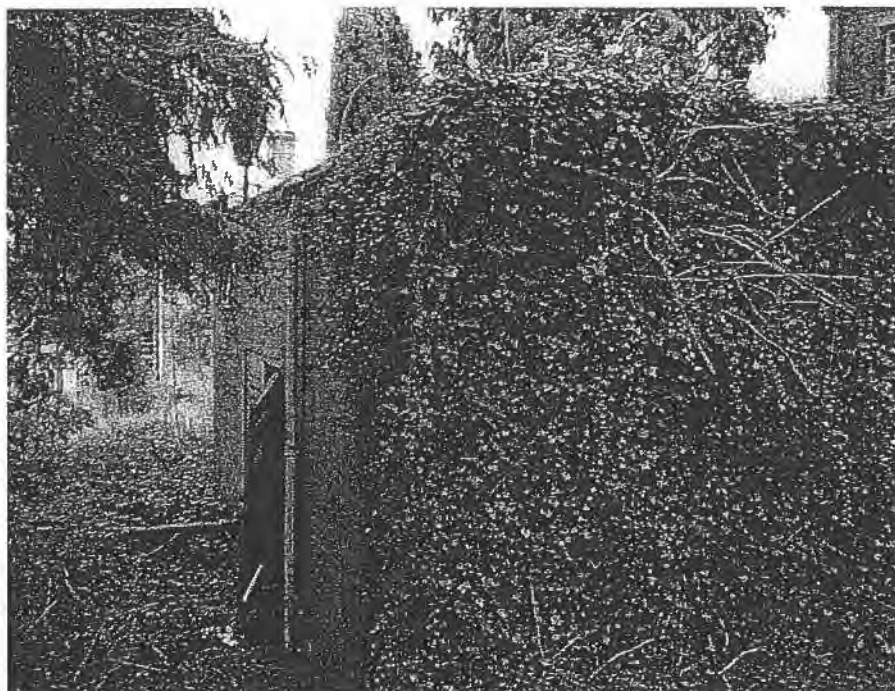
11 15B side elevation

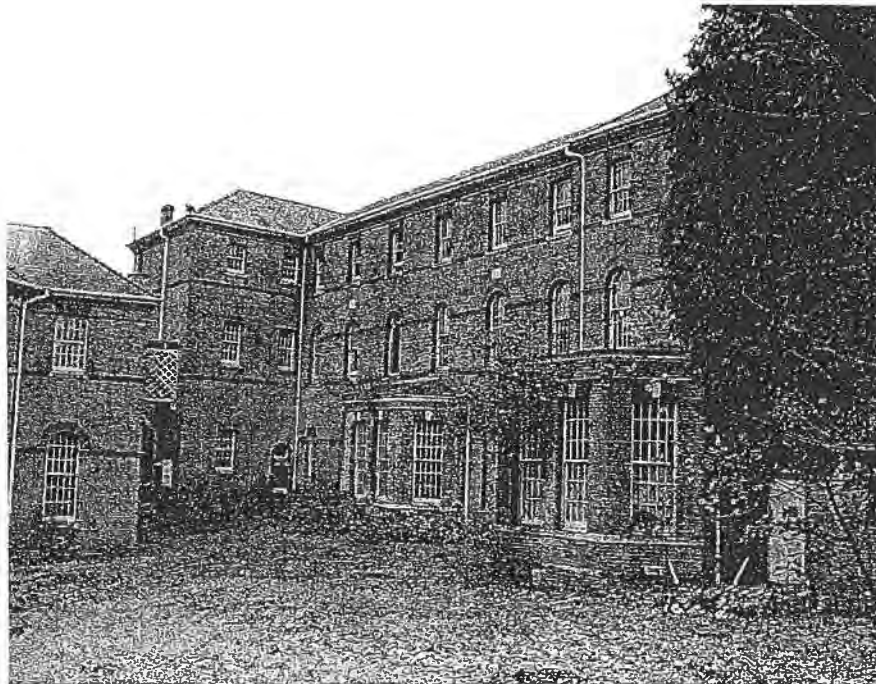
02 West elevation

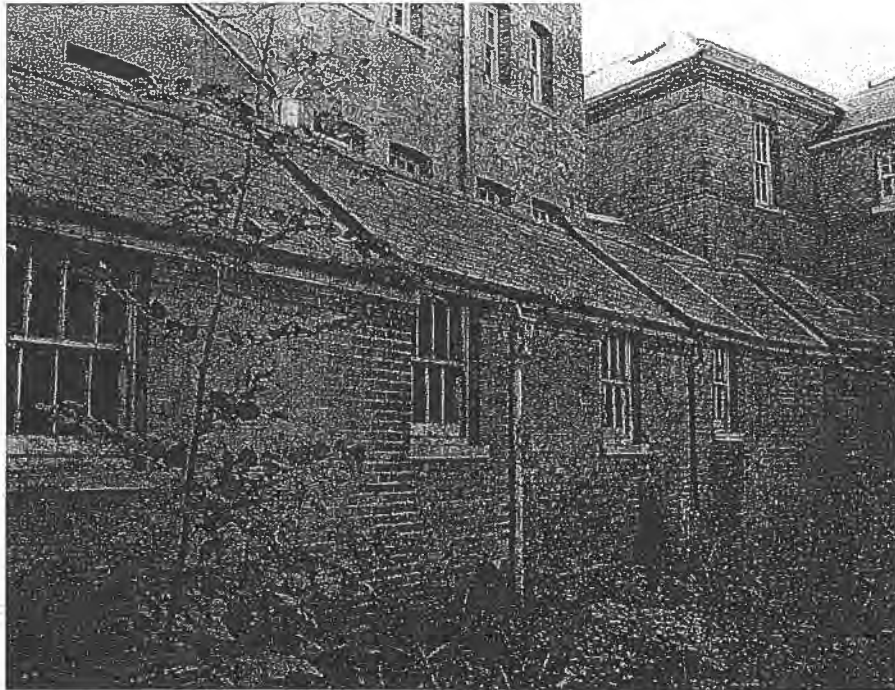
07 Links corridor

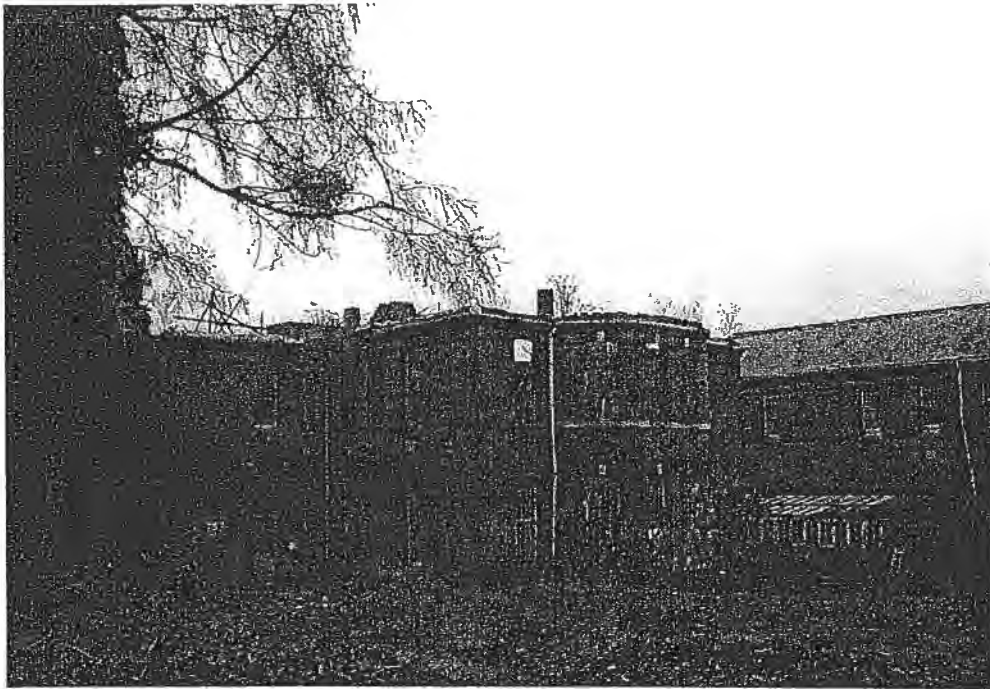
01 North elevation to west block

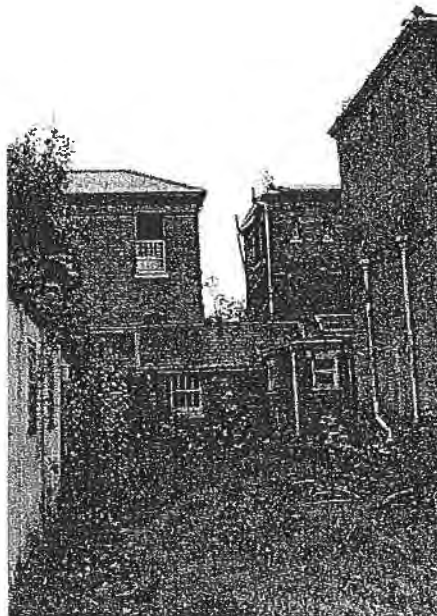
02 South elevation to west block

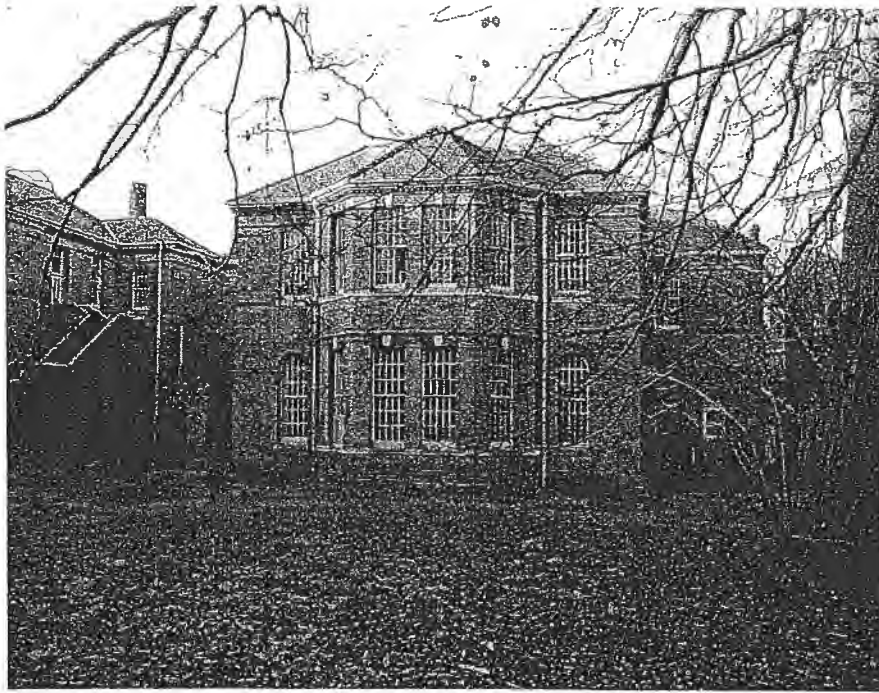
01 S Elevation of 19A

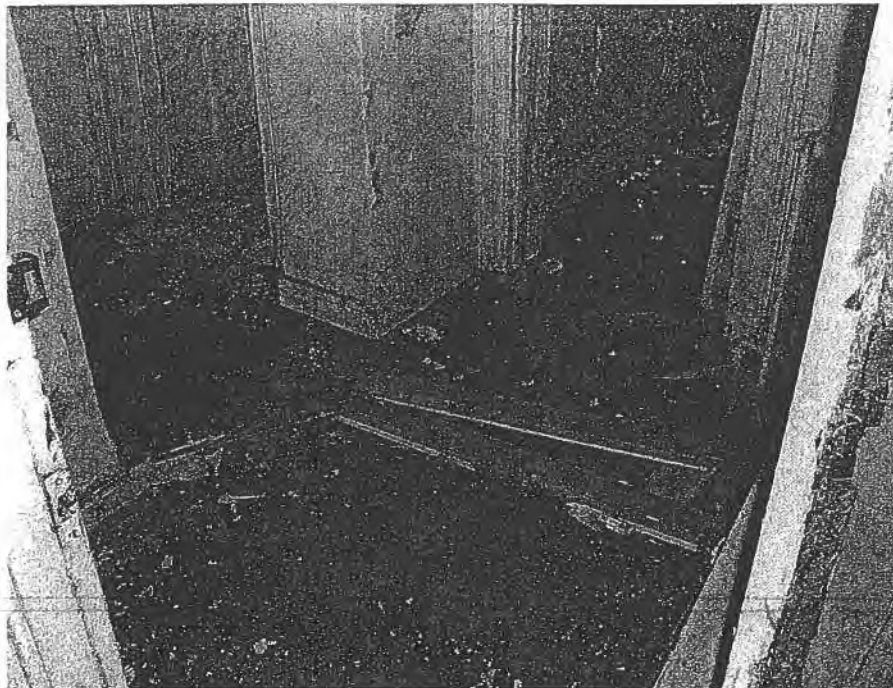
| Element Description | Condition |
|---|---|
| The ground floor structures are predominantly of suspended timber construction although there are some areas of solid flooring. Upper floors are mainly of suspended timber construction. | The floors to the single storey rooms around the link corridor are in poor condition and many are suffering from dry and wet rot attack and have partially collapsed. These floors will require complete replacement. The ground floor of the main building is in fair condition, however, there is a potential for hidden deterioration, particularly since there are isolated areas of dry rot attack evident.<br><br>The upper timber floors are in fair condition and sound underfoot. |

| Element | Material |
|---|---|
| 3. Floors | Limited materials are likely to be salvageable due to the dry rot attack. |

05. Collapsed floor
