17 November 2006

Outline Condition Survey Report  
Cane Hill Hospital – Building 24

## **Outline Condition Survey Report**

**English Partnerships**

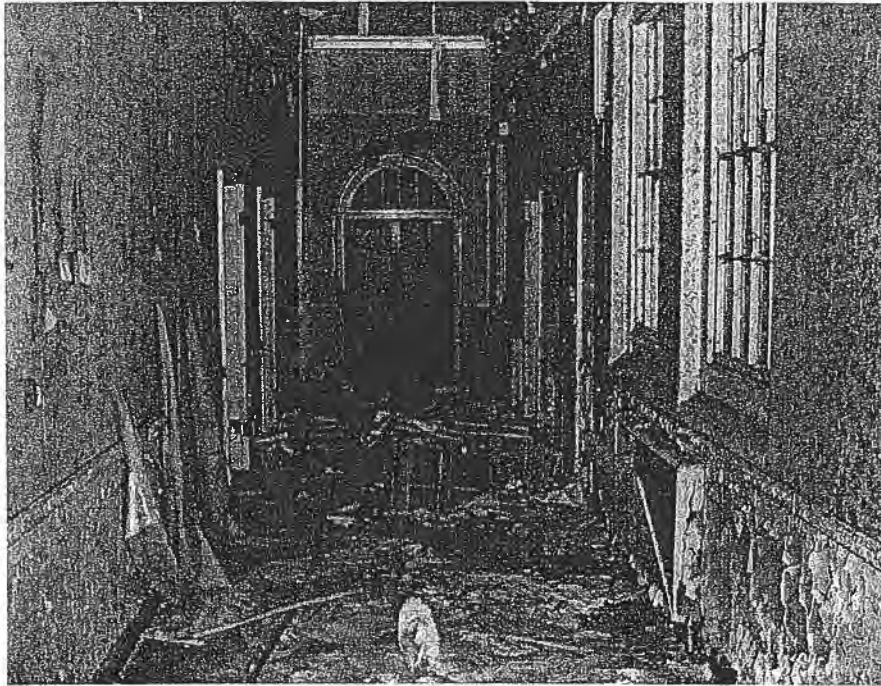
07 Link Corridor

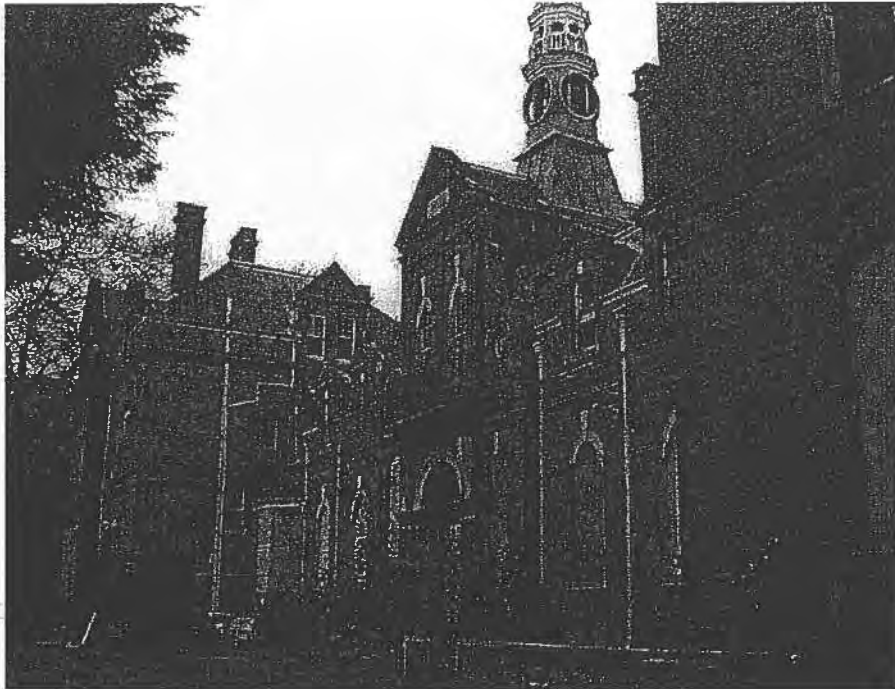
01 South Elevation

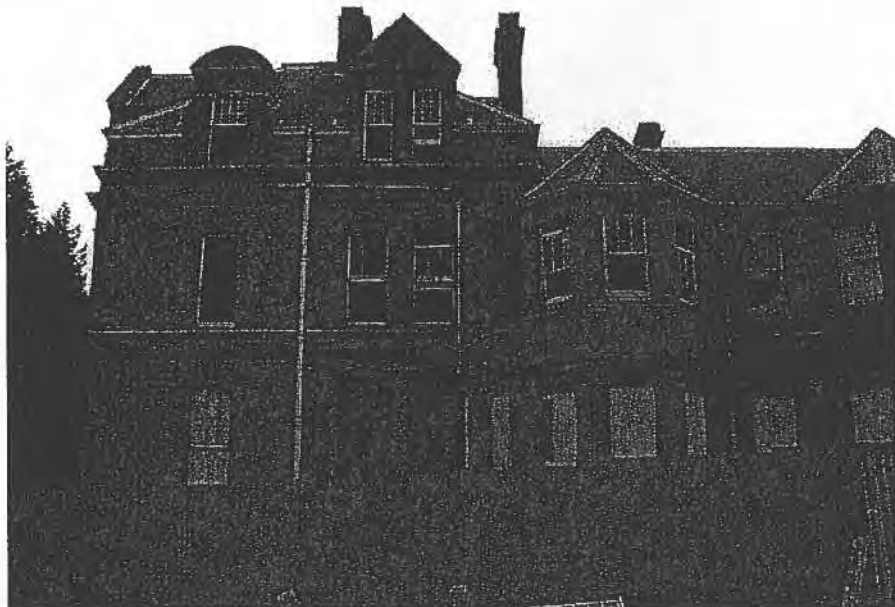
02 East Elevation

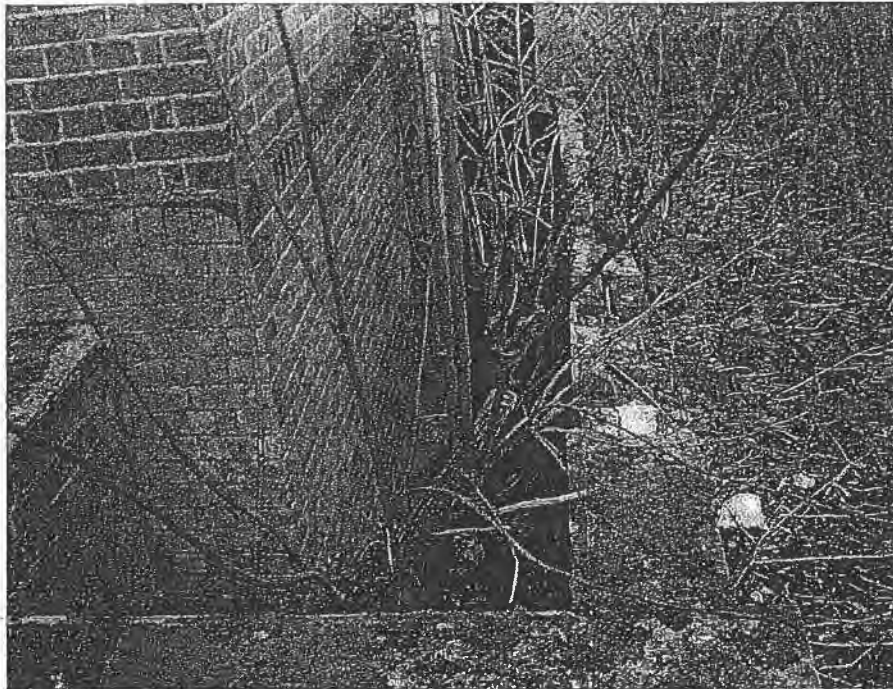
05 Retaining Wall

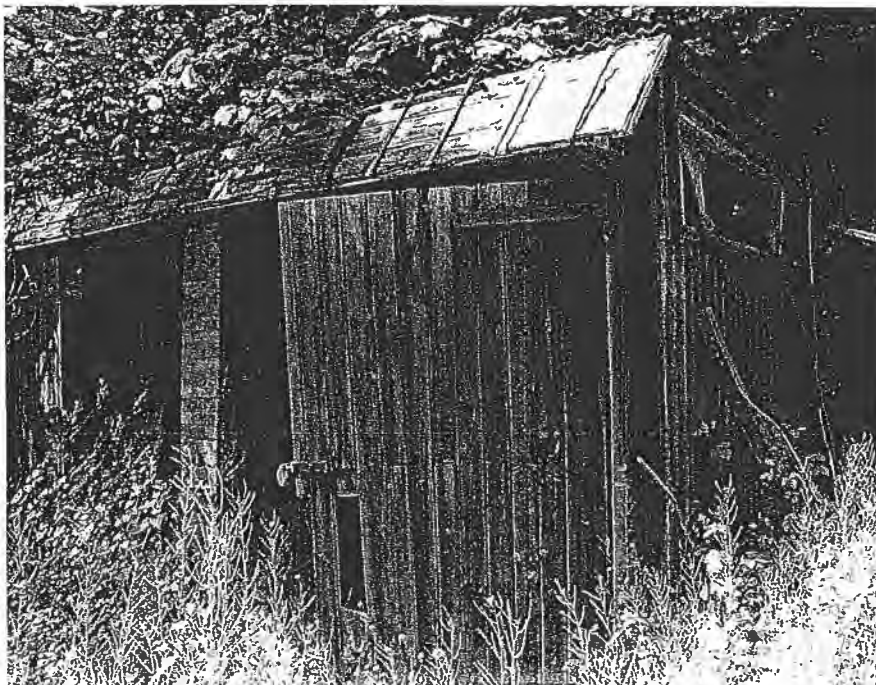
08 Machinery Shed

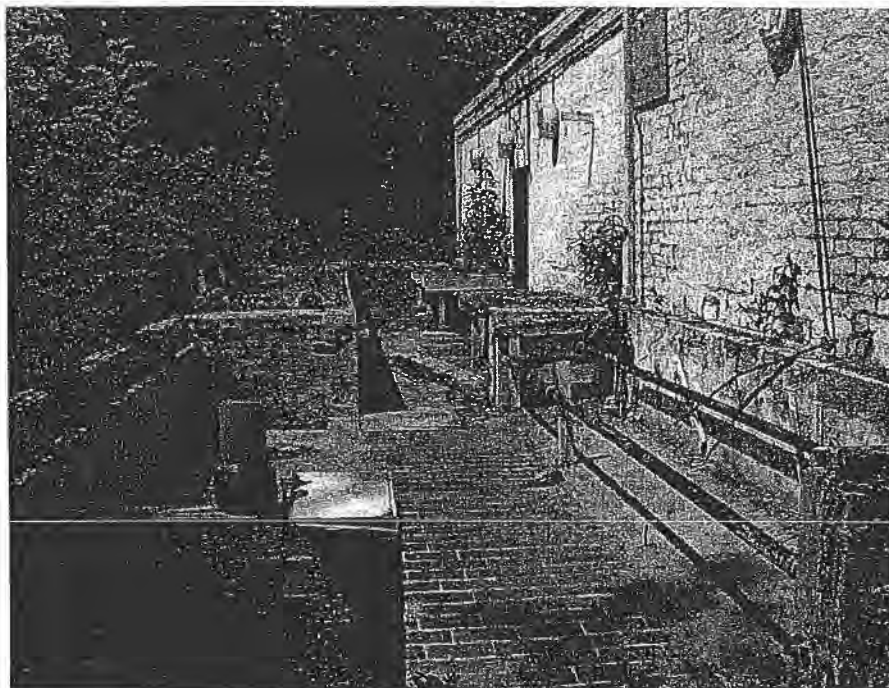
11 Glass house

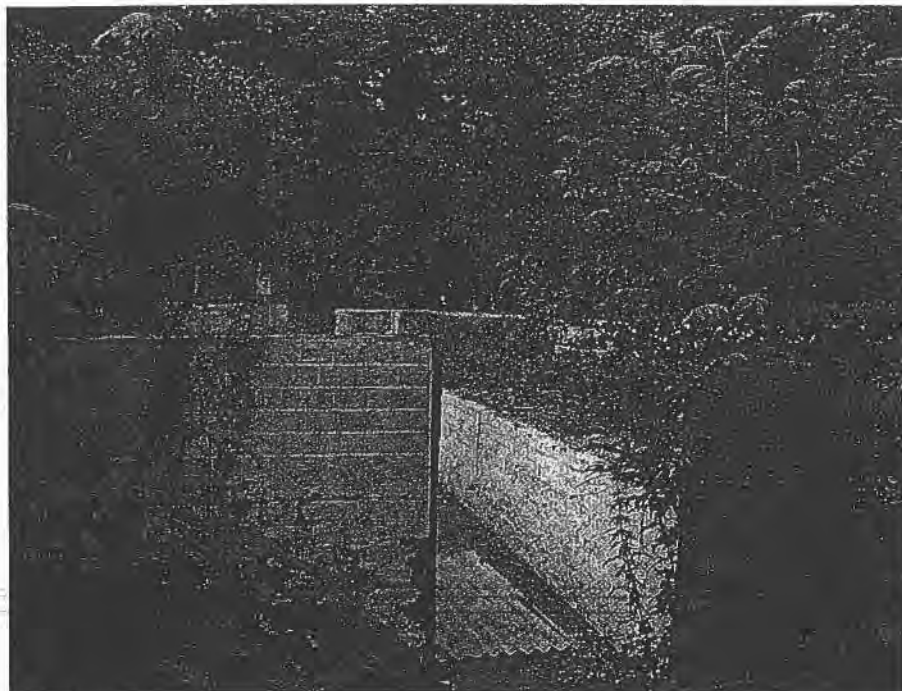
13 Glass house

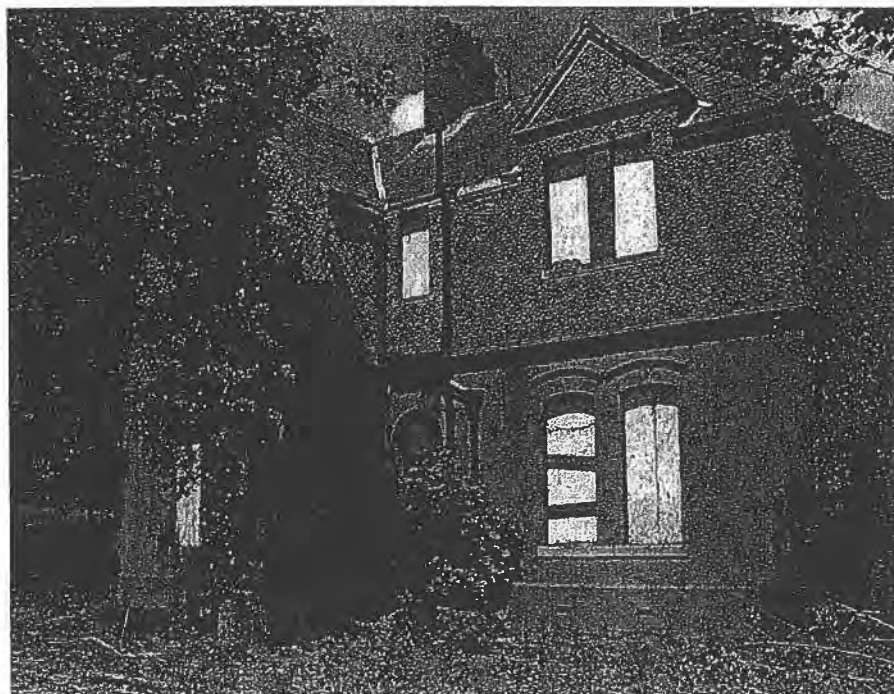
14 Lodge

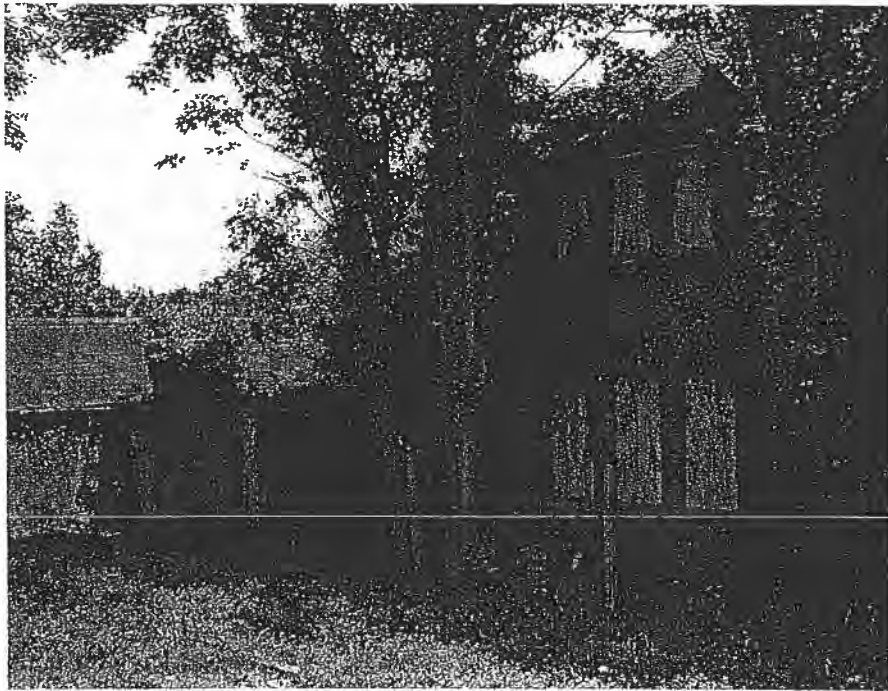
15 Lodge

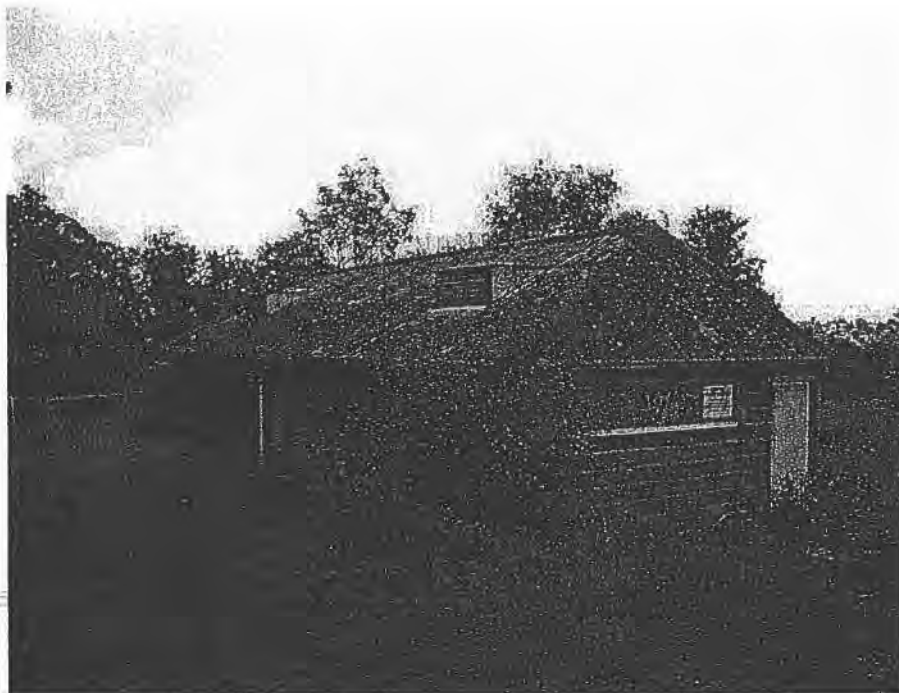
17 Pool house

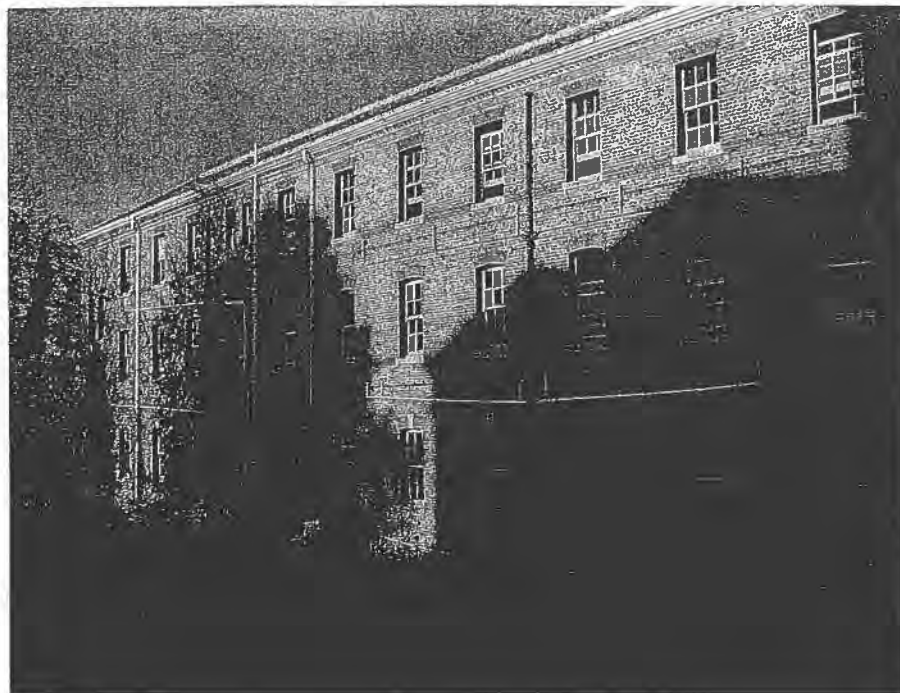
01 West Elevation

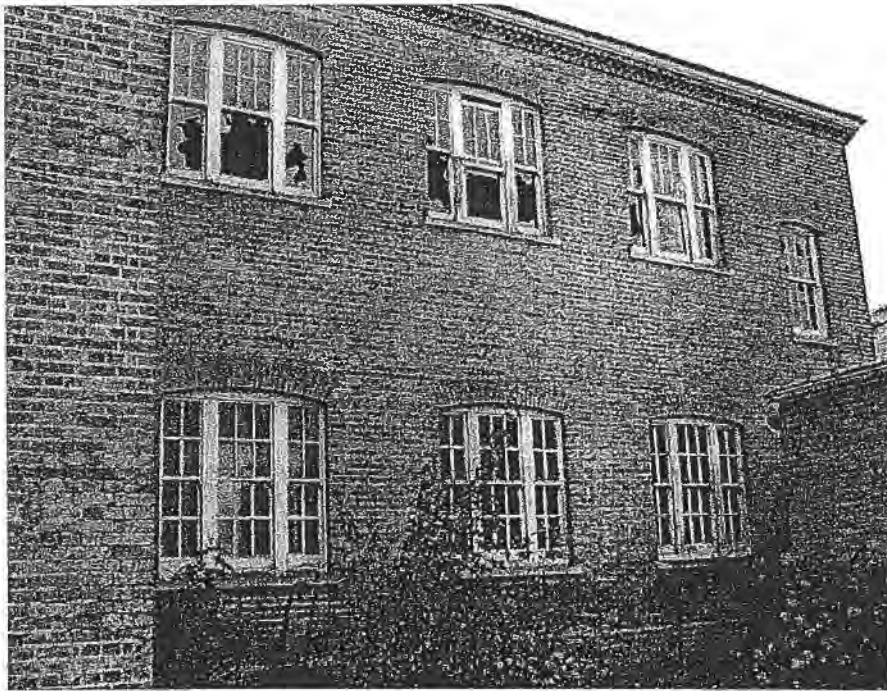
01 N Elevation of 6A

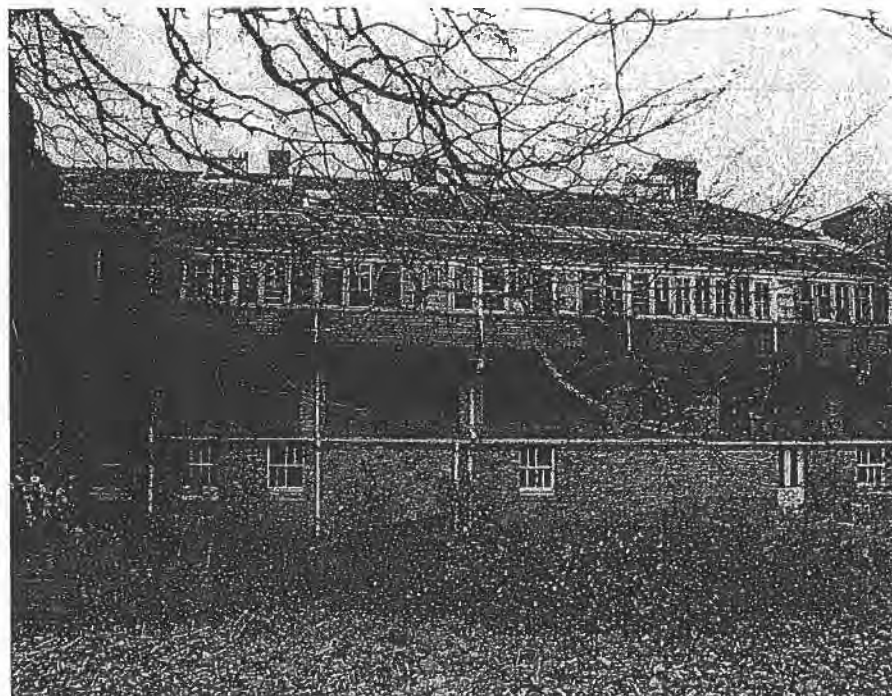
04 S Elevation of 6A

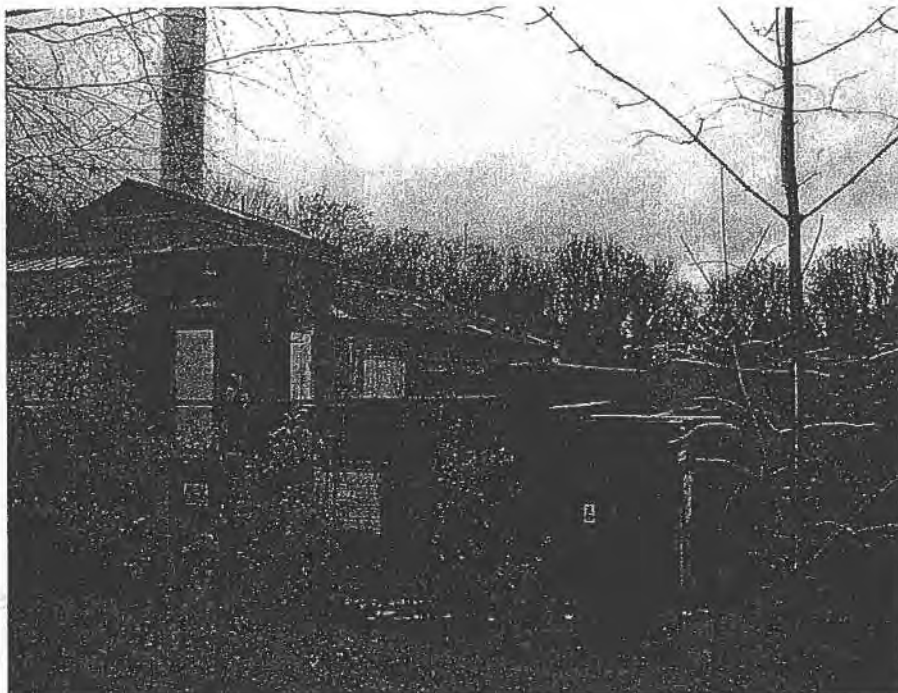
11 SE Elevation of 6C

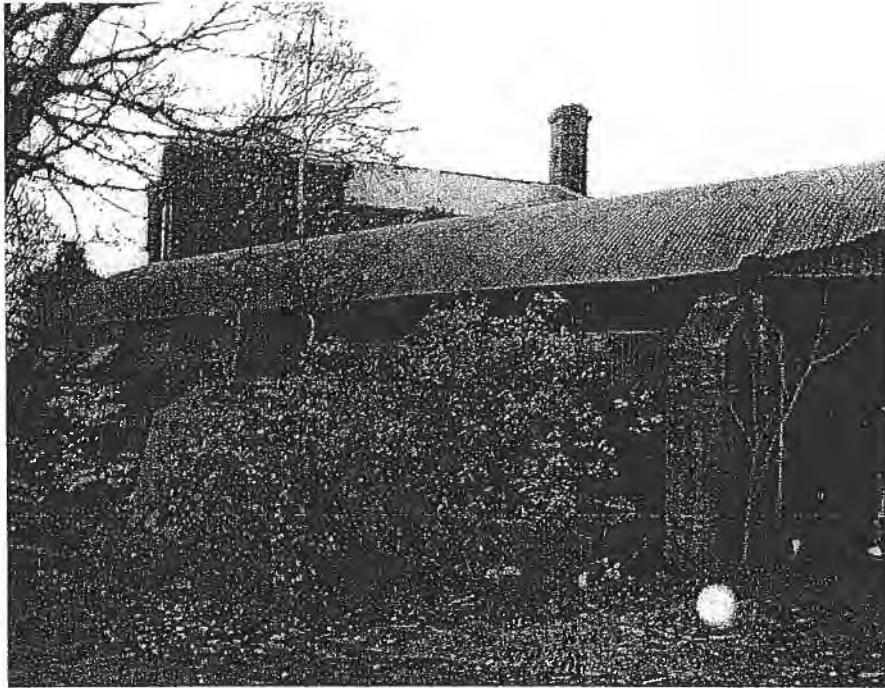
13 W Elevation of 6D

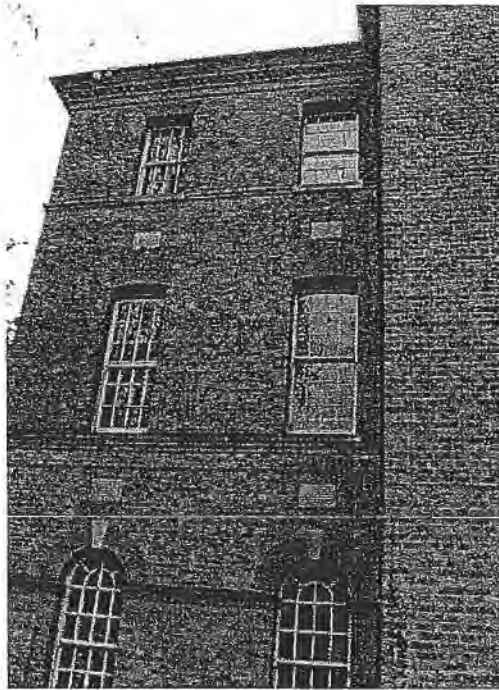
03 West Elevation

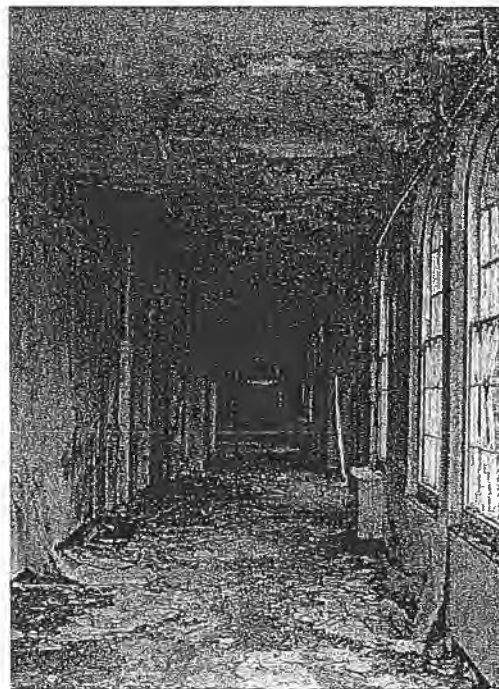
04 Central Corridor

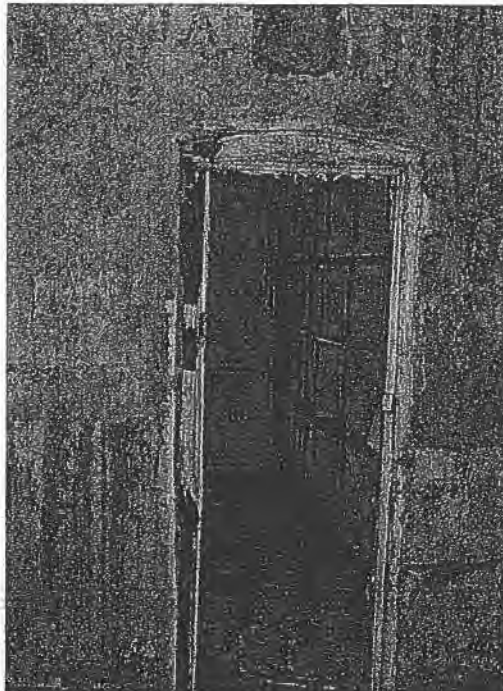
05 Rotten Door Frame

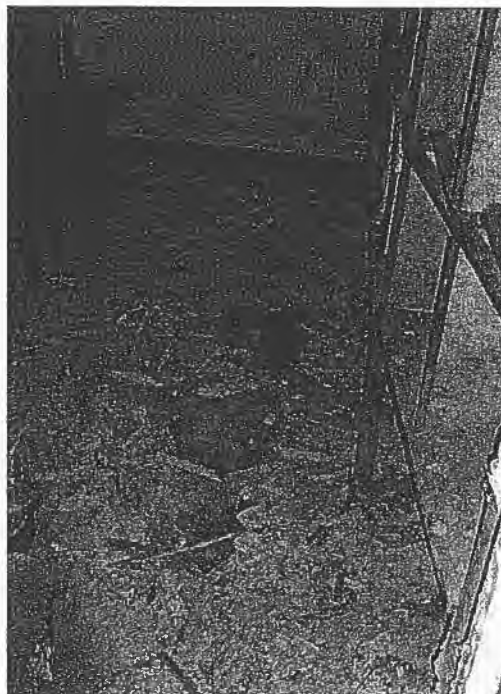
06 Damaged Floor

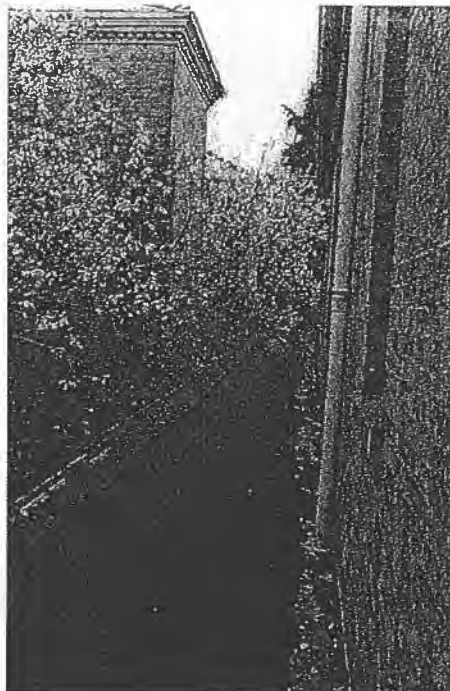
03 Building A & Link Corridor

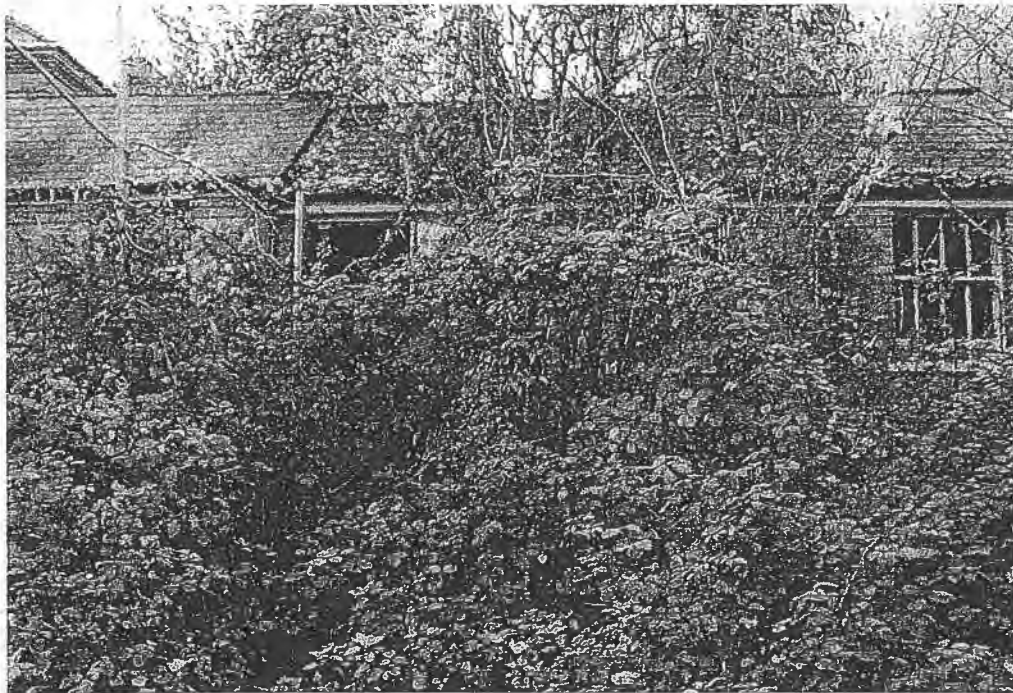
23 Internal courtyard

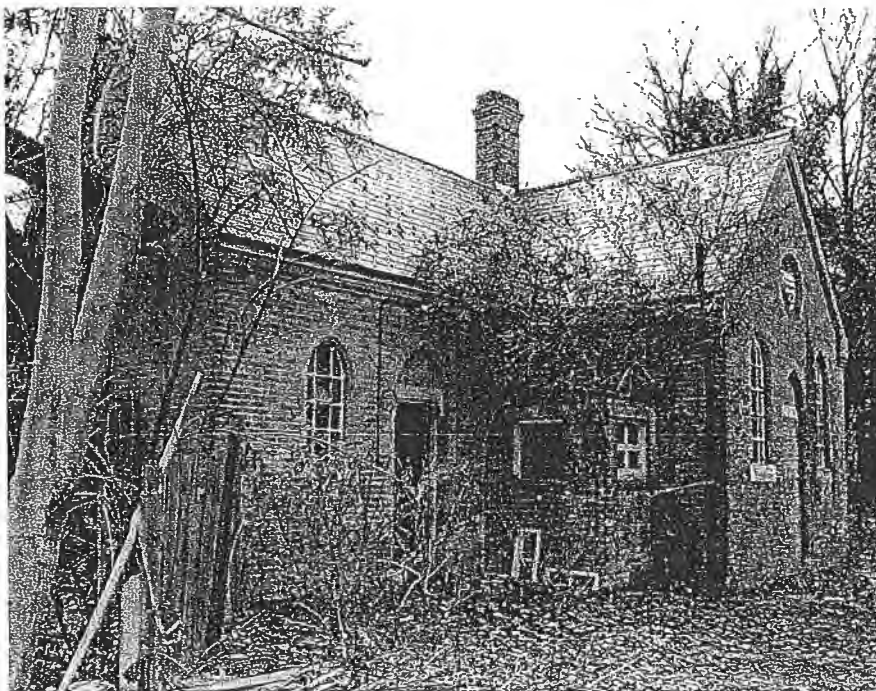
02 W elevation of 9B

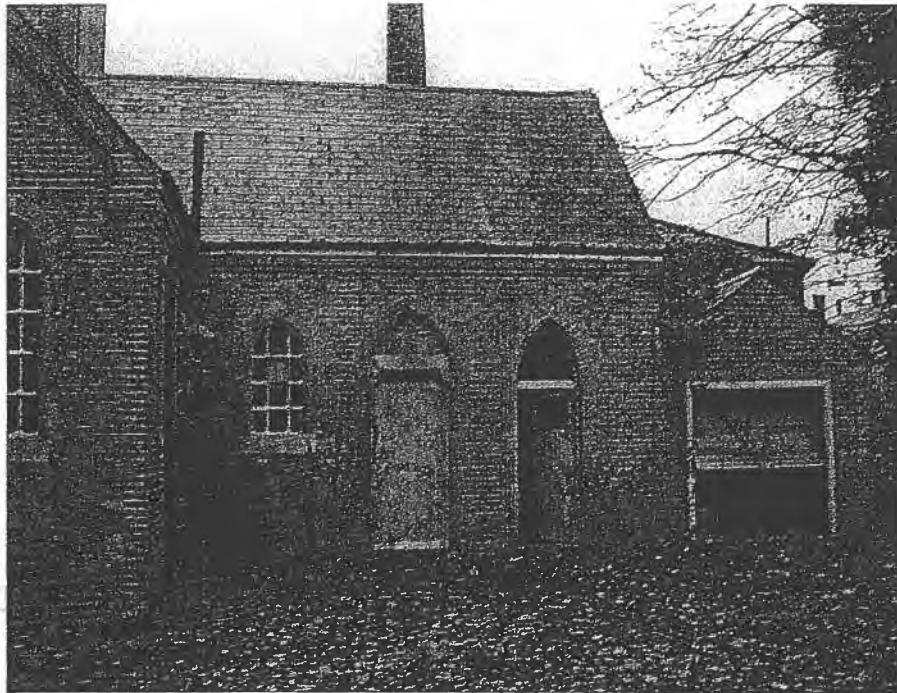
03 W Elevation of 9B

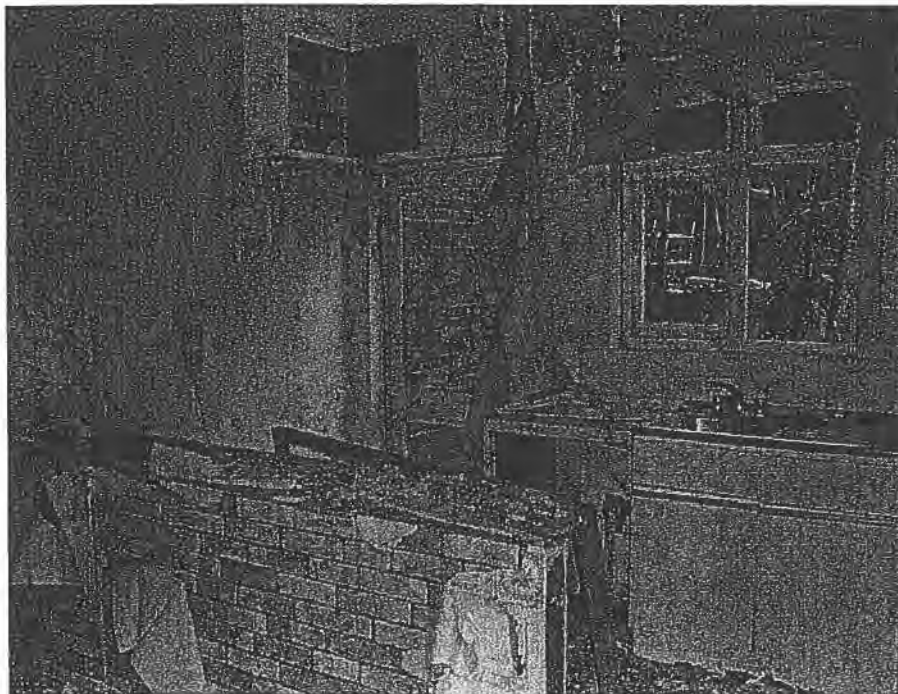
12 Kitchen in 9A

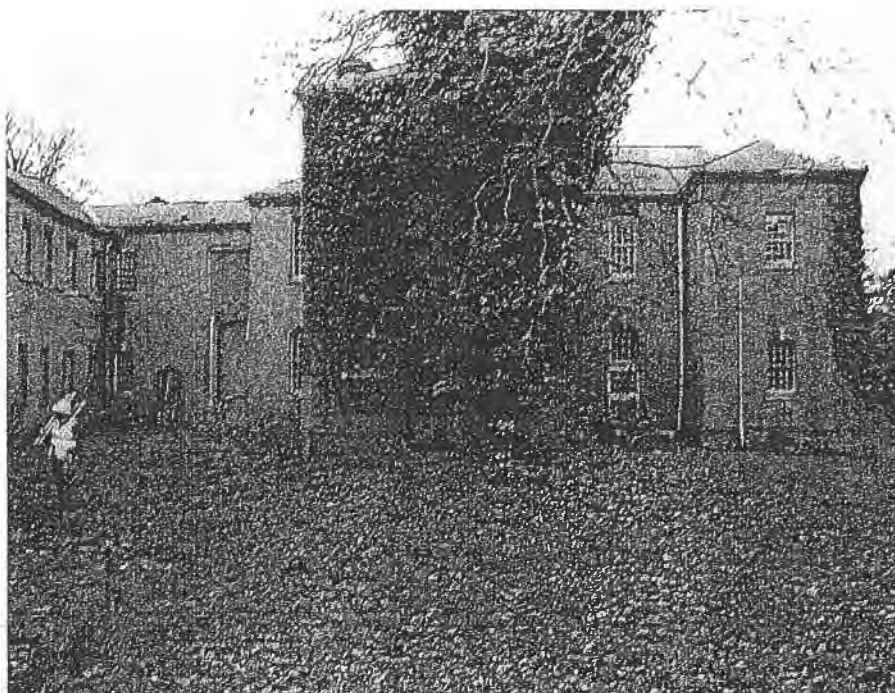
01 N elevation

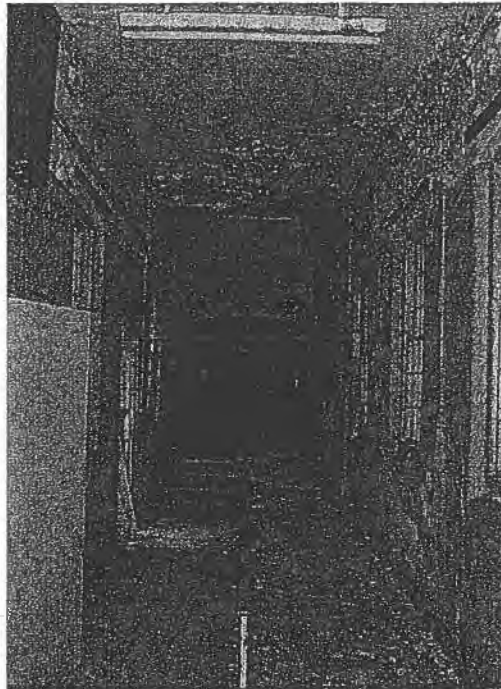
09 General view of links corridor

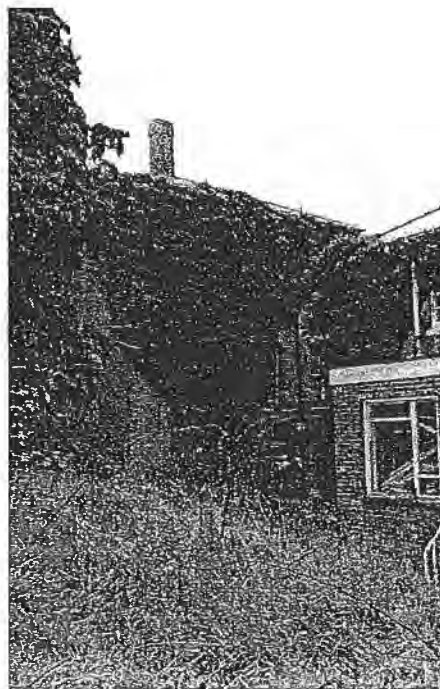
06 Part of West block

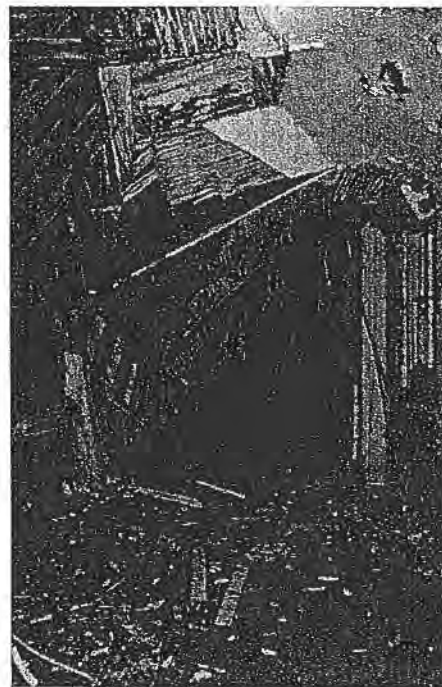
10 Collapsed ceiling to west block
